RESERVE STUDY - FEBRUARY 1, 2020

High Rise Homeowners Association (Sample Only)
3525 Main Street
Los Angeles, California

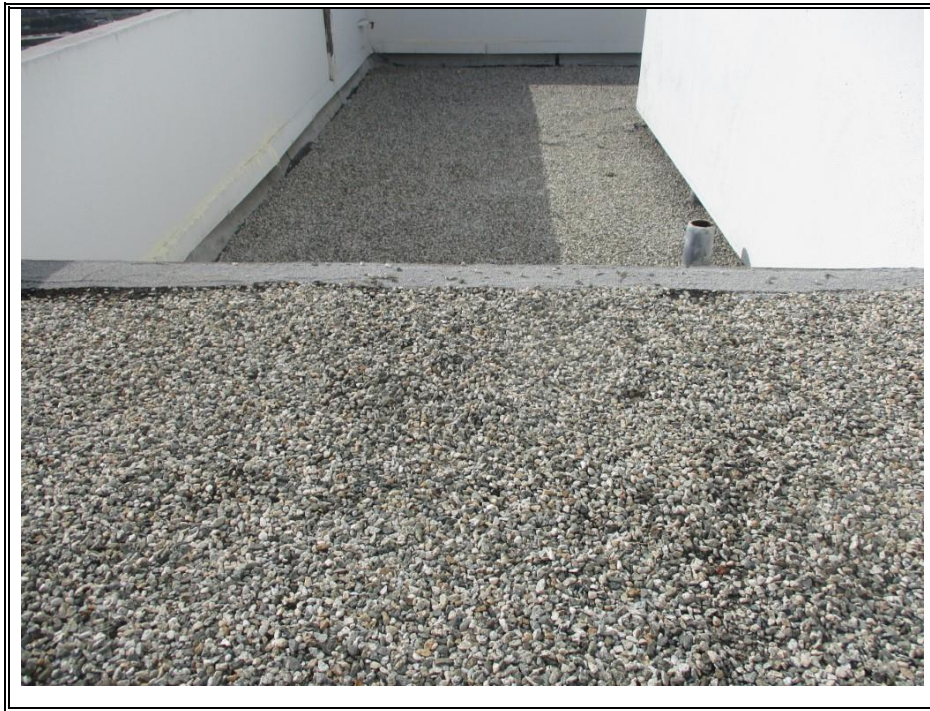
CATEGORY:	ROOF/DECKS	
COMPONENT(S):	BUILT-UP ROOF	ID#(S) 0101

BUILT-UP ROOF (TYPICAL)

OBSERVATIONS: *This component includes the built-up roofing (flat). We were informed that repairs were recently performed on the front canopy roof. It appeared to be in average to aging condition and performing well for its age. On this type of structure, 2 layers are generally permitted. However, if the association should decide to re-roof over the existing roofing, experience dictates that the typical useful life of the new materials would be reduced by approximately one third (33%). The average component cost and typical useful life reflects removal of the existing roofing prior to the installation of the new roofing.*

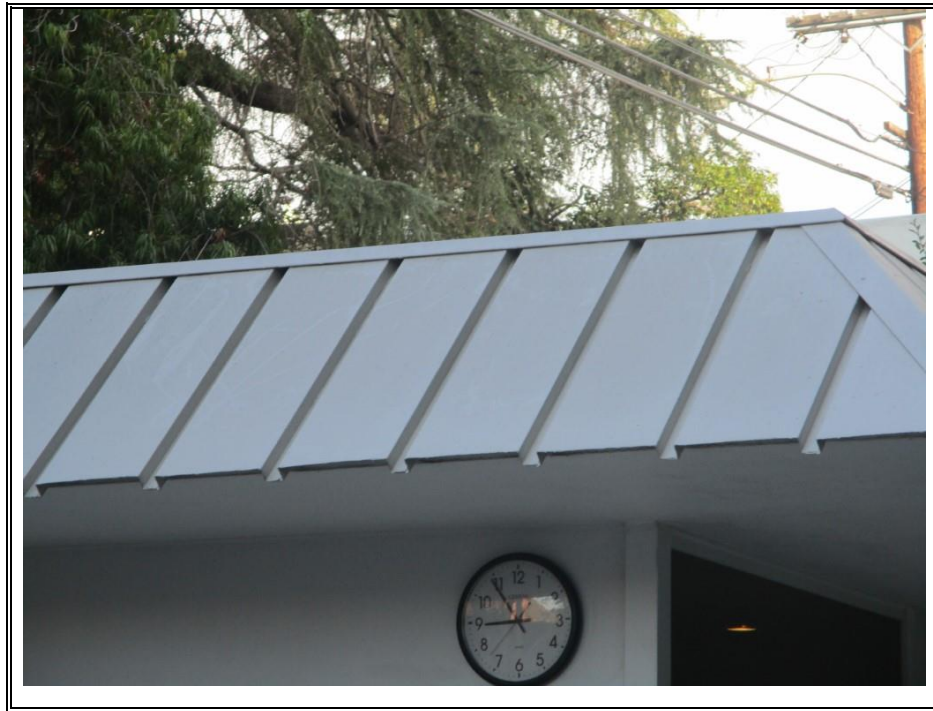
CATEGORY:	ROOF/DECKS	
COMPONENT(S):	METAL ROOF	ID#(S) 0102

METAL ROOF (TYPICAL)

OBSERVATIONS: *This component includes the metal roofing (sloped) on the mansard at the pool restroom building. It would typically have a life expectancy in excess of 30 years and therefore no amount has been budgeted for its replacement at this time.*

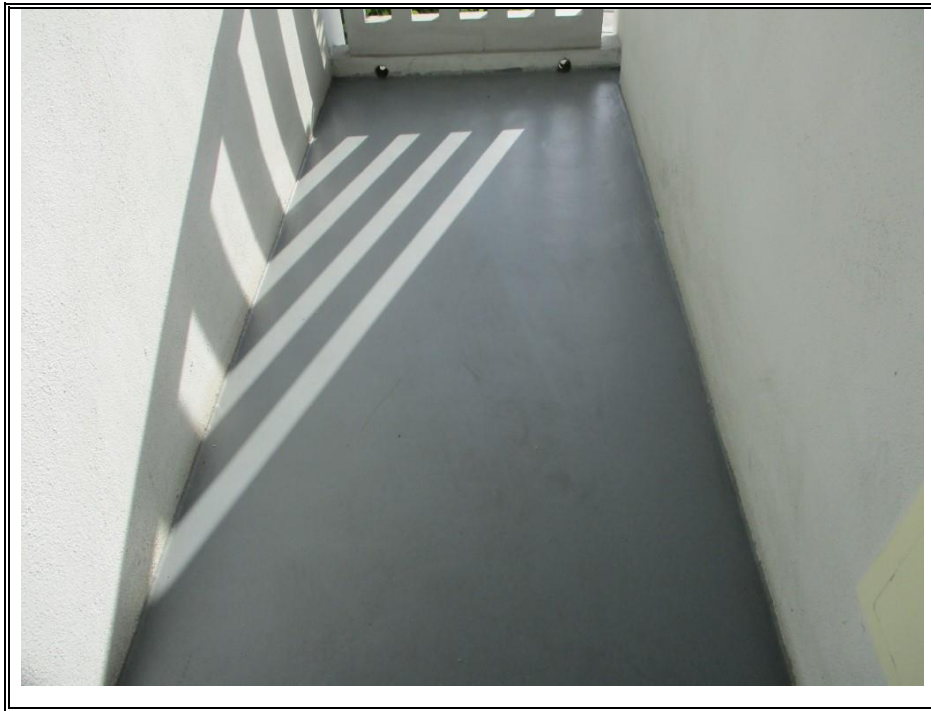
CATEGORY:	ROOF/DECKS		
COMPONENT(S):	MEMBRANE DECKS- COMMON (RESURFACE)	ID#(S)	0103

MEMBRANE DECKS- COMMON (RESURFACE) (TYPICAL)

OBSERVATIONS: *This component includes the membrane deck surfaces over the concrete exterior walkways. They appeared to be of varying ages and conditions and, for reporting purposes, their remaining lives have been averaged. Resurfacing of these areas is critical in order to prevent internal damage to the structural elements and possible leakage into units that are adjacent to, or beneath these decks. The average component cost does not provide for any possible repairs/replacement of substrate damage that is sometimes discovered upon future removal of the deck surfacing.*

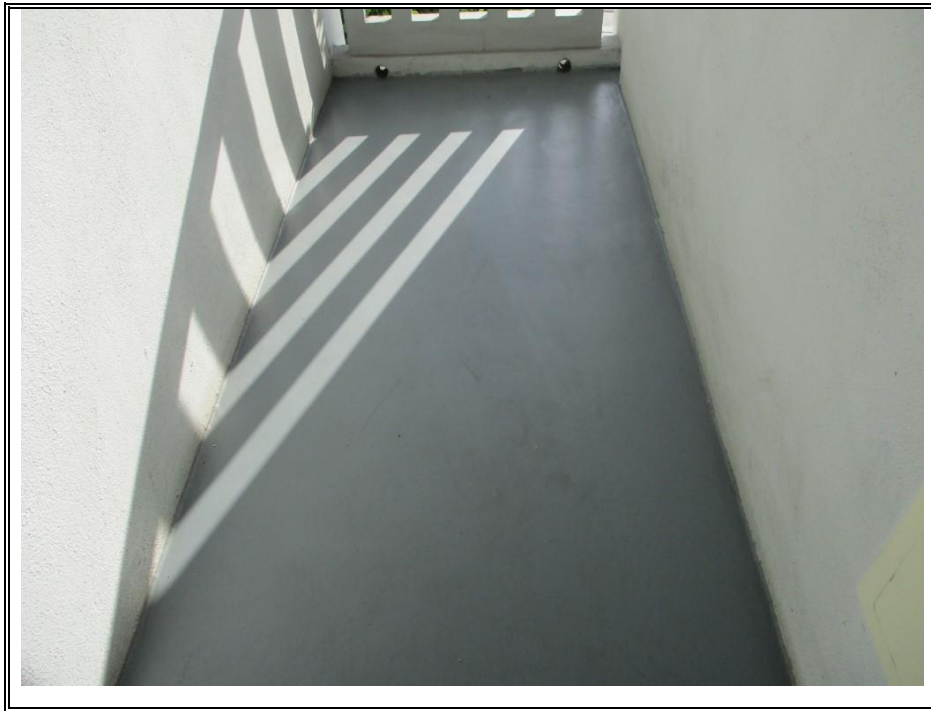
CATEGORY:	ROOF/DECKS	
COMPONENT(S):	MEMBRANE DECKS-COMMON (COATING)	ID#(S) 0104

MEMBRANE DECKS-COMMON (COATING) (TYPICAL)

OBSERVATIONS: *This component includes the coating for the deck surfaces described in component ID #0103. They appeared to be of varying ages and conditions and, for reporting purposes, their remaining lives have been averaged.*

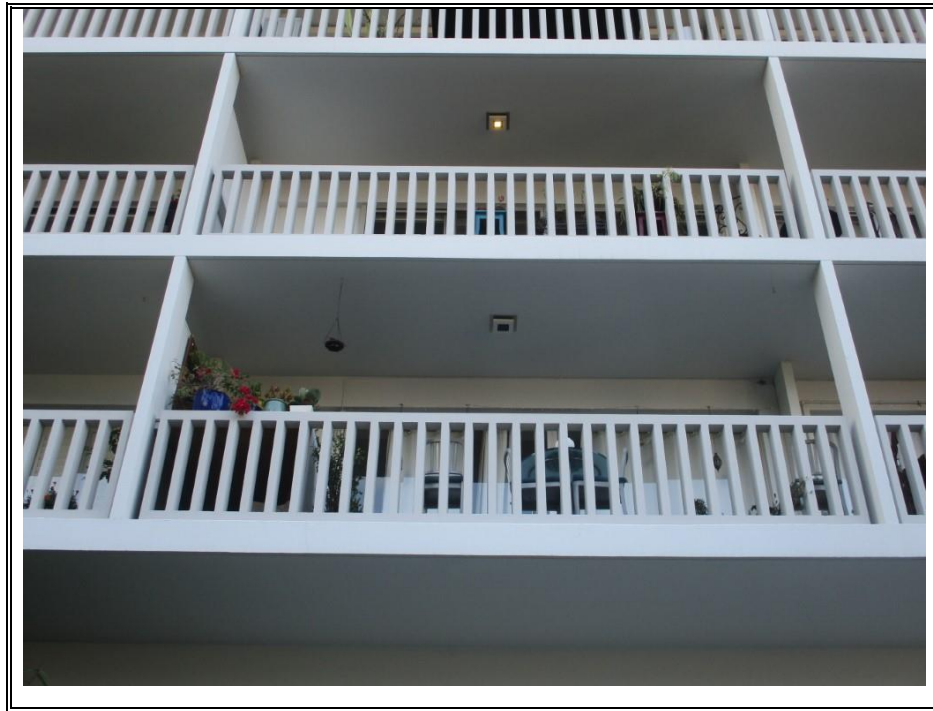
CATEGORY:	ROOF/DECKS	
COMPONENT(S):	MEMBRANE DECKS-UNITS (RESURFACE)	ID#(S) 0105

MEMBRANE DECKS-UNITS (RESURFACE) (TYPICAL)

OBSERVATIONS: *This component includes the membrane deck surfaces of the individual units. We were informed that maintenance and repairs are the responsibility of the individual unit owners. However, the lack of attention to these surfaces could cause damage to the building structure, and it is recommended that the association retain responsibility for same.*

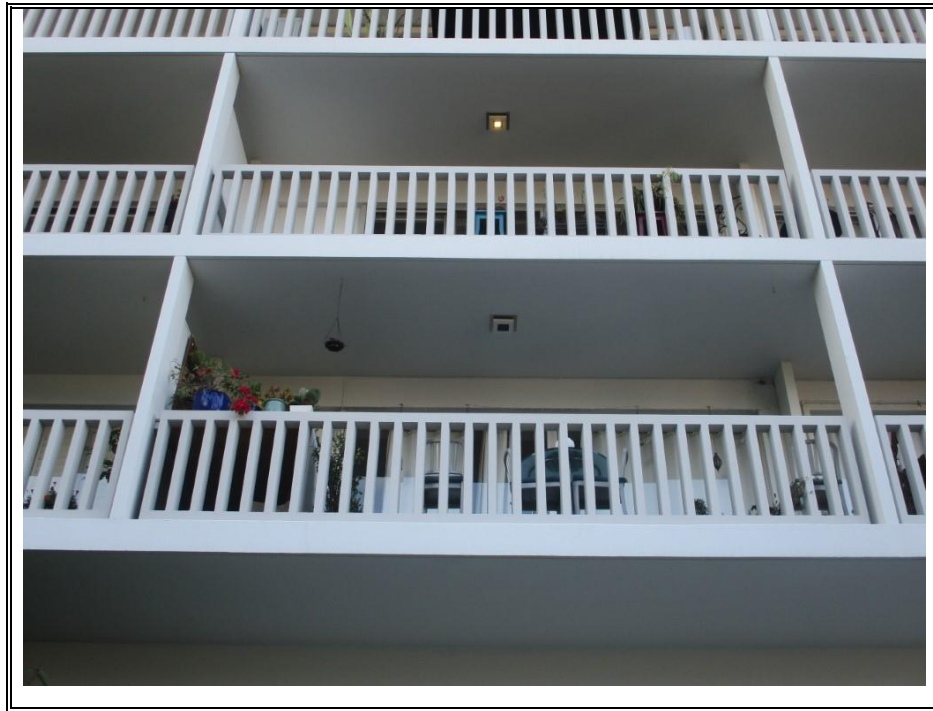
CATEGORY:	ROOF/DECKS	
COMPONENT(S):	MEMBRANE DECKS-UNITS (COATING)	ID#(S) 0106

MEMBRANE DECKS-UNITS (COATING) (TYPICAL)

OBSERVATIONS: *This component includes the coating for the deck surfaces described in component ID #0105. We were informed that maintenance and repairs are the responsibility of the individual unit owners. However, the lack of attention to these surfaces could cause damage to the building structure, and it is recommended that the association retain responsibility for same.*

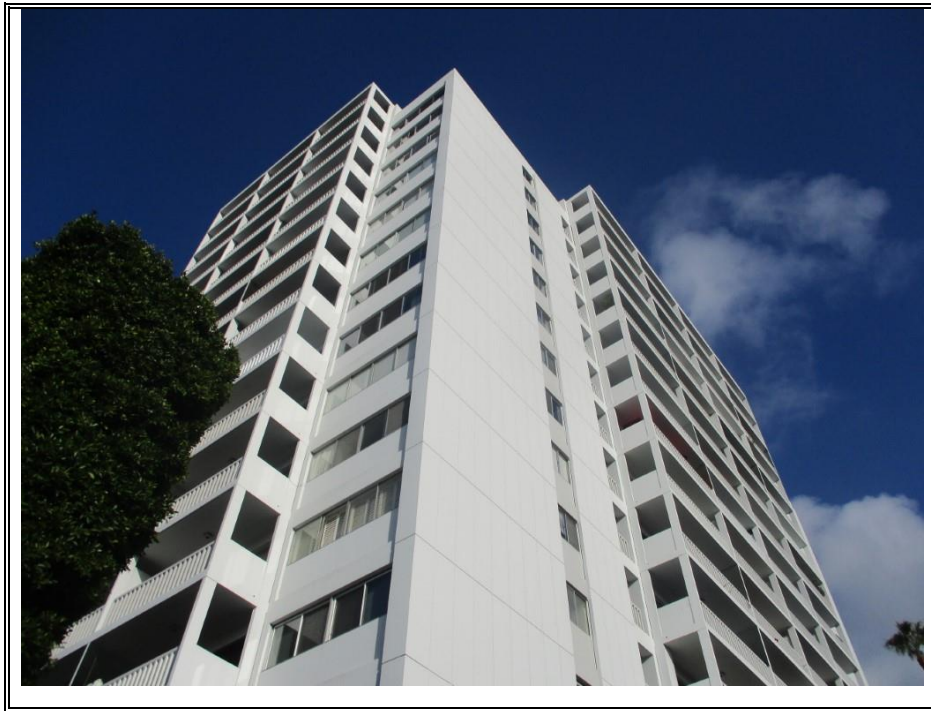
CATEGORY:	STRUCTURE		
COMPONENT(S):	FOUNDATIONS/STRUCTURAL FRAME	ID#(S)	0201

FOUNDATIONS/STRUCTURAL FRAME (TYPICAL)

OBSERVATIONS: *This component includes the foundations and structural frame, along with the exterior surfaces of the main building and the pool restroom building. Provided there are no major catastrophes, the proper drainage principles are maintained and that structural pest control procedures are adhered to (see component ID #0202), this would normally be considered to be a lifetime component for which no reserve budget would be called for.*

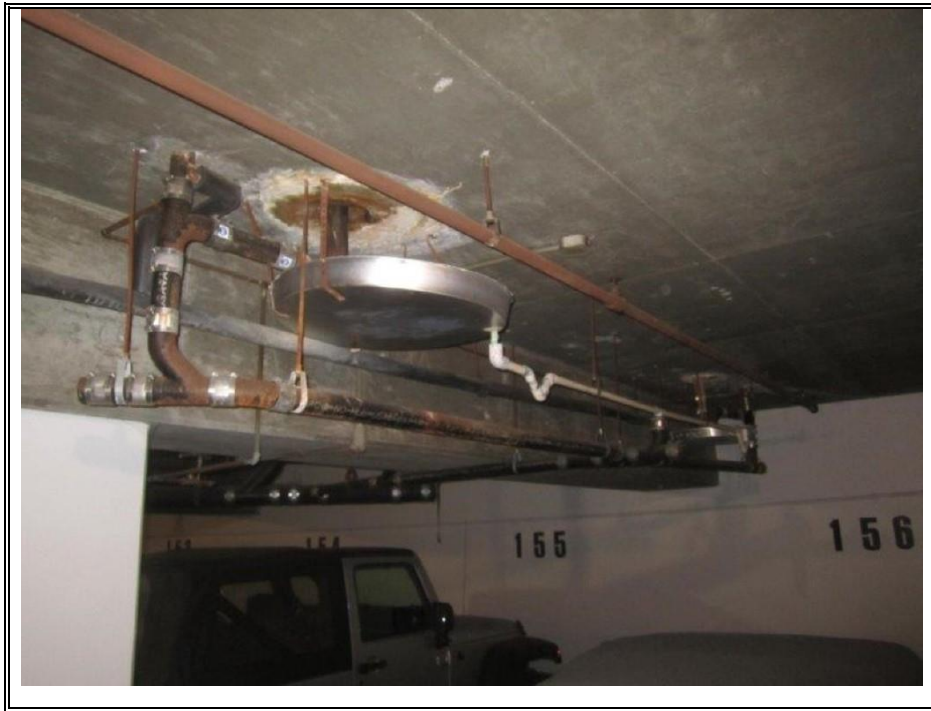
CATEGORY:	STRUCTURE	
COMPONENT(S):	WATERPROOFING	ID#(S) 0202

WATERPROOFING (TYPICAL)

OBSERVATIONS: *This component addresses the waterproofing of the building. The existing waterproofing appeared to be questionable, based on what was visible and evidenced by sub-grade leakage. If left unchecked, there is a likelihood that structural damage and/or mold infestation could result. Further evaluation of the drainage should be obtained from a qualified waterproofing consultant regarding this situation (See Component ID# 0508). Bids should be obtained for any corrective work deemed necessary, and adjustments can be incorporated into a future Reserve Study Update.*

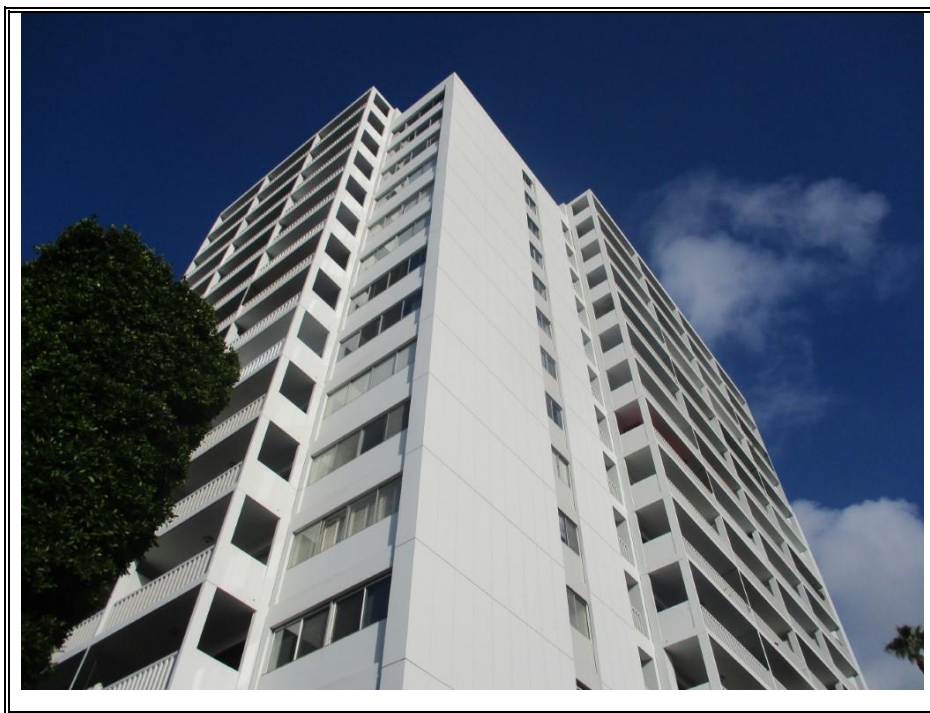
CATEGORY:	STRUCTURE	
COMPONENT(S):	STRUCTURAL PEST CONTROL	ID#(S) 0203

STRUCTURAL PEST CONTROL (TYPICAL)

OBSERVATIONS: *This component addresses the potential need for fumigation of the building. When and where an infestation of wood destroying pests or organisms occurs, and how severe the infestation will be, is difficult to predict. The California Department of Real Estate (DRE) suggests that annual inspections be performed to discover any infestation in its early stages before it becomes a serious problem. As this building is primarily concrete and steel, no funding for complete fumigation has been provided. It is recommended that any necessary treatments be funded on an as-needed basis from the operating account. Also, it is suggested that the association seek the services of a licensed pest control operator for further evaluation and recommendations.*

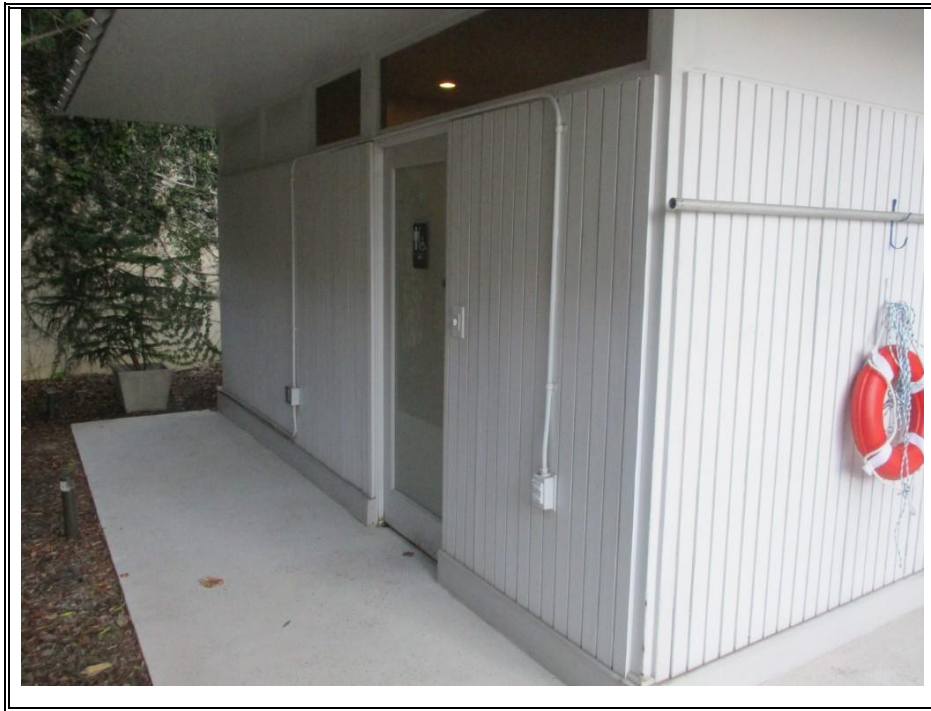
CATEGORY:	STRUCTURE	
COMPONENT(S):	SIDING	ID#(S) 0204

SIDING (TYPICAL)

OBSERVATIONS: *This component includes the T-11 plywood siding on the exterior of the pool restroom building. We were informed that maintenance was performed in 2017 and it generally appeared to be in average condition for its age.*

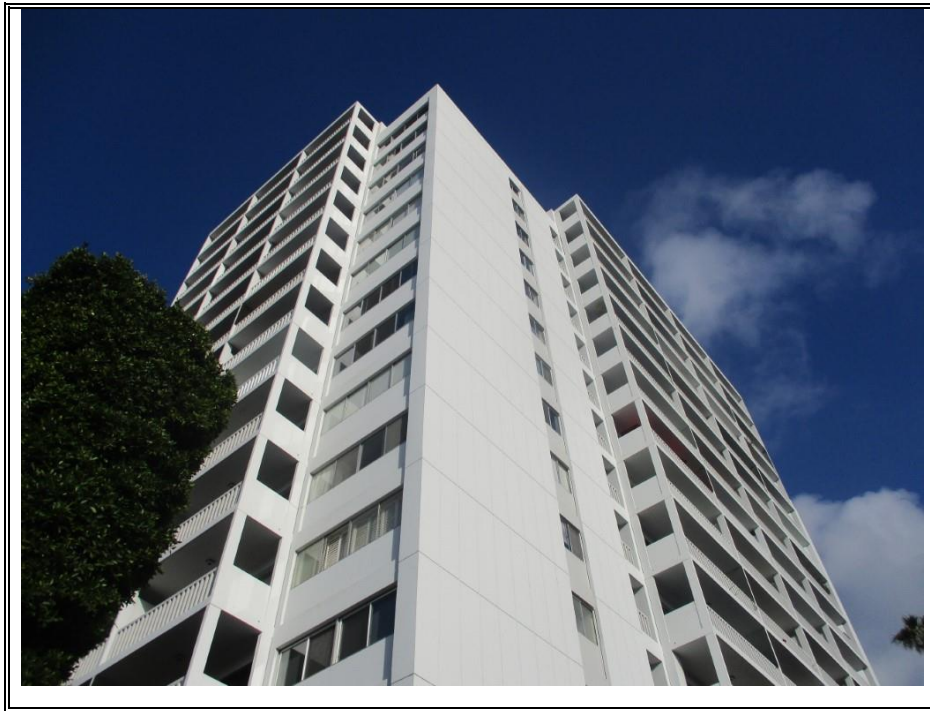
CATEGORY:	<i>PAINT</i>	
COMPONENT(S):	<i>EXTERIOR FLATWORK</i>	ID#(S) 0301

EXTERIOR FLATWORK (TYPICAL)

OBSERVATIONS: *This component includes the painted surfaces of the concrete, on the exterior of the high-rise building and on the adjacent masonry walls. We were previously informed that it was painted in 2012 and appeared to be in average condition for its age.*

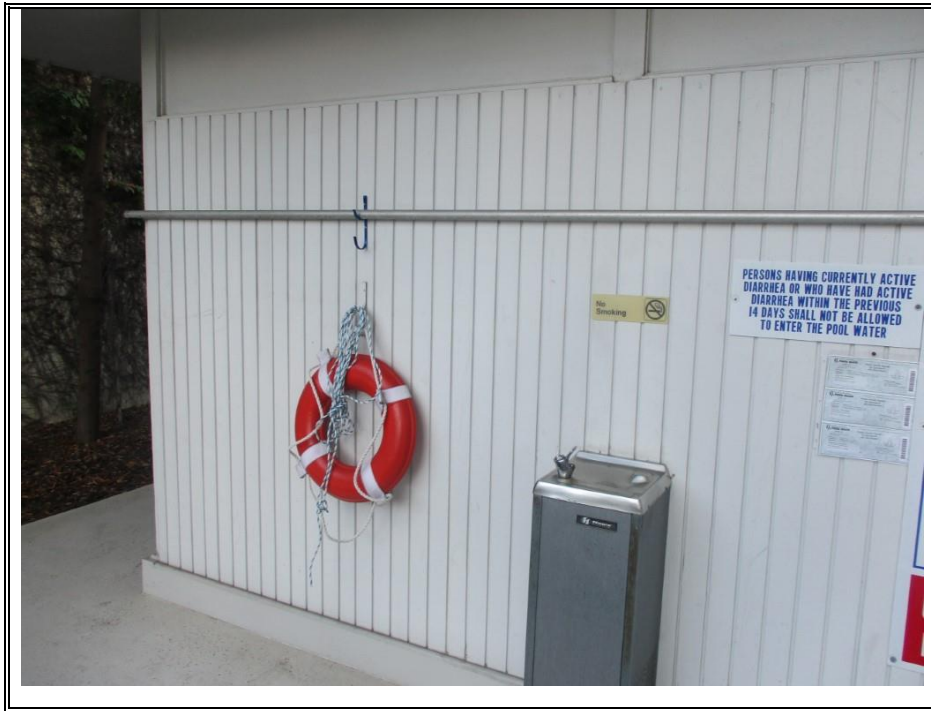
CATEGORY:	<i>PAINT</i>	
COMPONENT(S):	<i>SIDING & TRIM</i>	ID#(S) 0302

SIDING & TRIM (TYPICAL)

OBSERVATIONS: *This component includes the painted surfaces of the plywood siding at the pool restroom building, and other miscellaneous wood trim. We were informed of touch up painting in 2017 and they generally appeared to be in average condition.*

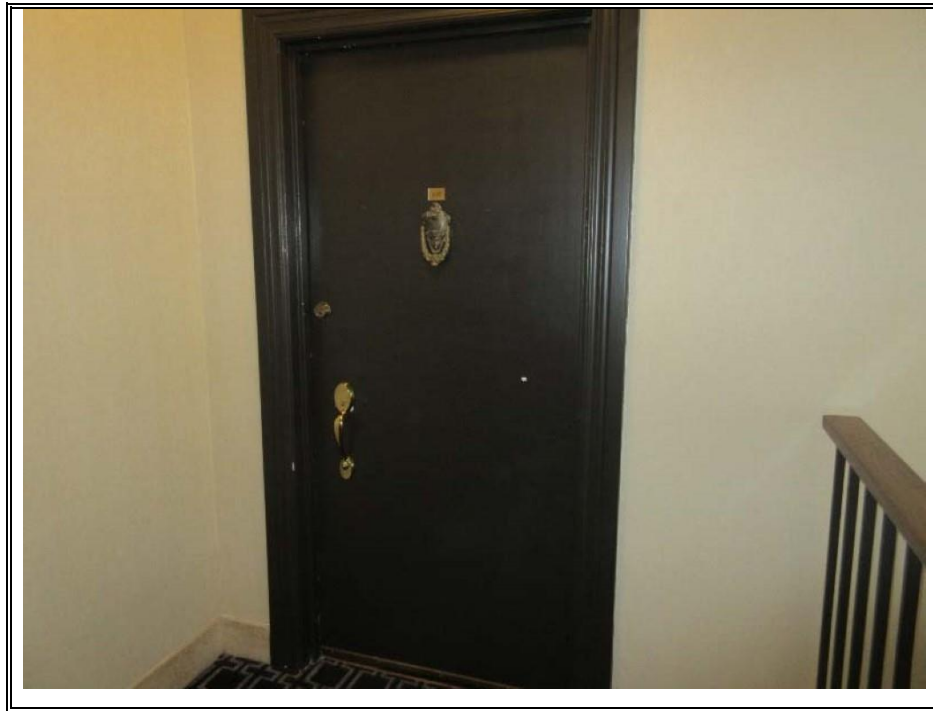
CATEGORY:	PAINT	
COMPONENT(S):	DOORS	ID#(S) 0303

DOORS (TYPICAL)

OBSERVATIONS: *This component includes the painted surfaces of the exteriors of the individual unit doors, as well as both sides of the common area doors. We were informed of touch up painting in 2017 and they generally appeared to be in average condition.*

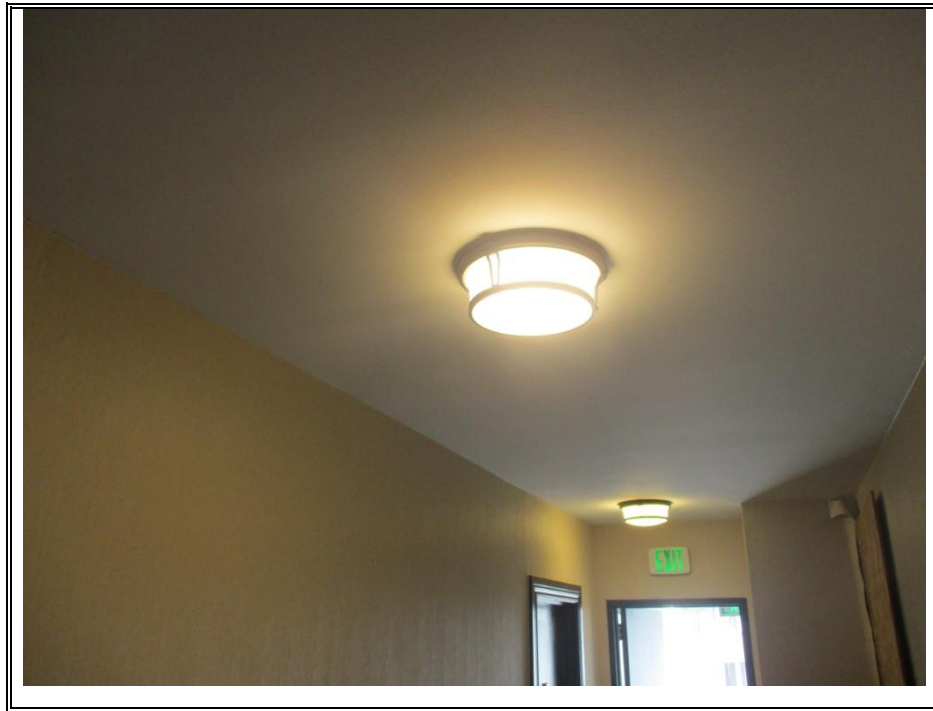
CATEGORY:	PAINT	
COMPONENT(S):	INTERIOR FLATWORK-HALLWAY	ID#(S) 0304

INTERIOR FLATWORK-HALLWAY (TYPICAL)

OBSERVATIONS: *This component includes the painted surfaces of the internal hallways (ceilings and trim). We were informed of touch up painting in 2017 and they generally appeared to be in average condition for their age.*

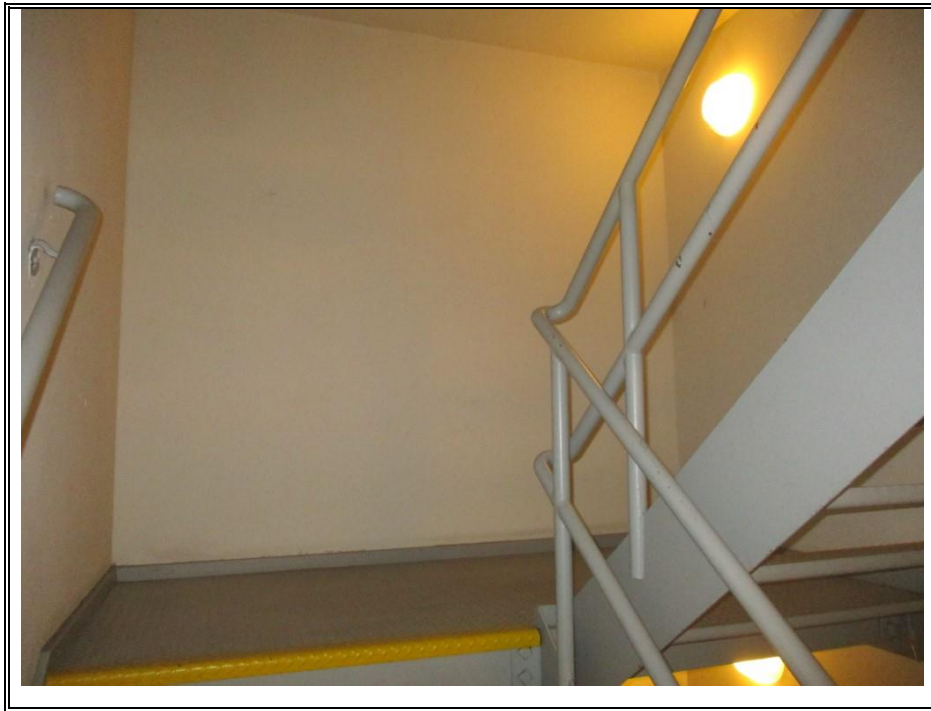
CATEGORY:	PAINT	
COMPONENT(S):	INTERIOR FLATWORK-STAIRWELLS	ID#(S) 0305

INTERIOR FLATWORK-STAIRWELLS (TYPICAL)

OBSERVATIONS: *This component includes the painted surfaces of the stairwells (walls and ceilings). We were informed of touch up painting in 2017 and they generally appeared to be in average condition for their age.*

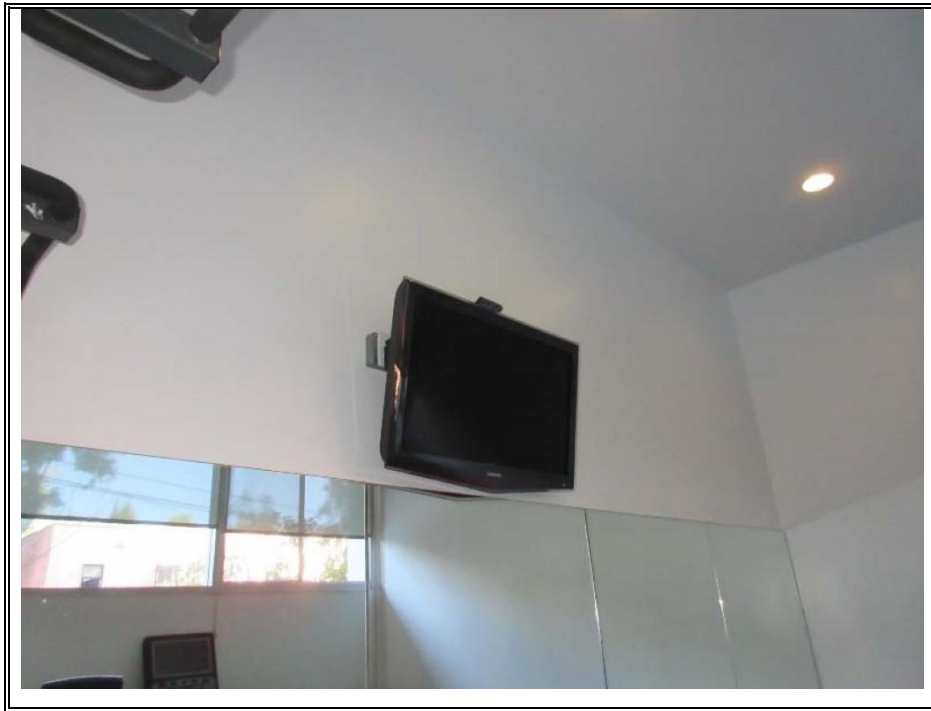
CATEGORY:	PAINT	
COMPONENT(S):	INTERIOR FLATWORK-RECREATION	ID#(S) 0306

INTERIOR FLATWORK-RECREATION (TYPICAL)

OBSERVATIONS: *This component includes the painted surfaces of the gym, restrooms, lobby, office, and other miscellaneous common areas. We were informed of touch up painting in 2017 and they generally appeared to be in average condition for their age.*

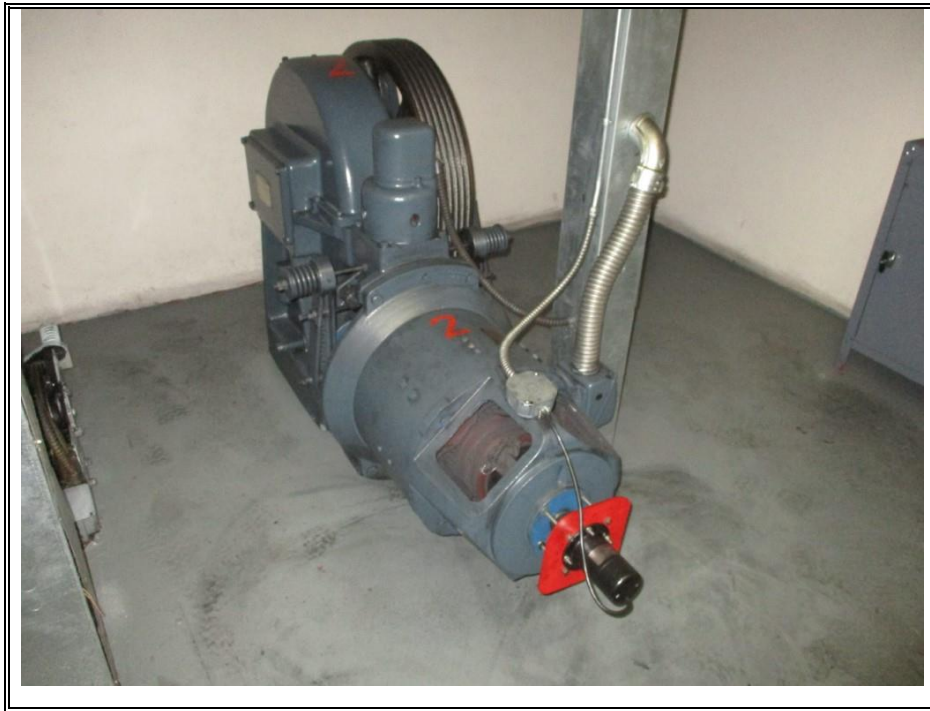
CATEGORY:	MECHANICAL	
COMPONENT(S):	ELEVATORS-MECHANICAL	ID#(S) 0401

ELEVATORS-MECHANICAL (TYPICAL)

TO PROTECT YOUR INVESTMENT: *We recommend obtaining a maintenance contract with a qualified specialist.*
