RESERVE STUDY - MARCH 9, 2023

High Rise Homeowners Association (Sample Only)  
3525 Main Street  
Los Angeles, California

# TABLE OF CONTENTS

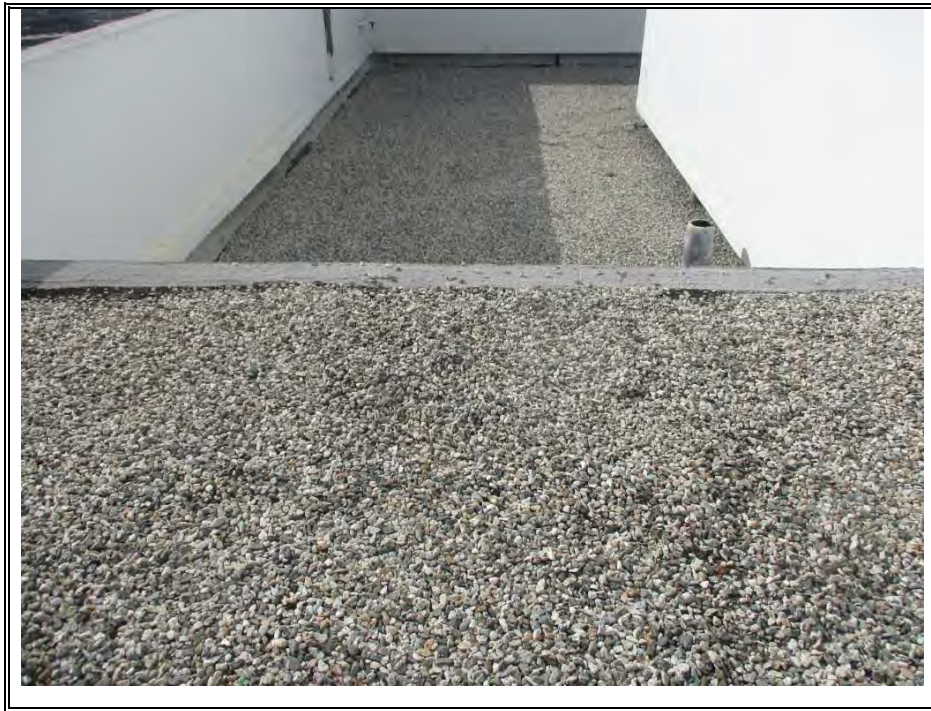
<b>CATEGORY:</b>	ROOF/DECKS	
<b>COMPONENT(S):</b>	BUILT-UP ROOF	<b>ID#(S)</b> 0101

**BUILT-UP ROOF (TYPICAL)**

**OBSERVATIONS:** *This component includes the built-up roofing (flat). We were informed that repairs were recently performed on the front canopy roof. It appeared to be in average to aging condition and performing well for its age. On this type of structure, 2 layers are generally permitted. However, if the association should decide to re-roof over the existing roofing, experience dictates that the typical useful life of the new materials would be reduced by approximately one third (33%). The average component cost and typical useful life reflects removal of the existing roofing prior to the installation of the new roofing.*

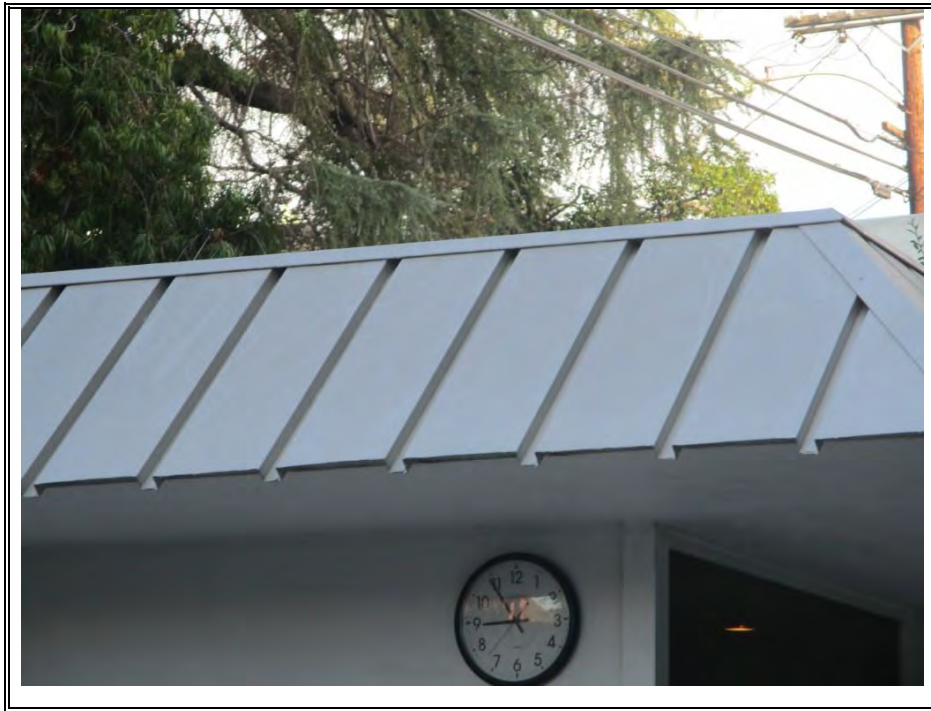
<b>CATEGORY:</b>	ROOF/DECKS	
<b>COMPONENT(S):</b>	METAL ROOF	<b>ID#(S)</b> 0102

**METAL ROOF (TYPICAL)**

**OBSERVATIONS:** *This component includes the metal roofing (sloped) on the mansard at the pool restroom building. It would typically have a life expectancy in excess of 30 years and therefore no amount has been budgeted for its replacement at this time.*

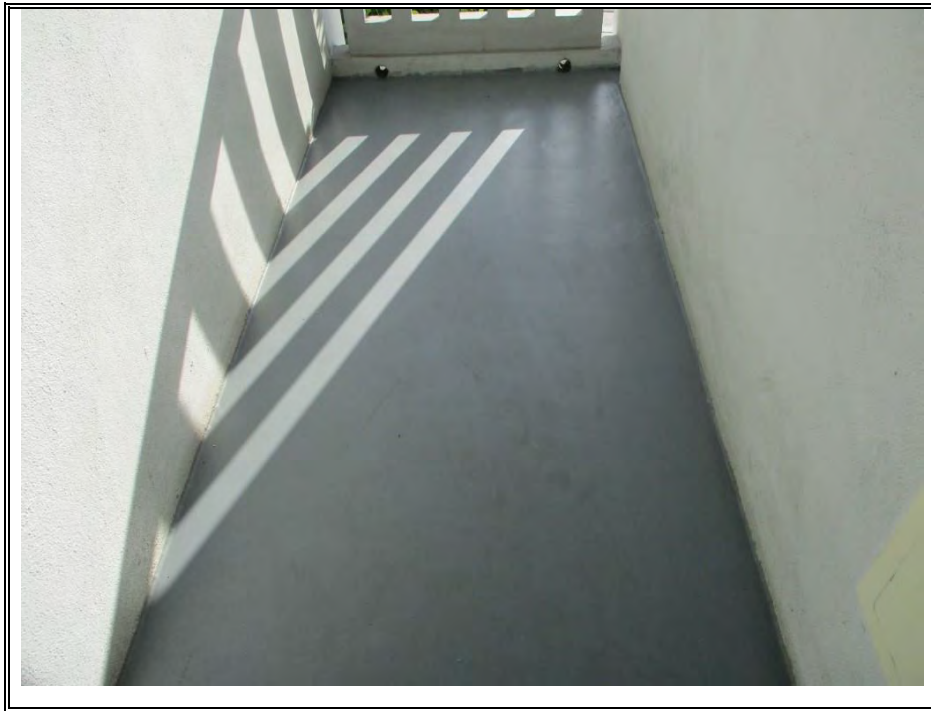
<b>CATEGORY:</b>	ROOF/DECKS	
<b>COMPONENT(S):</b>	MEMBRANE DECKS- COMMON (RESURFACE)	<b>ID#(S)</b> 0103

#### **MEMBRANE DECKS- COMMON (RESURFACE) (TYPICAL)**

**OBSERVATIONS:** *This component includes the membrane deck surfaces over the concrete exterior walkways. They appeared to be of varying ages and conditions and, for reporting purposes, their remaining lives have been averaged. Resurfacing of these areas is critical in order to prevent internal damage to the structural elements and possible leakage into units that are adjacent to, or beneath these decks. The average component cost does not provide for any possible repairs/replacement of substrate damage that is sometimes discovered upon future removal of the deck surfacing.*

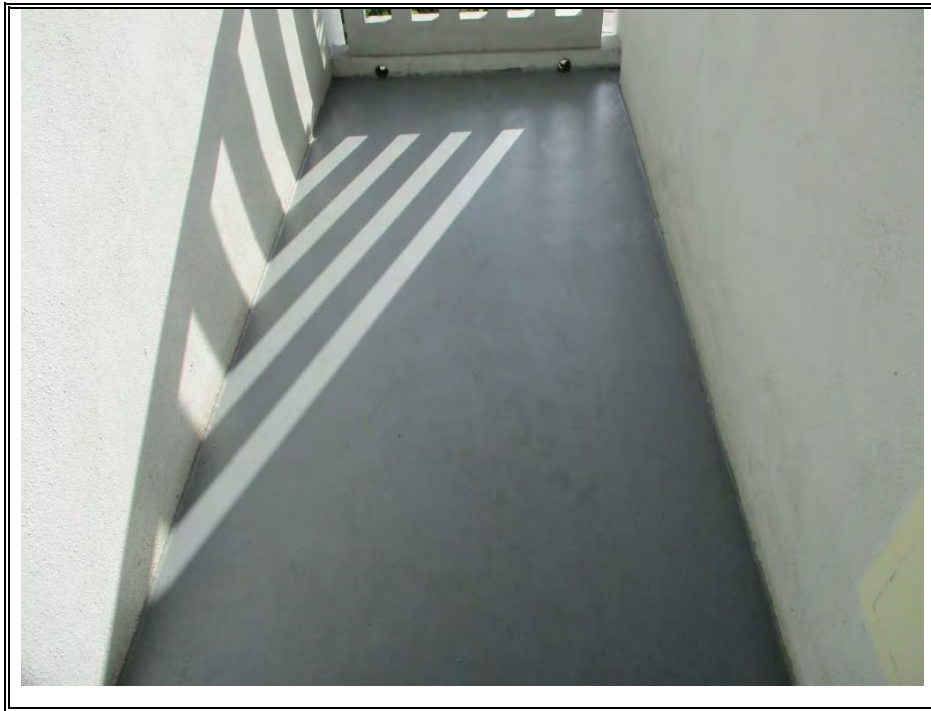
<b>CATEGORY:</b>	ROOF/DECKS	
<b>COMPONENT(S):</b>	MEMBRANE DECKS-COMMON (COATING)	<b>ID#(S)</b> 0104

**MEMBRANE DECKS-COMMON (COATING) (TYPICAL)**

**OBSERVATIONS:** *This component includes the coating for the deck surfaces described in component ID #0103. They appeared to be of varying ages and conditions and, for reporting purposes, their remaining lives have been averaged.*

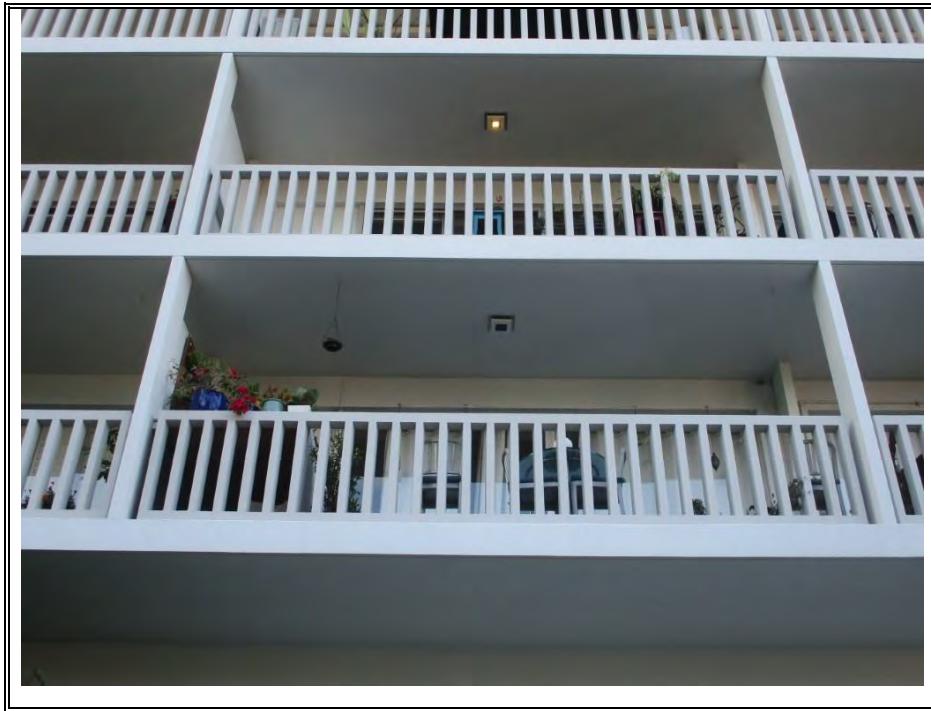
<b>CATEGORY:</b>	ROOF/DECKS	
<b>COMPONENT(S):</b>	MEMBRANE DECKS-UNITS (RESURFACE)	<b>ID#(S)</b> 0105

**MEMBRANE DECKS-UNITS (RESURFACE) (TYPICAL)**

**OBSERVATIONS:** *This component includes the membrane deck surfaces of the individual units. We were informed that maintenance and repairs are the responsibility of the individual unit owners. However, the lack of attention to these surfaces could cause damage to the building structure, and it is recommended that the association retain responsibility for same.*

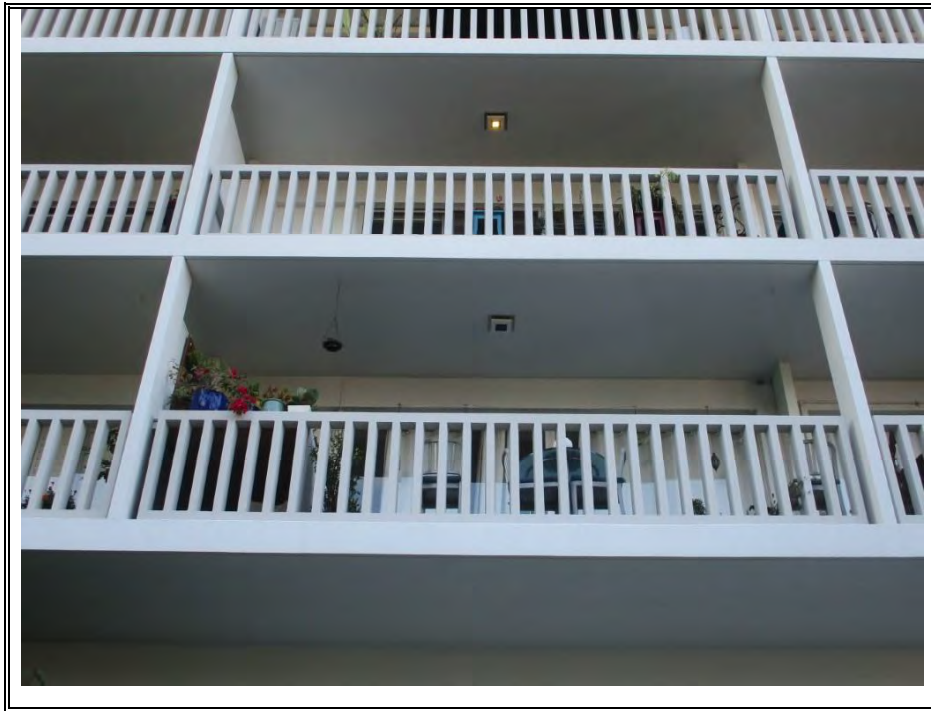
<b>CATEGORY:</b>	ROOF/DECKS	
<b>COMPONENT(S):</b>	MEMBRANE DECKS-UNITS (COATING)	<b>ID#(S)</b> 0106

**MEMBRANE DECKS-UNITS (COATING) (TYPICAL)**

**OBSERVATIONS:** *This component includes the coating for the deck surfaces described in component ID #0105. We were informed that maintenance and repairs are the responsibility of the individual unit owners. However, the lack of attention to these surfaces could cause damage to the building structure, and it is recommended that the association retain responsibility for same.*

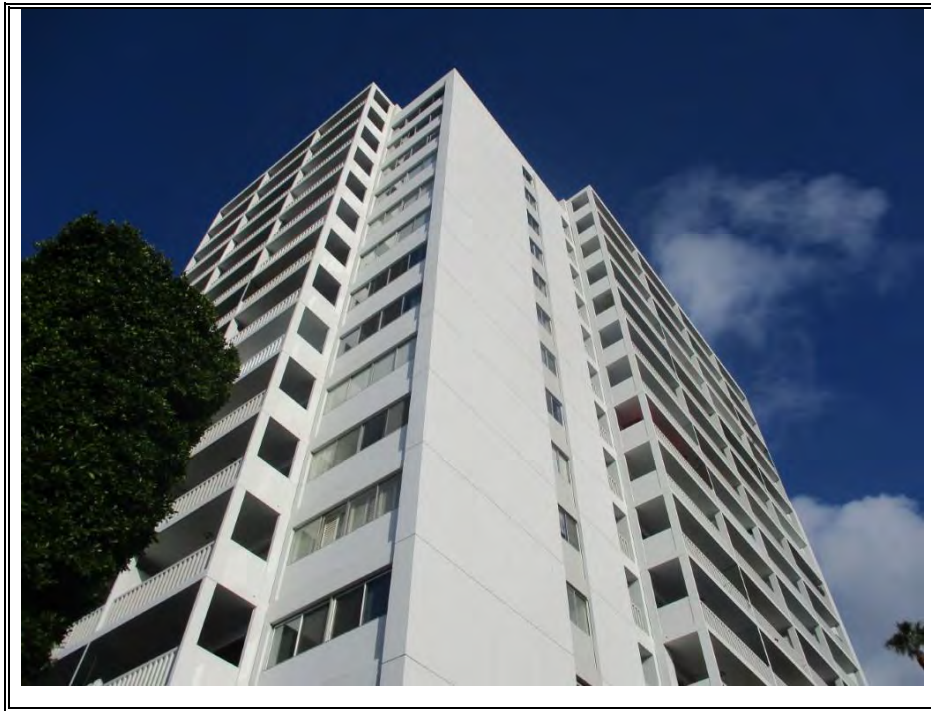
<b>CATEGORY:</b>	STRUCTURE		
<b>COMPONENT(S):</b>	FOUNDATIONS/STRUCTURAL FRAME	<b>ID#(S)</b>	0201

**FOUNDATIONS/STRUCTURAL FRAME (TYPICAL)**

**OBSERVATIONS:** *This component includes the foundations and structural frame, along with the exterior surfaces of the main building and the pool restroom building. Provided there are no major catastrophes, the proper drainage principles are maintained and that structural pest control procedures are adhered to (see component ID #0202), this would normally be considered to be a lifetime component for which no reserve budget would be called for.*
