RESERVE STUDY - MARCH 9, 2023

Planned Unit Development Homeowners Association (Sample Only)

1234 Main Street

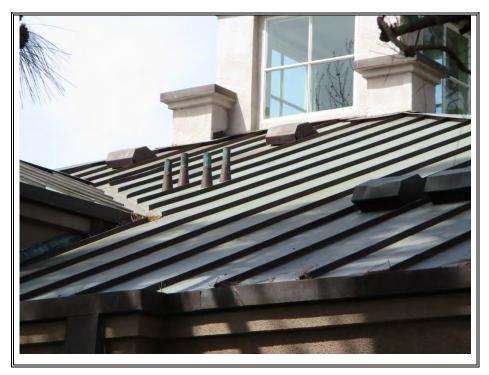
ID#(S) 0102

STANDING SEAM ROOF - CLUBHOUSE (TYPICAL)

OBSERVATIONS: This component includes the standing seam roofing (sloped/metal) on the clubhouse. It appeared to be in average condition.

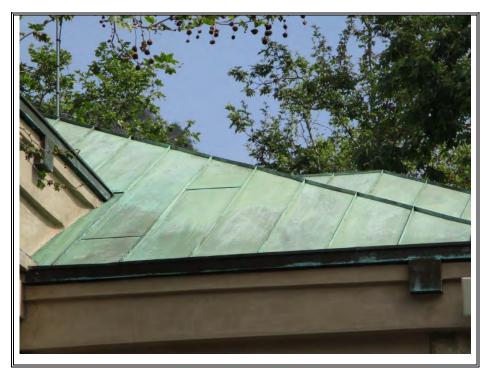
ID#(S) 0103

STANDING SEAM ROOF - GUARDHOUSE (TYPICAL)

OBSERVATIONS: This component includes the standing seam roofing (sloped/metal) on the guard house. It appeared to be in average condition.

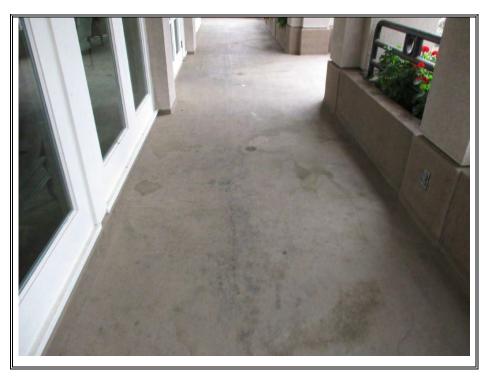
ID#(S) 0104

MEMBRANE DECKS-RESURFACE (TYPICAL)

OBSERVATIONS: This component includes the membrane deck surfaces at the clubhouse. We were informed they are scheduled for resurfacing. Resurfacing of these areas is critical to prevent internal damage to the structural elements and possible leakage into areas that are located adjacent to, or beneath these decks. The average component cost does not provide for any possible repairs/replacement of substrate damage that is sometimes discovered upon future removal of the deck surfacing.

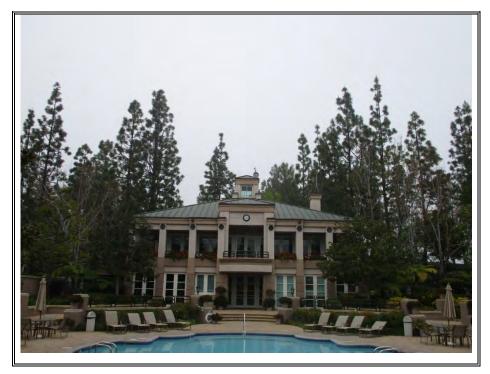
ID#(S) 0201

FOUNDATIONS/STRUCTURAL FRAMES (TYPICAL)

OBSERVATIONS: This component includes the foundations and structural frames, along with the exterior surfaces of the caretaker building, clubhouse, and guardhouse. Provided there are no major catastrophes, the proper drainage principles are maintained and that structural pest control procedures are adhered to, these would normally be considered lifetime components for which no reserve budget would be necessary.

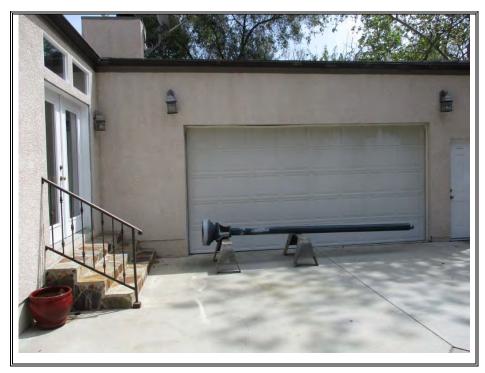
ID#(S) 0203

GARAGE DOOR (TYPICAL)

OBSERVATIONS: This component includes the aluminum roll-up doors at the caretaker building and guardhouse, respectively. They appeared to be in good condition.

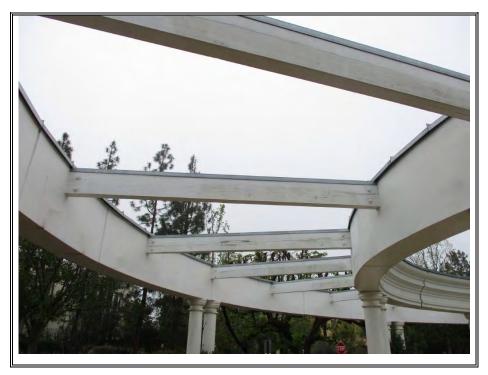
ID#(S) 0204

POOL TRELLIS - REPAIR (TYPICAL)

OBSERVATIONS: This component includes the wood trellis with metal caps at the pool area. It would typically have an anticipated useful life expectancy beyond the scope of this report (30 years). However, an allowance for regular repairs and maintenance has been provided.

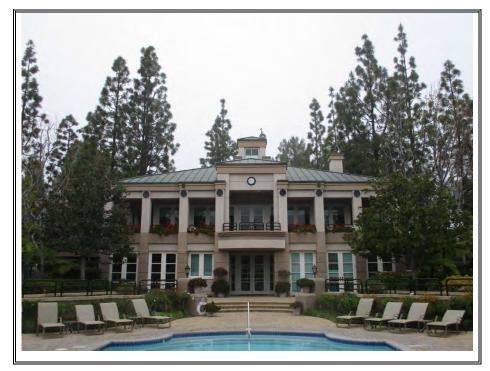
ID#(S) 0301

EXTERIOR FLATWORK - CLUBHOUSE (TYPICAL)

OBSERVATIONS: This component includes the painted surfaces of the stucco, and a limited amount of trim, on the exterior of the clubhouse. They appeared to be in average to aging condition.

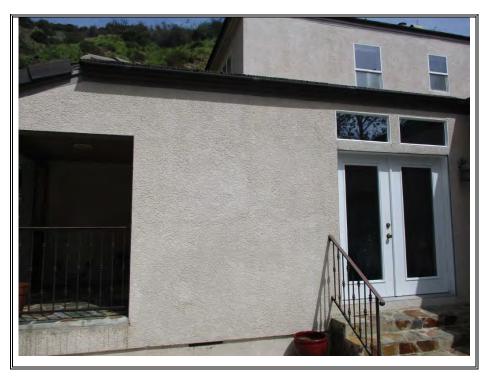
ID#(S) 0302

EXTERIOR FLATWORK - CARETAKERBUILDING (TYPICAL)

OBSERVATIONS: This component includes the painted surfaces of the stucco, and a limited amount of trim, on the exterior of the caretaker building. They appeared to be in an average to aging condition.

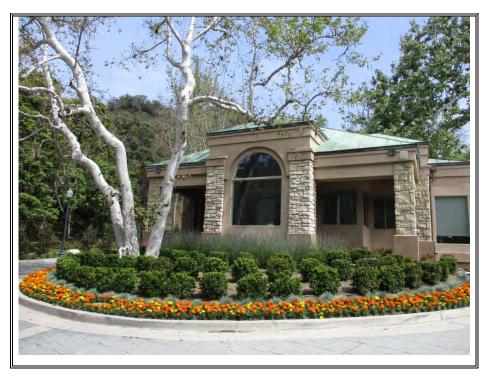
ID#(S) 0303

EXTERIOR FLATWORK - GUARDHOUSE (TYPICAL)

OBSERVATIONS: This component includes the painted surfaces of the stucco, and a limited amount of trim, on the exterior of the guardhouse. They appeared to be in an average to aging condition.

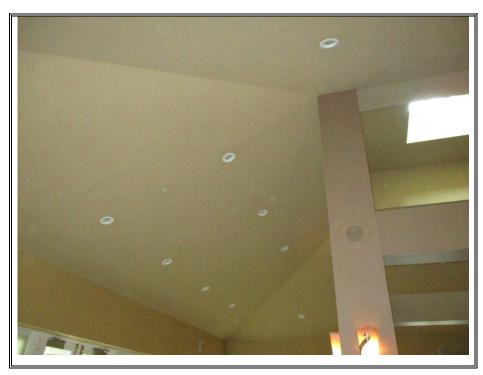
ID#(S) 0305

INTERIOR FLATWORK (TYPICAL)

OBSERVATIONS: This component includes the painted surfaces of the stairwells and internal hallways in the clubhouse, guardhouse, and caretaker building. They appeared to be in average condition.

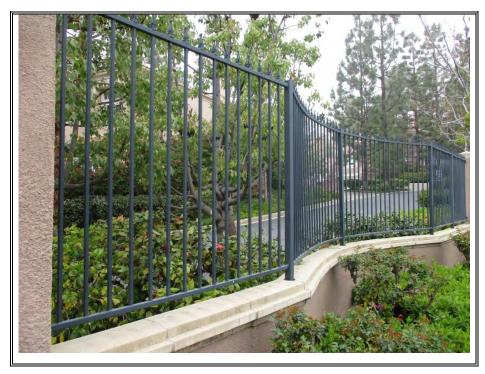
ID#(S) 0306

IRONWORK (TYPICAL)

OBSERVATIONS: This component includes the painted surfaces of the wrought iron fencing, gates, and rails at the exteriors of the clubhouse, guardhouse, and caretaker buildings. They appeared to be in average condition.

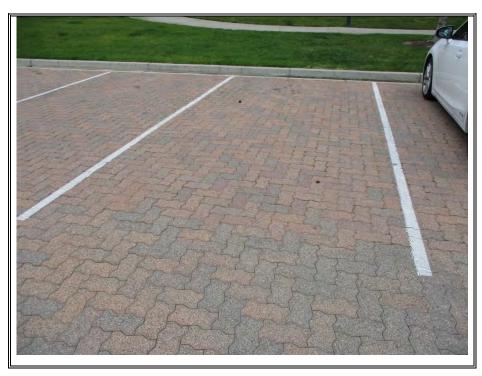
ID#(S) 0307

PARKING STRIPES (TYPICAL)

OBSERVATIONS: This component includes the painted parking stripes that delineate the individual parking spaces. They appeared to be in average condition.

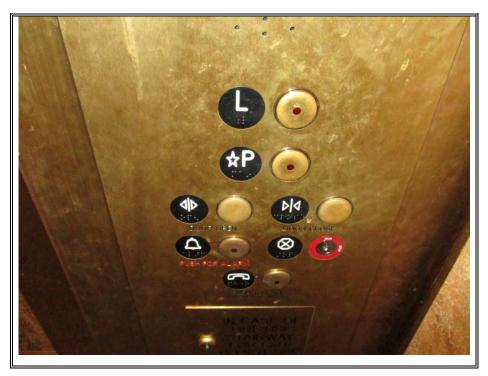
ID#(S) 0401

ELEVATOR-MECHANICAL (TYPICAL)

OBSERVATIONS: This component includes the mechanical aspects of the elevator. The typical useful life is difficult to predict, and a rough estimate (allowance) for future upgrades has been provided. It is recommended that further evaluation be obtained from an elevator specialist.

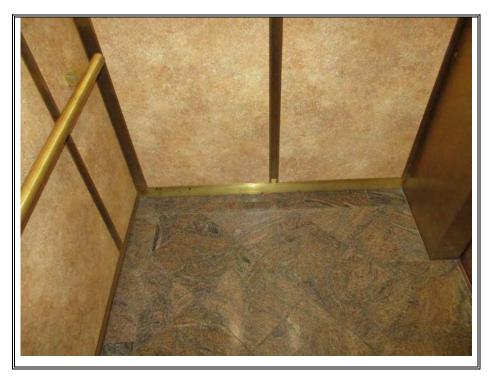
ID#(S) 0402

ELEVATOR-CAB REMODEL (TYPICAL)

OBSERVATIONS: This component provides for the remodeling of the elevator cab (interior). It appeared to be in average condition and well maintained.

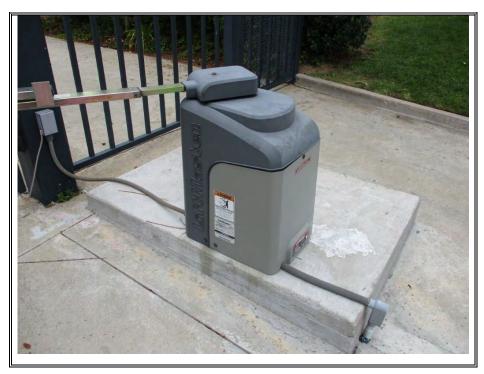
ID#(S) 0403

GATE OPERATORS-SWING ARM (TYPICAL)

OBSERVATIONS: This component includes the swing arm-type vehicle gate operators at the main entrance to the property. They appeared to be functional, but in an aging condition.

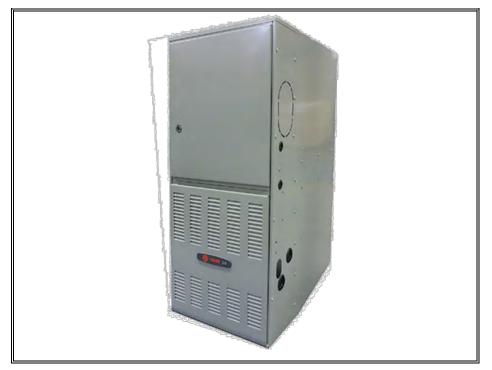
ID#(S) 0406

HEAT PUMP-CARETAKER BUILDING (TYPICAL)

OBSERVATIONS: This component includes a heat pump at the caretakers building. We were informed it was in good condition.

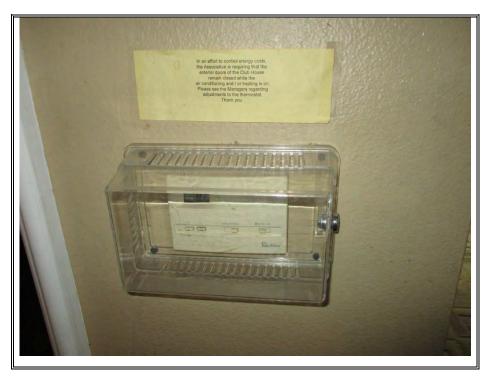
ID#(S) 0407

HEAT PUMPS-CLUBHOUSE (TYPICAL)

OBSERVATIONS: This component includes the heat pumps at the clubhouse. They appeared to be in average condition.

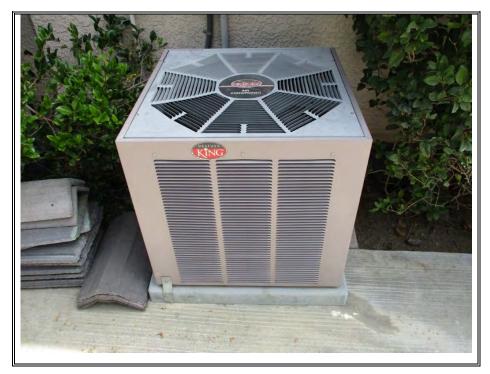
ID#(S) 0408

CONDENSER-CARETAKER BUILDING (TYPICAL)

OBSERVATIONS: This component includes the condenser for the air conditioning system at the caretaker building. It appeared to be in an aging condition.

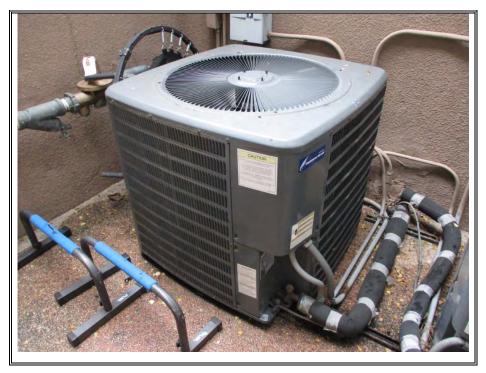
ID#(S) 0409

CONDENSERS-CLUBHOUSE (TYPICAL)

OBSERVATIONS: This component includes the condensers for the air conditioning system at the clubhouse. They appeared to be in average condition.

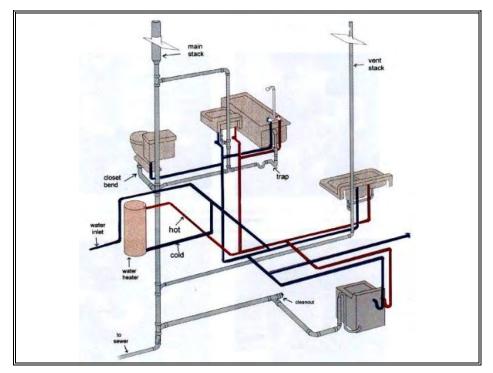
```
ID#(S) 0502
```

DRAINAGE/SEWER PIPING (TYPICAL)

OBSERVATIONS: This component addresses the sewer and drainage piping. The visible portions appeared to be in average condition and no problems were observed or reported. No amount has been provided for complete replacement as the piping would typically have a life well in excess of the scope of this projection and would therefore be considered a lifetime component.

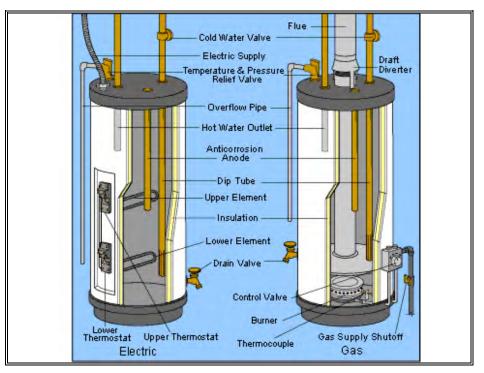
ID#(S) 0503

WATER HEATER – CARETAKER BUILDING (TYPICAL)

OBSERVATIONS: This component includes a "Rinnai" tankless water heater at the caretaker building. We were informed it was in good condition.

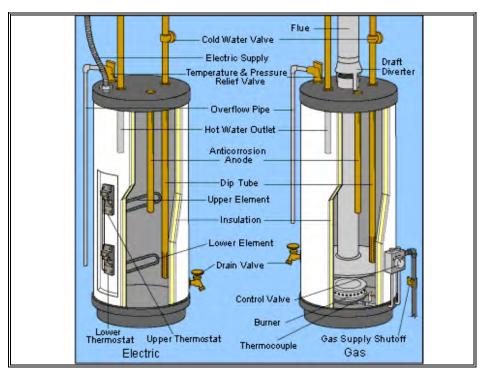
ID#(S) 0504

WATER HEATERS- CLUBHOUSE (TYPICAL)

OBSERVATIONS: This component includes the point of use water heaters at the clubhouse restrooms and kitchen. They appeared to be in average condition; however, a visual examination cannot make predictions as to future performance (i.e. even with correct maintenance, these units can fail without warning).

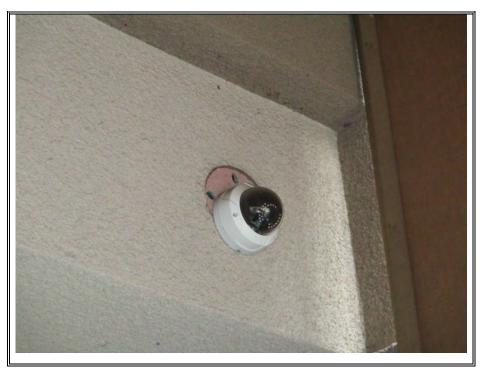
ID#(S) 0601

SURVEILLANCE CAMERA SYSTEM (TYPICAL)

OBSERVATIONS: This component includes the cameras, monitor, and recorder for the surveillance camera system at the main entrance in the guard house. The system appeared to be in good condition.

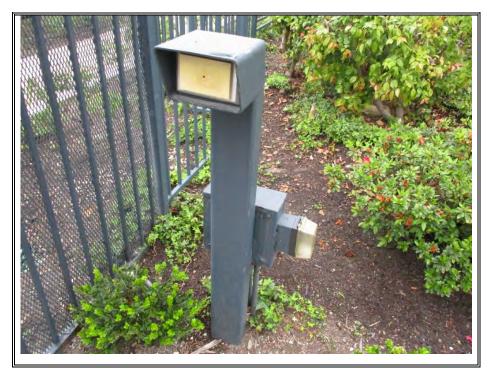
ID#(S) 0602

CARD READER (TYPICAL)

OBSERVATIONS: This component includes a card reader system, including a card reader, a transmitter, and a control panel for the gate operators. It appeared to be in an aging condition.

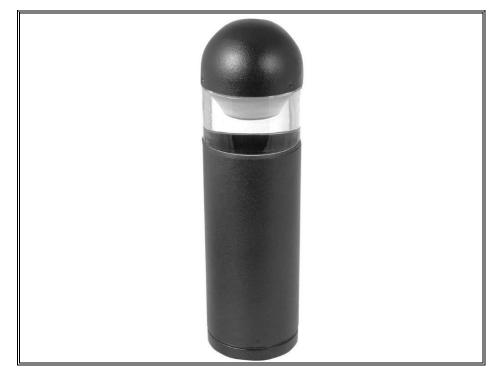
ID#(S) 0605

LIGHTING-BOLLARD (TYPICAL)

OBSERVATIONS: This component includes the bollard type light fixtures along the walkways. They appeared to be in average condition. The external location of these fixtures usually makes them subject to a greater rate of deterioration due to exposure to the elements. Also, it is often desirable to replace these fixtures as they eventually become dated and/or more energy efficient options become available.

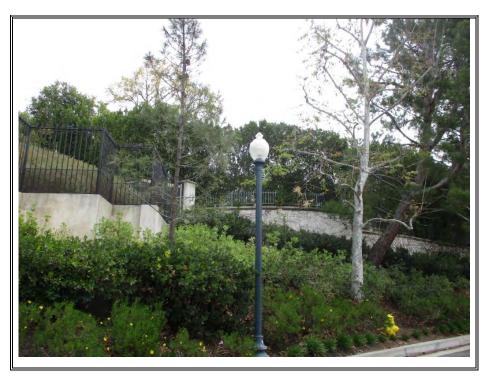
ID#(S) 0606

LIGHTING-STREET (TYPICAL)

OBSERVATIONS: This component includes the light fixtures along the streets. They appeared to be in average condition. These types of fixtures are typically subject to a greater level of deterioration from the elements.

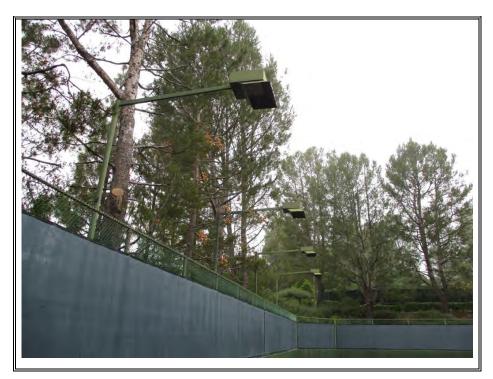
ID#(S) 0608

LIGHTING-TENNIS/BASKETBALL (TYPICAL)

OBSERVATIONS: This component includes the light fixtures at the tennis and basketball courts. They appeared to be in average condition. These types of fixtures are typically subject to a greater level of deterioration from the elements.

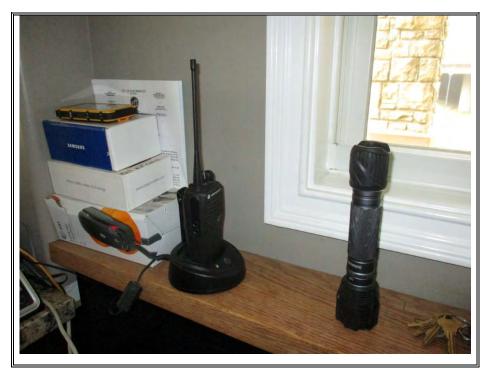
ID#(S) 0609

RADIO EQUIPMENT (TYPICAL)

OBSERVATIONS: This component includes the handheld radio equipment. It appeared to be in average condition.

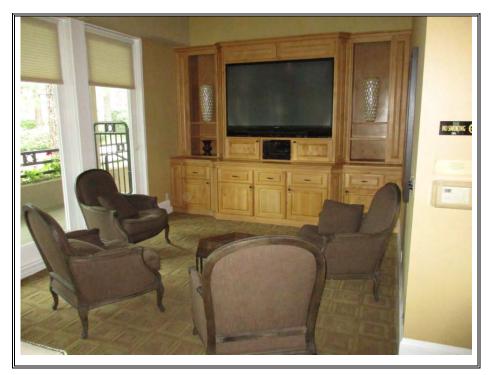
ID#(S) 0701

CARPETING (TYPICAL)

OBSERVATIONS: This component includes the carpeting in the clubhouse. It appeared to be in aging condition.

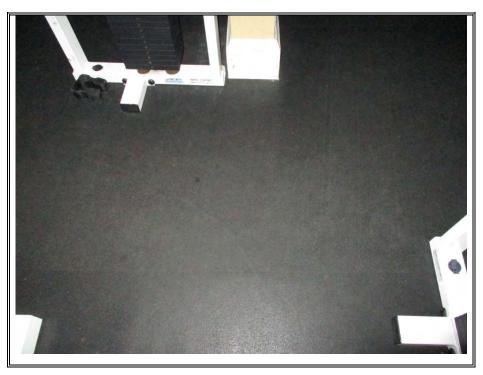
ID#(S) 0702

RUBBER (TYPICAL)

OBSERVATIONS: This component includes the rubber flooring in the gym. It appeared to be in average condition.

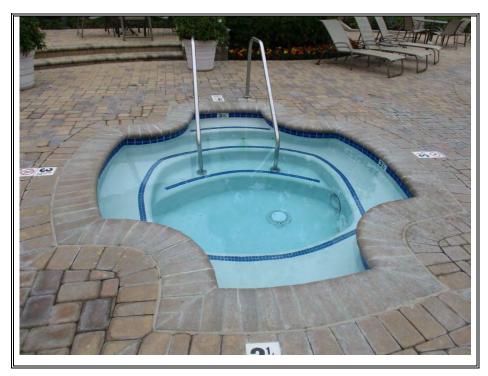
ID#(S) 0802

PLASTER-SPA (TYPICAL)

OBSERVATIONS: This component includes the plaster lining of the spa. It appeared to be in an aging condition. Coarseness of the plaster, which occurs over time, is conducive to algae growth and can be injurious to users of the spa (potential association liability).

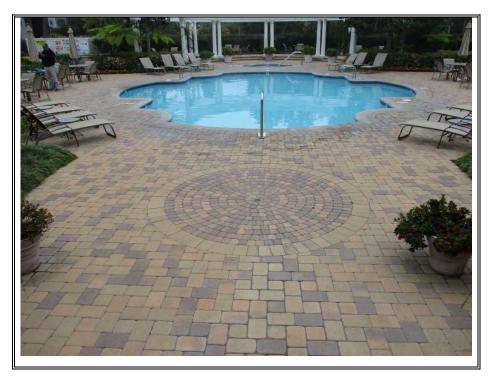
ID#(S) 0803

CONCRETE DECK - PAVERS (TYPICAL)

OBSERVATIONS: This component includes the concrete paver surfaces at the pool area. They appeared to be in average condition and no significant issues were observed or reported. Decks near water features are subject to additional deterioration due to added moisture, chemicals and pedestrian traffic, and are therefore prone to discoloration, pitting, and scaling. It may be decided to eventually replace the surfaces for aesthetics and functionality. Otherwise, concrete areas are generally considered a lifetime component and therefore no amount has been budgeted for replacement. Occasional repairs would typically be funded from the operating account.

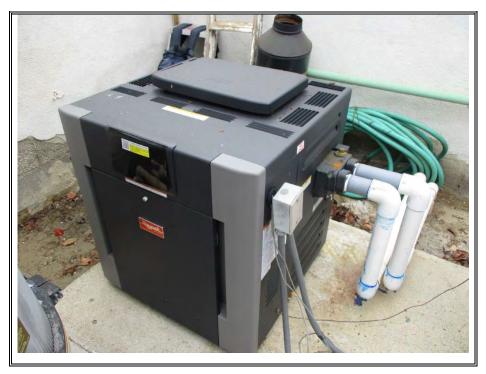
ID#(S) 0806

HEATERS (TYPICAL)

OBSERVATIONS: This component includes the heaters for the pool and spa. They appeared to be in good condition.

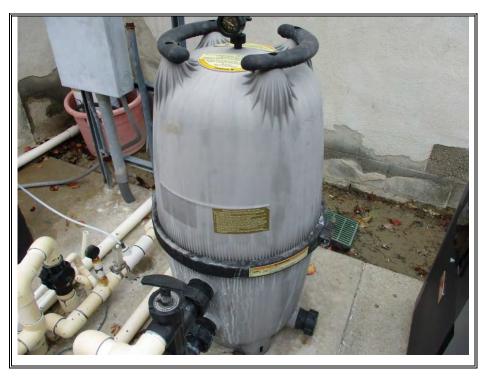
ID#(S) 0807

FILTERS (TYPICAL)

OBSERVATIONS: This component includes the filters for the pool and spa. They appeared to be in average condition.

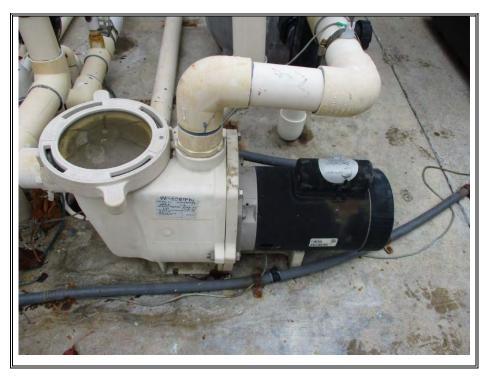
ID#(S) 0809

PUMPS (TYPICAL)

OBSERVATIONS: This component includes the pumps for the pool and spa. They appeared to be in average condition.

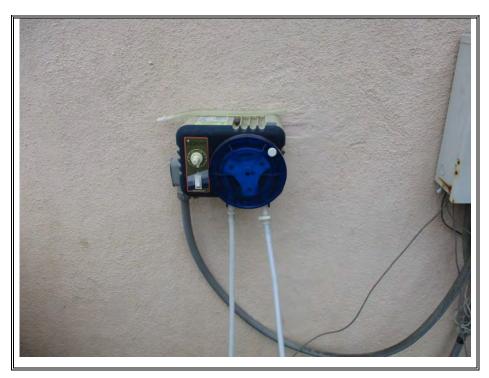
ID#(S) 0810

CHLORINATORS (TYPICAL)

OBSERVATIONS: This component includes the chlorinators that automatically add chlorine to the pool/spa water on a continuous basis. They appeared to be in average condition.

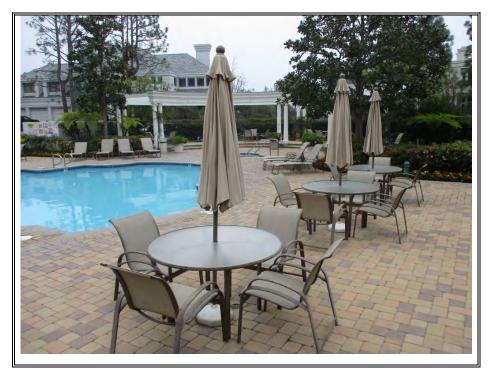
ID#(S) 0811

FURNITURE (TYPICAL)

OBSERVATIONS: This component provides for the replacement of the furniture around the pool and spa, comprised of tables, vinyl strapped chairs and chaises. It appeared to be in an average to aging condition. Exposure to dirt, dust, suntan oils, tree sap, pool chemicals, insecticide sprays, and environmental factors (especially ultraviolet light) contribute significantly to the deterioration of this type of furniture.

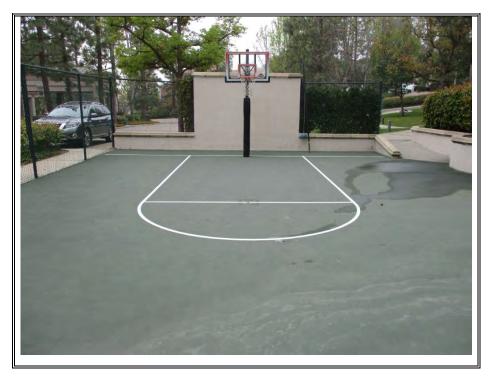
ID#(S) 0902

PLAYING SURFACES-BASKETBALL (TYPICAL)

OBSERVATIONS: This component includes the membrane playing surfaces of the basketball courts (like the surfaces of a tennis court). They appeared to be in an average condition. Re-surfacing is critical to ensure the proper "speed of play" for the basketball players.

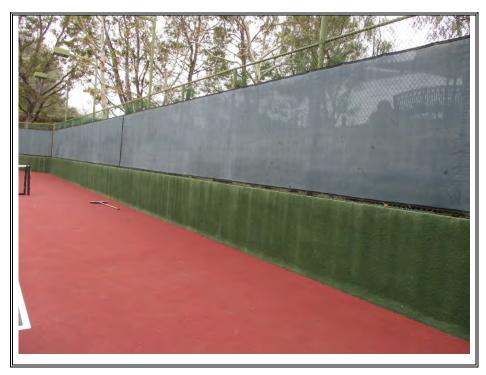
ID#(S) 0903

WINDSCREEN (TYPICAL)

OBSERVATIONS: This component includes the windscreen for the chain link fencing around the tennis courts. It serves the purpose of blocking some of the wind as well as provides a solid uniform background that improves ball definition for the player. The windscreen appeared to be in average condition.

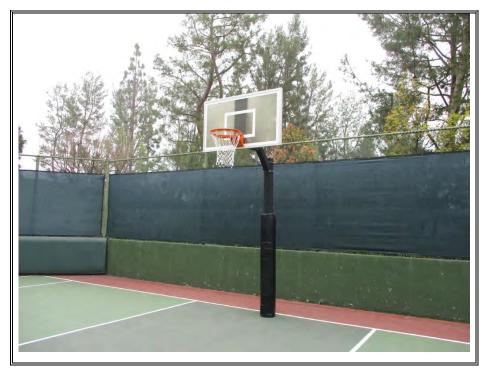
ID#(S) 0905

BASKETBALL HOOPS/BACKBOARDS (TYPICAL)

OBSERVATIONS: This component includes the acrylic type backboards and fabric hoops for the basketball courts. They appeared to be in an average condition.
