COMPLETE RSI RESERVE STUDY WITH SITE VISIT

HIGH RISE HOMEOWNERS' ASSOCIATION

1234 Main Street
Anywhere, California

2/10/2026

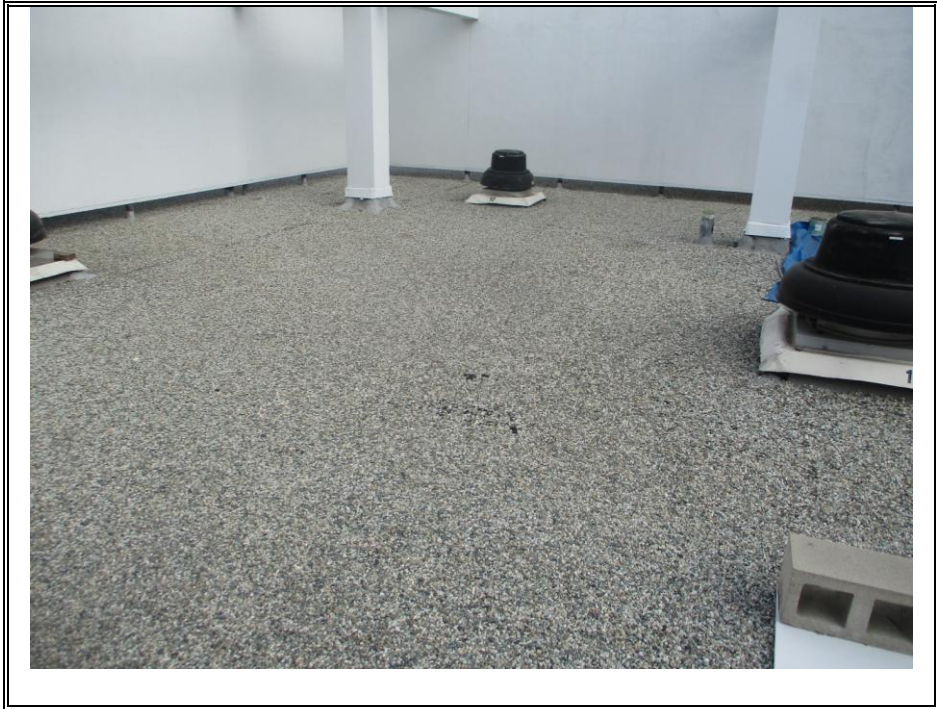
CATEGORY:	ROOF/DECKS	
COMPONENT(S):	BUILT-UP ROOF	ID#(S) 0101

BUILT-UP ROOF (TYPICAL)

OBSERVATIONS: *This component addresses the built-up roofing (flat). We were informed that repairs were recently performed on the front canopy roof. It appeared to be in average condition for its age. On this type of structure, 2 layers are generally permitted. However, if the association should decide to re-roof over the existing roofing, experience dictates that the typical useful life of the new materials would be reduced by approximately one third (33%). The average component cost and typical useful life reflects removal of the existing roofing prior to the installation of the new roofing.*

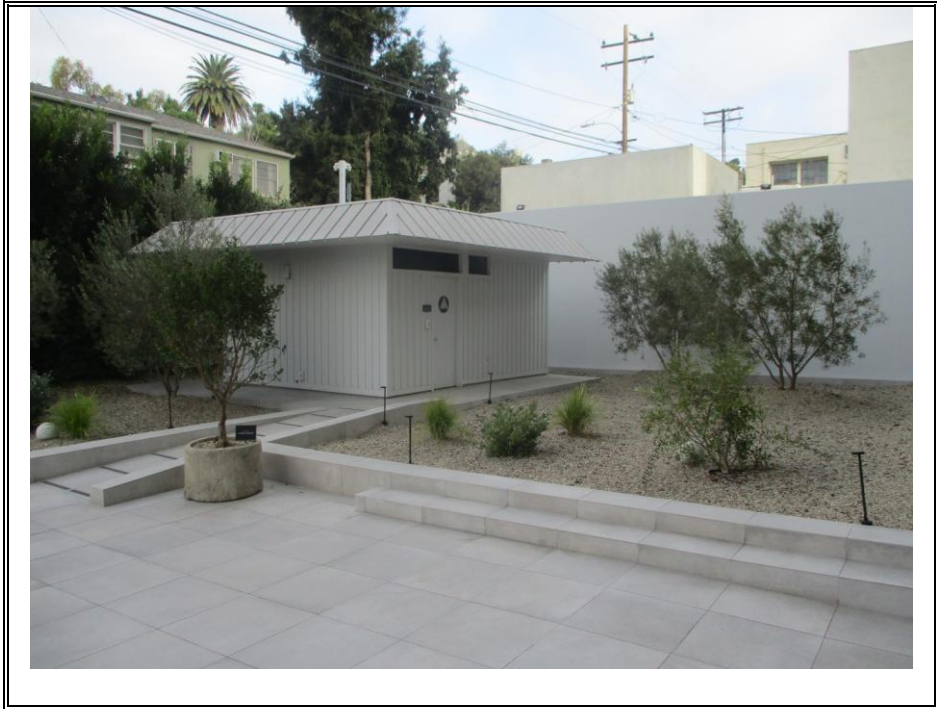
CATEGORY:	ROOF/DECKS	
COMPONENT(S):	METAL ROOF	ID#(S) 0102

METAL ROOF (TYPICAL)

OBSERVATIONS: *This component addresses the metal roofing (sloped) on the mansard at the pool restroom building. It appeared to be in good condition. It would typically have a life expectancy in excess of 30 years.*

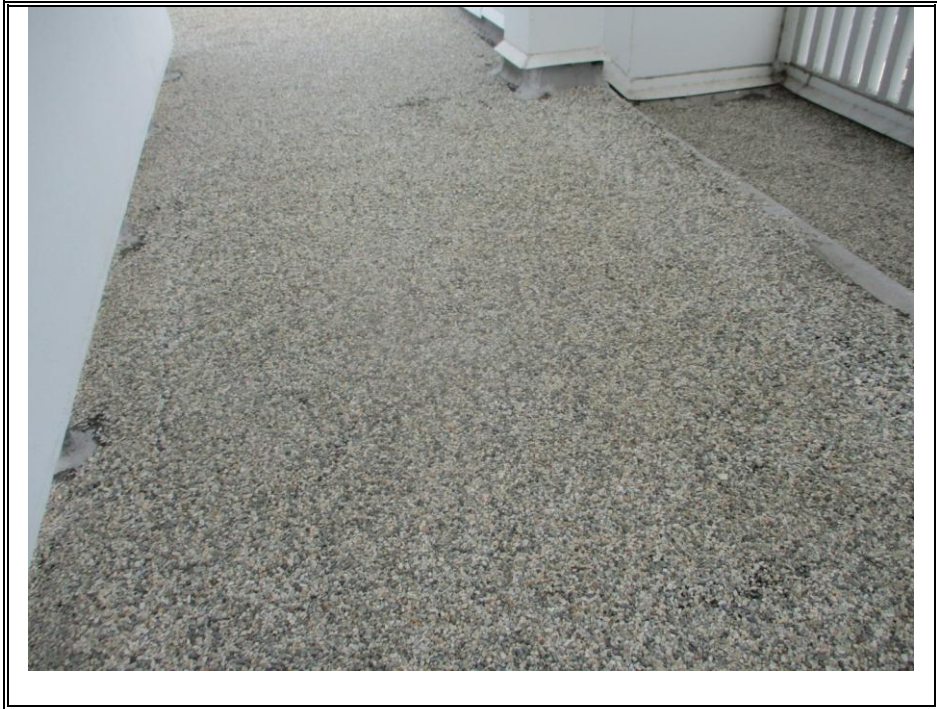
CATEGORY:	ROOF/DECKS	
COMPONENT(S):	ROOF MAINT/REPAIR/CONSULT	ID#(S) 0103

ROOF MAINT/REPAIR/CONSULT (TYPICAL)

OBSERVATIONS: *This component addresses an allowance for roof maintenance, repairs, and consulting.*

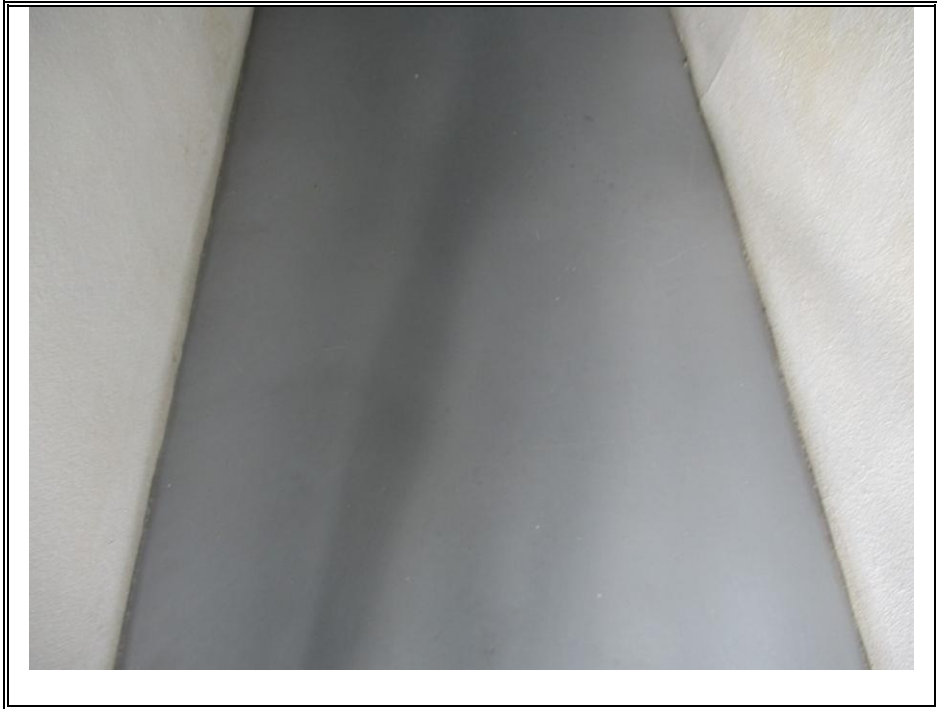
CATEGORY:	ROOF/DECKS	
COMPONENT(S):	MEMBRANE DECKS- COMMON (RESURFACE)	ID#(S) 0104

MEMBRANE DECKS- COMMON (RESURFACE) (TYPICAL)

OBSERVATIONS: *This component addresses the membrane deck surfaces over the concrete walkways. They appeared to be in an average condition for their age. Resurfacing these areas is critical in order to prevent internal damage to the structural elements and possible leakage into areas adjacent to, or beneath these decks. The average component cost does not provide for any possible repairs/replacement of substrate damage that is sometimes discovered upon future removal of the deck surfacing.*

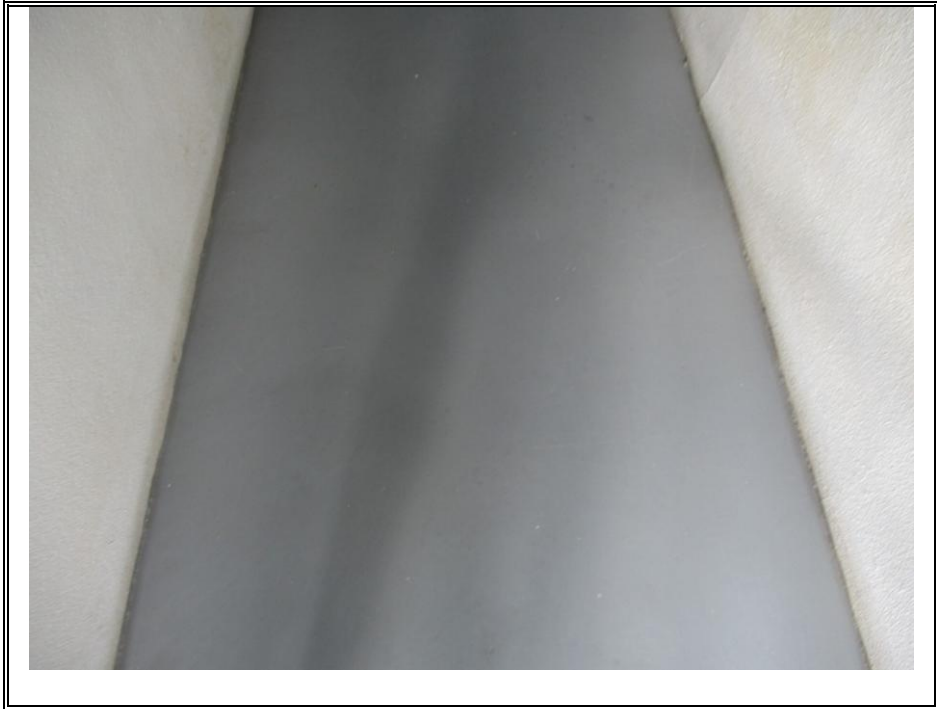
CATEGORY:	ROOF/DECKS	
COMPONENT(S):	MEMBRANE DECKS-COMMON (COATING)	ID#(S) 0105

MEMBRANE DECKS-COMMON (COATING) (TYPICAL)

OBSERVATIONS: *This component addresses the coating for the deck surfaces. We were informed of recent maintenance, and it appeared to be in average condition.*

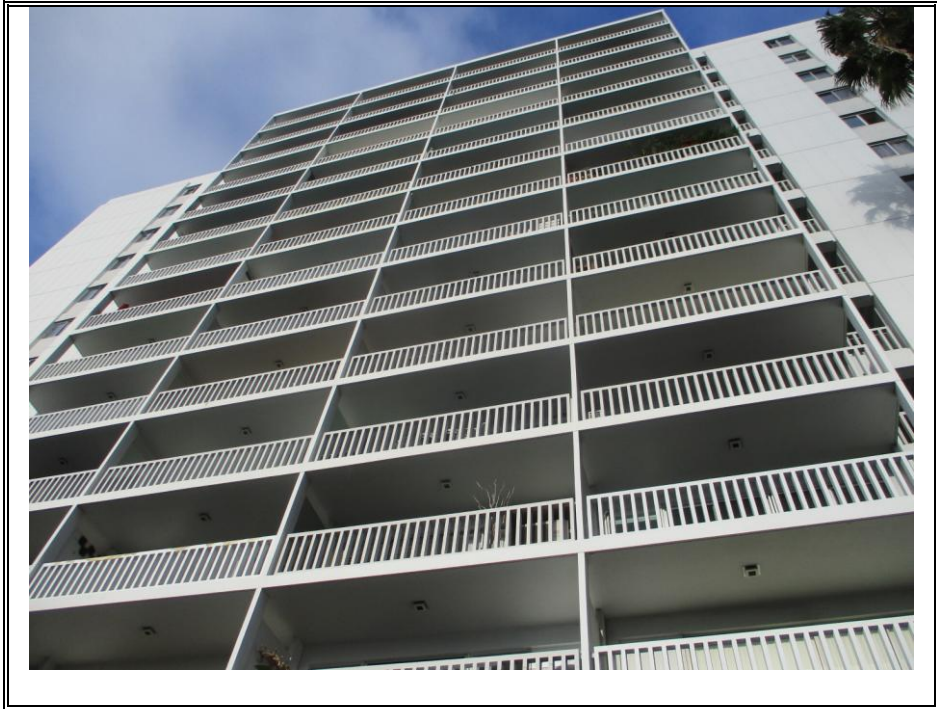
CATEGORY:	ROOF/DECKS	
COMPONENT(S):	MEMBRANE DECKS-UNITS (RESURFACE)	ID#(S) 0106

MEMBRANE DECKS-UNITS (RESURFACE) (TYPICAL)

OBSERVATIONS: *This component addresses the membrane deck surfaces of the individual units. As they are constructed of concrete, the decks would have a life expectancy beyond the scope of the reporting.*

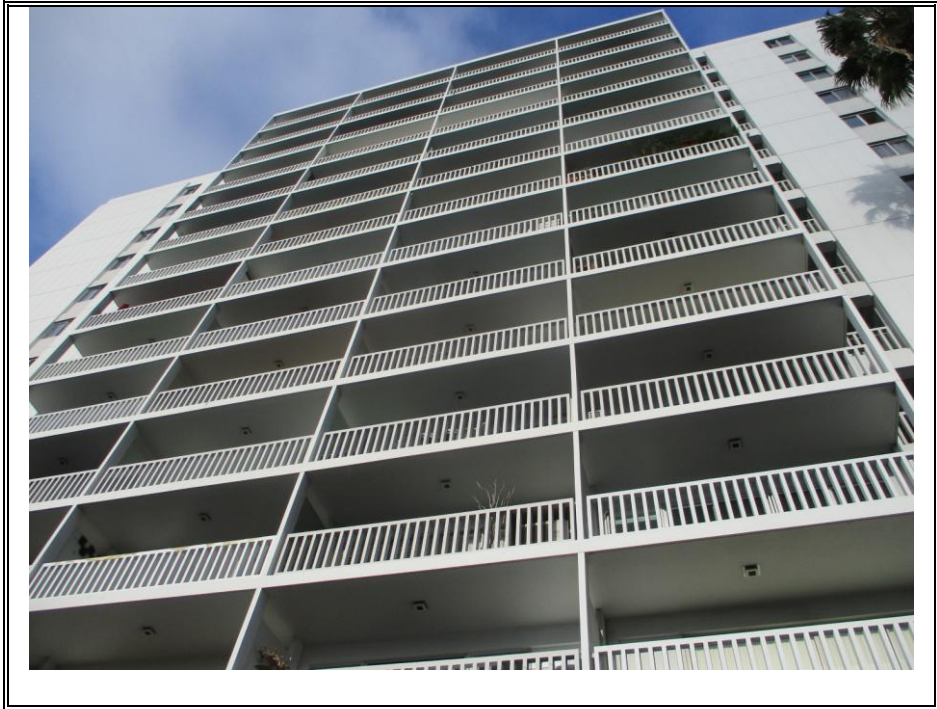
CATEGORY:	ROOF/DECKS	
COMPONENT(S):	MEMBRANE DECKS-UNITS (COATING)	ID#(S) 0107

MEMBRANE DECKS-UNITS (COATING) (TYPICAL)

OBSERVATIONS: *This component addresses the coating for the unit deck surfaces. We were informed that maintenance and repairs are the responsibility of the individual unit owners.*

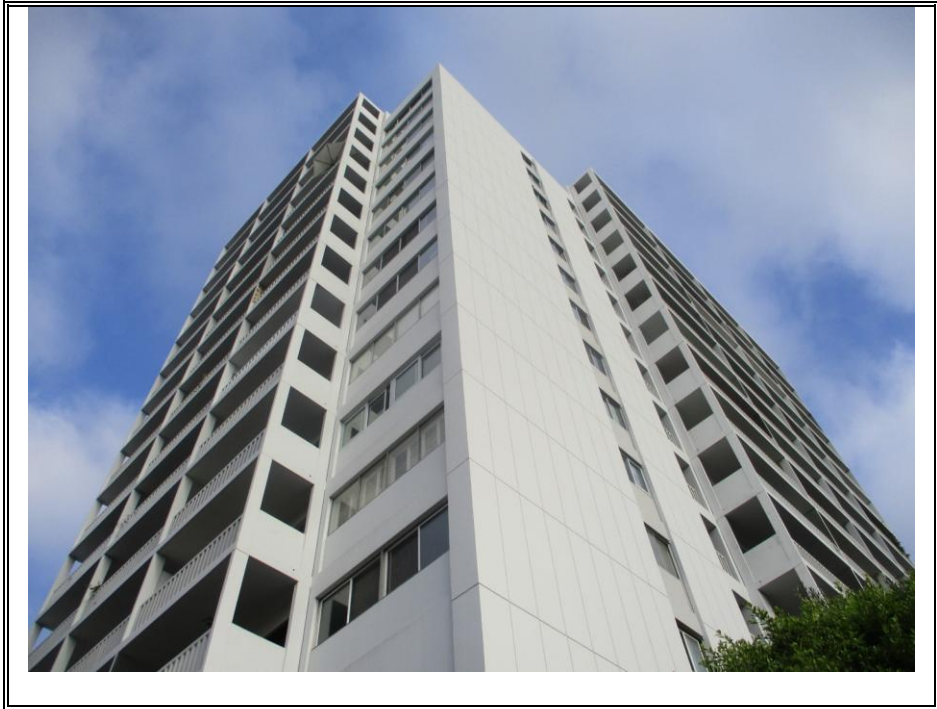
CATEGORY:	STRUCTURE	
COMPONENT(S):	FOUNDATIONS/STRUCTURAL FRAME	ID#(S) 0201

FOUNDATIONS/STRUCTURAL FRAME (TYPICAL)

OBSERVATIONS: *This component addresses the foundations and structural frame, along with the exterior surfaces of the main building and the pool restroom structure. We were informed of extensive concrete mitigation due to prolonged moisture intrusion into the garage. Provided there are no major catastrophes, the proper drainage principles are maintained and that structural pest control procedures are adhered to, the structures themselves and associated infrastructure would be considered lifetime components. Additionally, there would be infrastructure within structures, such as water piping systems, electrical panels, service lines, outlets, and switches. And, in some instances, natural gas piping systems, heating, air-conditioning, and ventilation ducting systems would be included. Components that have predictable life expectancies and a remaining life expectancy of less than 30 years will be outlined elsewhere in this report.*

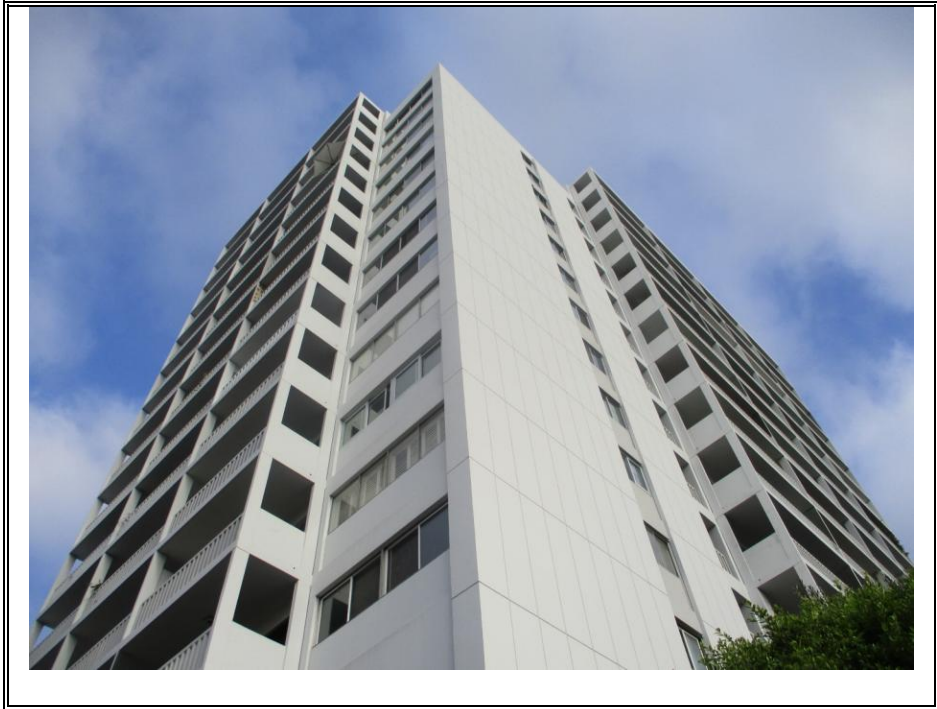
CATEGORY:	STRUCTURE	
COMPONENT(S):	STRUCTURAL PEST CONTROL	ID#(S) 0202

STRUCTURAL PEST CONTROL (TYPICAL)

OBSERVATIONS: *This component addresses the potential need for fumigation of the building. When and where an infestation of wood destroying pests or organisms occurs, and how severe the infestation will be, is difficult to predict. The California Department of Real Estate (DRE) suggests that annual inspections be performed to discover any infestation in its early stages before it becomes a serious problem. As this building is primarily concrete and steel, no funding for complete fumigation has been provided. It is recommended that any necessary treatments be funded on an as-needed basis from the operating account. Also, it is suggested that the association seek the services of a licensed pest control operator for further evaluation and recommendations.*

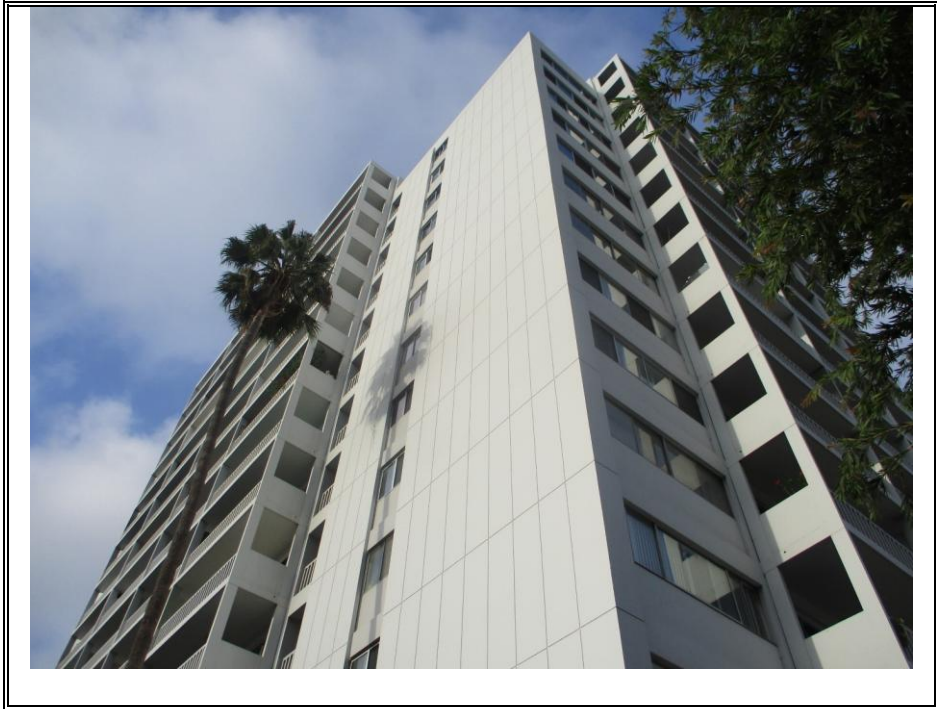
CATEGORY:	<i>PAIN</i>	
COMPONENT(S):	<i>EXTERIOR FLATWORK</i>	ID#(S) 0301

EXTERIOR FLATWORK (TYPICAL)

OBSERVATIONS: *This component addresses the painted surfaces of the concrete, on the exterior of the high-rise building and on the adjacent masonry walls. They appeared to be in an average condition for their age.*

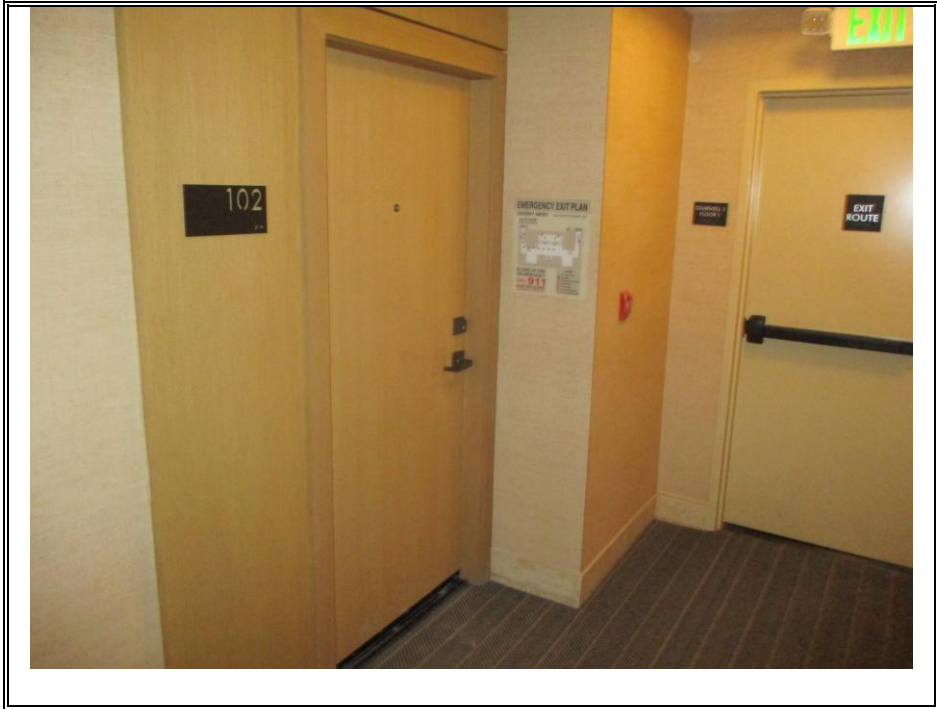
CATEGORY:	PAINT	
COMPONENT(S):	DOORS-LACQUER	ID#(S) 0304

DOORS-LACQUER (TYPICAL)

OBSERVATIONS: *This component addresses the lacquered surfaces of some of the exteriors of the individual unit doors. We were informed they were refurbished in 2024, and they appeared to be in good condition.*

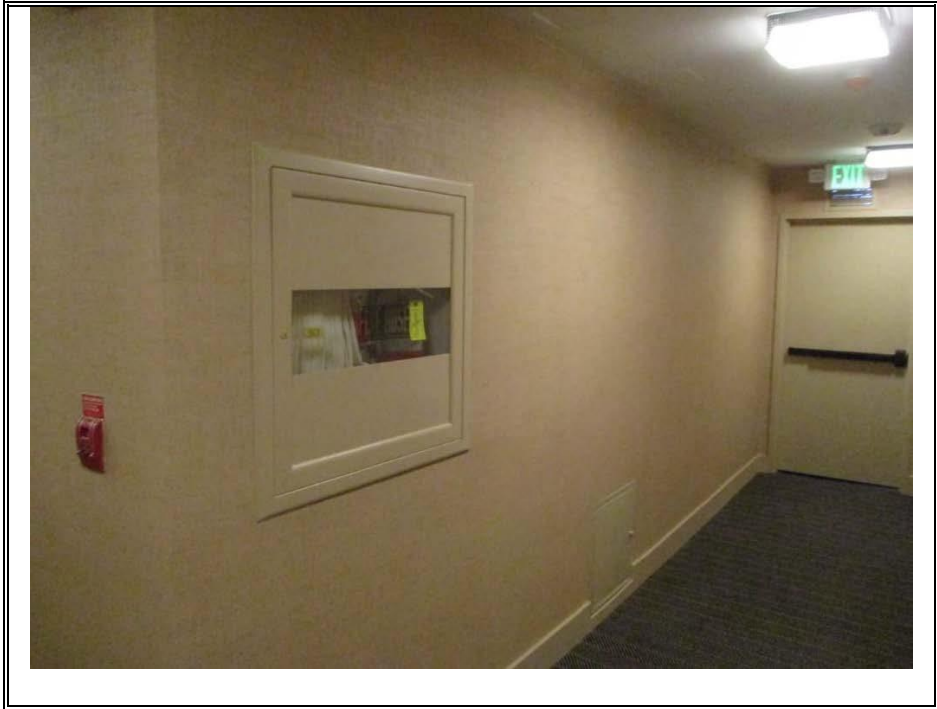
CATEGORY:	<i>PAIN</i>	
COMPONENT(S):	<i>INTERIOR FLATWORK-HALLWAY</i>	ID#(S) 0305

INTERIOR FLATWORK-HALLWAY (TYPICAL)

OBSERVATIONS: *This component addresses the painted surfaces of the internal hallways (ceilings and trim). We were informed that they were painted in 2024, and they appeared to be in good condition.*

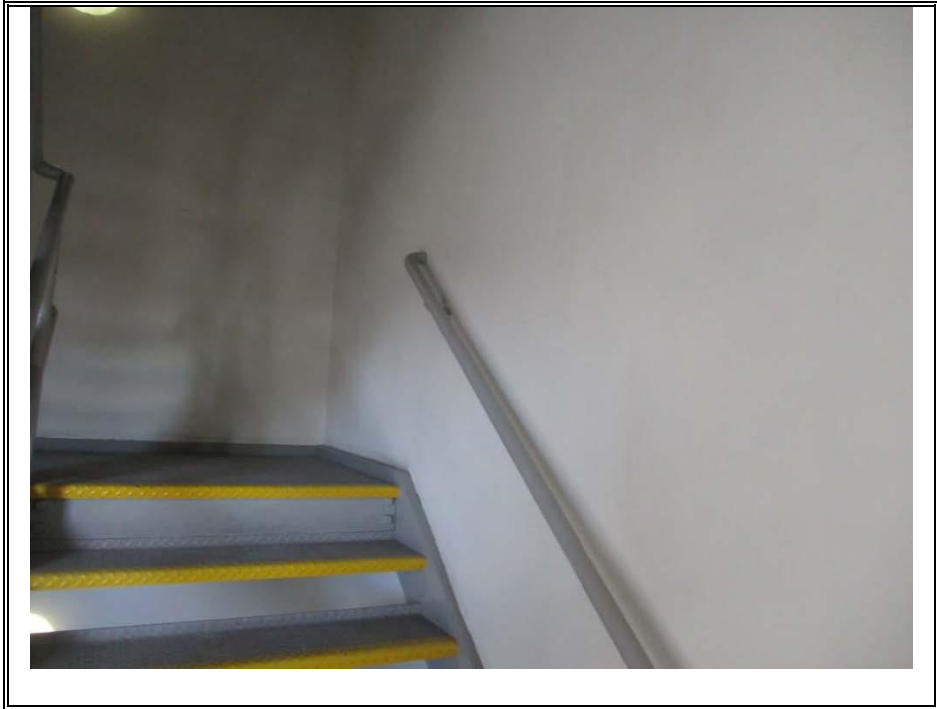
CATEGORY:	PAINT	
COMPONENT(S):	INTERIOR FLATWORK-STAIRWELLS	ID#(S) 0306

INTERIOR FLATWORK-STAIRWELLS (TYPICAL)

OBSERVATIONS: *This component addresses the painted surfaces of the stairwells (walls and ceilings). They appeared to be in an average condition for their age.*

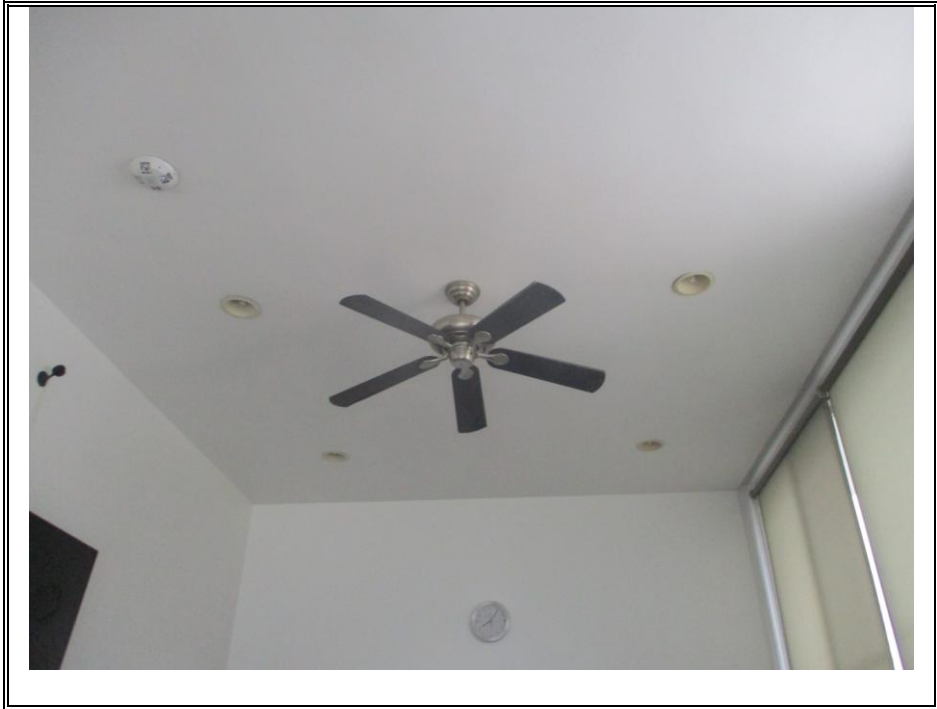
CATEGORY:	PAINT	
COMPONENT(S):	INTERIOR FLATWORK-RECREATION	ID#(S) 0307

INTERIOR FLATWORK-RECREATION (TYPICAL)

OBSERVATIONS: *This component addresses the painted surfaces of the gym, restrooms, lobby, office, and other miscellaneous common areas. They appeared to be in various conditions, and for the purposes of reporting the remaining life has been averaged.*

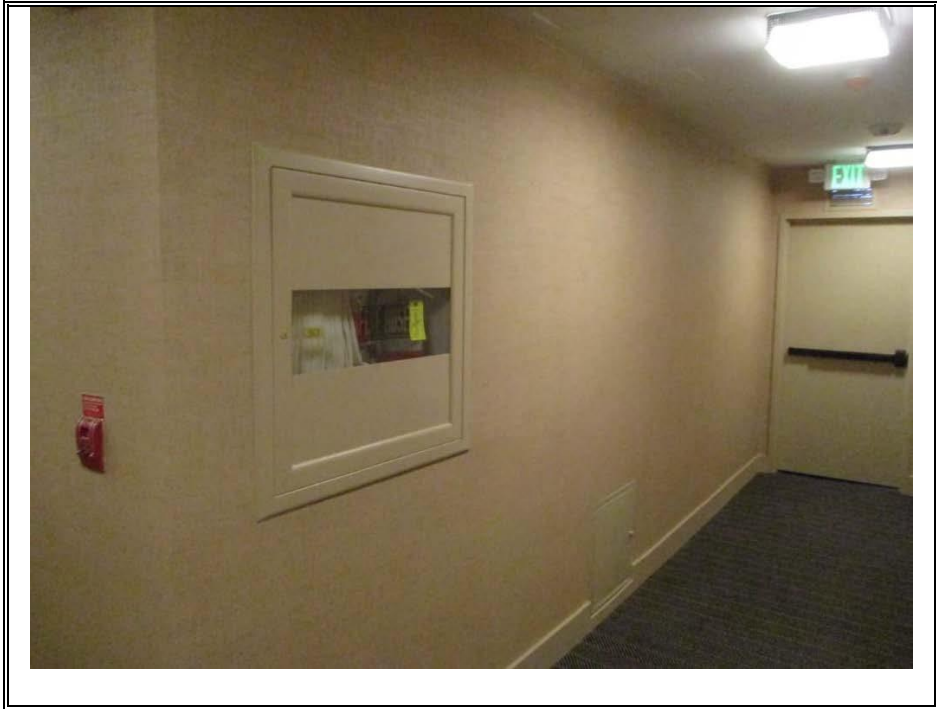
CATEGORY:	<i>PAINT</i>	
COMPONENT(S):	<i>WALLPAPER</i>	ID#(S) 0308

WALLPAPER (TYPICAL)

OBSERVATIONS: *This component addresses the wallpapered surfaces of the internal hallways and common areas. We were informed that they were installed in 2024, and they appeared in good condition.*

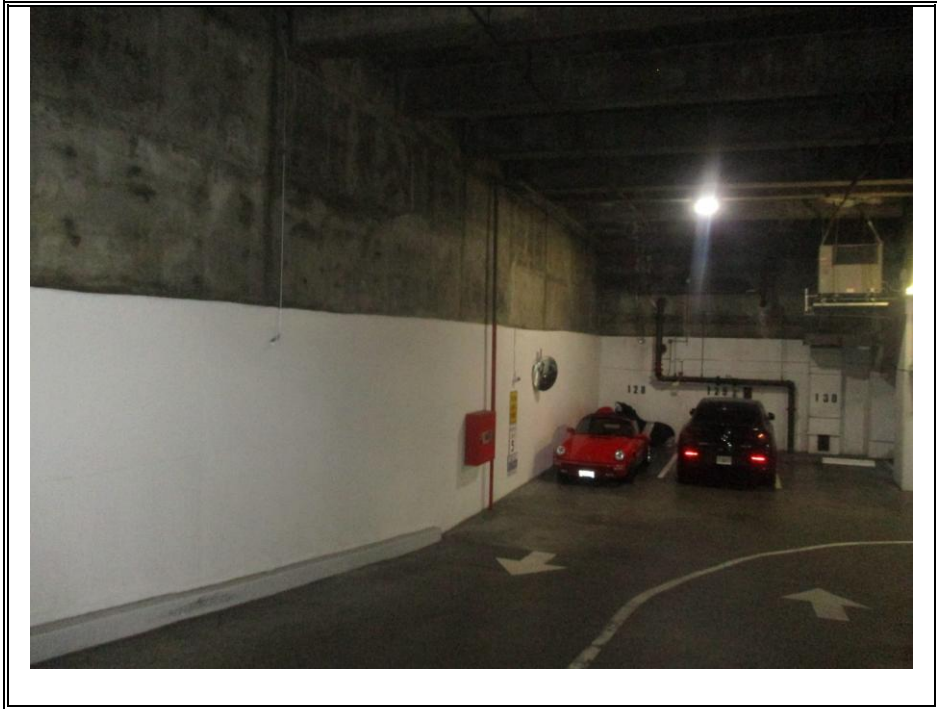
CATEGORY:	<i>PAIN</i>	
COMPONENT(S):	<i>GARAGE INTERIOR</i>	ID#(S) 0309

GARAGE INTERIOR (TYPICAL)

OBSERVATIONS: *This component addresses the painted surfaces of the interior walls of the garages. We were previously informed that they were painted in 2013, and they generally appeared to be in average condition for their age.*

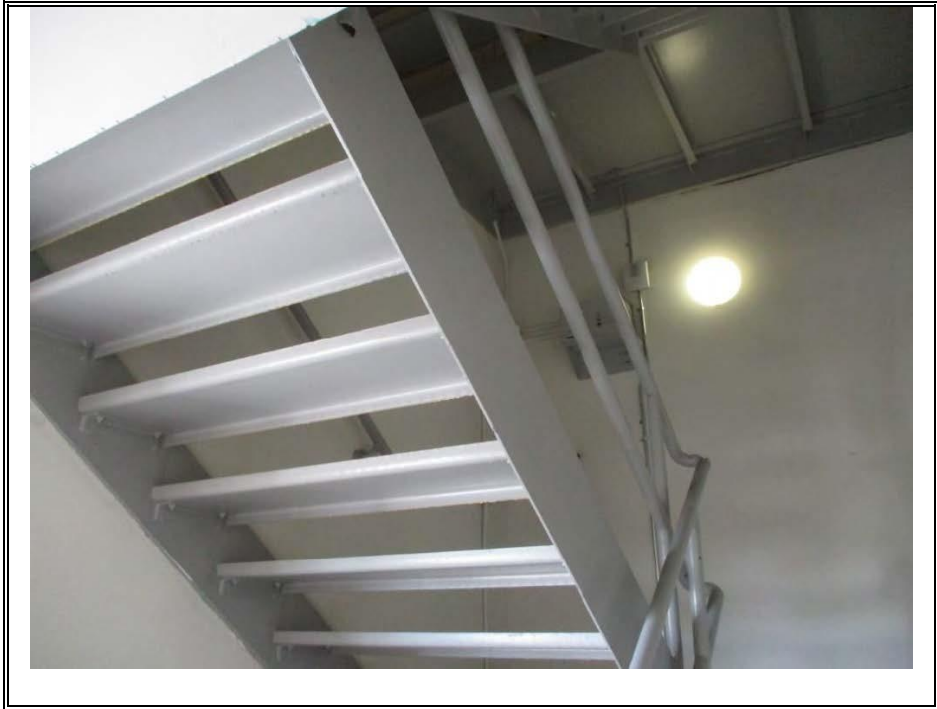
CATEGORY:	PAINT	
COMPONENT(S):	IRONWORK-INTERIOR	ID#(S) 0311

IRONWORK-INTERIOR (TYPICAL)

OBSERVATIONS: *This component addresses the painted surfaces of the wrought iron rails at the stairwells, steps, and landings. They appeared to be in an average condition for their age.*

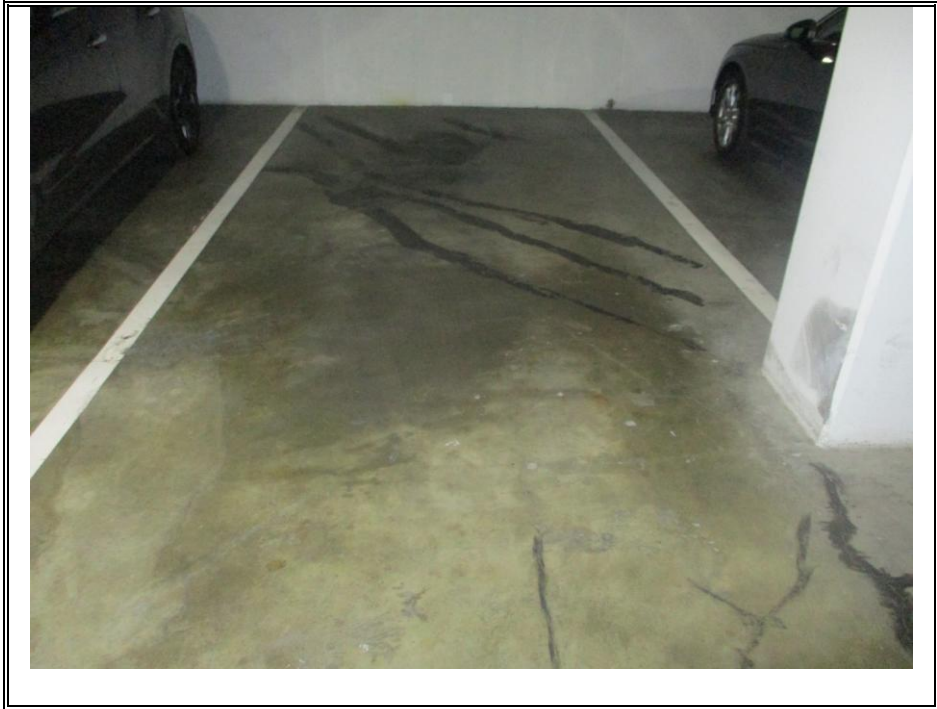
CATEGORY:	<i>PAINT</i>	
COMPONENT(S):	<i>PARKING STRIPES</i>	ID#(S) 0313

PARKING STRIPES (TYPICAL)

OBSERVATIONS: *This component addresses the painted parking stripes that delineate the individual parking spaces in the garages. They appeared to be in an average condition for their age.*
