COMPLETE RSI RESERVE STUDY WITH SITE VISIT

RECREATION SAMPLE RESERVE STUDY

1234 Main Street
Anywhere, California

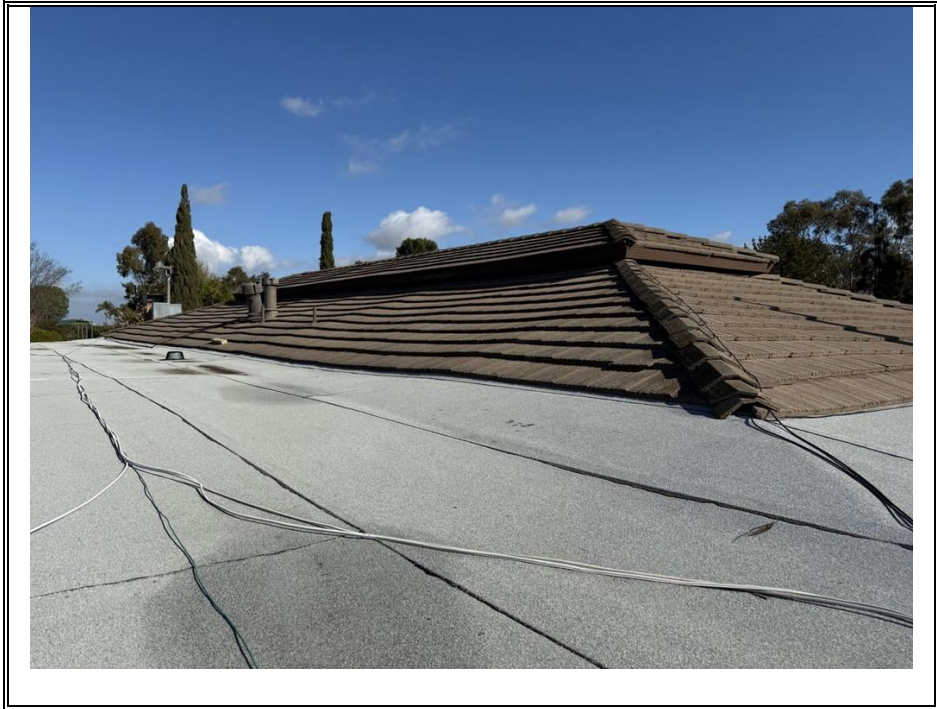
CATEGORY:	ROOF/DECKS	
COMPONENT(S):	CAP SHEET ROOF	ID#(S) 0101

CAP SHEET ROOF (TYPICAL)

OBSERVATIONS: *This component addresses the cap-sheet roofing (flat) on the front lobby, café, laundry, and maintenance buildings. It generally appeared to be in an average condition; however, ponding was noted on the southern section of the café building roofing. On this type of structure, 2 layers are generally permitted. However, if it is decided to re-roof over the existing roofing, experience dictates that the typical useful life of the new materials would be reduced by approximately one third (33%). The average component cost and typical useful life reflects removal of the existing roofing prior to the installation of the new roofing.*

TO PROTECT YOUR INVESTMENT: *Reseal separated laps and seams. Reseal flashings as necessary. Roof drains should be maintained in a clean and operational condition to prevent damming, water retention and associated leakage. A maintenance contract with a qualified roofing contractor is recommended.*

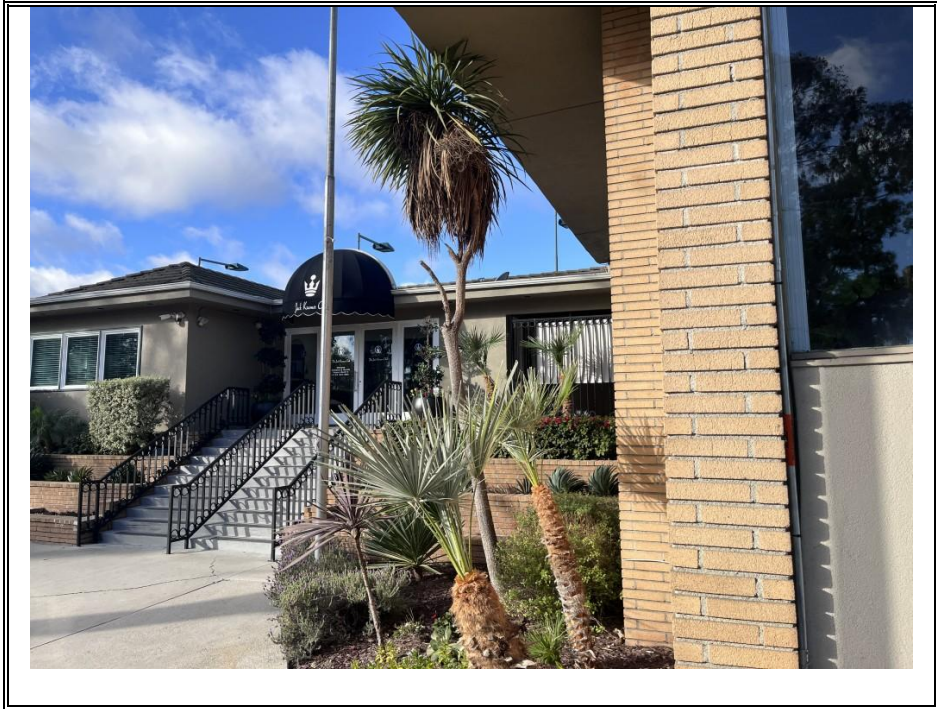
CATEGORY:	STRUCTURE	
COMPONENT(S):	STRUCTURES	ID#(S) 0201

STRUCTURES (TYPICAL)

OBSERVATIONS: *This component addresses the foundations and structural frame, along with the internal weather-shell components and essential structure elements of the buildings. Provided there are no major catastrophes, the proper drainage principles are maintained and that structural pest control procedures are adhered to, the structures themselves and associated infrastructure would be considered lifetime components. Additionally, there would be infrastructure within structures, such as water piping systems, electrical panels, service lines, outlets, and switches. And, in some instances, natural gas piping systems, heating, air-conditioning, and ventilation ducting systems would be included. Components that have predictable life expectancy and a remaining life expectancy of less than 30 years will be outlined elsewhere in this report.*

TO PROTECT YOUR INVESTMENT: *Maintained grade levels 4-6 inches below the lowest edge of the structural frame. Grading should be sloped away from the structures for drainage, and downspouts should be discharged onto hardscape areas or splash blocks and directed away from the structures. Annual inspections of the buildings and the essential systems by qualified maintenance personnel are recommended.*

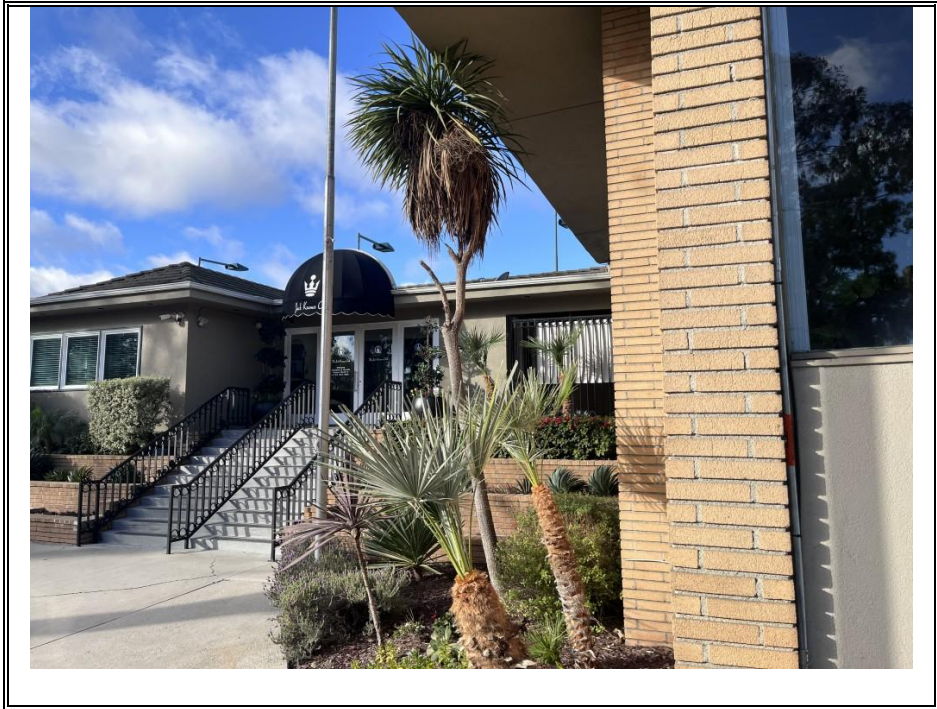
CATEGORY:	STRUCTURE	
COMPONENT(S):	FUMIGATION	ID#(S) 0202

FUMIGATION (TYPICAL)

OBSERVATIONS: *This component addresses the potential fumigation. Prudent maintenance suggests that annual inspections be performed to discover any infestation. As this building is primarily concrete and steel, no funding for complete fumigation has been provided; any necessary treatments should be funded on an as-needed basis from the operating account. It is suggested that further evaluation be obtained from a licensed pest control operator.*

TO PROTECT YOUR INVESTMENT: *A maintenance contract with a qualified pest control contractor is recommended, which can minimize the necessity for fumigation. Repair loose or cracked siding or stucco, peeling paint and gaps at trim around windows and doors to prevent moisture getting into the framing leading to termite infestation, fungus, and/or mold. Low foundation walls, cracks in foundation walls, leaking pipes, over-watered landscape surrounding the structure, and damaged or nonexistent gutters and downspouts that discharge near the perimeter of the structures should be monitored and repaired as necessary.*

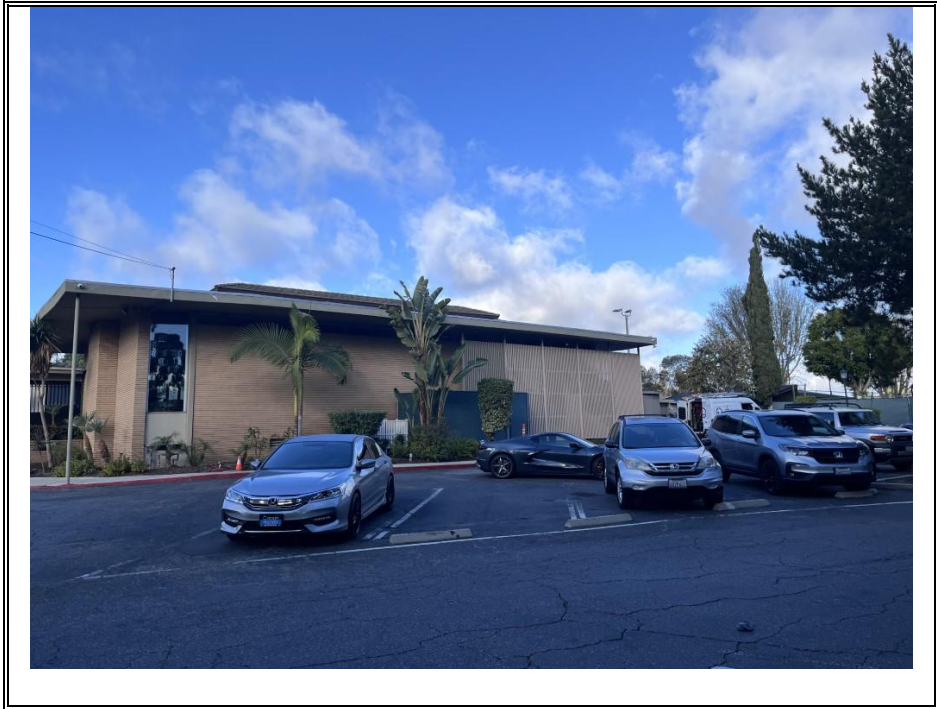
CATEGORY:	STRUCTURE	
COMPONENT(S):	WOOD SIDING	ID#(S) 0203

WOOD SIDING (TYPICAL)

OBSERVATIONS: *This component addresses the wood siding on the exteriors of the maintenance / equipment buildings. It appeared to be in an average to aging condition. The other trim, including the wood fascia, is not included here, as it would be replaced as necessary on an on-going basis.*

TO PROTECT YOUR INVESTMENT: *Regular painting and repair of any cracks and splits should be performed to protect the siding and prevent termite infestation. Any protruding nails should also be re-driven and sealed.*

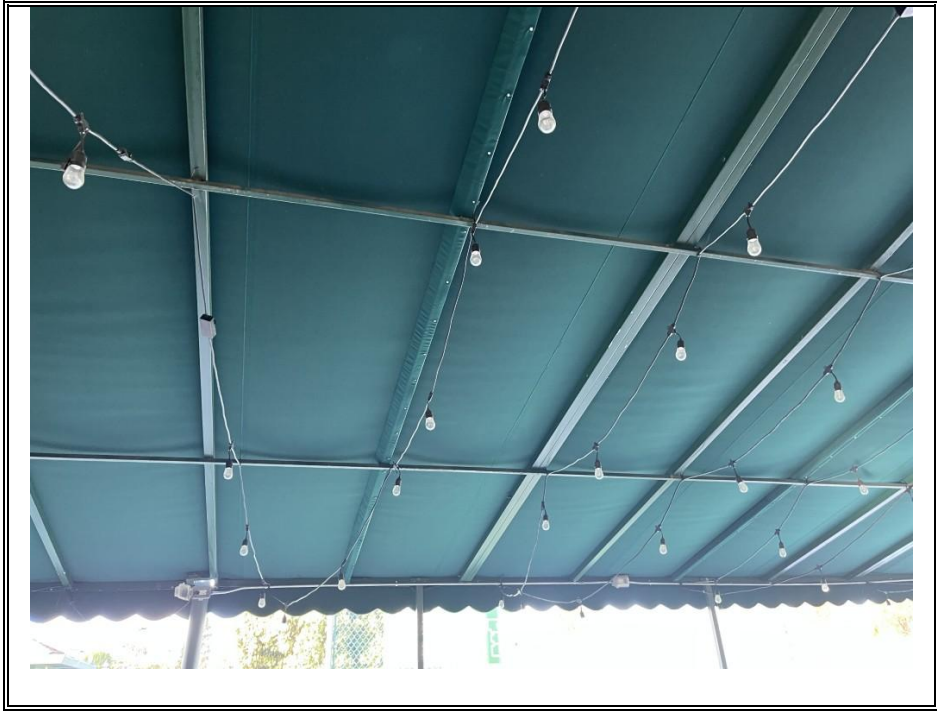
CATEGORY:	STRUCTURE	
COMPONENT(S):	CANOPIES	ID#(S) 0206

CANOPIES (TYPICAL)

OBSERVATIONS: *This component addresses the canvas canopies over gym equipment, play structure picnic tables, sports courts, and various building entrances. They appeared to be in various conditions; therefore, for purposes of reporting the remaining life has been averaged.*

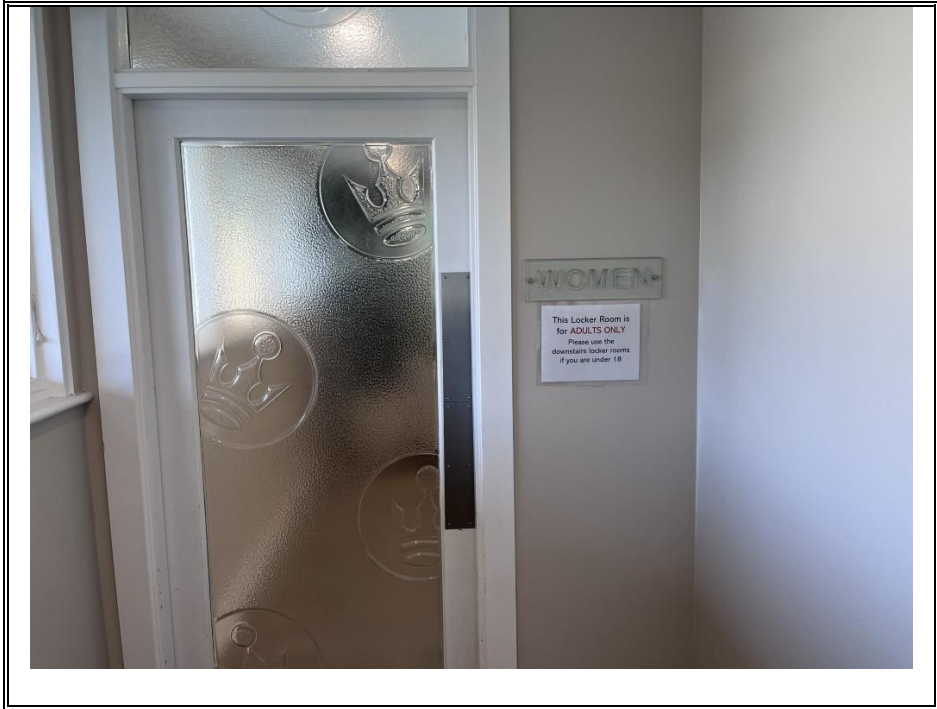
DOORS (TYPICAL)

OBSERVATIONS: *This component addresses a placeholder for the refurbishment of the custom glass and/or fire doors.*

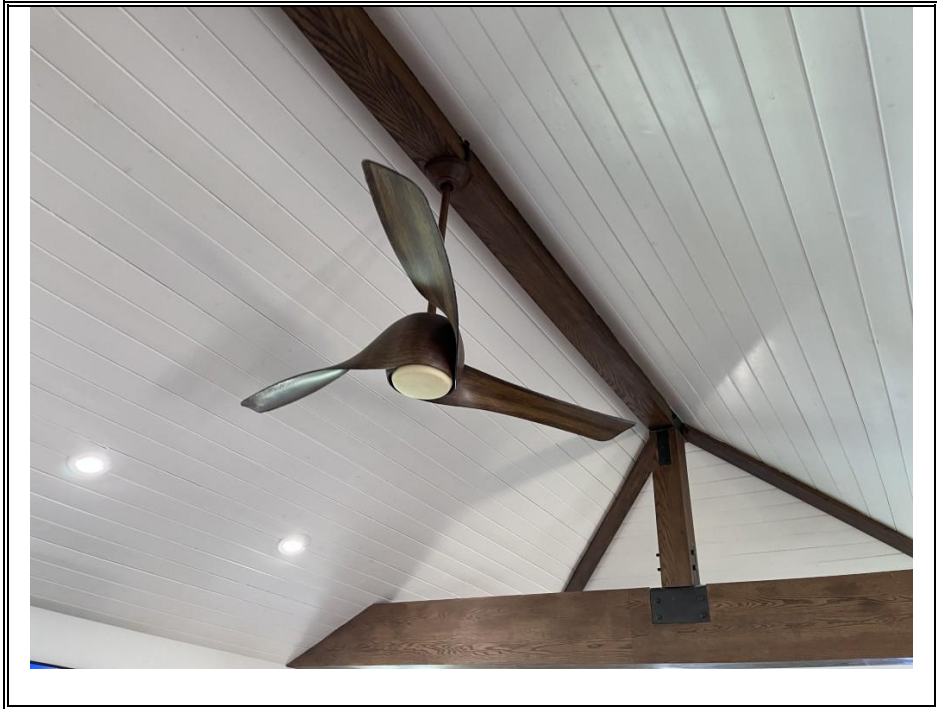
CATEGORY:	<i>PAIN</i>	
COMPONENT(S):	<i>INTERIOR FLATWORK</i>	ID#(S) 0304

INTERIOR FLATWORK (TYPICAL)

OBSERVATIONS: *This component addresses the painted surfaces of the interiors of the front lobby, gym, café, and restrooms. They appeared to be in an average condition.*

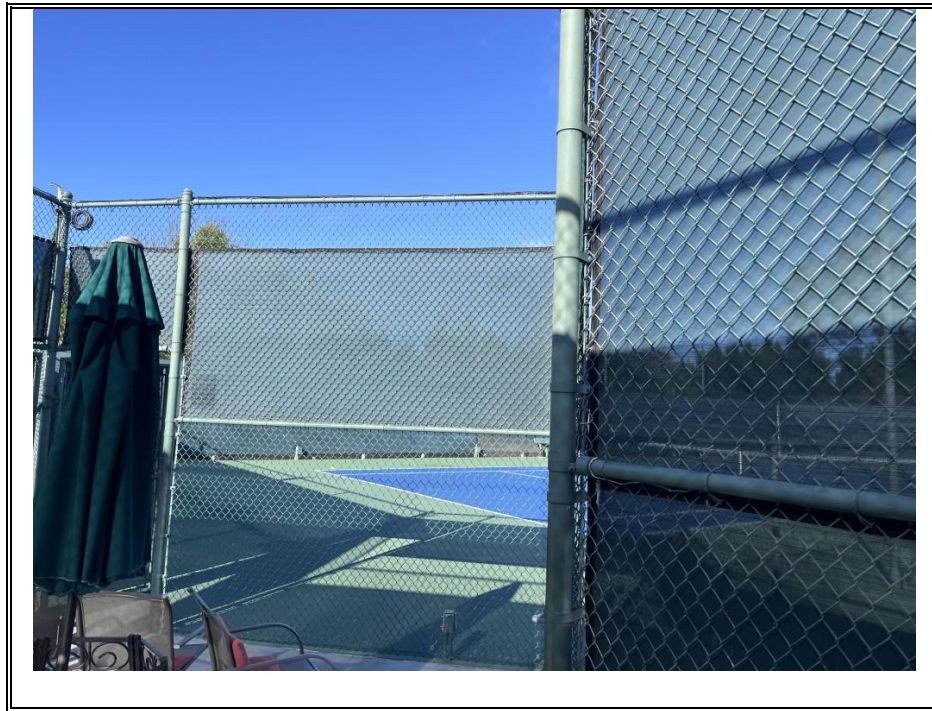
ID#(S) 0306

CHAIN LINK FENCING (TYPICAL)

OBSERVATIONS: *This component addresses the painted surfaces of the chain link fencing throughout the club. They appeared to be in an average condition.*

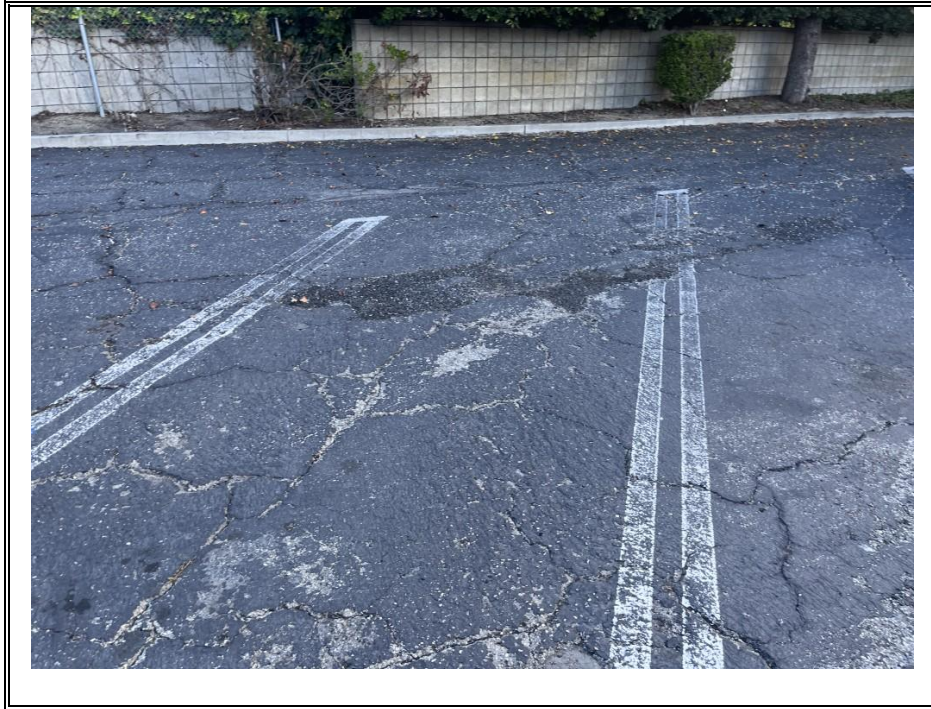
PARKING STRIPES (TYPICAL)

OBSERVATIONS: *This component addresses the painted parking stripes that delineate the individual parking spaces. They appeared to be in an aged condition.*

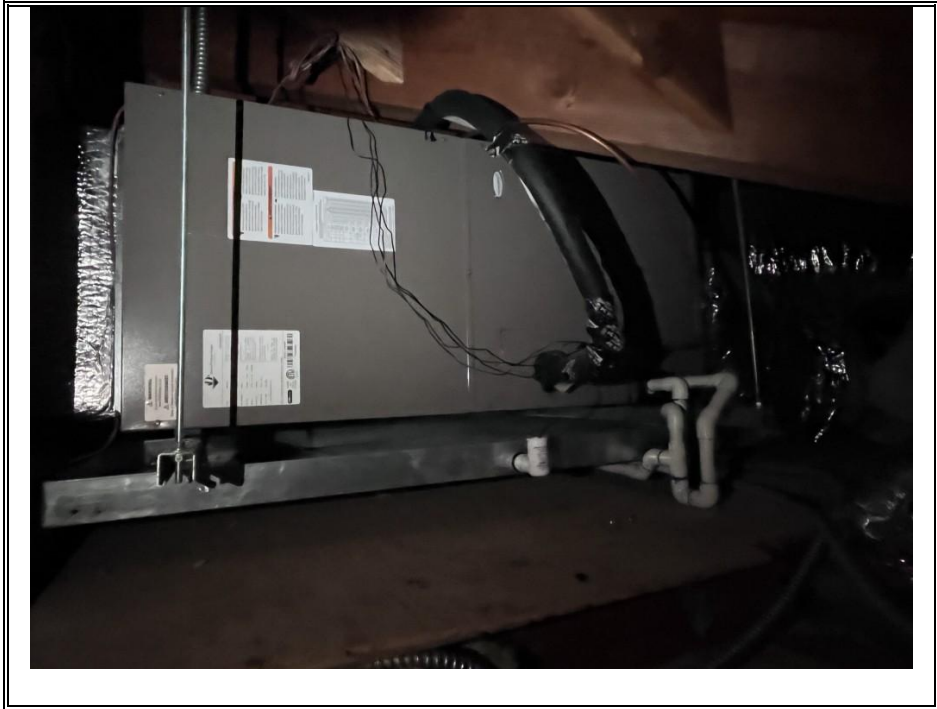
CATEGORY:	MECHANICAL	
COMPONENT(S):	HEAT PUMPS	ID#(S) 0401

HEAT PUMPS (TYPICAL)

OBSERVATIONS: *This component addresses the heat pumps that serve the café and front office. The attic mounted unit serving the original building appeared to be in good condition. The unit serving the add-on areas was inaccessible for inspection; therefore, for purposes of reporting the remaining life has been estimated and the ages averaged.*

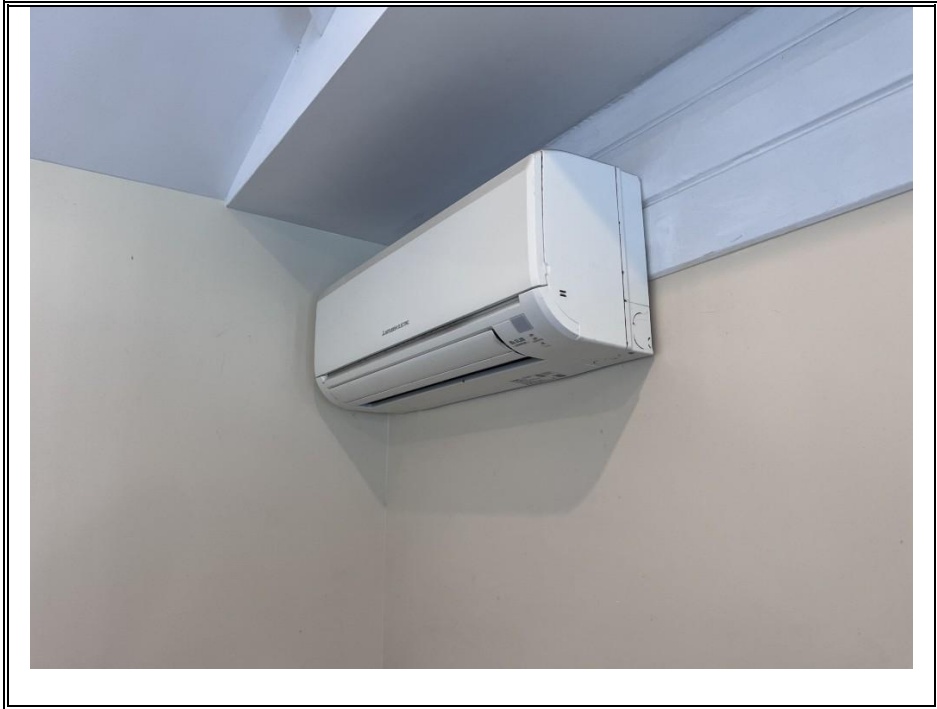
CATEGORY:	MECHANICAL	
COMPONENT(S):	DUCTLESS AIR HANDLERS	ID#(S) 0403

DUCTLESS AIR HANDLERS (TYPICAL)

OBSERVATIONS: *This component addresses the ductless air handlers at the gym and kitchen. They appeared to be in an average to aging condition.*

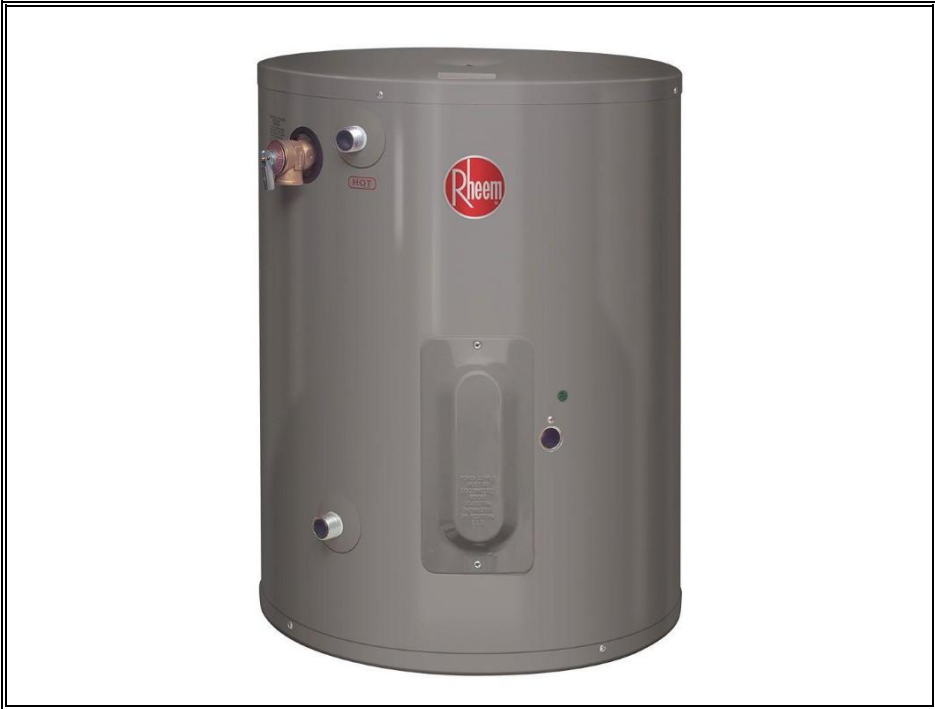
CATEGORY:	PLUMBING	
COMPONENT(S):	WATER HEATER	ID#(S) 0503

WATER HEATER (TYPICAL)

OBSERVATIONS: *This component addresses a water heater that serves the cafe building. It was inaccessible for inspection (locked); therefore, for purposes of reporting the remaining life has been estimated. It should be noted that a visual examination cannot make predictions as to future performance (i.e. even with correct maintenance, these units can fail without warning).*

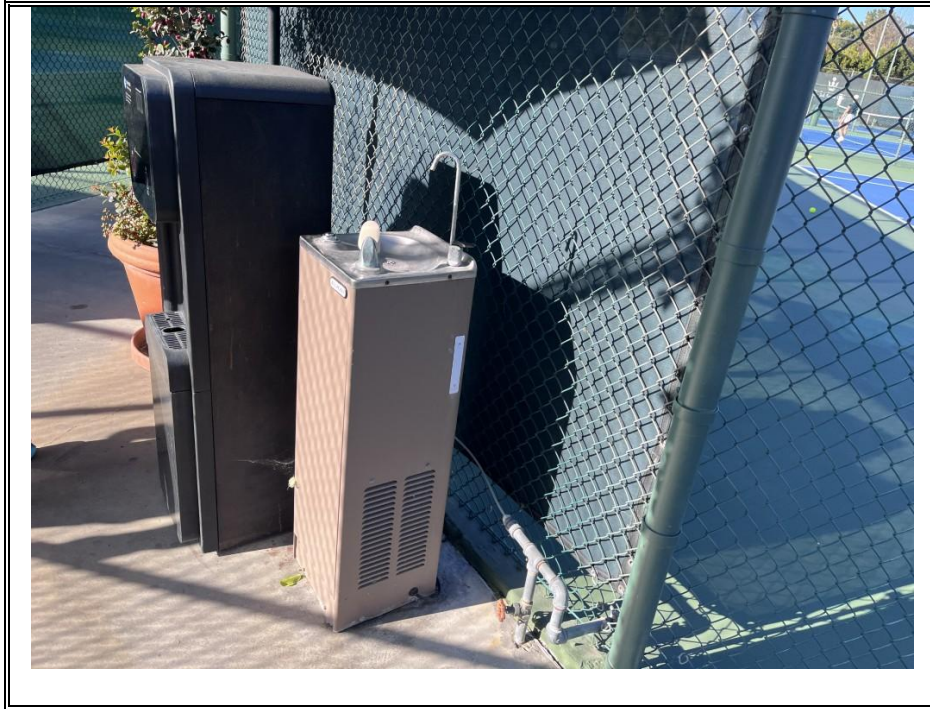
DRINKING FOUNTAINS (TYPICAL)

OBSERVATIONS: *This component addresses the chilled water drinking fountains throughout the club. They appeared to be in various conditions, mostly aging; therefore, for purposes of reporting the remaining life has been averaged.*

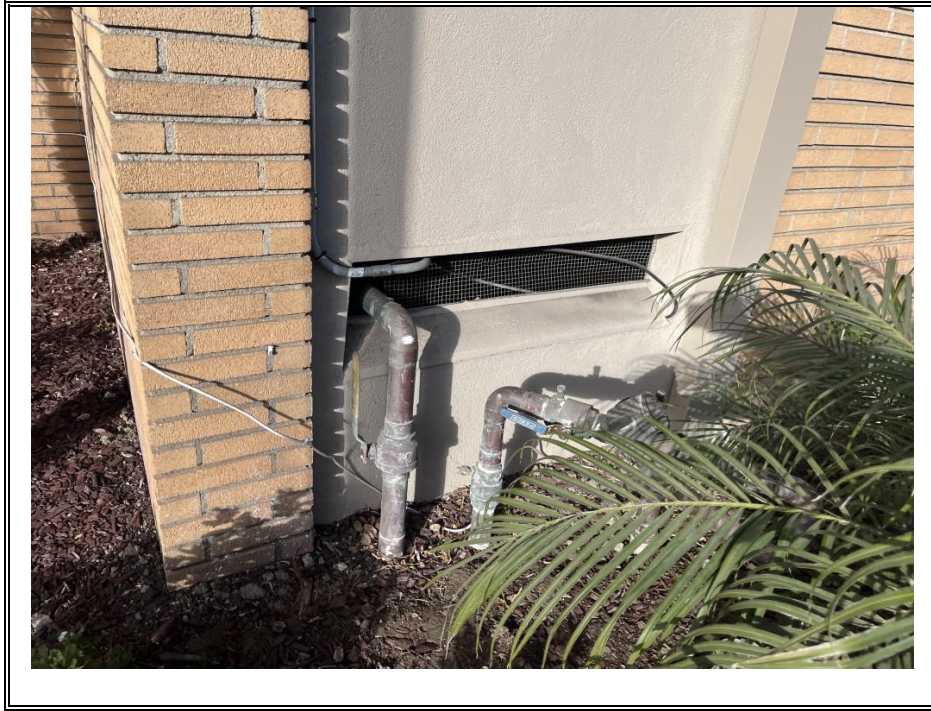
BACKFLOW PREVENTER (TYPICAL)

OBSERVATIONS: *This component addresses the backflow preventer serving the domestic water system. Its actual performance life would be difficult to determine; however, a time frame has been provided for budgeting purposes.*

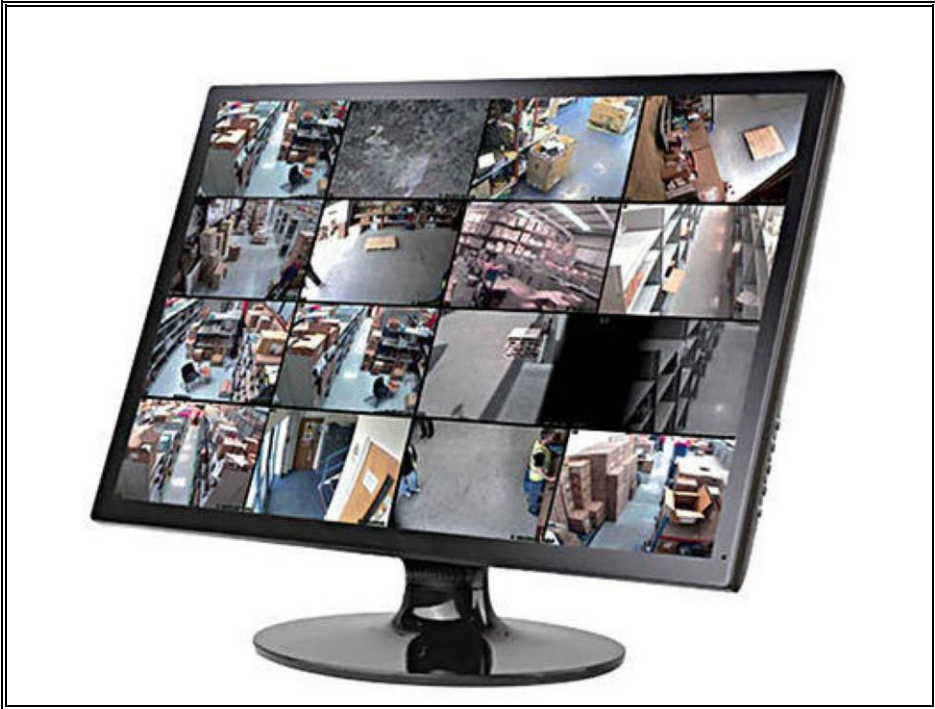
CATEGORY:	ELECTRICAL	
COMPONENT(S):	SURVEILLANCE CAMERA SYSTEM	ID#(S) 0601

SURVEILLANCE CAMERA SYSTEM (TYPICAL)

OBSERVATIONS: *This component addresses an allowance to maintain the surveillance camera system, including the cameras and recording equipment. These systems are typically repaired / refurbished (versus being replaced all at the same time), as the cameras are often replaced on an as-needed basis and the recording /monitoring equipment replaced on a less frequent cycle. The system appeared to be in an average condition.*

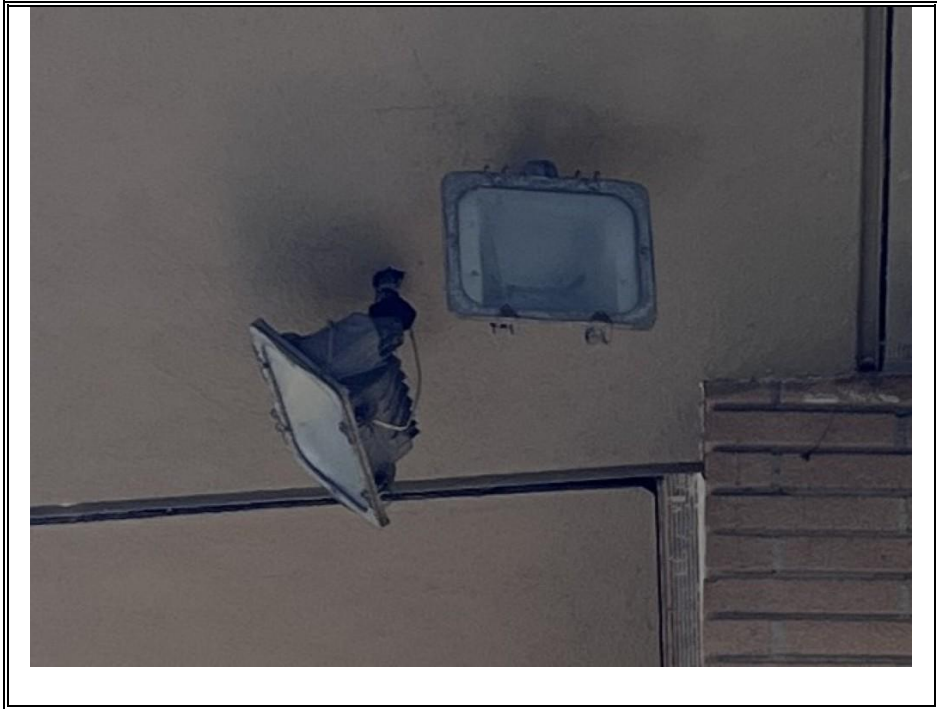
LIGHTING-UTILITARIAN (TYPICAL)

OBSERVATIONS: *This component addresses the smaller standard fixtures throughout the club. They appeared to be in an average to aging condition.*

TO PROTECT YOUR INVESTMENT: *Ensure the fixtures are secure.*

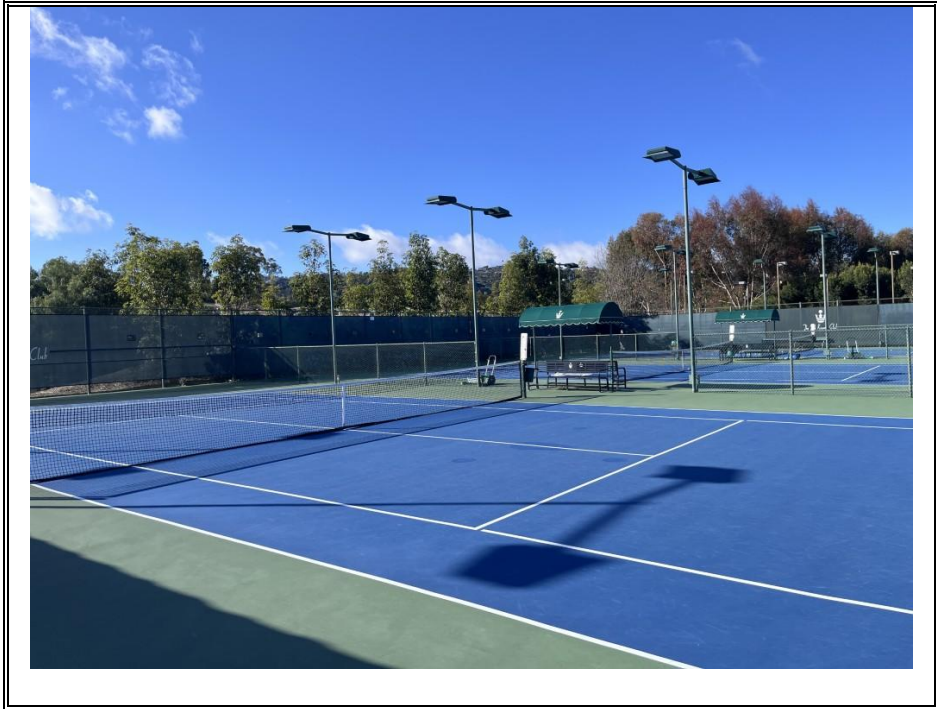
LIGHTING-TENNIS (TYPICAL)

OBSERVATIONS: *This component addresses the LED light fixtures at the tennis courts. We were informed that they were installed circa 2017, and they appeared to be in good condition.*

TO PROTECT YOUR INVESTMENT: *Ensure the fixtures are secure.*

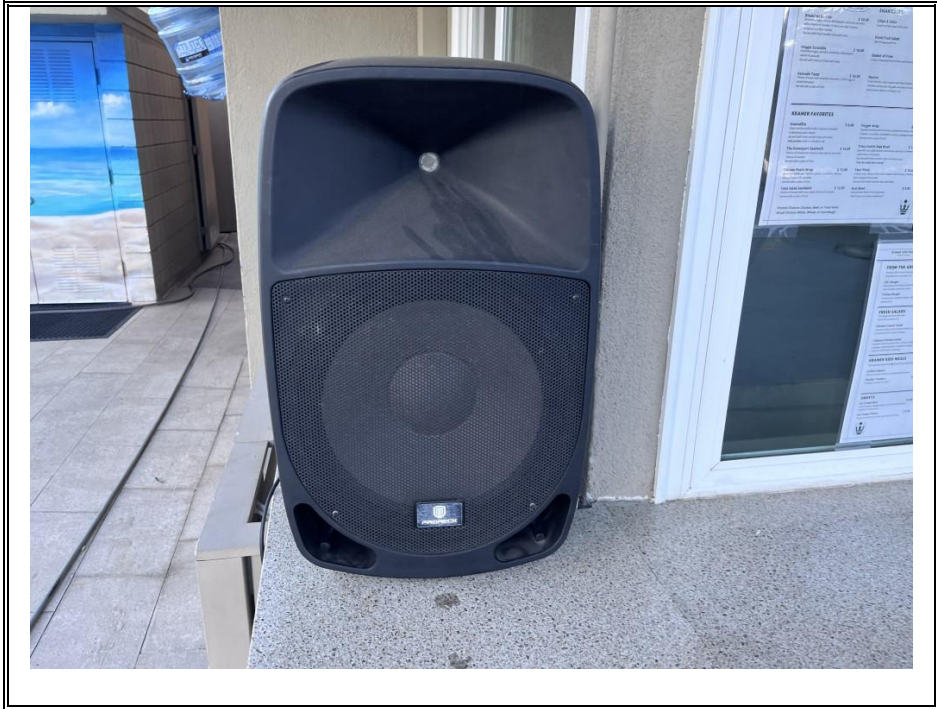
AUDIO / VISUAL EQUIPMENT (TYPICAL)

OBSERVATIONS: *This component addresses an allowance for the repair, replacement, or refurbishment, of the audio / visual equipment, comprised of speakers, receivers, recorders, transmitters, wiring, and routing equipment.*

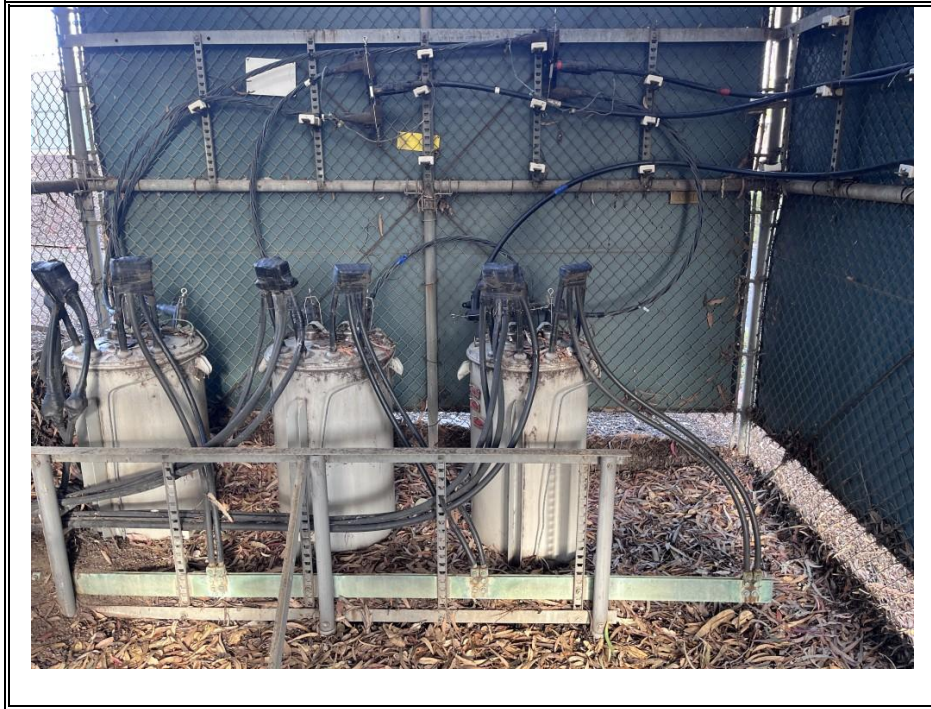
TRANSFORMERS (TYPICAL)

OBSERVATIONS: *This component addresses the transformers in the chain link cage at the southern end of the parking lot. They generally appeared to be in an aging condition. Replacement typically occurs between 30 and 50 years.*

TO PROTECT YOUR INVESTMENT: N/A

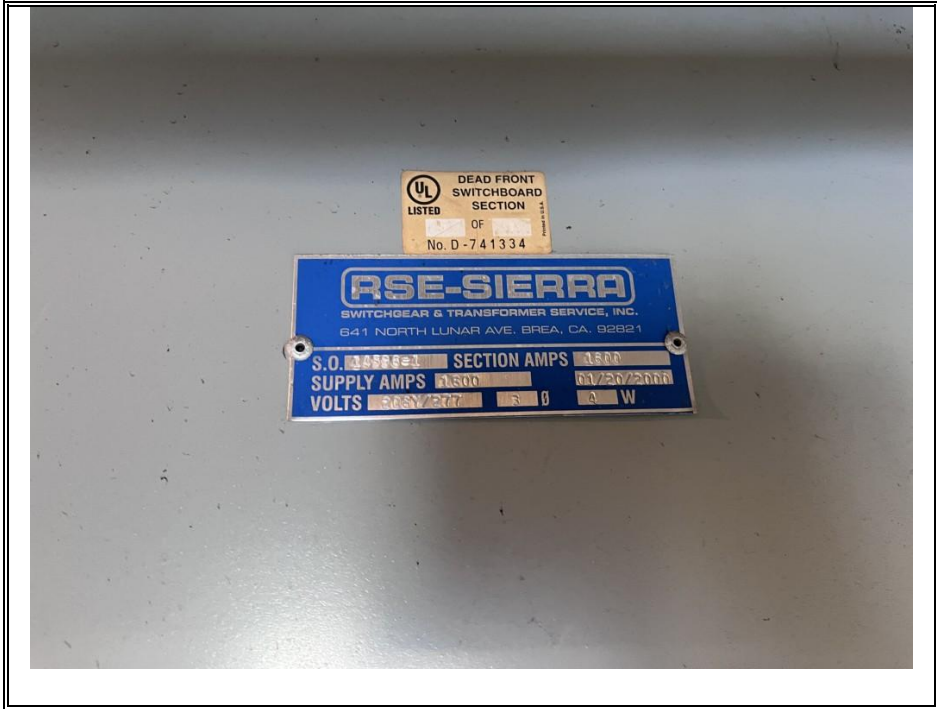
ELECTRICAL SYSTEM (TYPICAL)

OBSERVATIONS: *This component addresses what appeared to be an original electrical system. The electrical panels were observed to be of an antiquated design/type, and the service capacity is suspected to be inadequate for current needs. We recommend further evaluation by a qualified electrical contractor.*

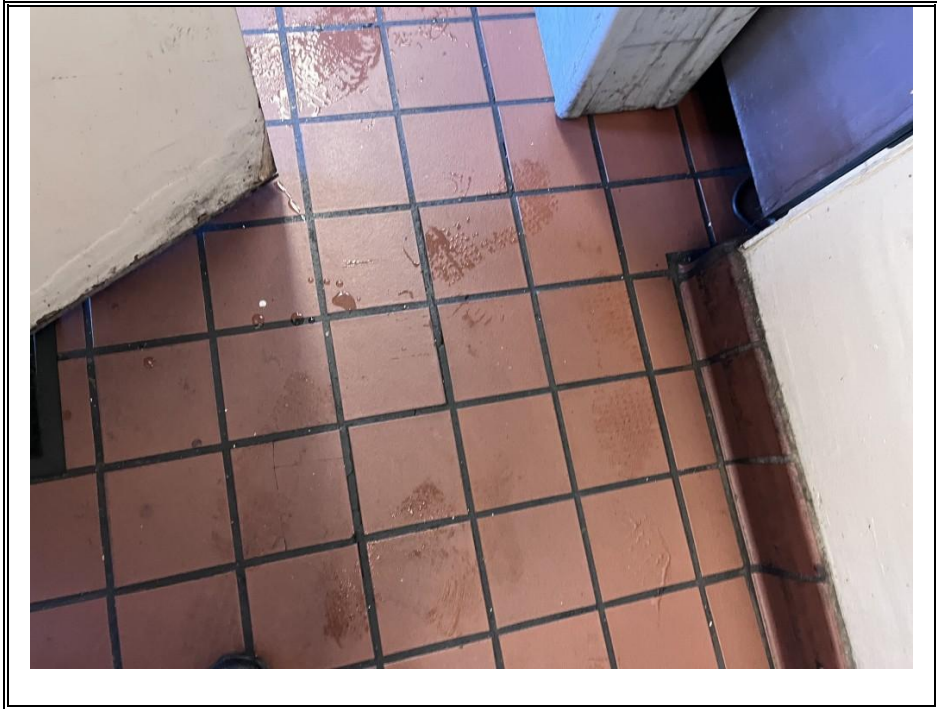
TILE-KITCHEN (TYPICAL)

OBSERVATIONS: *This component addresses the ceramic tile flooring in the kitchen. It appeared to be in an average condition.*

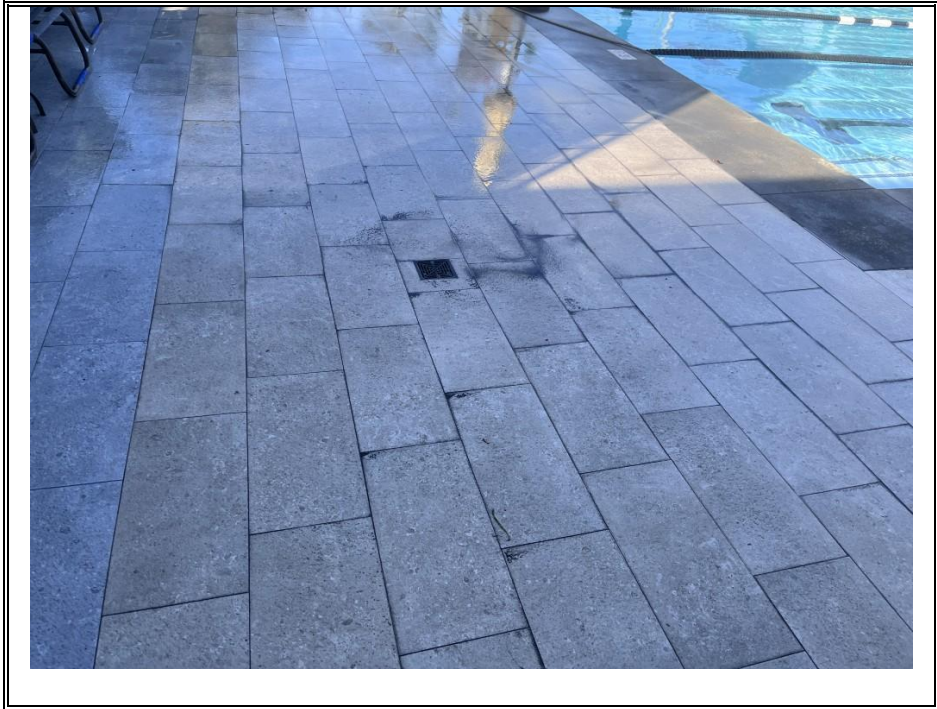
TILE DECK (TYPICAL)

OBSERVATIONS: *This component addresses the tile deck surfaces of the pool and exterior bar deck. There were surface drains which should allow for drainage of these areas, however, if the drains become clogged or standing water occurs, this may lead to moisture permeating through the concrete surface. We suggest monitoring the surfaces for signs of any excessive moisture. Should this occur, it is recommended that appropriate qualified specialists be consulted for further review and recommendations.*

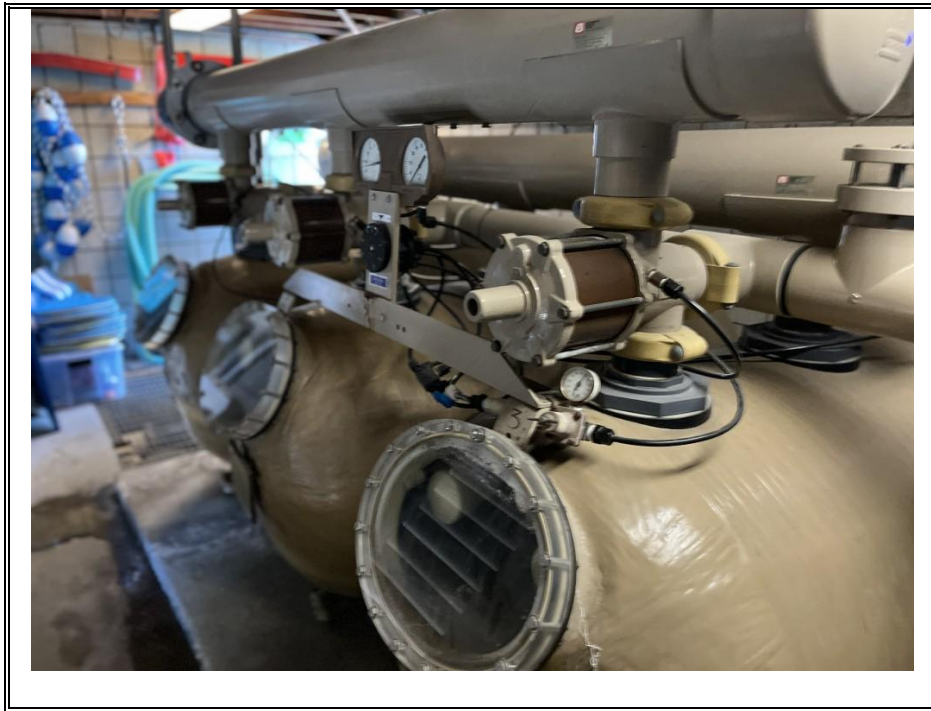
EQUIPMENT (TYPICAL)

OBSERVATIONS: *This component addresses an allowance for the equipment that serves the pool. It appeared to be in average condition.*

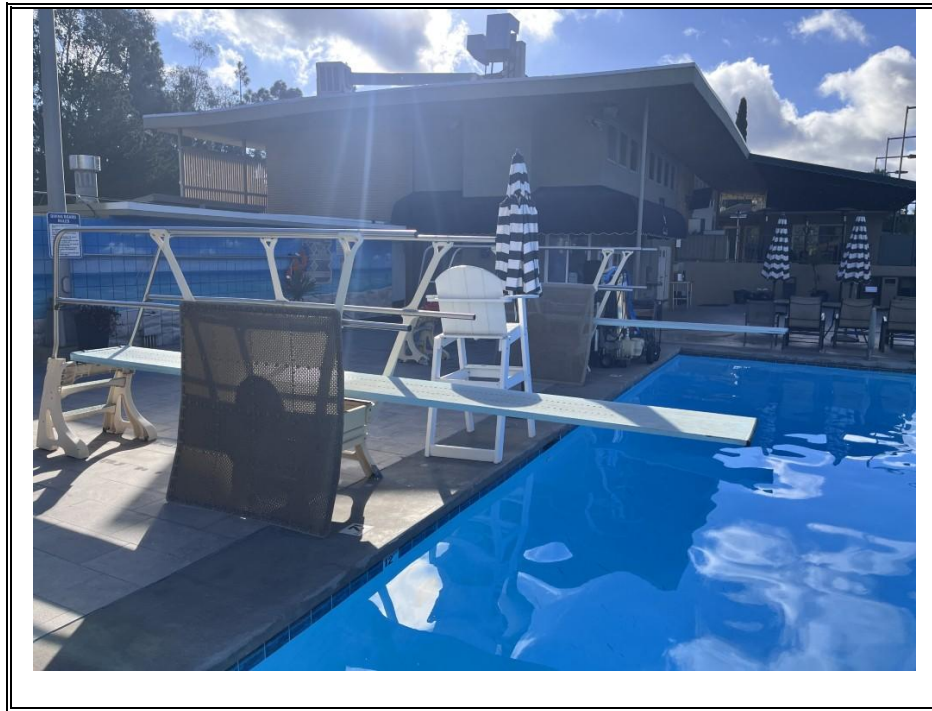
DIVING BOARDS (TYPICAL)

OBSERVATIONS: *This component addresses the diving boards. They appeared to be in an average condition.*

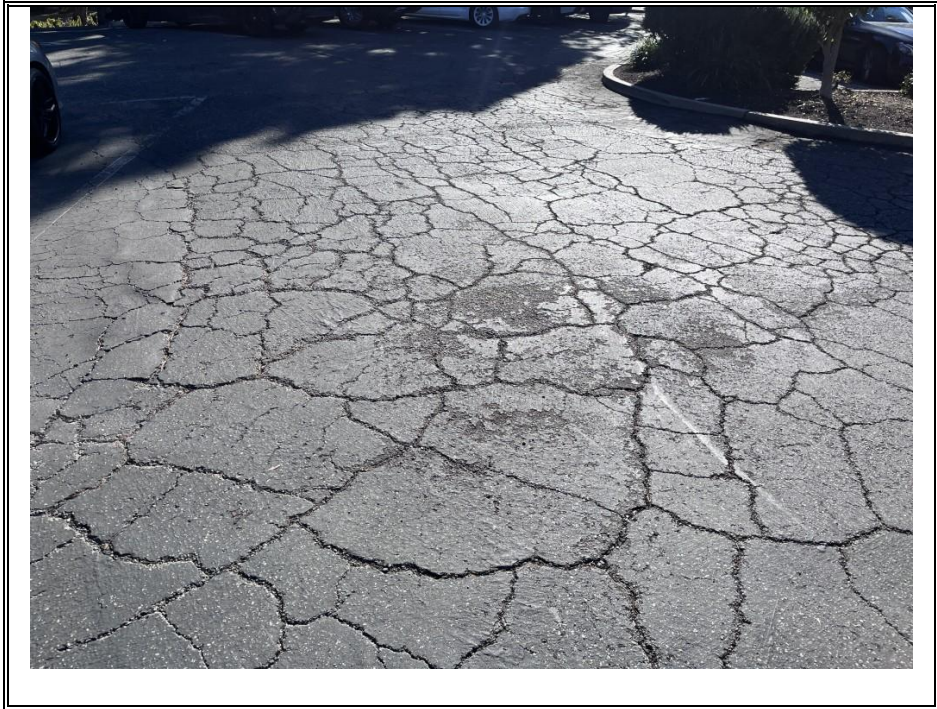
ASPHALT SEAL COAT (TYPICAL)

OBSERVATIONS: *This component addresses the seal coat for the asphalt streets. It appeared to be in an aged condition. It serves to enhance the longevity of the underlying asphalt as well as its appearance by replenishing the oil and fine aggregates of the underlying asphalt. It is important that this procedure be undertaken within 6 months of any overlay or resurfacing and performed thereafter on a 3 – 5-year cycle (typically a warranty requirement).*

TO PROTECT YOUR INVESTMENT: *Cracks exceeding ¼ inch should be repaired with a rubberized sealant compound. Irrigation run-off can accelerate degradation and should be prevented / diverted.*

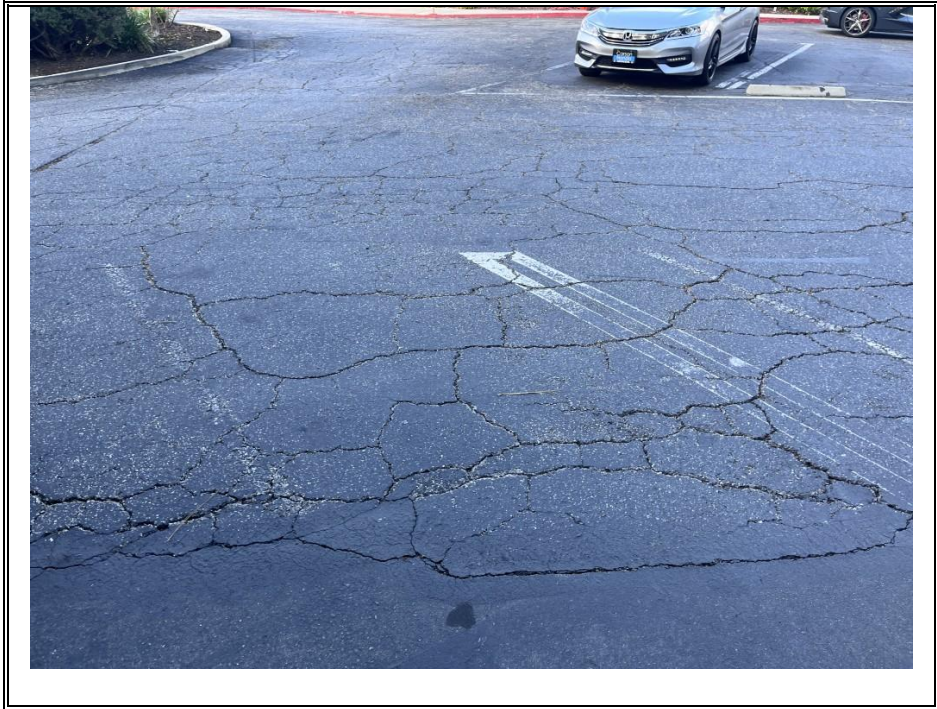
ASPHALT REPLACEMENT (TYPICAL)

OBSERVATIONS: *This component addresses replacement of the asphalt surfaces. The surfaces appeared to be in an aged condition, with major cracking noted throughout and failing infrastructure adjacent to Montecillo Dr. Aging, oxidation, erosion, and vehicle traffic eventually cause cracking, surface wear, and delamination of the seal coat. Replacement entails removal of the existing asphalt, grading and compaction of the aggregate base material, and the installation of hot asphalt. It is recommended that engineering be obtained prior to replacement. In conjunction with replacement, seal coat should be performed within 6 months and then at 3 – 5-year intervals thereafter.*

TO PROTECT YOUR INVESTMENT: *Cracks exceeding ¼ inch should be repaired with a rubberized sealant compound. Irrigation run-off can accelerate degradation and should be prevented / diverted.*

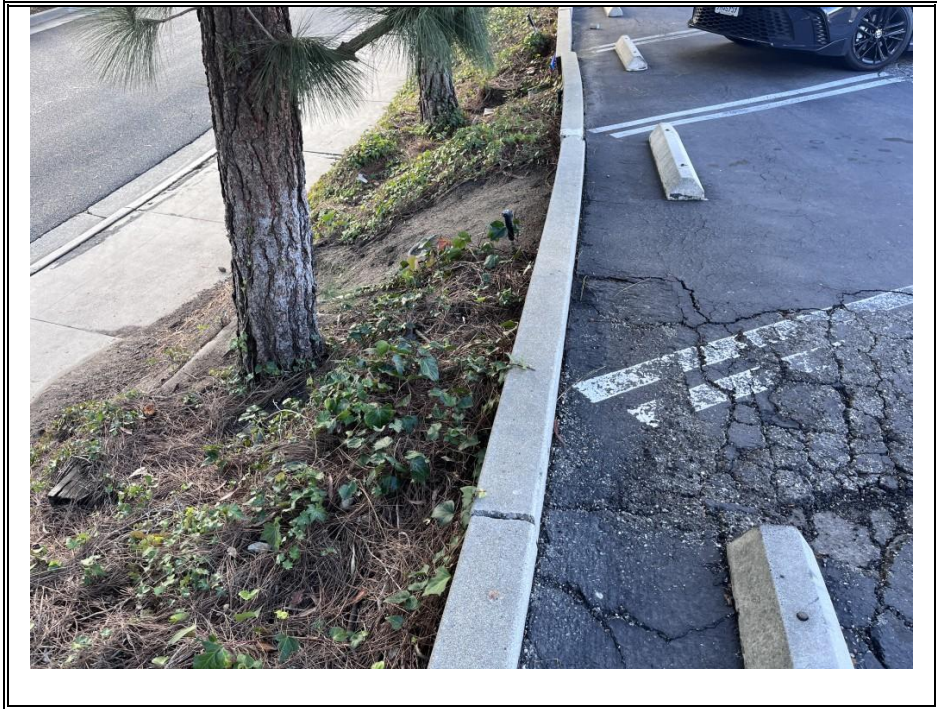
RETAINING WALL-PARKING LOT (TYPICAL)

OBSERVATIONS: *This component addresses a placeholder for the installation of a retaining wall along the sloped landscape between the parking lot and Montecillo Dr. Major erosion was noted along the slope, which appears to be the cause to the failing infrastructure at the adjacent sections of the parking lot. Further evaluation by a qualified contractor is recommended.*

TO PROTECT YOUR INVESTMENT: *Little by way of maintenance can be performed.*

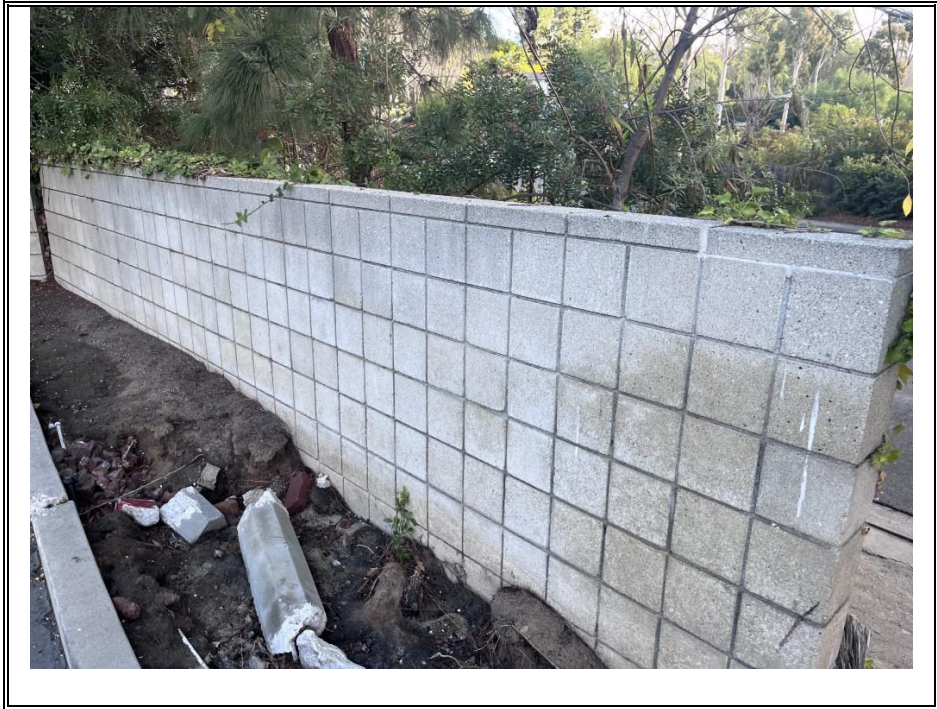
CONCRETE-FLATWORK/WALLS (TYPICAL)

OBSERVATIONS: *This component addresses a placeholder for the refurbishment of the concrete walkways and paths, as well as the concrete block wall fencing. Although they appeared to be in average condition, they should be regularly monitored for cracking and displacement. Otherwise, concrete areas are generally considered a lifetime component. Occasional repairs would typically be funded from the operating account.*

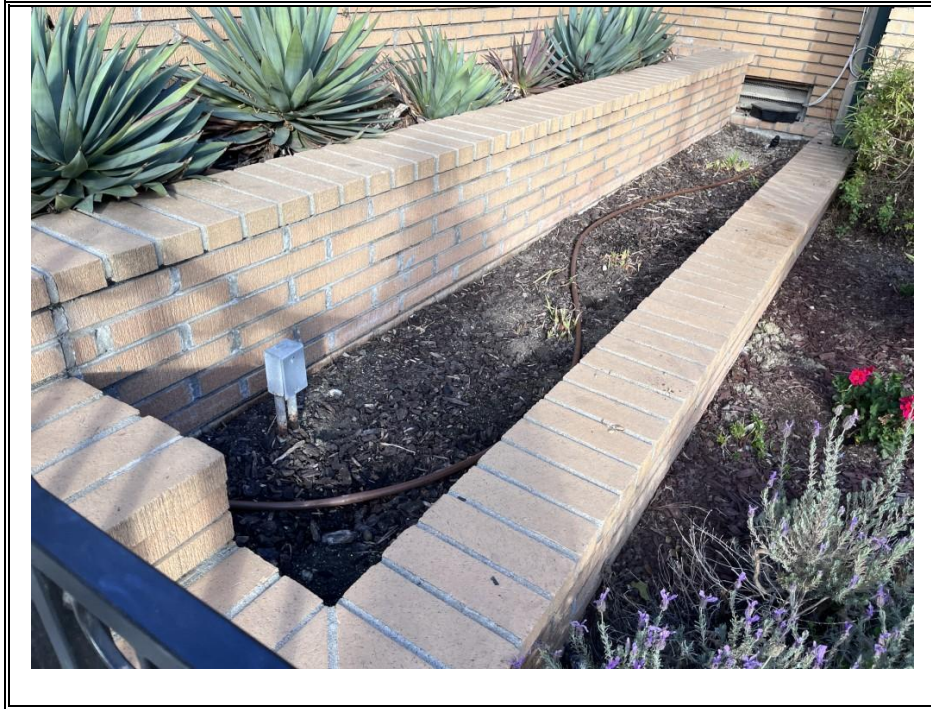
IRRIGATION PIPING (TYPICAL)

OBSERVATIONS: *This component addresses a placeholder for the refurbishment of the irrigation piping throughout the landscaping.*

TO PROTECT YOUR INVESTMENT: N/A
