COMPLETE RSI RESERVE STUDY WITH SITE VISIT

RECREATION SAMPLE RESERVE STUDY

1234 Main Street
Anywhere, California

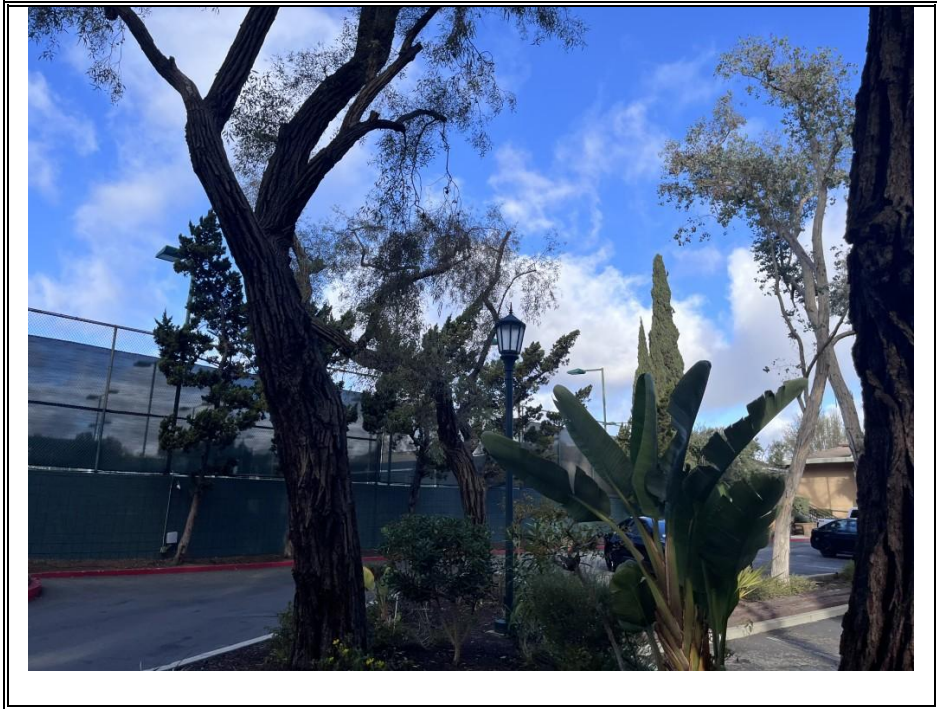
MAJOR TREE TRIMMING/REMOVAL (TYPICAL)

OBSERVATIONS: *This component addresses major tree trimming / removal. There were no major problems observed (or reported to us) with respect to structural damage from any trees. It is assumed that any maintenance is to be carried out on an as needed basis and funded from the operating account.*

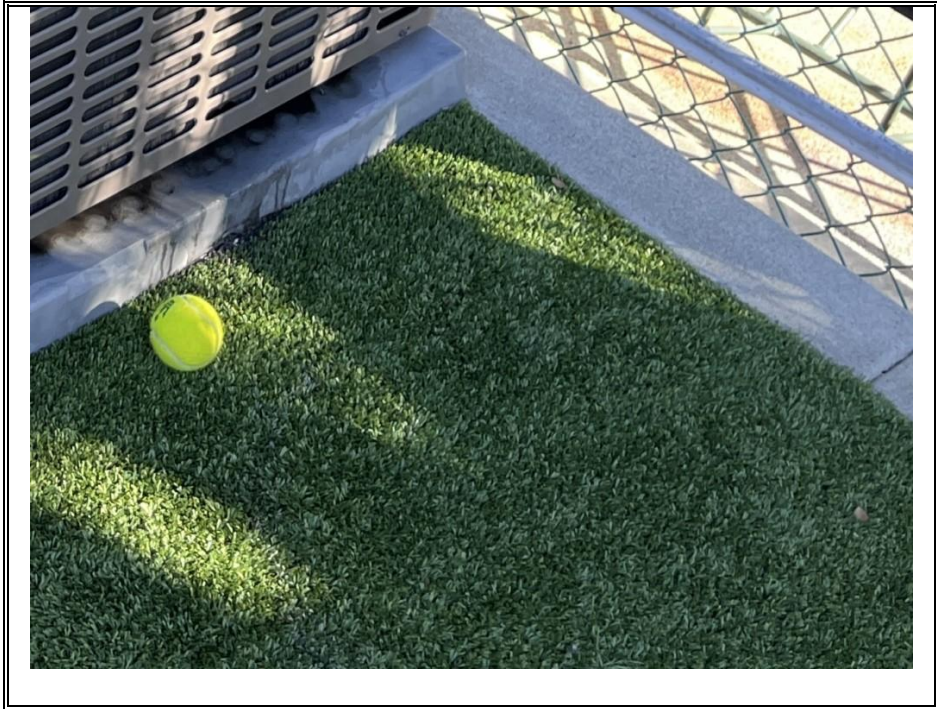
ARTIFICIAL TURF (TYPICAL)

OBSERVATIONS: *This component addresses the artificial turf adjacent to the lobby. It appeared to be in an average condition.*

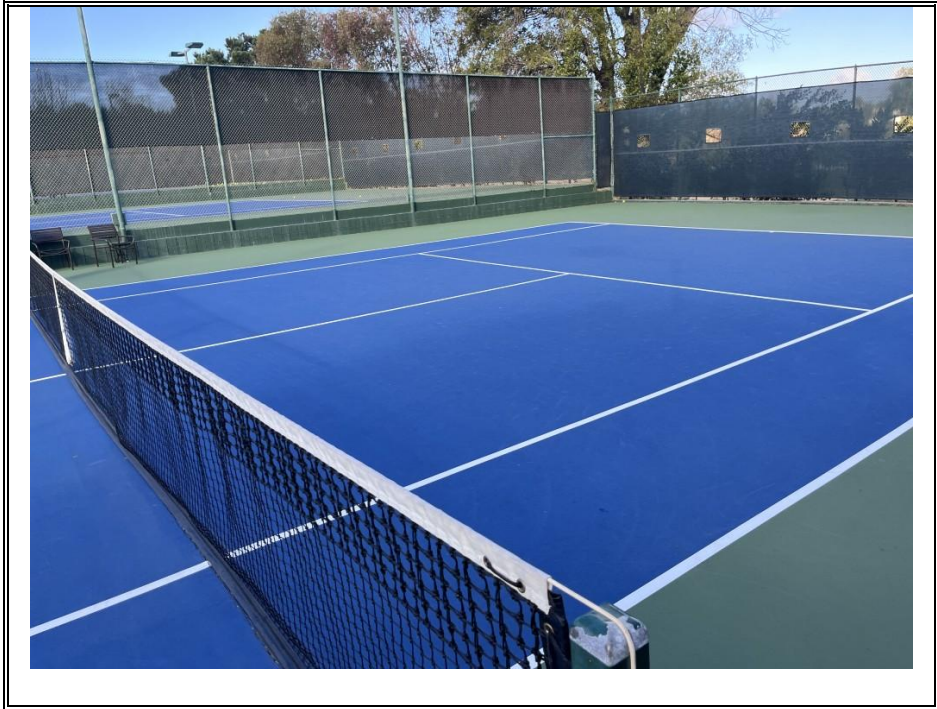
PLAYING SURFACES-TENNIS (TYPICAL)

OBSERVATIONS: *This component addresses the playing surfaces of the tennis courts. They appeared to be in good condition. Re-surfacing is critical to ensure the proper "speed of play" for the tennis players.*

TO PROTECT YOUR INVESTMENT: *Proper footwear will protect the playing surface from excessive wear.*

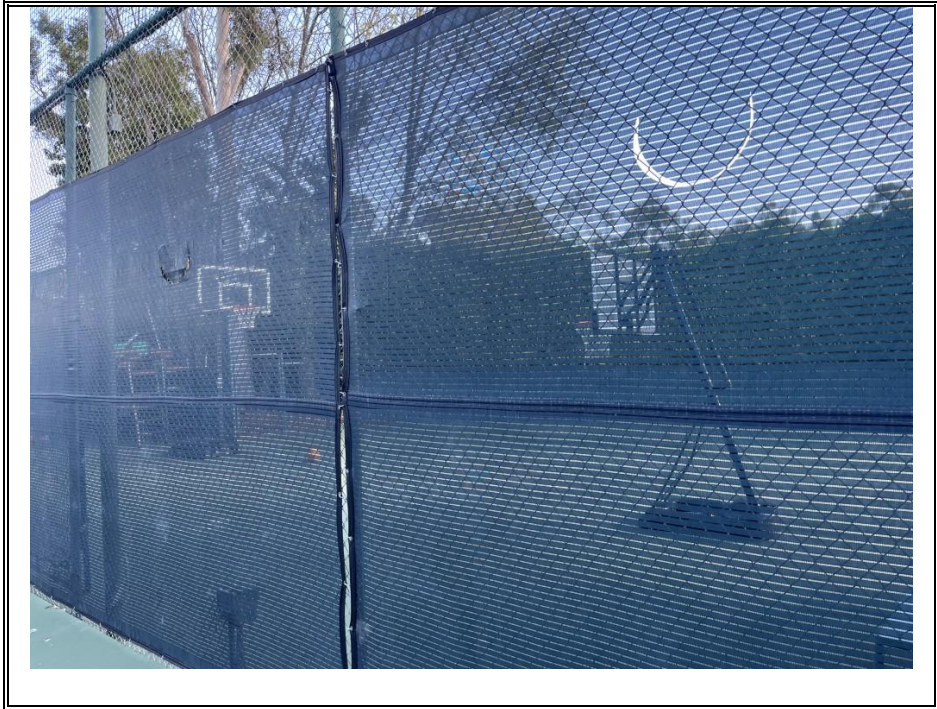
PLAYING SURFACES-BASKETBALL (TYPICAL)

OBSERVATIONS: *This component addresses the playing surfaces of the basketball court. It appeared to be in an average condition. Re-surfacing is critical to ensure the proper "speed of play" for the tennis players.*

TO PROTECT YOUR INVESTMENT: *Proper footwear will protect the playing surface from excessive wear.*

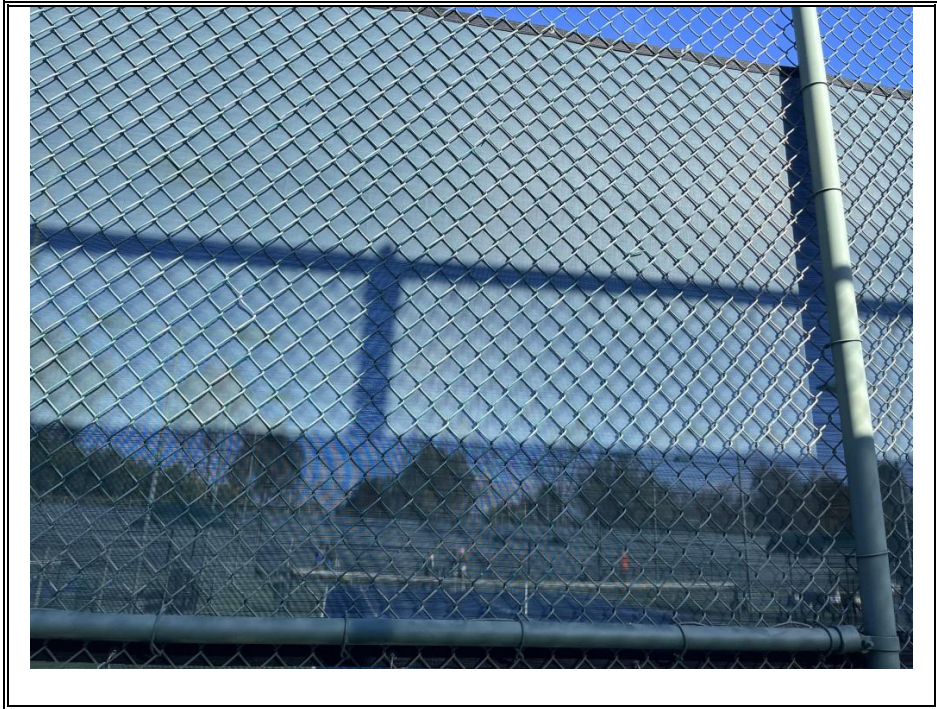
WINDSCREEN (TYPICAL)

OBSERVATIONS: *This component addresses the custom stenciled windscreen for the chain-link fencing around the tennis courts. It appeared to be in various conditions, mostly aged; therefore, for purposes of reporting the remaining life has been averaged. It serves the purpose of blocking some of the wind as well as providing a solid uniform background that improves ball definition for the player.*

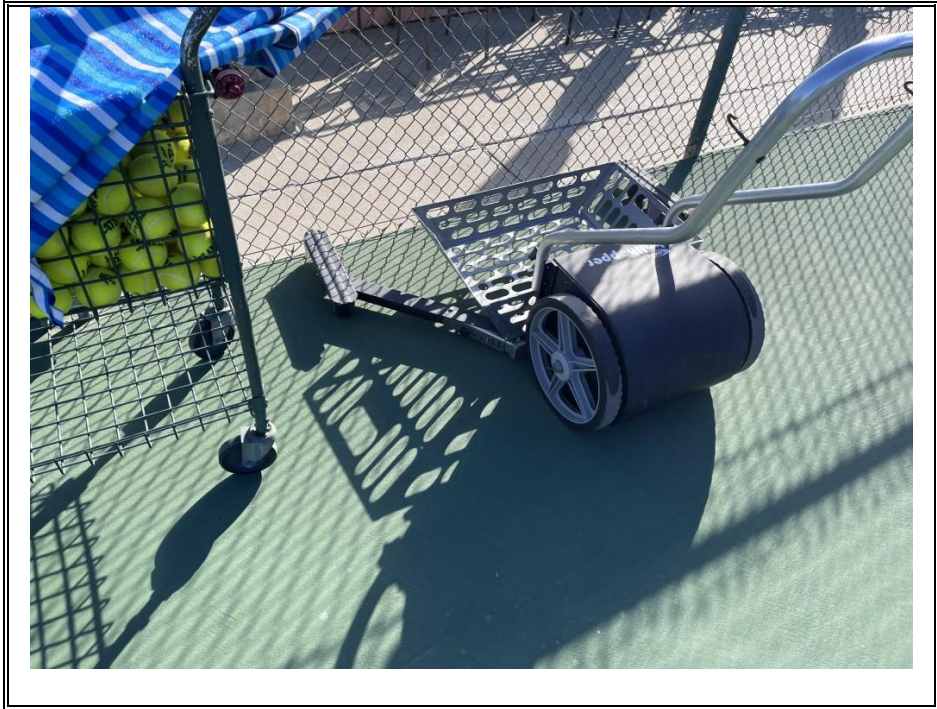
SPORTS EQUIPMENT (TYPICAL)

OBSERVATIONS: *This component addresses an allowance for the periodic repair, replacement, refurbishment, or maintenance of the sports equipment.*

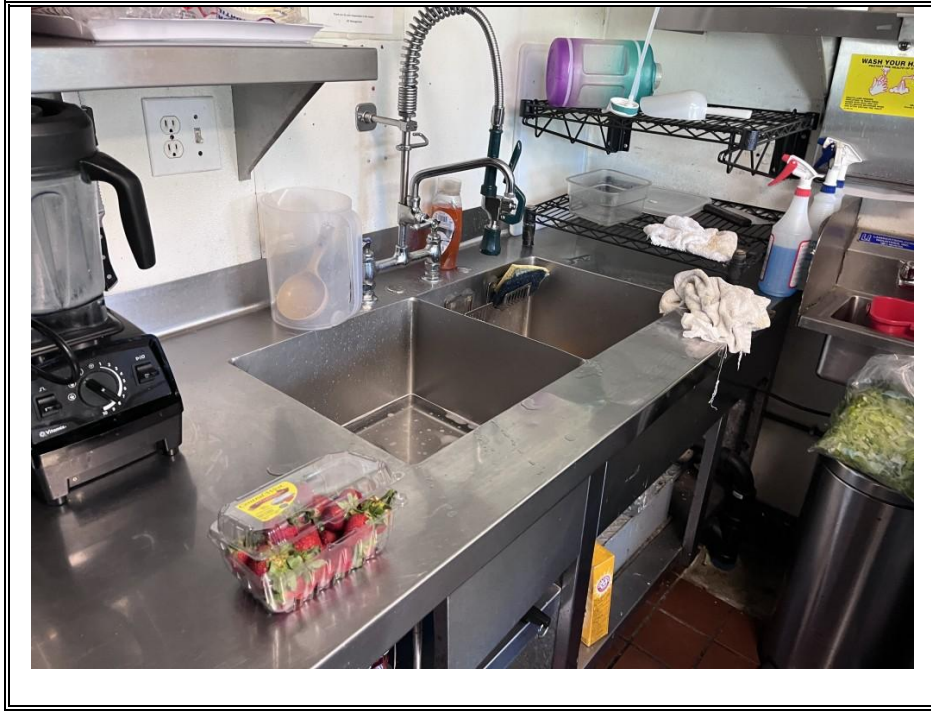
SINK (TYPICAL)

OBSERVATIONS: *This component addresses the stainless-steel washing station for the kitchen. It appeared to be in an average condition.*

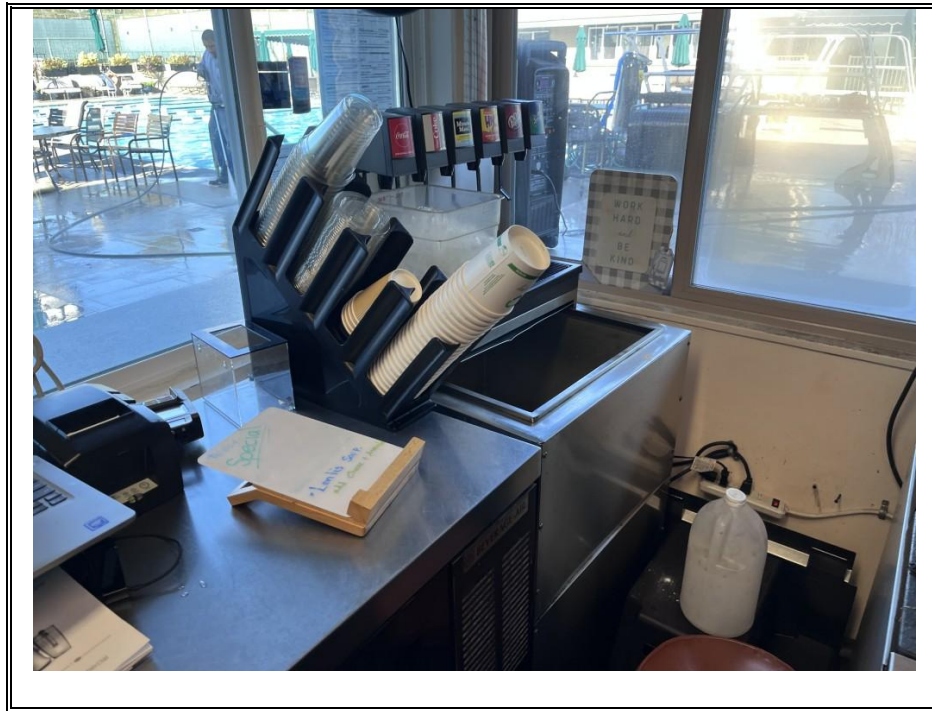
SODA MACHINE (TYPICAL)

OBSERVATIONS: *This component addresses the soda machine for the kitchen. It appeared to be in an average condition.*

TO PROTECT YOUR INVESTMENT: *It is recommended this equipment be serviced regularly by a qualified technician.*

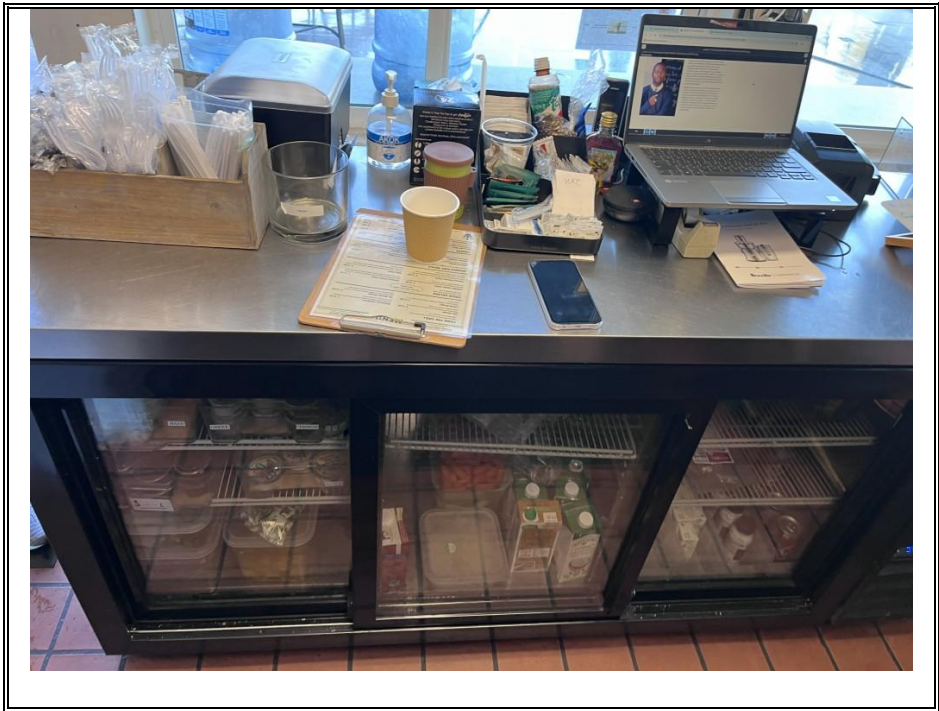
REFRIGERATED CHEST-FREEZERS (TYPICAL)

OBSERVATIONS: *This component addresses the reach-in refrigerated chest units with stainless countertops that serve the cash register and POS systems for the kitchen. They appeared to be in an average condition.*

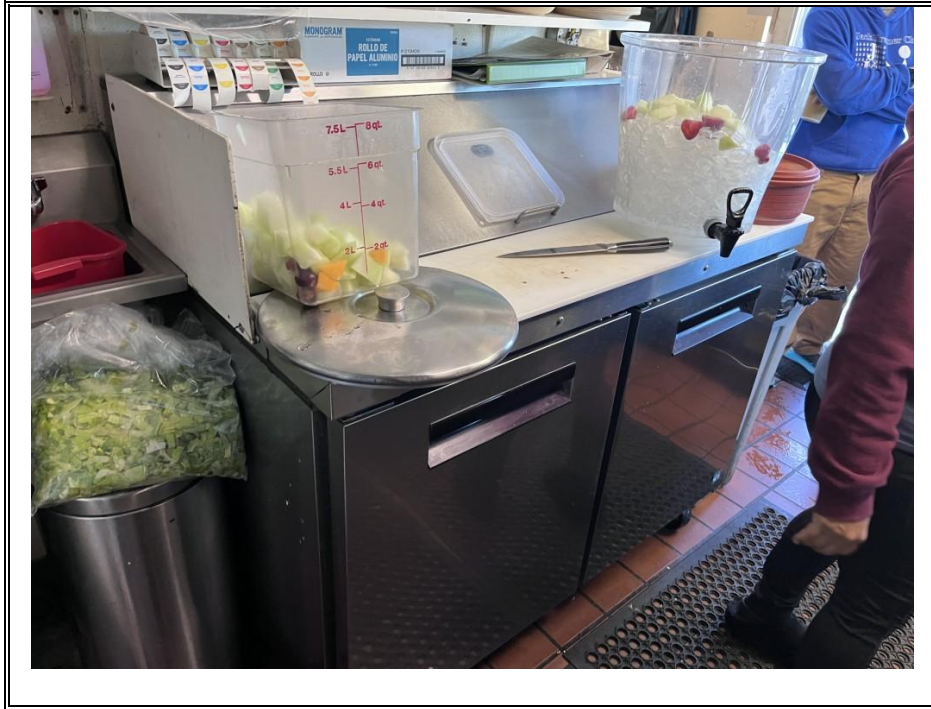
REFRIGERATED PREP STATION (TYPICAL)

OBSERVATIONS: *This component addresses a prep-station with a refrigerated base. It appeared to be in an average condition.*

TO PROTECT YOUR INVESTMENT: *It is recommended this equipment be serviced regularly by a qualified technician.*

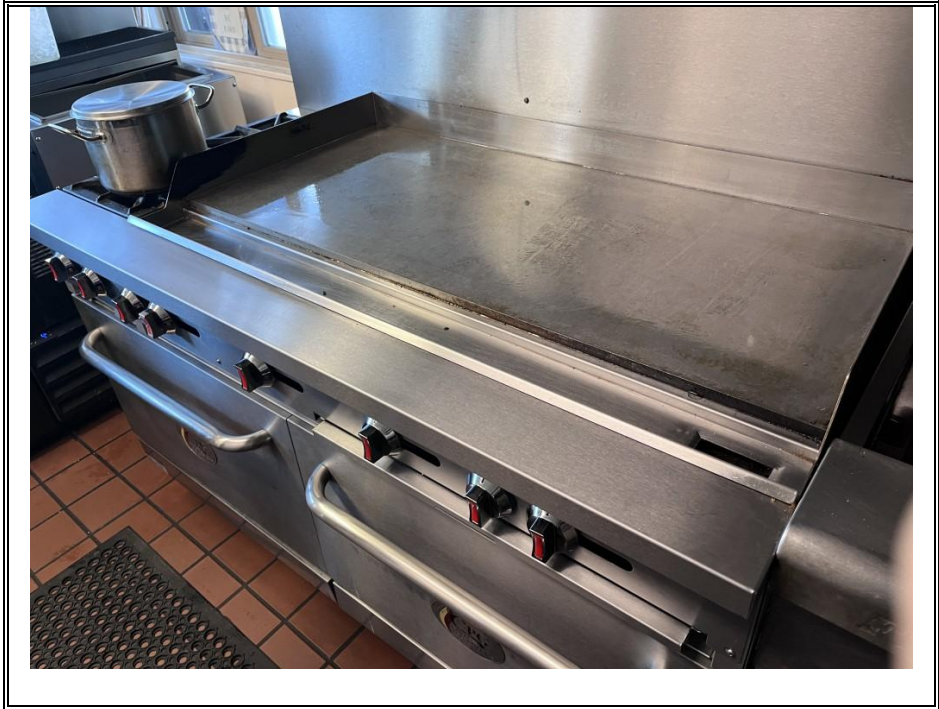
DUAL CONVECTION OVEN (TYPICAL)

OBSERVATIONS: *This component addresses a dual convection oven with cooktop for the kitchen. We were informed that it was installed circa 2026, and it appeared to be in good condition.*

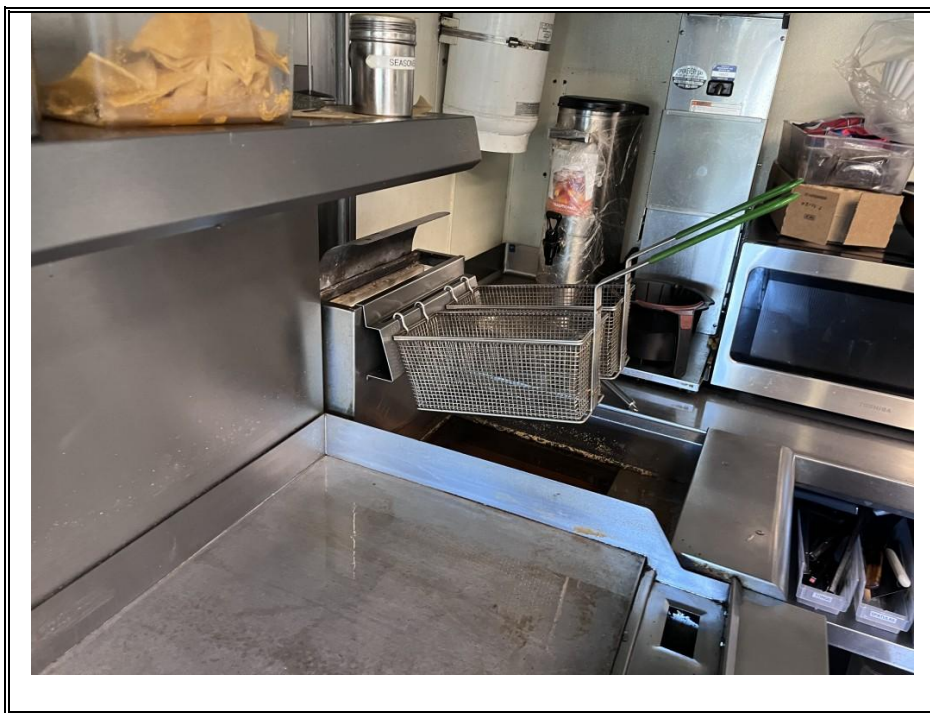
DEEP FRYER (TYPICAL)

OBSERVATIONS: *This component addresses a deep fryer for the kitchen. It appeared to be in an average condition.*

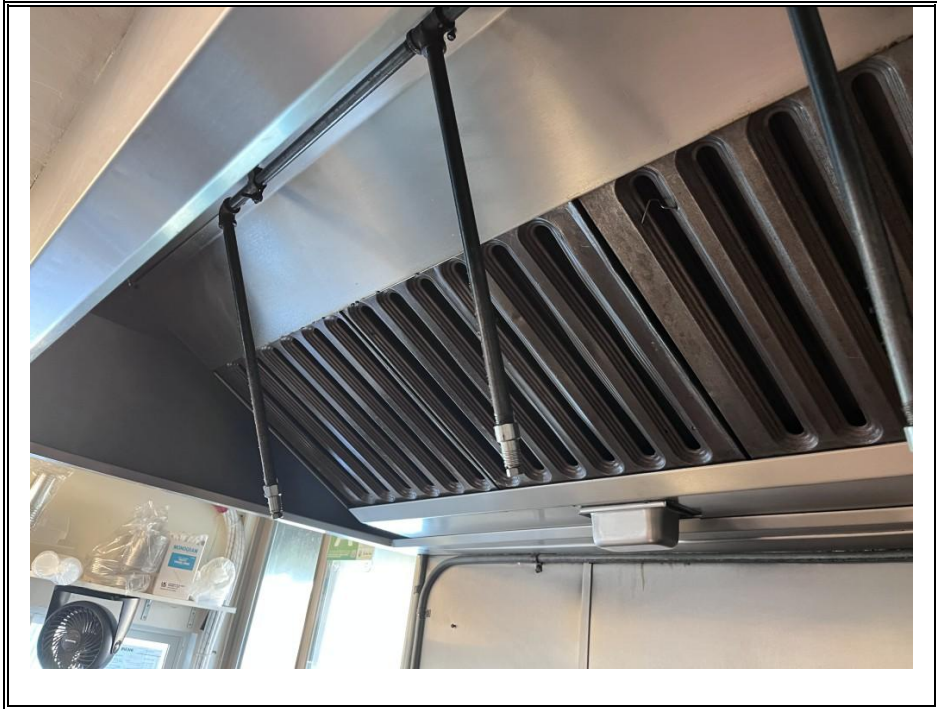
EXHAUST HOOD (TYPICAL)

OBSERVATIONS: *This component addresses an exhaust hood for the kitchen. It appeared to be in an average condition.*

TO PROTECT YOUR INVESTMENT: *It is recommended this equipment be serviced regularly by a qualified technician.*

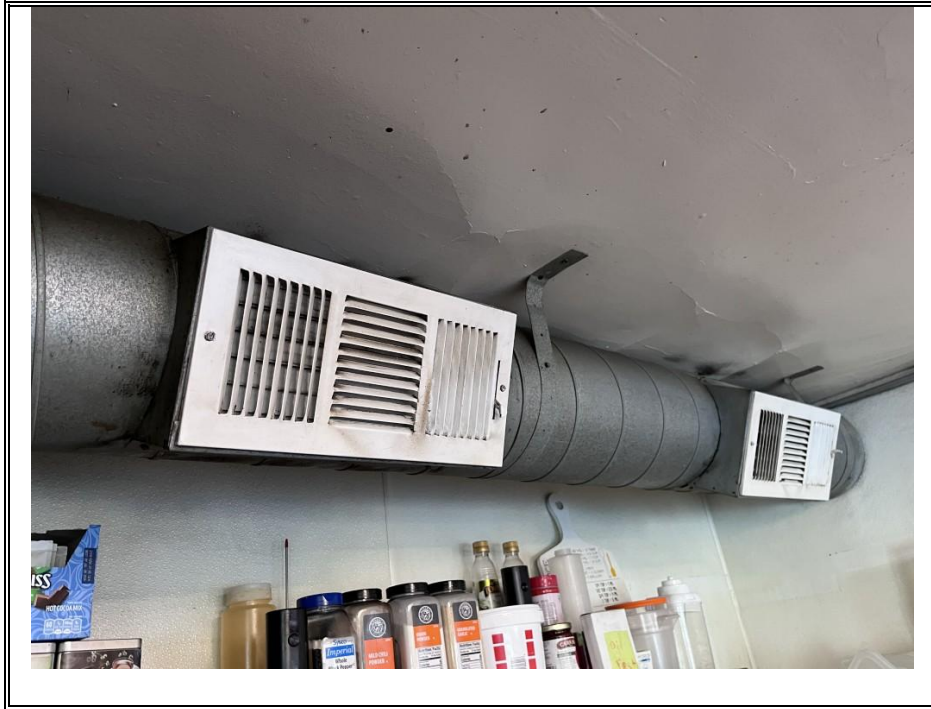
KITCHEN HOOD EXHAUSTER (TYPICAL)

OBSERVATIONS: *This component addresses a motor for the kitchen exhaust hood. It was inaccessible for inspection (encased). Therefore, for purposes of reporting the remaining life has been estimated.*

TO PROTECT YOUR INVESTMENT: *It is recommended this equipment be serviced regularly by a qualified technician.*

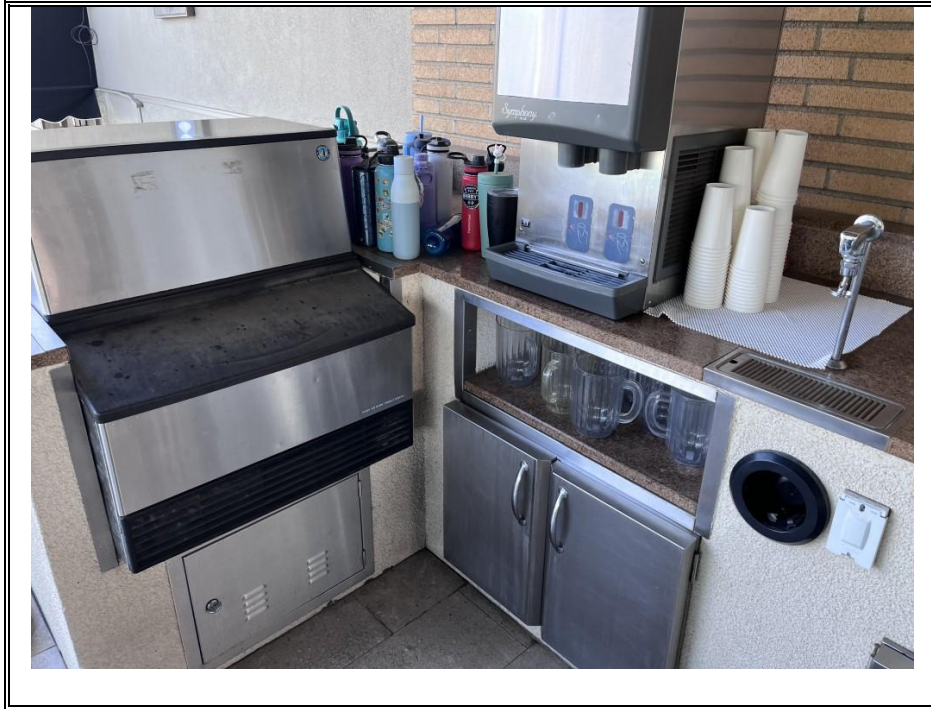
WET BAR (TYPICAL)

OBSERVATIONS: *This component addresses the wet bar on the pool-side exterior of the café, comprised of an ice machine, water bottle filler, refrigerators, sink, beer tap, and marble countertops. It appeared to be in an average condition. The average component cost is general for the type of equipment in use.*

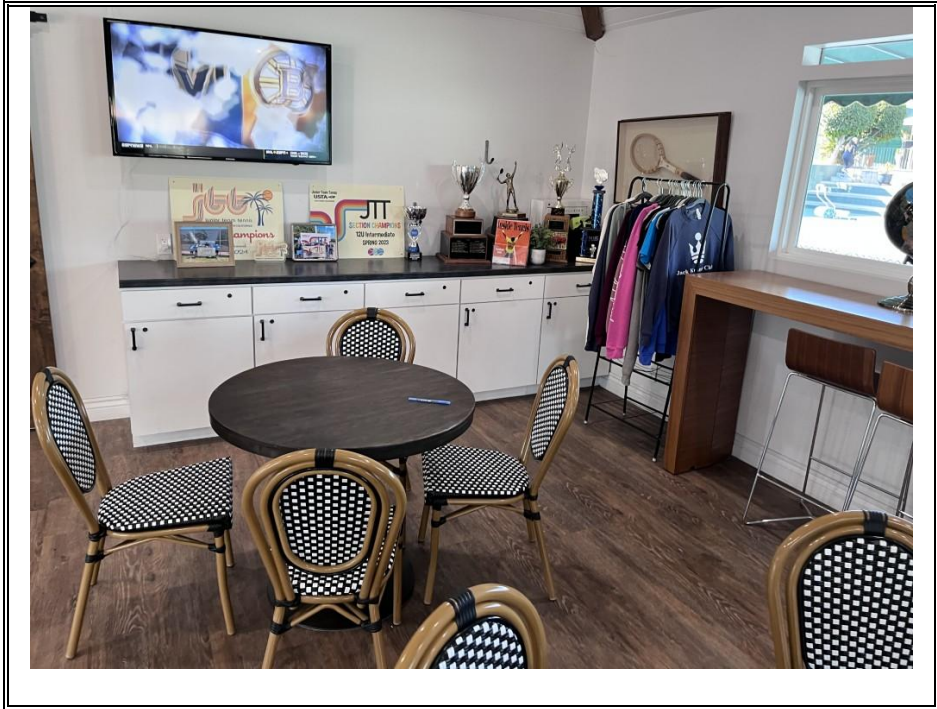
FURNISHINGS-LOBBY (TYPICAL)

OBSERVATIONS: *This component addresses the furniture in the lobby, comprised of a glass screen wall, front desk, credenzas, display cases, refrigerators, countertops and cabinets, TVs, tables, chairs, computers, monitors, and tablets. It appeared to be in various conditions; therefore, for purposes of reporting the remaining life has been averaged. The average component cost is general for the type of furnishings in use.*

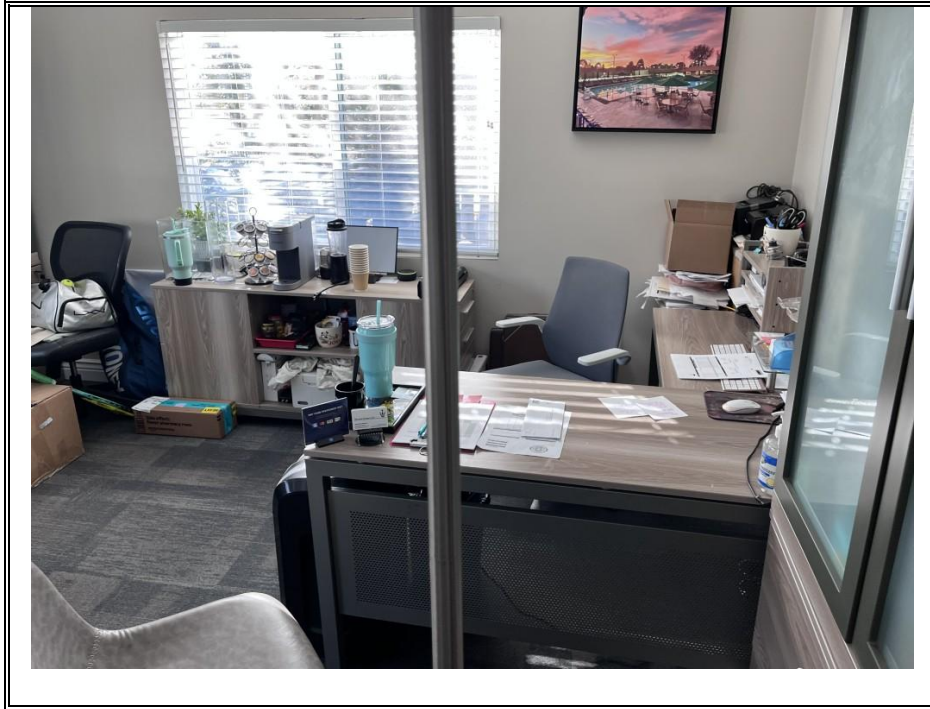
OFFICE EQUIPMENT (TYPICAL)

OBSERVATIONS: *This component addresses the equipment in the offices in the lobby, comprised of desks, chairs, filing cabinets, personal cabinets, computers, monitors, TVs, a refrigerator, and a mini fridge. It appeared to be in various conditions; therefore, for purposes of reporting the remaining life has been averaged. The average component cost is general for the type of equipment in use.*

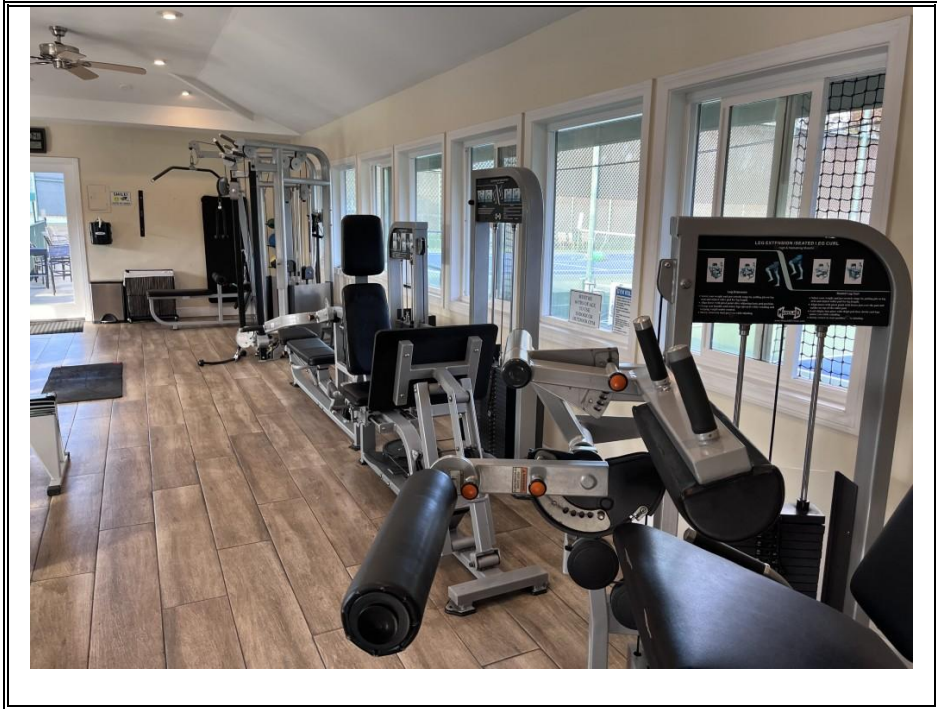
FITNESS EQUIPMENT (TYPICAL)

OBSERVATIONS: *This component addresses the fitness equipment in the gym, comprised of treadmills, ellipticals, stationary bicycles, rowing machines, ski simulators, weight machines, dumbbells / racks, leg / squat racks, and a TV. It appeared to be in various conditions; therefore, for purposes of reporting the remaining life has been averaged. Some of the equipment would most likely be replaced while other items may lend themselves to being refurbished. The average component cost is general for this type of equipment.*

TO PROTECT YOUR INVESTMENT: *The equipment should be maintained in a sanitary condition. Applicable instructions as well as warnings should be posted with respect to proper use of the equipment.*

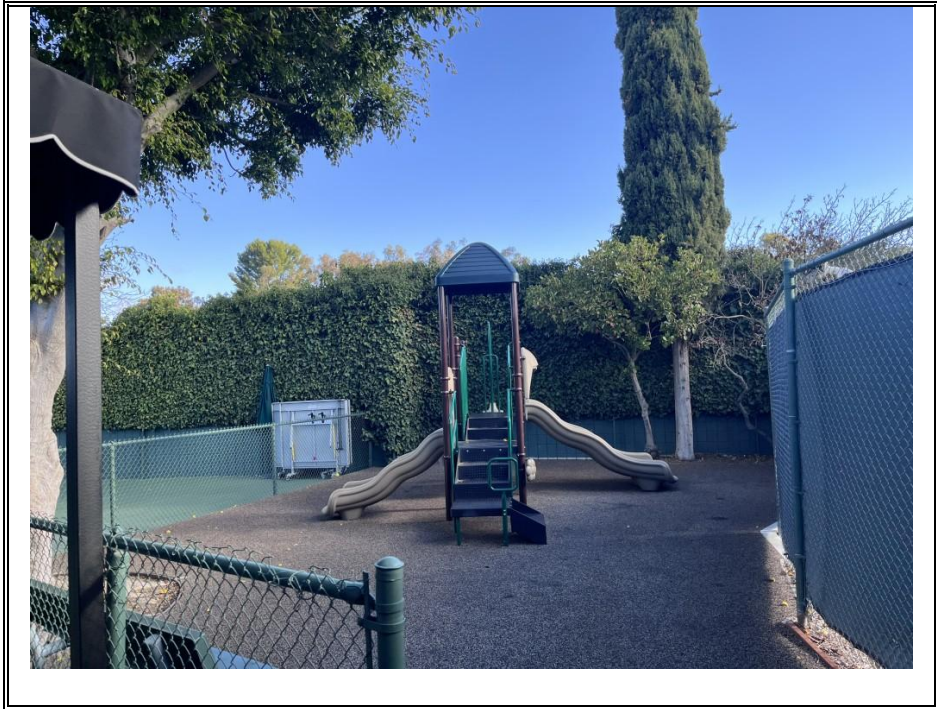
PLAY STRUCTURE (TYPICAL)

OBSERVATIONS: *This component addresses the play structure. It appeared to be in an average to aging condition. Play structures can range in price from just under \$5,000 for a simple swing set to well over \$75,000 for a more elaborate modular system with swings, slides, bridges, climbers, tubes, and towers. Per the Health & Safety Code, playground equipment must be inspected by a playground safety inspector certified by the National Playground Safety Institute. Equipment installed prior to 1994 must either be replaced or upgraded to State Regulations; equipment installed between the years 1994 and 1999 need only be upgraded to meet standards set forth by the Consumer Product Safety Commission.*

TO PROTECT YOUR INVESTMENT: *Per the U.S. Consumer Product Safety Commission, play structures should be regularly checked to ensure they are in good condition. This addresses examination for sharp points or edges, dangerous hardware (such as open "S" hooks or protruding bolt ends), and tripping hazards (including exposed concrete footings, tree stumps, rocks, etc.). In the case of adjacent structures that are over 30 inches high, they should be spaced at least 9 feet apart. Elevated surfaces, including platforms and ramps, should have guardrails to prevent falls. Spaces that could trap children, such as openings in guardrails or between ladder rungs, should measure either less than 3.5 inches or more than 9 inches. Surfaces around the equipment should have at least 12 inches of loose-fill material, or are mats made of safety-tested rubber-like materials. These surfaces should extend at least 6 feet in all directions, and in the case of swings at least twice the height of the suspending bar in back and in front.*

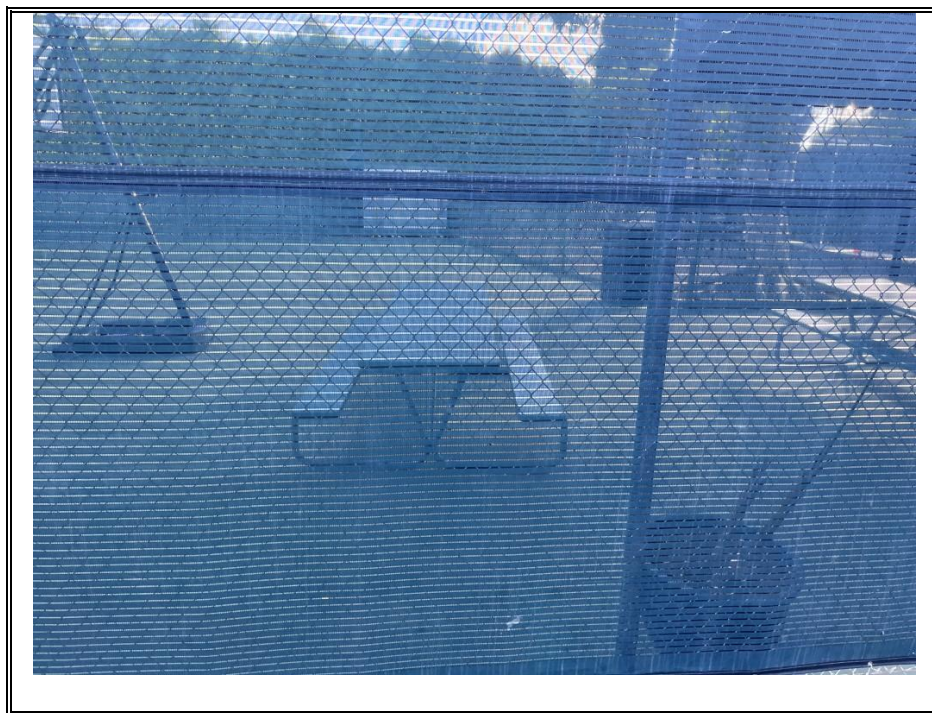
PICNIC TABLES (TYPICAL)

OBSERVATIONS: *This component addresses the coated metal picnic tables in the basketball area and adjacent to the gym. They appeared to be in an average to aging condition.*

TO PROTECT YOUR INVESTMENT: *Little by way of maintenance can be performed for this component.*

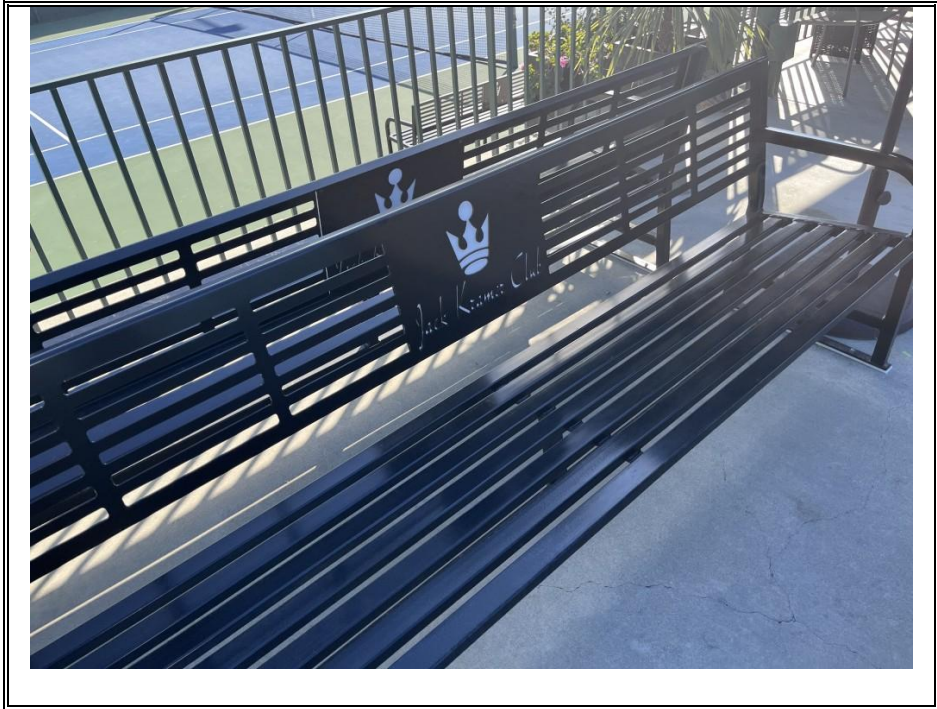
BENCHES (TYPICAL)

OBSERVATIONS: *This component addresses the coated metal benches throughout the club. We were informed that the majority were installed in 2026, and they appeared to be in good condition.*

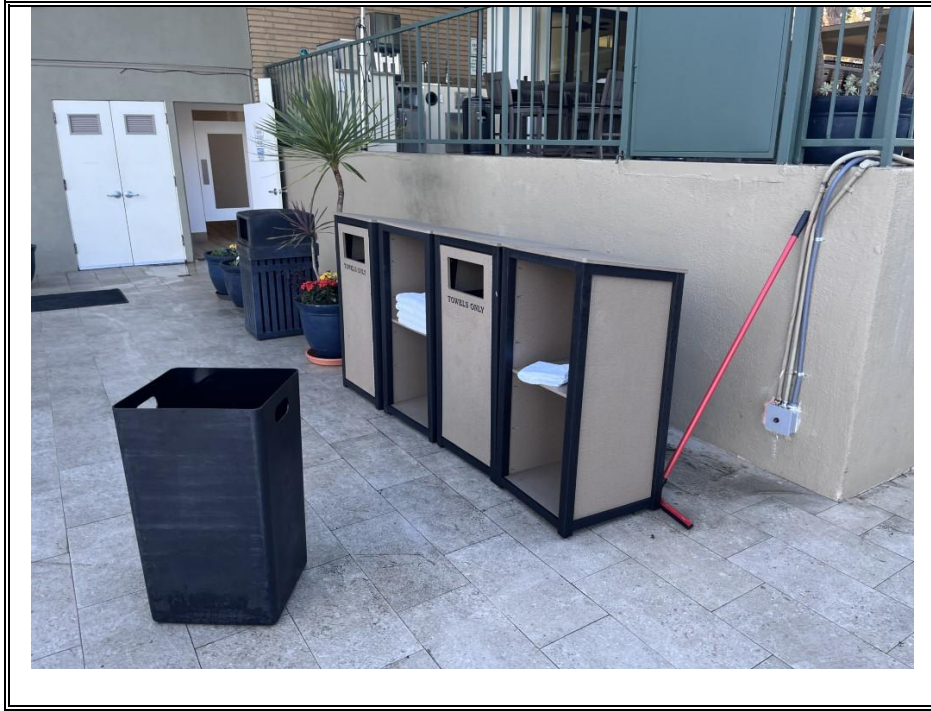
TRASH / LINEN CANS (TYPICAL)

OBSERVATIONS: *This component addresses the plastic and coated metal trash / linen receptacles throughout the club. They generally appeared to be in good condition.*

TO PROTECT YOUR INVESTMENT: *Little by way of maintenance can be performed for this component.*

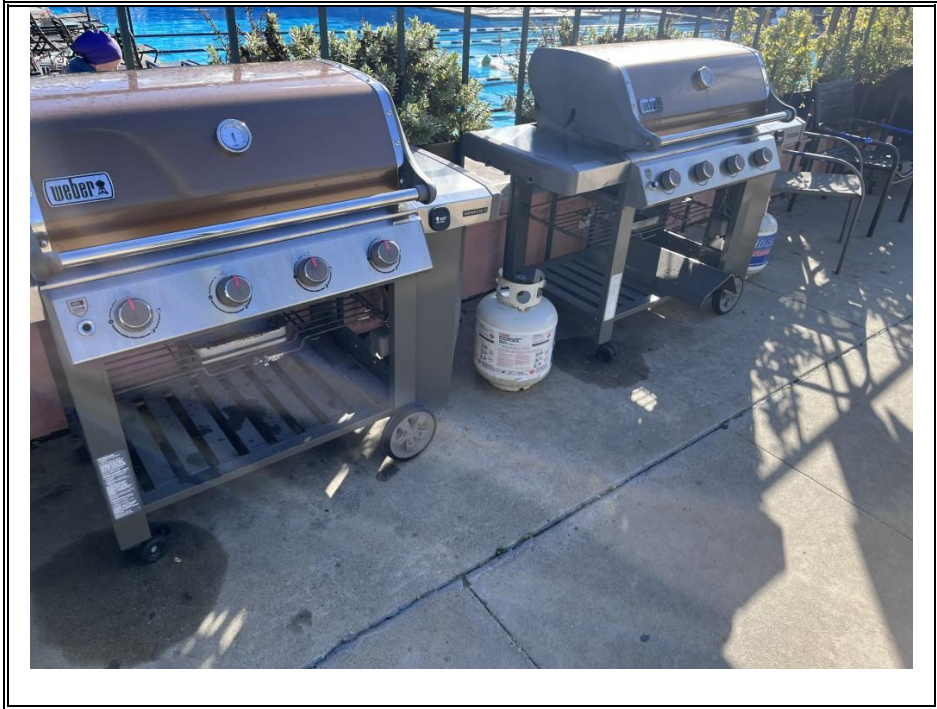
BARBECUES (TYPICAL)

OBSERVATIONS: *This component addresses the portable propane barbecues. They generally appeared to be in an average condition.*

TO PROTECT YOUR INVESTMENT: *It is essential that local fire and safety codes be checked for safety specifications, such as safety valves and proper clearance of grills from walls. In addition, it is recommended that the fire insurance policy be reviewed to ensure compliance. Maintenance should include regular cleaning of the internal grills as well as the exteriors. Care should be exercised to ensure that the gas is turned off when not in use. This would not only serve to save fuel but reduce the potential of fire hazard.*

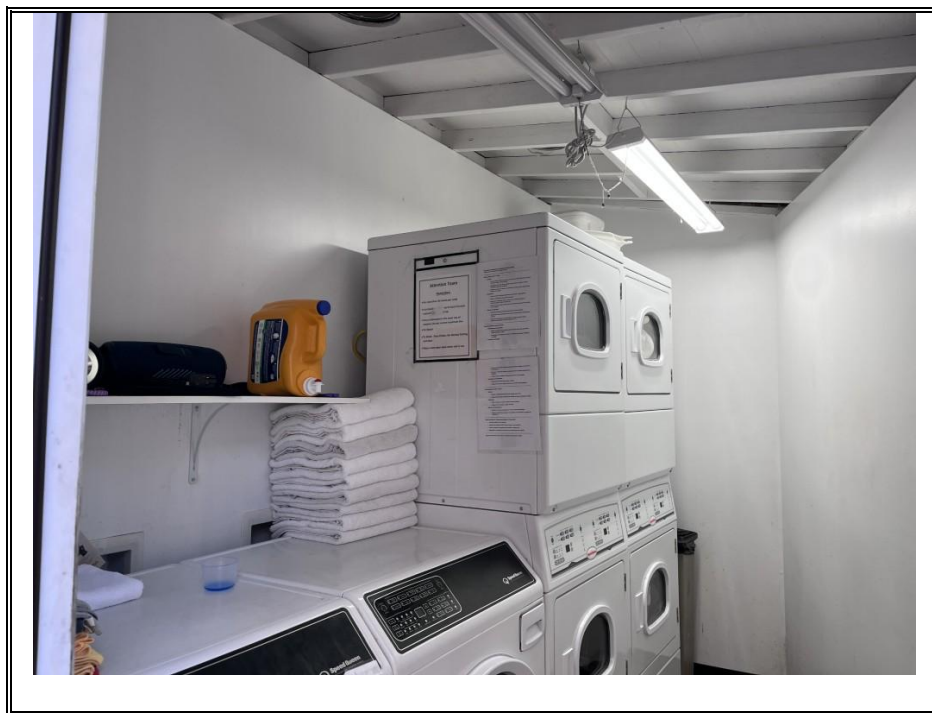
LAUNDRY EQUIPMENT (TYPICAL)

OBSERVATIONS: *This component addresses the washers and dryers in the laundry rooms. They appeared to be in an average condition.*

TO PROTECT YOUR INVESTMENT: *It is recommended that a maintenance contract be obtained from a qualified specialist.*

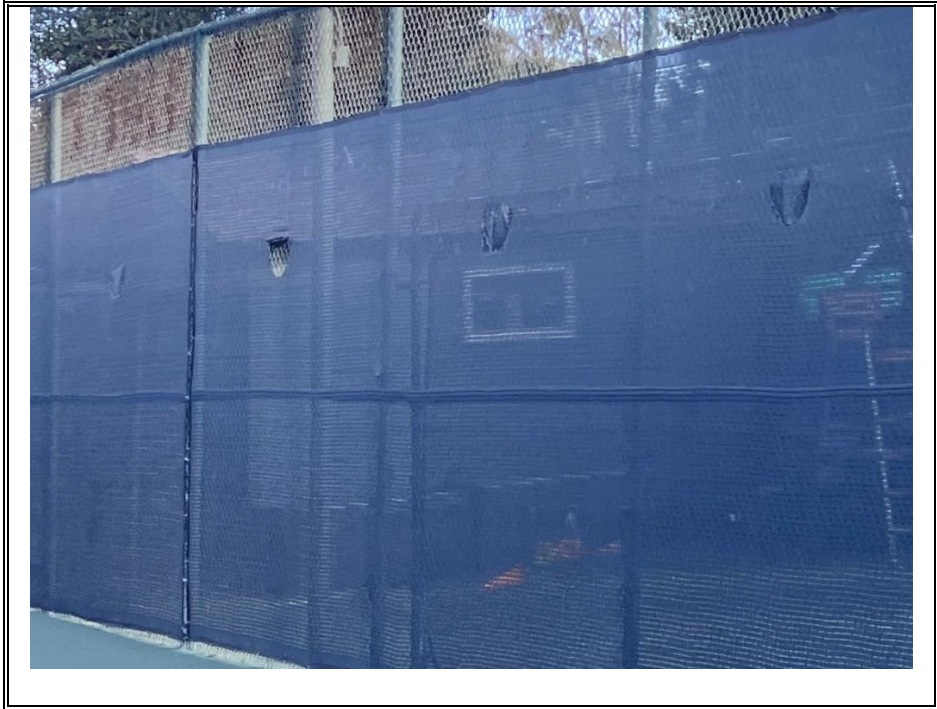
MAINTENANCE SHED (TYPICAL)

OBSERVATIONS: *This component addresses the maintenance shed behind the basketball court. It appeared to be in an average to aging condition.*

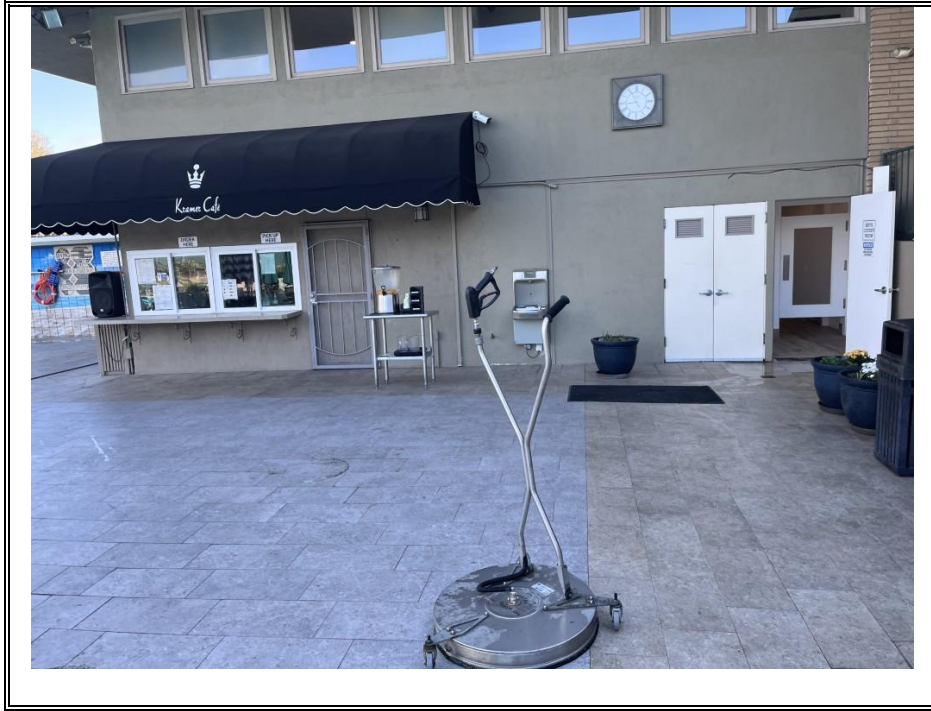
MAINTENANCE EQUIPMENT (TYPICAL)

OBSERVATIONS: *This component addresses the maintenance equipment. It appeared to be in an average condition.*

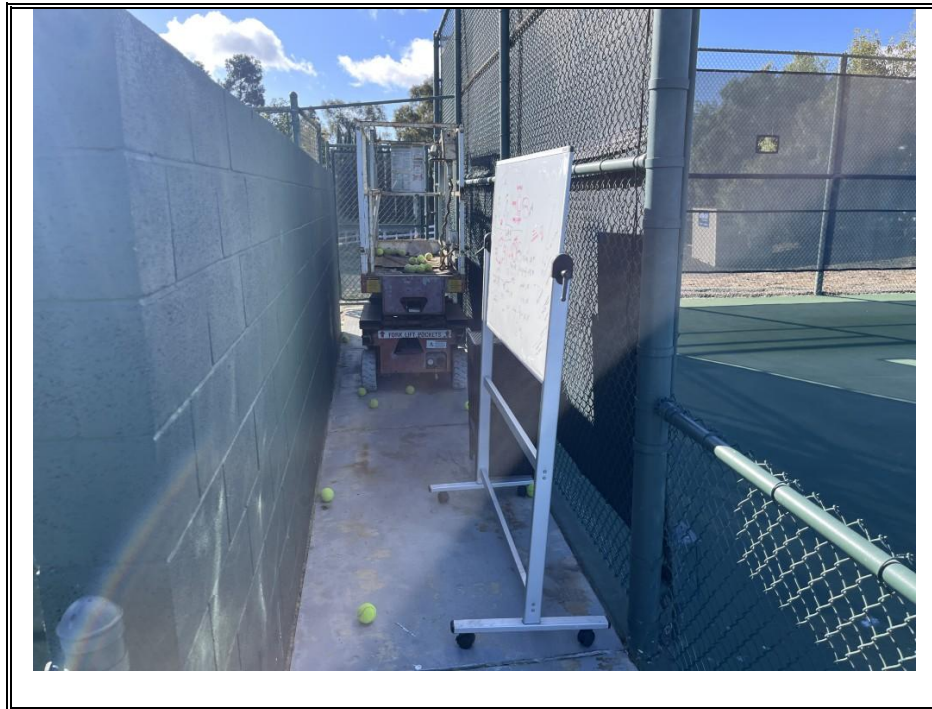
SCISSOR LIFT (TYPICAL)

OBSERVATIONS: *This component addresses the scissor lift. It appeared to be in an aging condition.*

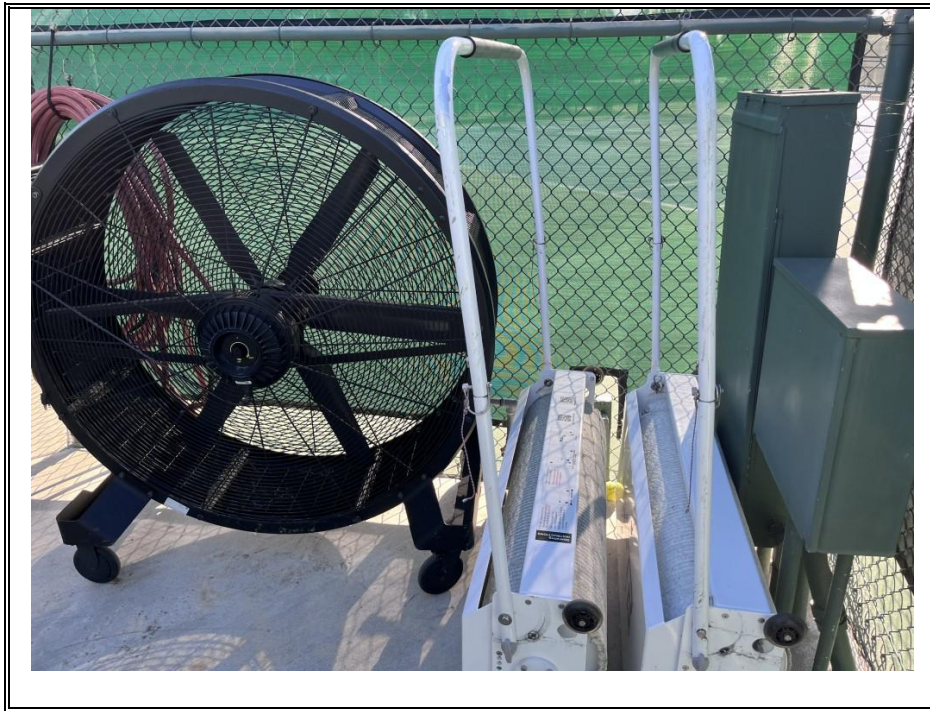
FAN (TYPICAL)

OBSERVATIONS: *This component addresses the large fan that serves the purpose of drying the courts. It appeared to be in an average condition.*
