RESERVE STUDY - FEBRUARY 1, 2020

High Rise Homeowners Association (Sample Only)
3525 Main Street
Los Angeles, California

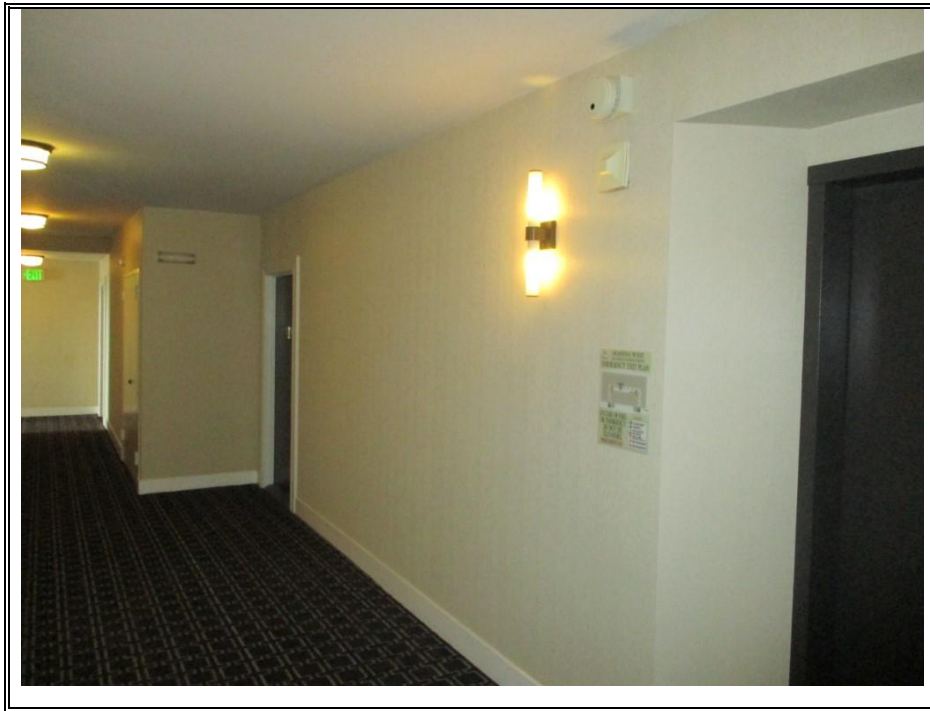
WALLPAPER (TYPICAL)

OBSERVATIONS: *This component includes the wallpapered surfaces of the internal hallways and common areas. We were informed that maintenance was performed in 2017 and they generally appeared to be in average to aging condition.*

TO PROTECT YOUR INVESTMENT: *Any peeling sections of wallpaper should be re-glued upon discovery in order to preserve the integrity of the remaining sections.*

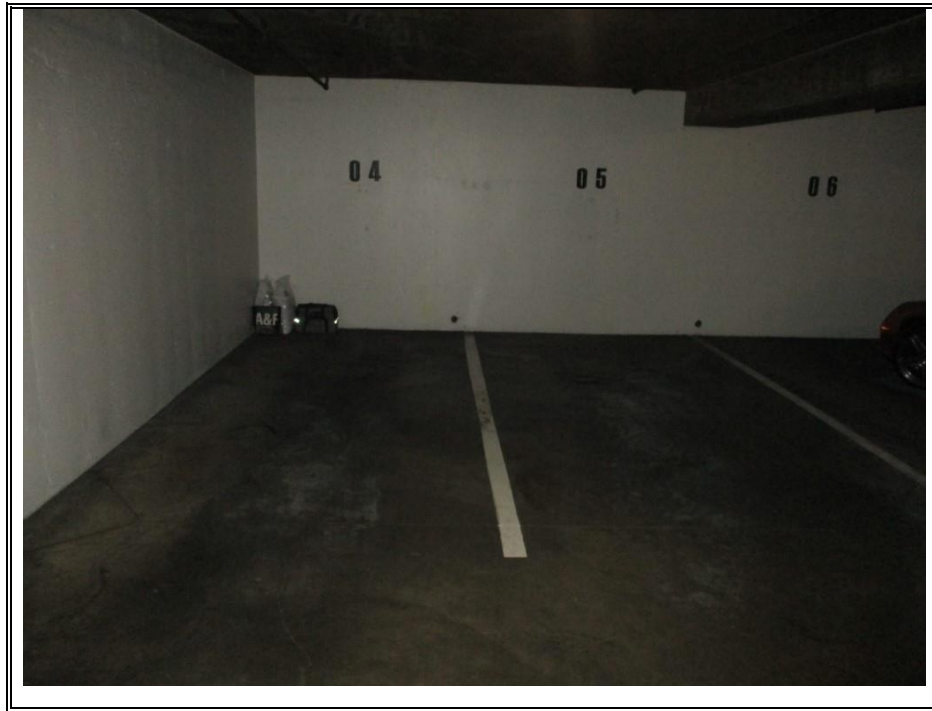
GARAGE INTERIOR (TYPICAL)

OBSERVATIONS: *This component includes the painted surfaces of the interior walls of the garages. We were previously informed that they were painted in 2012 and they appeared to be in good to average condition.*

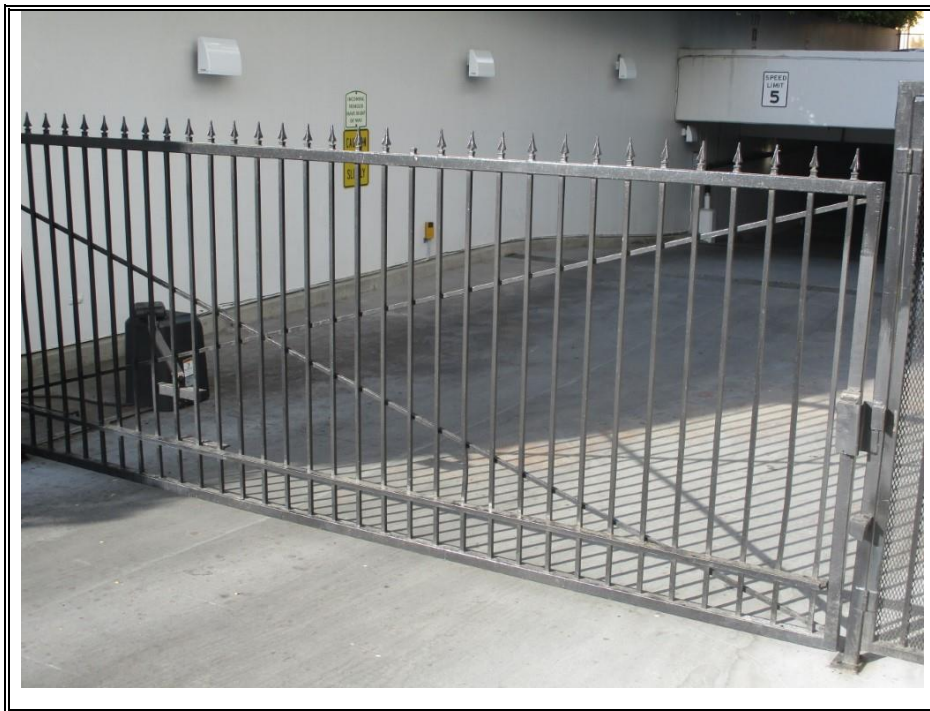
IRONWORK-EXTERIOR (TYPICAL)

OBSERVATIONS: This component includes the painted surfaces of the wrought iron fencing and gates at the exterior of the building. They appeared to be in various conditions and for reporting purposes their remaining lives have been averaged.

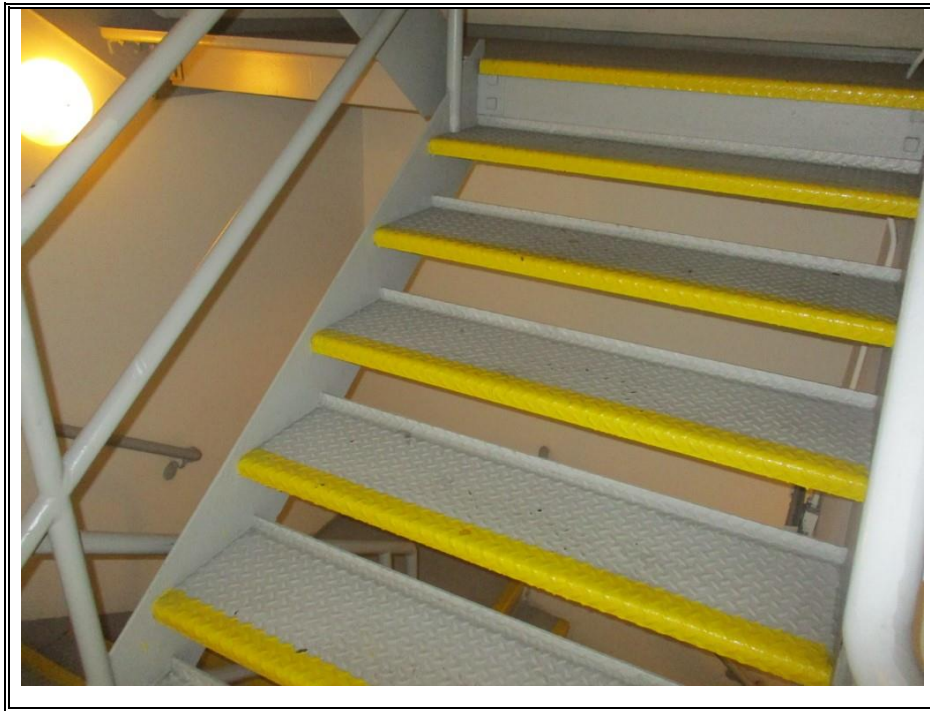
IRONWORK-INTERIOR (TYPICAL)

OBSERVATIONS: *This component includes the painted surfaces of the wrought iron rails at the stairwells, steps, and landings. They appeared to be in various conditions and for reporting purposes their remaining lives have been averaged*

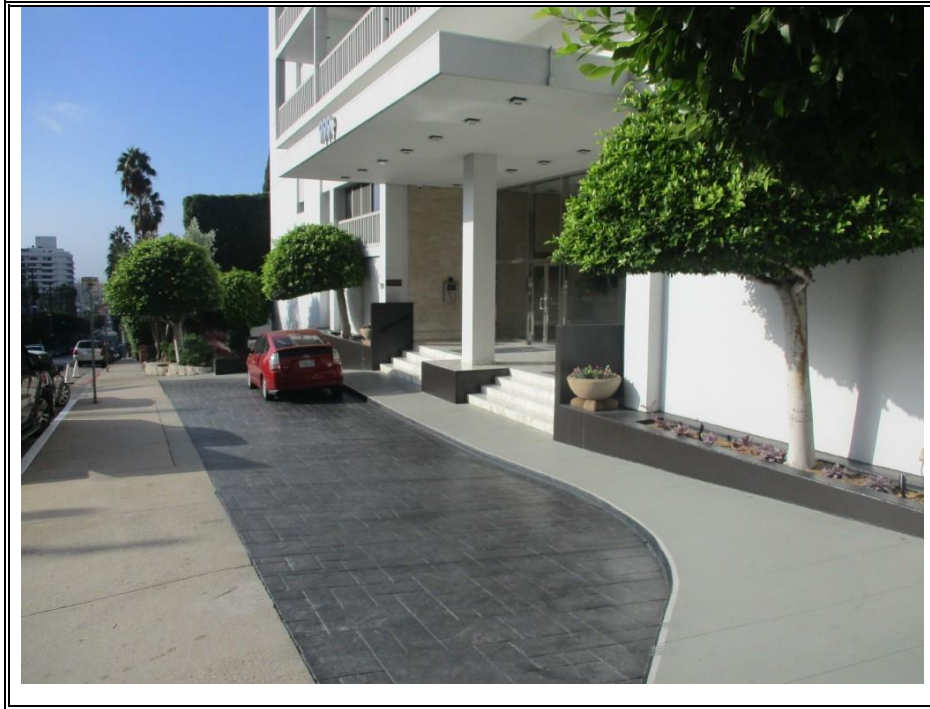
ENTRIES WALKWAY (TYPICAL)

OBSERVATIONS: *This component includes the epoxy painted surfaces of the entry walkway and garage driveways. We were previously informed that they were painted in 2017 and they appeared to be in good to average condition.*

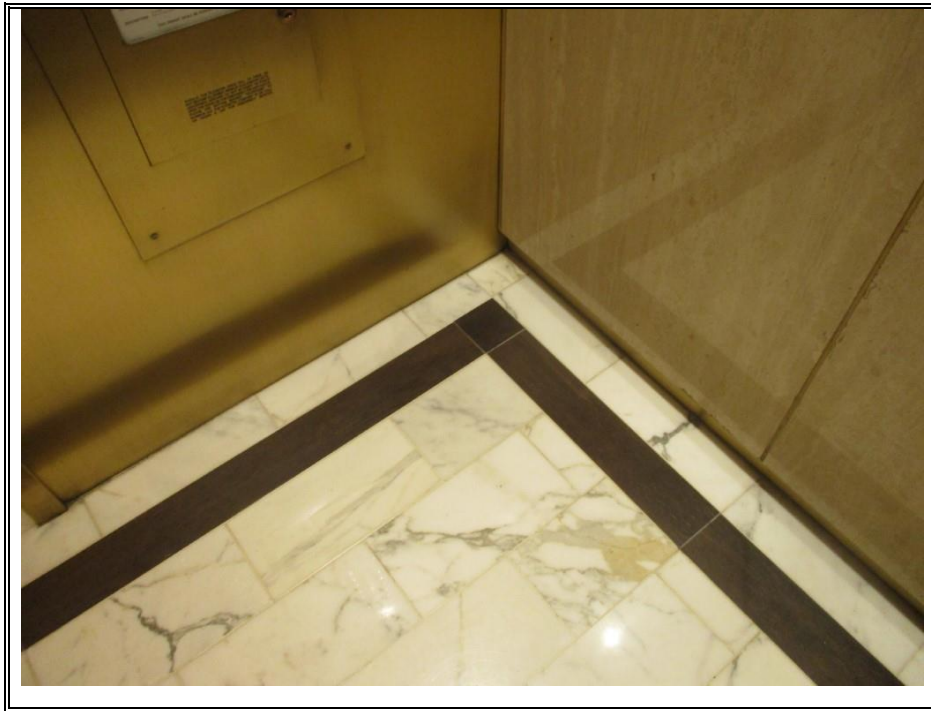
ELEVATORS-CAB REMODEL (TYPICAL)

OBSERVATIONS: *This component provides for the remodeling of the elevator cabs, comprised of marble interior and flooring. We were informed that maintenance was performed in 2017 and they appeared to be in average condition for their age.*

TO PROTECT YOUR INVESTMENT: *General surface cleaning of the elevator cab interior would be the extent of any maintenance necessary by the association.*

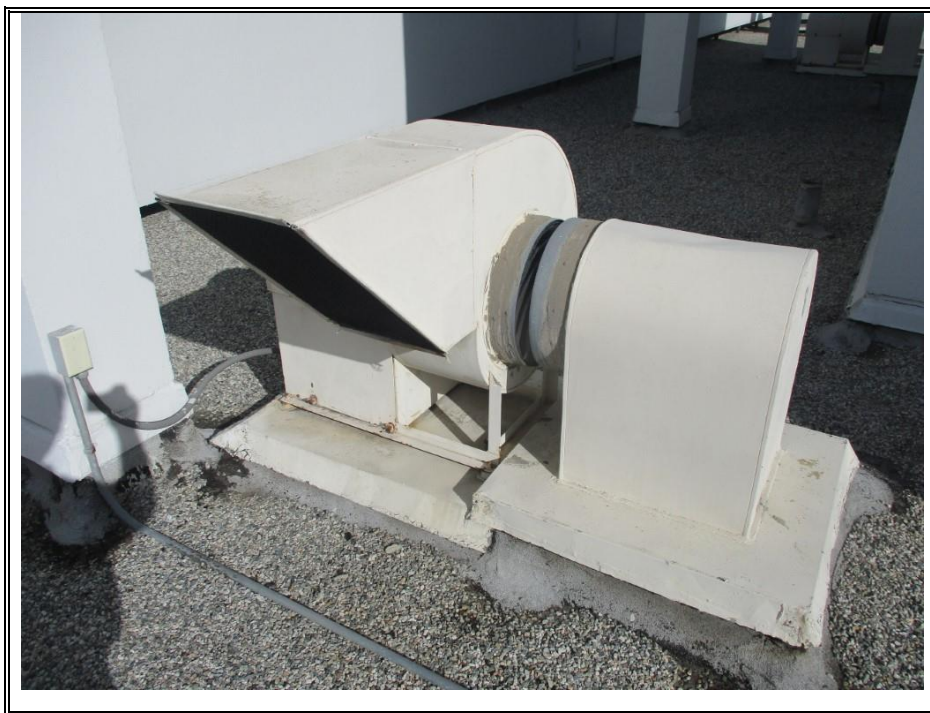
EXHAUST FANS-GARAGE (TYPICAL)

OBSERVATIONS: *This component includes the inline exhaust blowers on the roof and at garage level 2, comprised of 2 at 10 hp and 2 estimated at 2 hp, which serve the purpose of ventilating the common garage area. The fans on the roof were inaccessible for inspection (encased) and for reporting purposes the remaining lives have been estimated. It is recommended that a carbon monoxide detector be installed in conjunction with an auto-start mechanism in the interest of safety.*

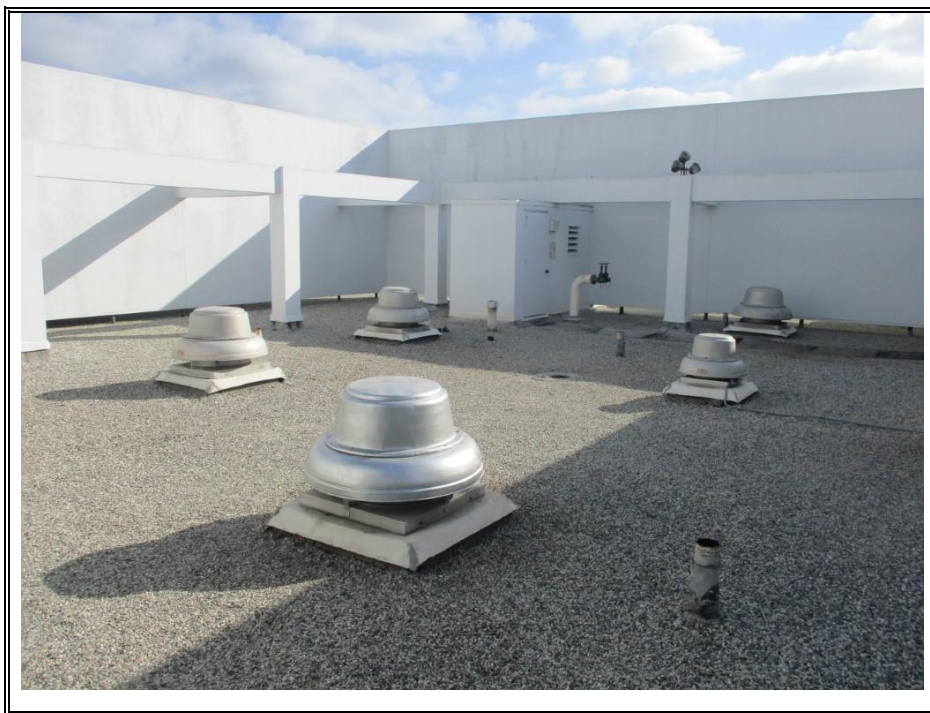
EXHAUST FANS-INTERIORS (TYPICAL)

OBSERVATIONS: *This component includes the mushroom type exhaust fans on the roof, estimated at ½ horsepower, which serve the purpose of ventilating the internal hallways. They were inaccessible for inspection (encased) and for reporting purposes the remaining lives have been estimated.*

TO PROTECT YOUR INVESTMENT: *The bearings should be oiled / greased on a periodic basis as well as occasional verification of operation of the fan. We recommend obtaining a maintenance contract with a qualified specialist.*

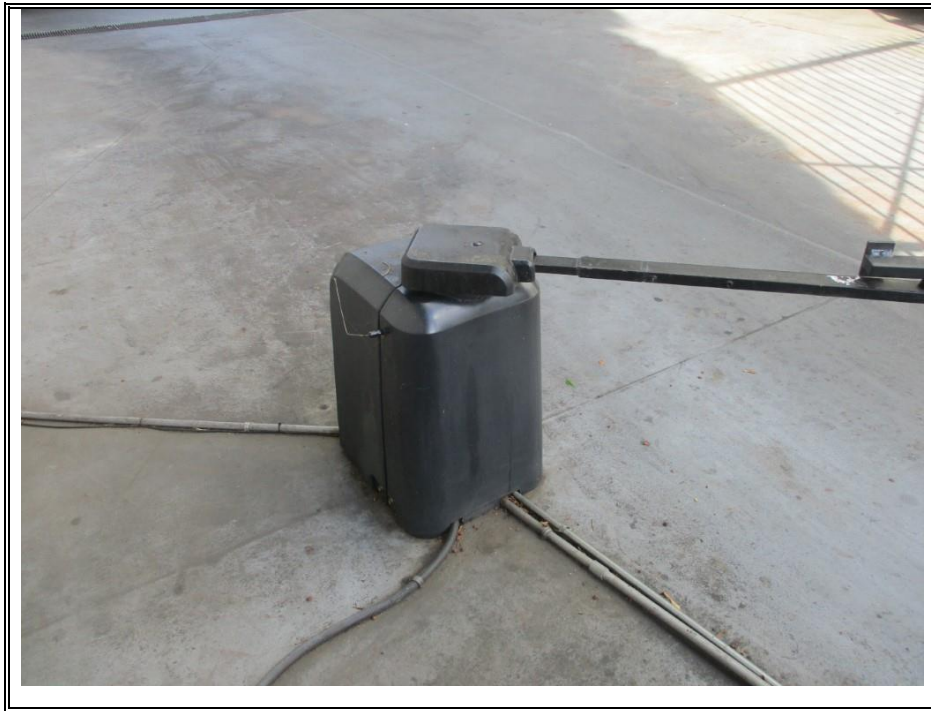
GATE OPERATOR (TYPICAL)

OBSERVATIONS: *This component includes a swing arm-type vehicle gate operator at the vehicle gate. We were previously informed it was installed in 2016 and appeared to be in good to average condition.*

TO PROTECT YOUR INVESTMENT: *Maintenance should include regular lubrication of all moving parts. It is suggested that a maintenance contract be obtained with a qualified specialist.*

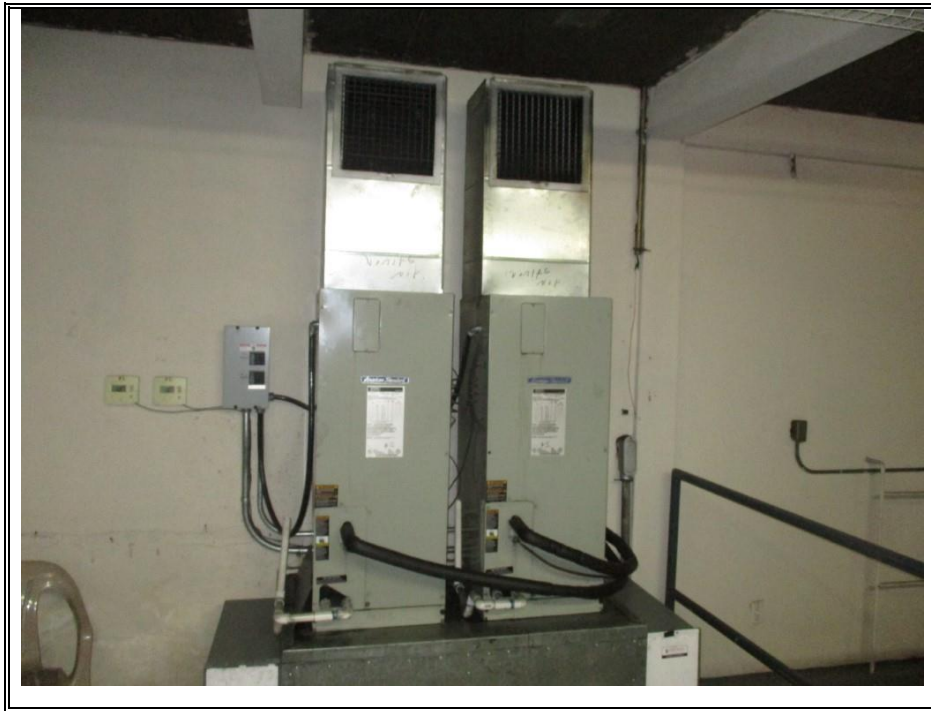
HEAT PUMPS-EVAPORATIVE COILS (TYPICAL)

OBSERVATIONS: *This component includes the evaporative coils for the “American Standard” heat pumps (split systems), dated 5/2002 and located at the elevator rooms. We were previously informed that maintenance was performed in 2017. They appeared to be in average condition for their age and performing well.*

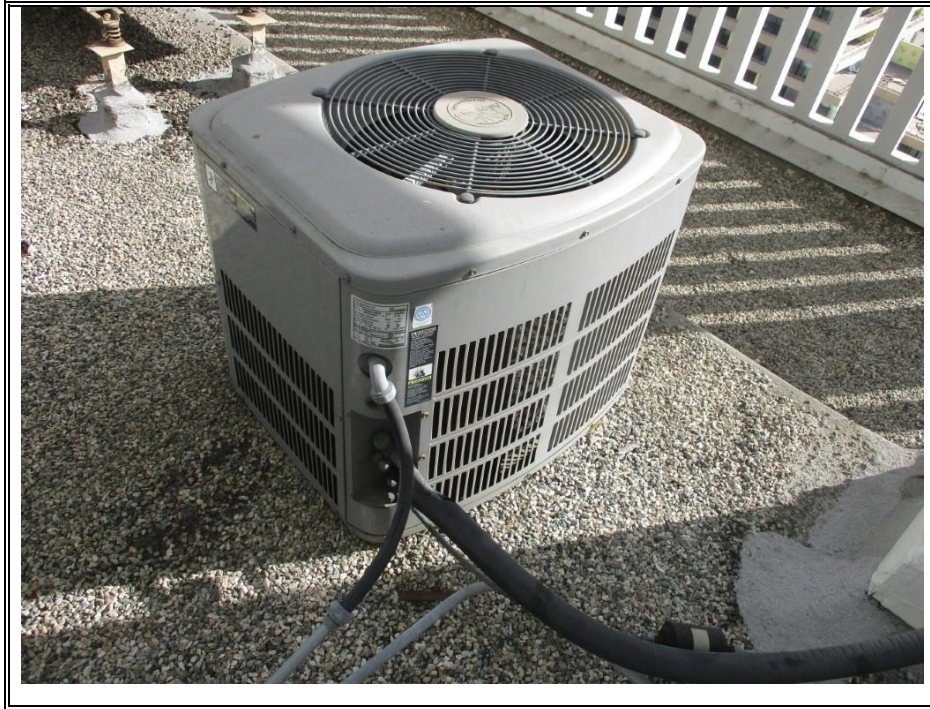
HEAT PUMPS-CONDENSERS (TYPICAL)

OBSERVATIONS: *This component includes the condensers for the “American Standard” heat pumps (split systems), dated 2001 and located on the roof. We were previously informed that maintenance was performed in 2017. They appeared to be in average condition for their age and performing well.*

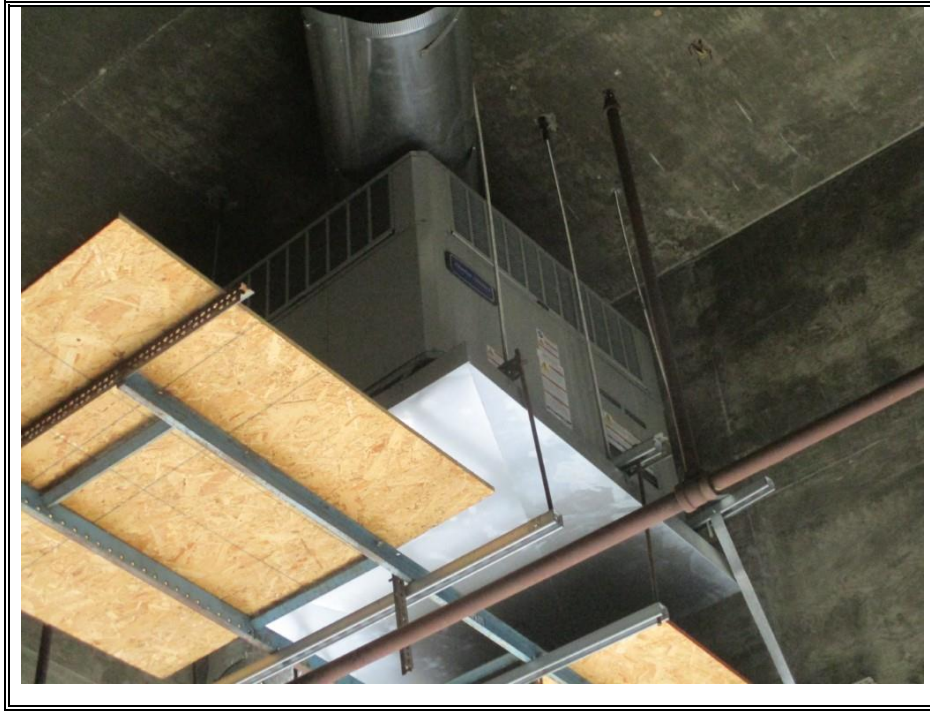
HEAT PUMPS-DUAL PACKS (TYPICAL)

OBSERVATIONS: *This component includes the dual pack electric heat pumps in the garage. They were inaccessible for inspection (requiring a 16' ladder) and, for reporting purposes, the remaining life has been estimated.*

TO PROTECT YOUR INVESTMENT: *The heat pumps should be serviced twice a year. We recommend obtaining a maintenance contract with a reputable licensed heating/air conditioning company.*

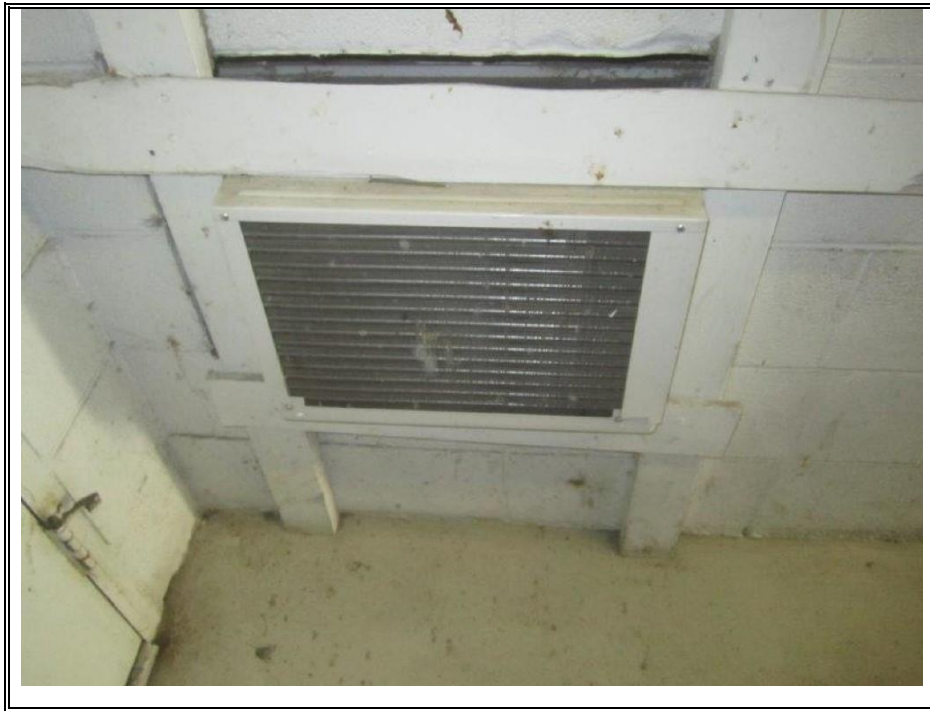
WINDOW AIR CONDITIONER (TYPICAL)

OBSERVATIONS: *This component includes an "LG" window air conditioning unit in the manager's office. We were previously informed it was to be installed in 2018 and it appeared to be in good condition.*

TO PROTECT YOUR INVESTMENT: *The air conditioner should be serviced twice a year. We recommend obtaining a maintenance contract with a reputable licensed heating/air conditioning company.*

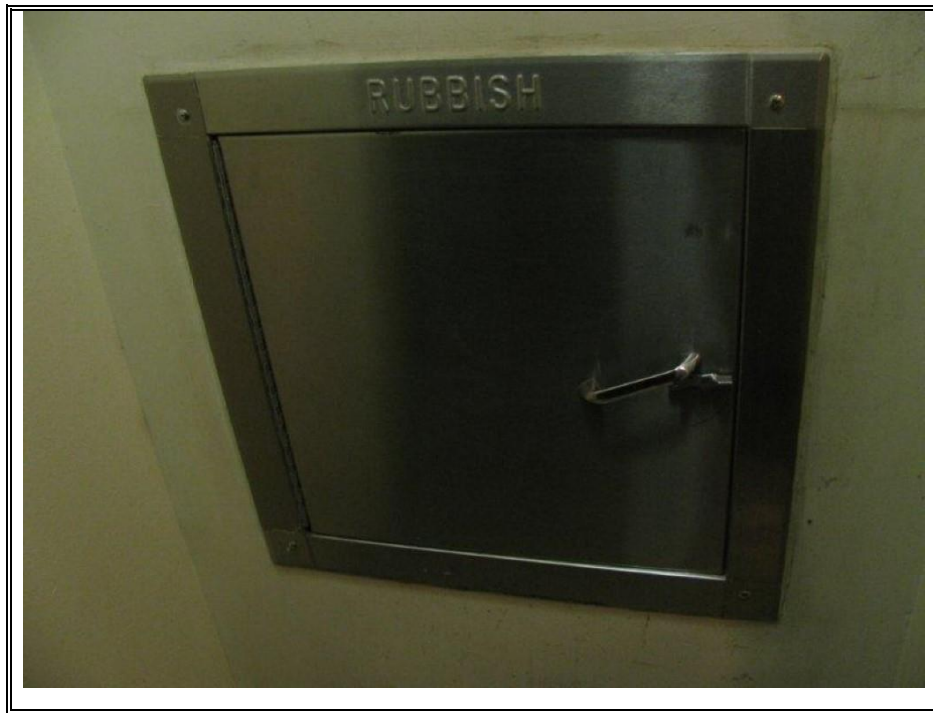
TRASH CHUTES (TYPICAL)

OBSERVATIONS: *This component provides for the replacement of the doors and other miscellaneous repairs, to the trash chutes in the hallways. They appeared to be in various conditions and for reporting purposes the remaining lives have been averaged.*

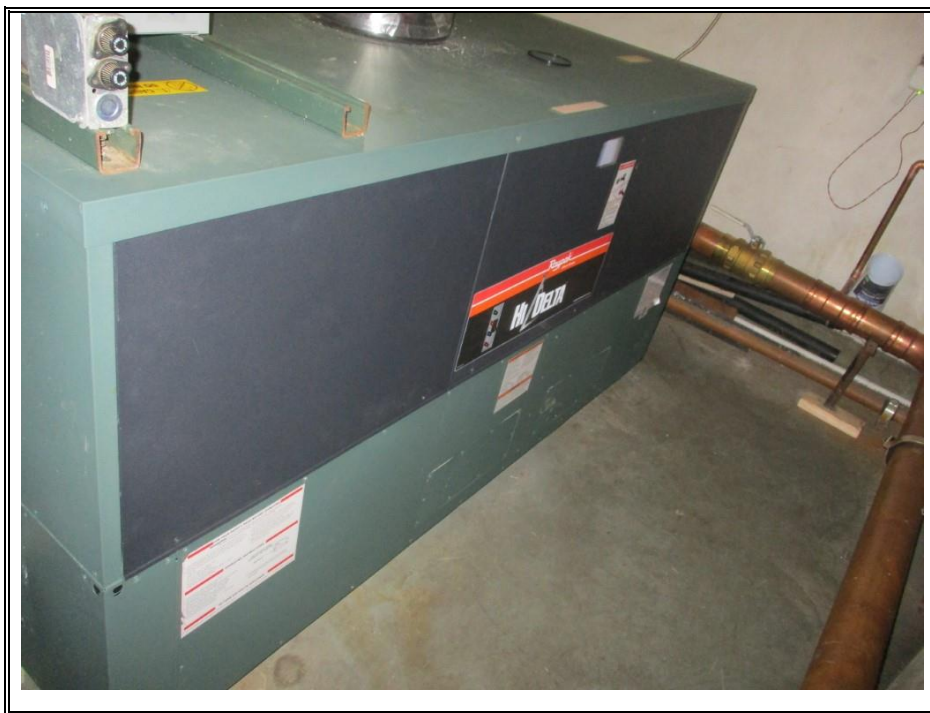
BOILER-REPLACE (TYPICAL)

OBSERVATIONS: This component includes an "Raypak Hi-Delta" 1,530,000 BTU boiler in the boiler equipment room. We were informed that it was installed in 2018 and it appeared to be in good condition. This type of equipment can fail without warning, often as a result of improper maintenance. See component ID #0502 for further comments.

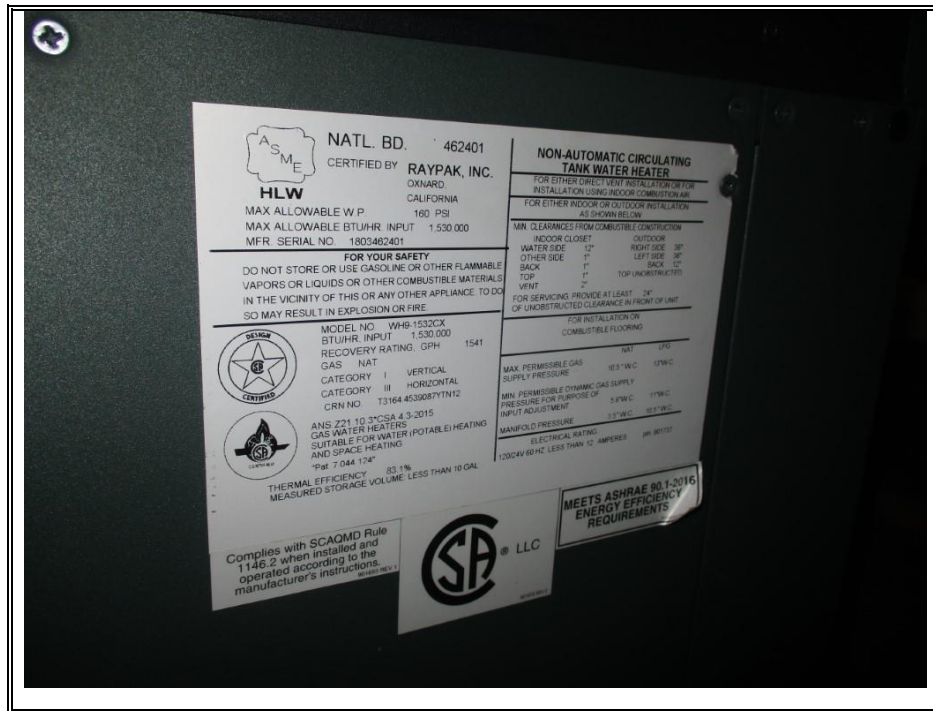
BOILER-OVERHAUL (TYPICAL)

OBSERVATIONS: This component includes the overhauling of the boiler identified in component ID #0501. Such overhaul should include reaming of the header/tube pack replacement to obtain maximum efficiency and service life from the boiler. This typically occurs at about mid-life of the boiler (i.e. 8 years). A life cycle of 16 years is therefore used for purposes of reporting. It should be noted that a visual examination can make no predictions as to future performance (i.e. even with correct maintenance, this unit can fail without warning).

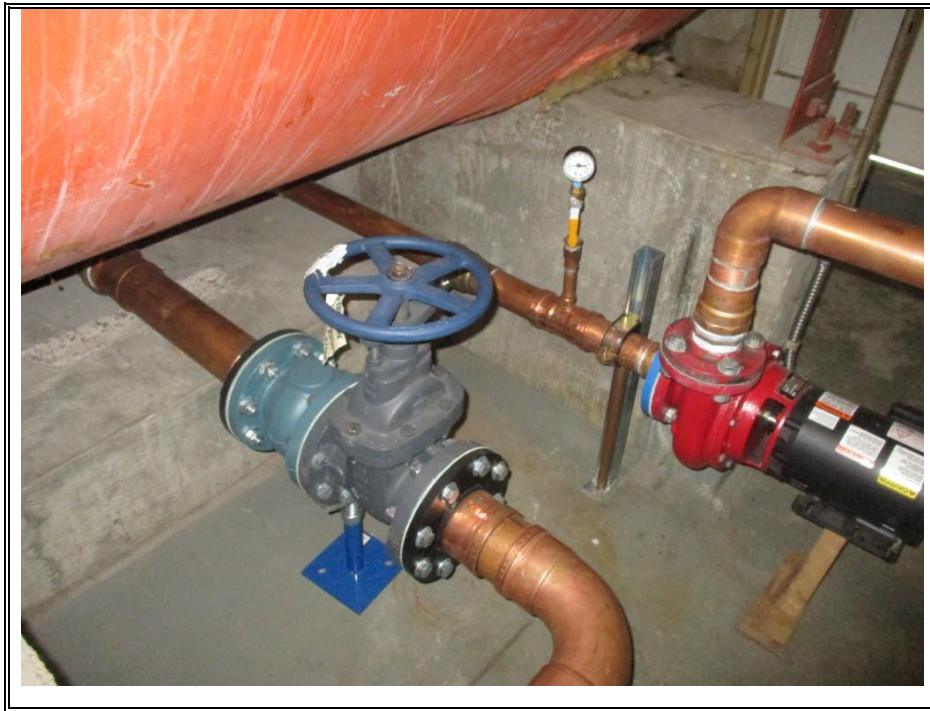
CIRCULATION PUMPS (TYPICAL)

OBSERVATIONS: *This component includes the circulation pumps, comprised of 1 at 1 hp and 1 at ½ hp, which serve to expedite hot water provision to the individual units. We were informed that one was installed in 2018 and for reporting purposes the remaining lives have been averaged.*

TO PROTECT YOUR INVESTMENT: *Maintenance should include periodic lubrication (which can considerably extend its life expectancy).*

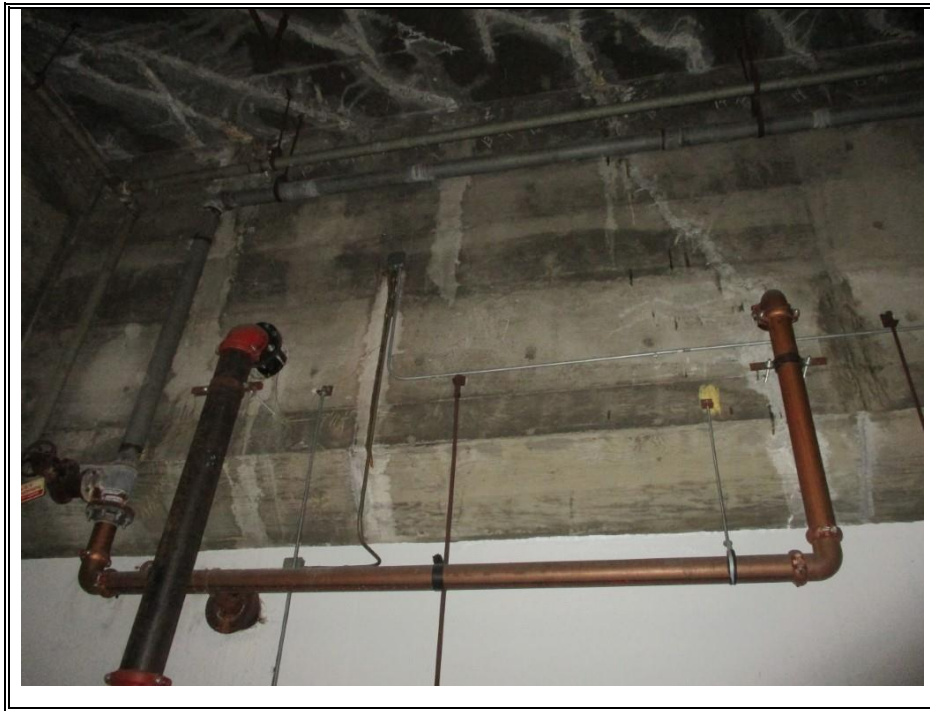
DISTRIBUTION PIPING-PHASE1 (TYPICAL)

OBSERVATIONS: *This component includes phase 1 of the copper distribution piping that provides potable water to the individual units throughout the complex. We were previously informed of limited replacements, and it generally appeared to be in aging condition and nearing the end of its anticipated useful service life. We were informed that the piping is anticipated to be replaced over the next 3 years, and for reporting purposes it has been split into 3 phases. Although previously considered to be a lifetime component, copper piping has more recently been found to fail as early as 15 years after installation. This is suspected to be primarily caused by changes in the chemical makeup of potable water due to the U.S. Environmental Protection Agency's (EPA) Safe Water Drinking Act and the Lead and Copper Rule (LCR). For purposes of reporting, an approximate time frame of 40 years has been assumed for future replacement. A rough cost estimate, based on number of units, has been provided. It is recommended that further evaluation be obtained from a licensed plumbing consultant / contractor, as well as consideration of an epoxy pipe lining system, and adjustments can be included in a future Reserve Study Update.*

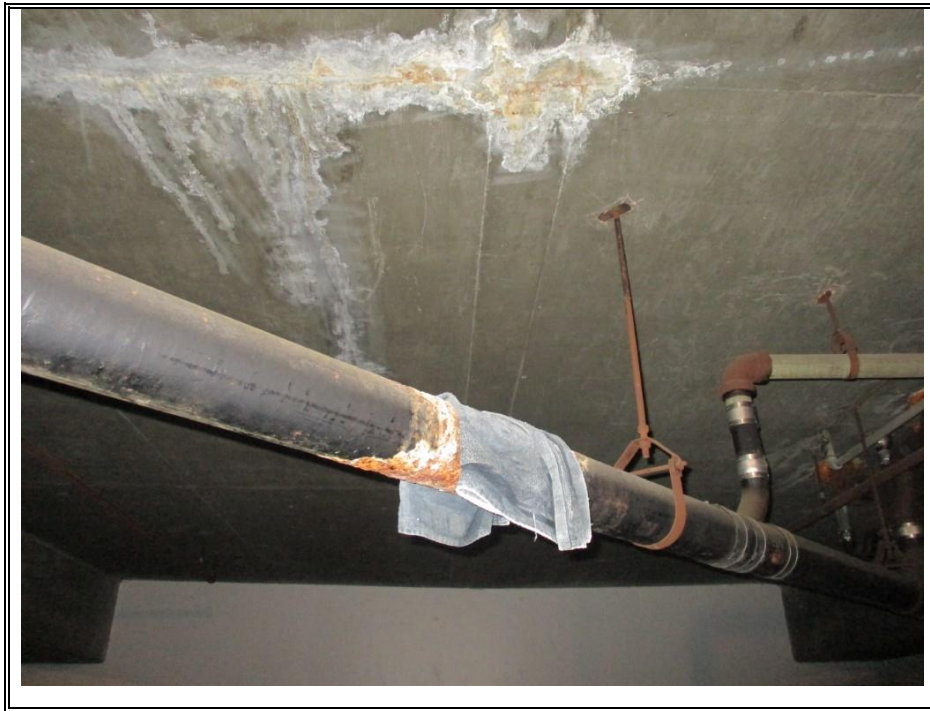
DRAINAGE/SEWER PIPING (TYPICAL)

OBSERVATIONS: *This component addresses the sewer and drainage piping. An allowance has been established for the periodic cleaning and repairs. No amount has been provided for complete replacement as the piping would typically have a life well in excess of the scope of this projection and would therefore be considered a lifetime component.*

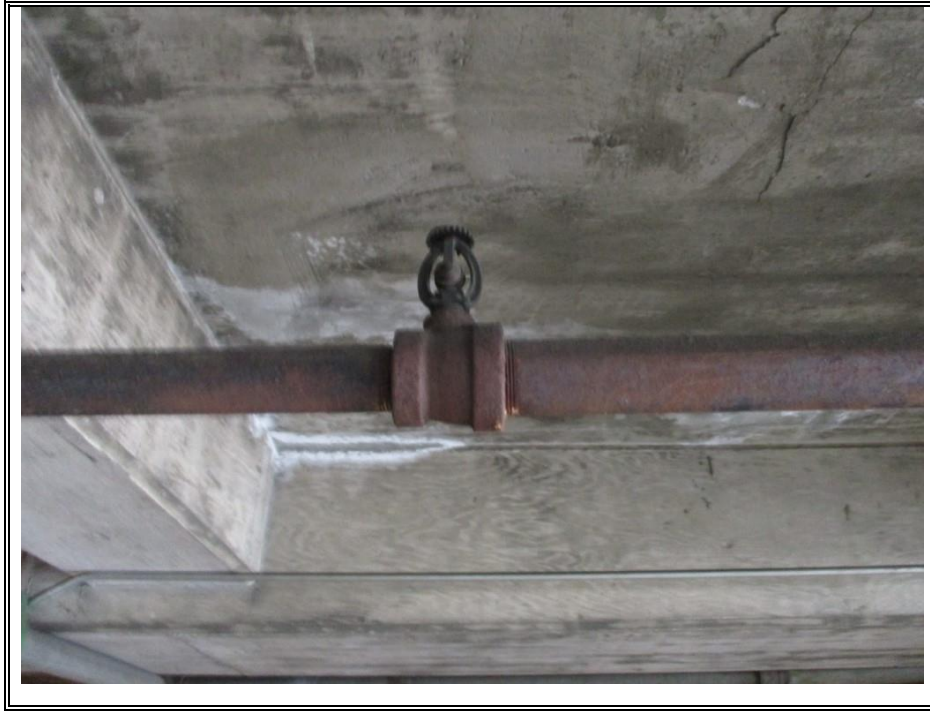
FIRE SPRINKLERS (TYPICAL)

OBSERVATIONS: *This component includes the fire sprinklers in the garage. They appeared to be in average condition. The fire sprinkler system would be considered to be a lifetime component and for purposes of reporting no amount has been provided for its future replacement. It is recommended that repairs be made on an as-needed basis and funded from the operating account.*

TO PROTECT YOUR INVESTMENT: *Periodic inspection and maintenance should be performed by a State Fire Marshall approved company.*

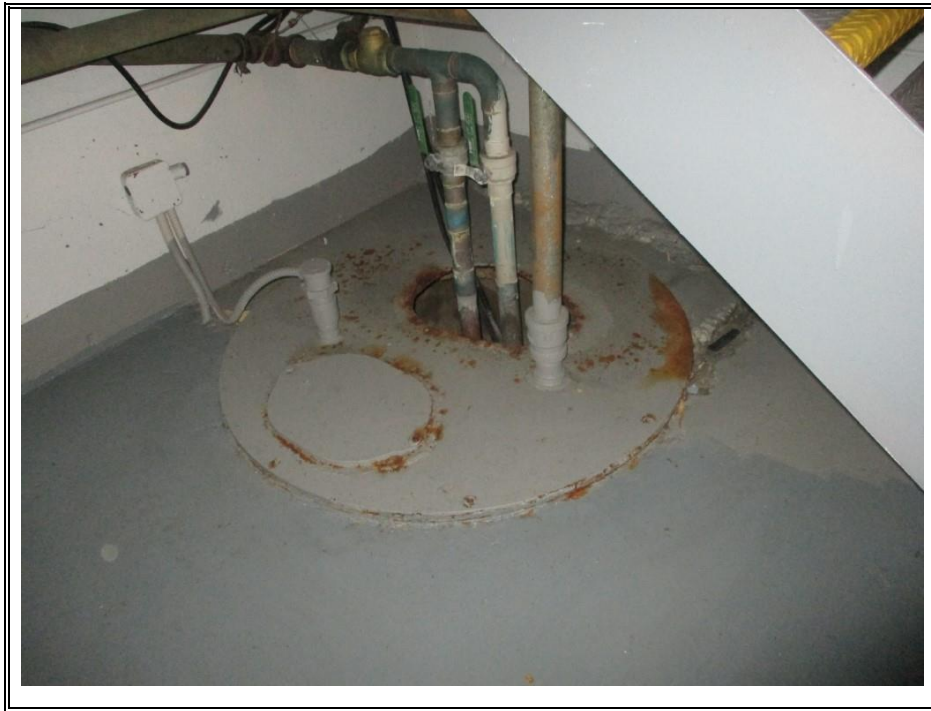
SUMP PUMPS (TYPICAL)

OBSERVATIONS: *This component includes the sump pumps in the garage/stairwell. They were inaccessible for inspection (covered by a steel plate), however we were previously informed they were installed in 2015. The pumps serve the purpose of preventing flooding by pumping water out to the street. These types of pumps are designed to operate automatically and are imperative for water removal during rainstorms. Failure of the pumps can also lead to over-saturation of the sub-surface soils and associated foundation and concrete slab settlement/cracking.*

TO PROTECT YOUR INVESTMENT: *Maintenance should include regular cleaning of the sumps along with verification that the pumps are operational. This should be specifically performed prior to the onset of the rainy season.*

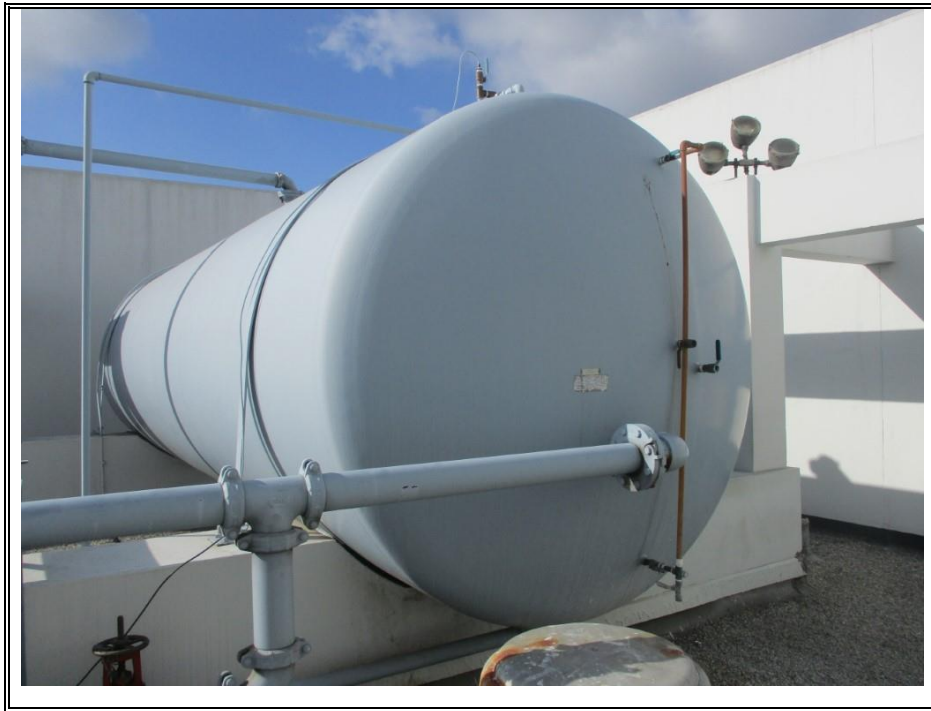
COLD WATER STORAGE TANK-RELINING (TYPICAL)

OBSERVATIONS: *This component provides for re-lining the ceramic lined cold water storage tank on the roof. We were previously informed that with re-lining, the tank should have a life of 30+ years and would therefore be considered a lifetime component. We previously informed that re-lining was last performed circa 2015.*

TO PROTECT YOUR INVESTMENT: *Maintenance should include periodic draining of a few gallons of water from the drain cock to relieve sediment build-up. It is also essential that the sacrificial anodes be checked at least every three months. A service contract with a reputable licensed plumbing contractor is again recommended for longevity of the system. The association may consider professionally installing a water treatment system, which would serve to enhance the longevity of the piping.*

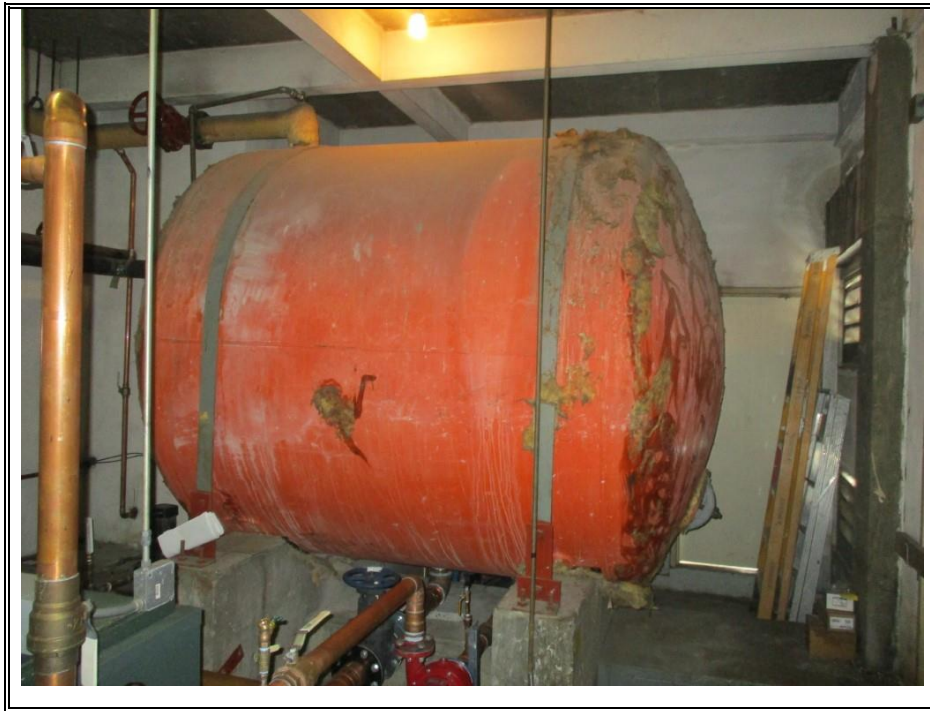
HOT WATER STORAGE TANK (TYPICAL)

OBSERVATIONS: *This component includes a hot water storage tank in the boiler equipment room. The lining was inaccessible for inspection (encased) and for reporting purposes the remaining life has been estimated. This type of equipment can fail without warning, often as a result of improper maintenance.*

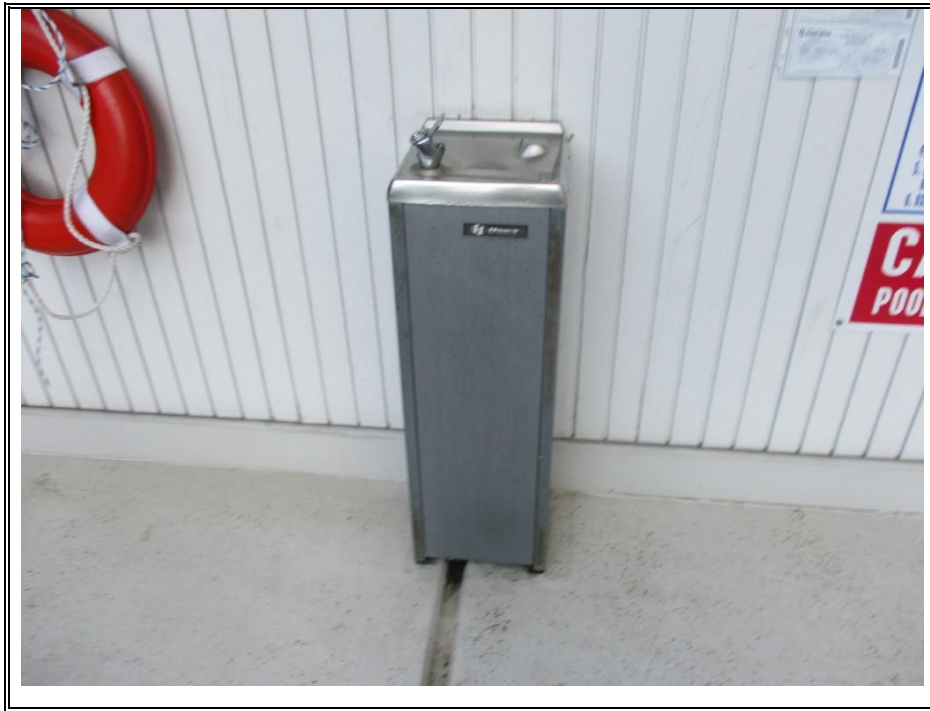
DRINKING FOUNTAIN (TYPICAL)

OBSERVATIONS: *This component includes a stainless-steel basin, chilled water drinking fountain in the pool restroom building. It appeared to be in average to aging condition.*

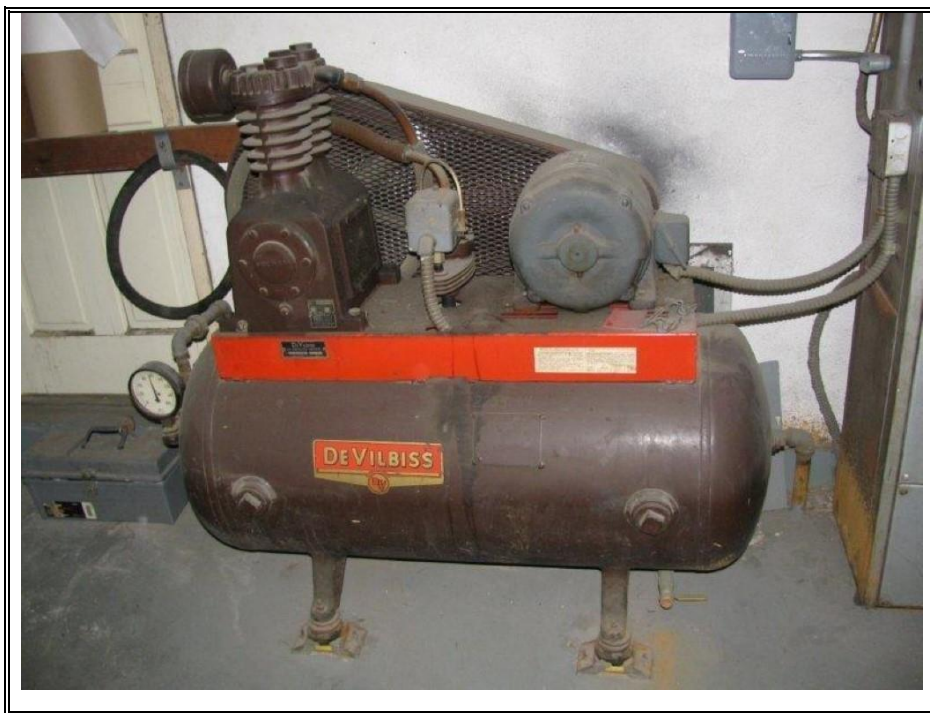
AIR COMPRESSOR (TYPICAL)

OBSERVATIONS: *This component includes the 3-horsepower air compressor in the boiler equipment room, manufactured in 1994, which services the boiler system. We were previously informed it was overhauled in 2017 and for reporting purposes the remaining life has been averaged.*

TO PROTECT YOUR INVESTMENT: *It is recommended that a full-service maintenance contract be obtained with a reputable licensed contractor.*

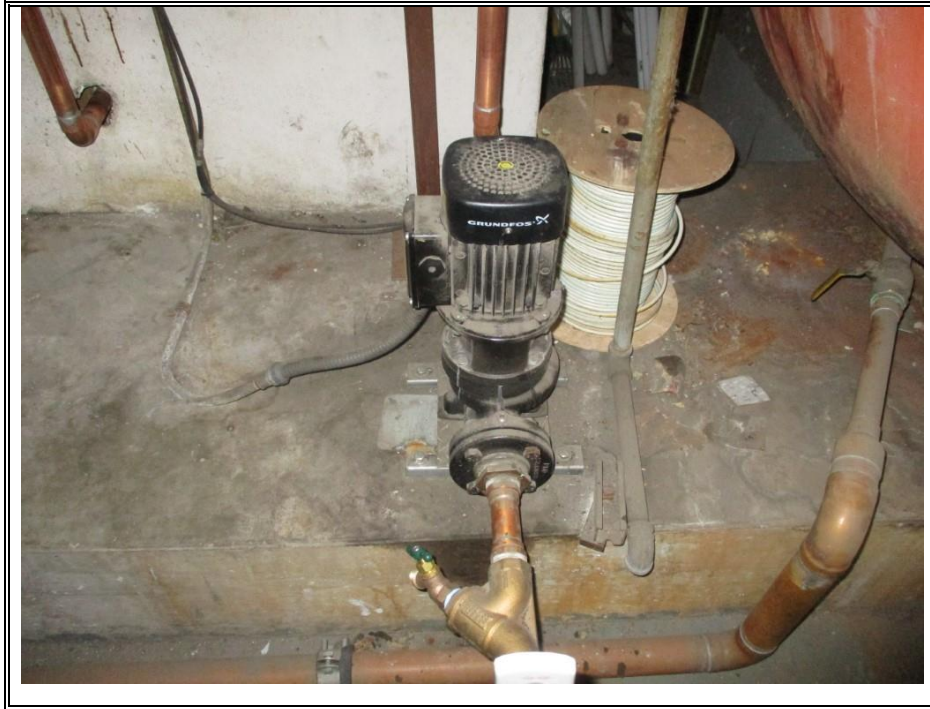
BOOSTER PUMP (TYPICAL)

OBSERVATIONS: *This component includes the "Grundfos" booster pump and motor in a maintenance closet at garage level two, which serves to increase water pressure provision to the individual units. It appeared to be in average to aging condition.*

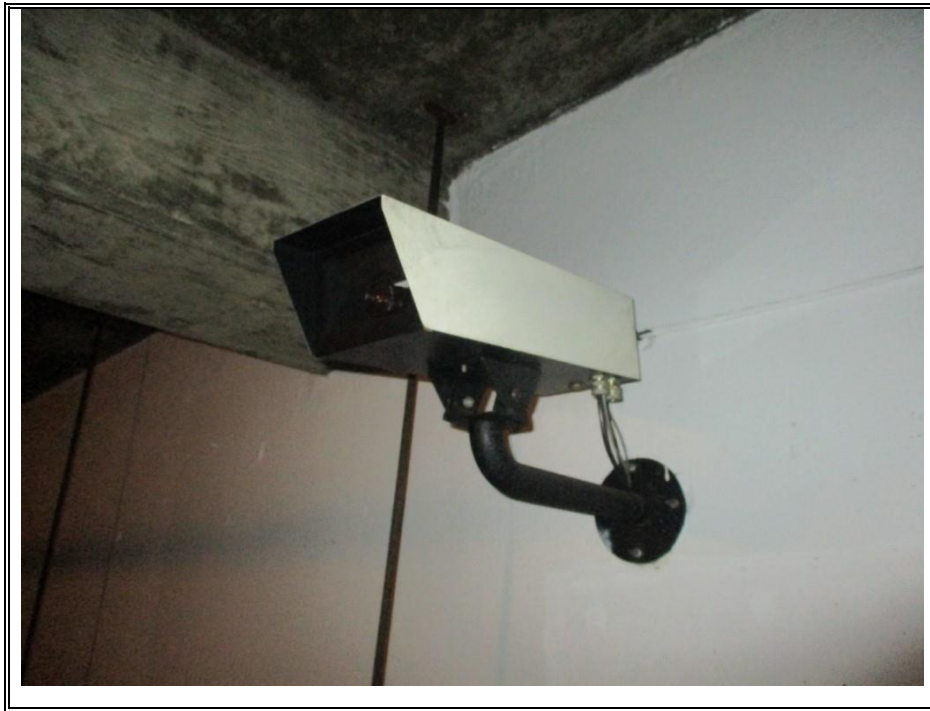
CCTV SYSTEM (TYPICAL)

OBSERVATIONS: *This component includes the cameras, monitor and recorder for the closed-circuit television system. They appeared to be in good condition*

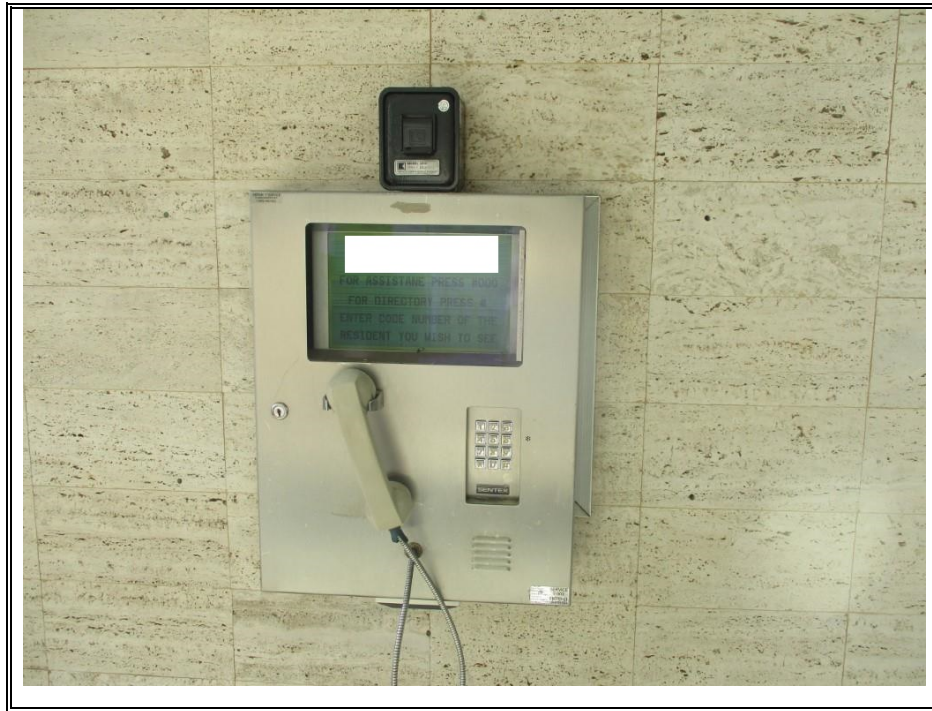
INTERCOM (TYPICAL)

OBSERVATIONS: This component includes a telephone-type entry intercom system with LCD scroll, at the pedestrian entry to the building. We were informed it was serviced in 2017 and appeared to be in average condition for its age.

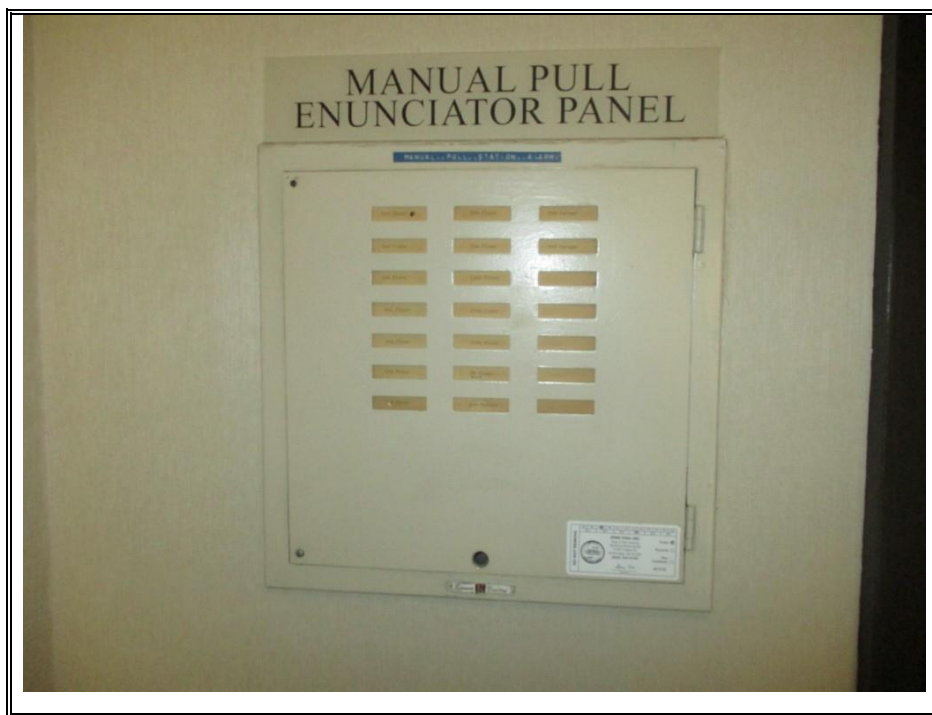
FIRE ANNUNCIATOR SYSTEM (TYPICAL)

OBSERVATIONS: This component includes a fire annunciator system (panel) adjacent to the manager's office. We were informed it was serviced in 2017 and it appeared to be in average condition for its age.

TO PROTECT YOUR INVESTMENT: Little by way of maintenance can be performed for this component. However, it should be professionally inspected on a regular (suggested annual) basis.
