RESERVE STUDY - FEBRUARY 1, 2020

High Rise Homeowners Association (Sample Only)
3525 Main Street
Los Angeles, California

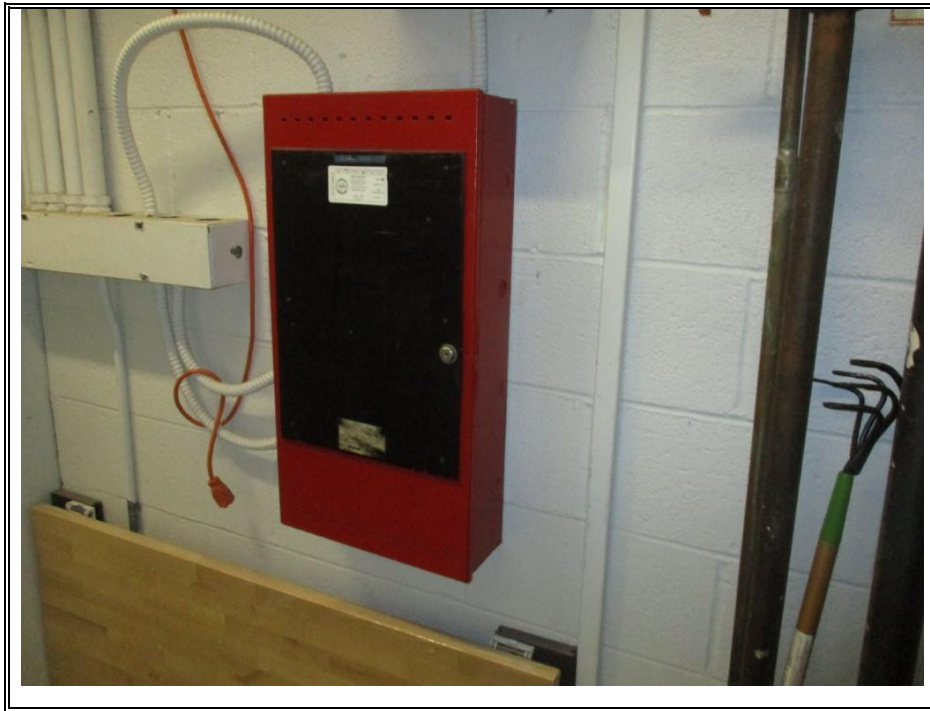
FIRE ALARM SYSTEM (TYPICAL)

OBSERVATIONS: *This component includes a fire alarm system in the service hallway at the east end of the building. It appeared to be in good condition for its age. We were informed it receives regular service and the remaining life has been arbitrarily extended. We were also previously informed by the service company that the current system is “grandfathered” from existing codes. To upgrade/replace the system would require re-wiring the entire building and substantial additional equipment such as audible speakers, smoke alarms, etc., and it would have to conform to the “2 door rule” mode. In addition, a potential asbestos removal problem may exist. A rough estimate for replacement with a new system has been provided. As additional information is obtained, adjustments can be included in a future Reserve Study Update.*

TO PROTECT YOUR INVESTMENT: *Little by way of maintenance can be performed for this component. However, it should be professionally inspected on a regular (suggested annual) basis.*

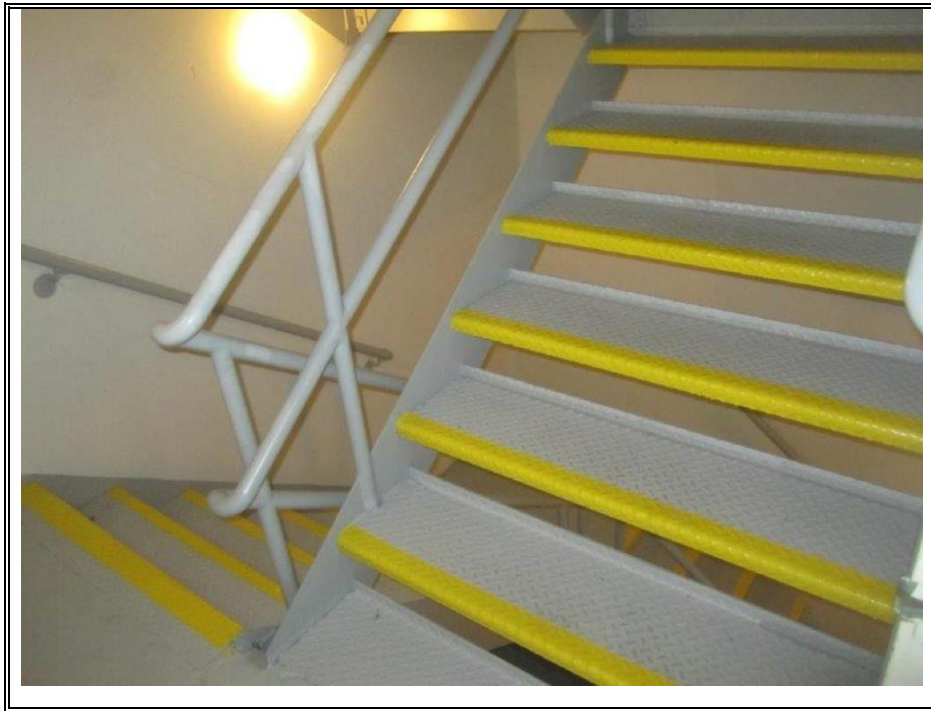
LIGHTING-EMERGENCY (TYPICAL)

OBSERVATIONS: *This component includes the emergency light fixtures throughout the building. They appeared to be in average condition and are usually desired to be replaced for appearance sake. It is recommended that replacement be made on an as-needed basis and funded from the operating account.*

TO PROTECT YOUR INVESTMENT: *Maintenance would entail periodically checking the fixtures to make sure that they are secure and that the batteries are fully charged. Also, occasional examination for, and changing of burned out bulbs would be prudent. In addition, cleaning of the fixtures is recommended on an as-needed basis.*

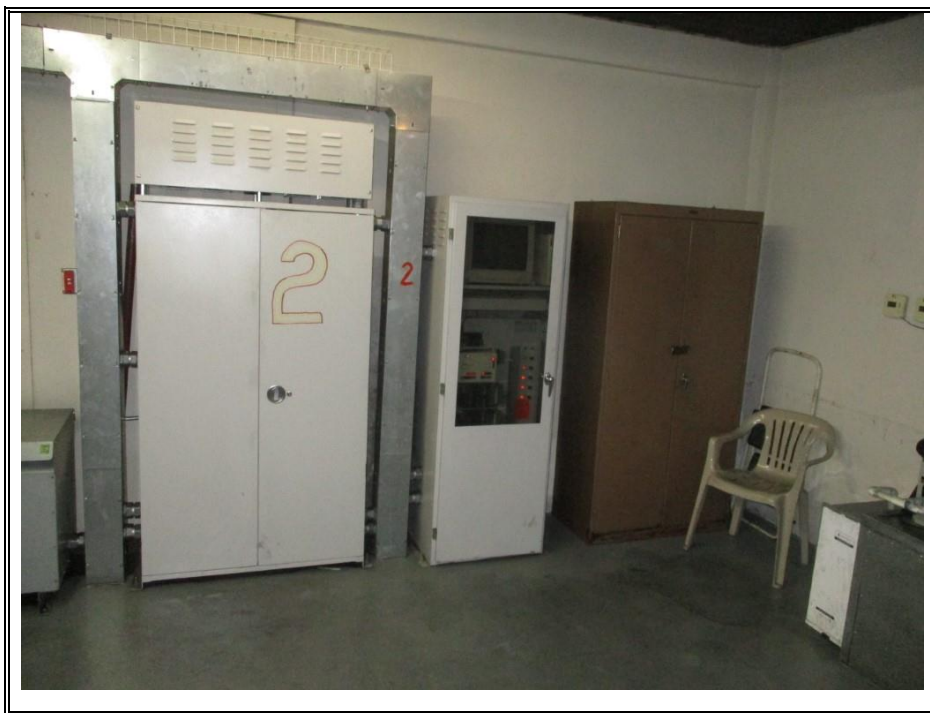
LIGHTING-EMERGENCY LIGHT BACK-UP POWER (TYPICAL)

OBSERVATIONS: This component includes the battery pack back-up power systems for the emergency lights in the elevator equipment room. They were inaccessible for inspection (the cabinets were locked). For reporting purposes, their remaining lives have been estimated. A rough estimate has been provided for replacement. It is recommended that further information be obtained from the service provider, and adjustments can be included in a future Reserve Study Update if necessary.

TO PROTECT YOUR INVESTMENT: Periodic testing should be performed for the system to ensure proper operation.

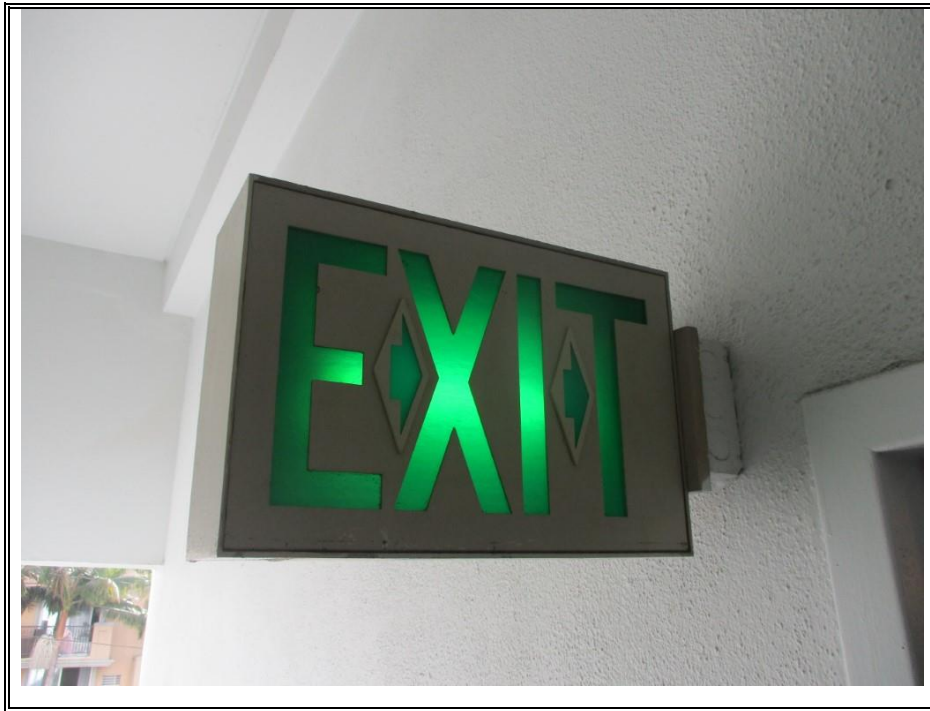
LIGHTING-EXIT SIGNS (TYPICAL)

OBSERVATIONS: *This component includes the lighted exit signs throughout the complex. They appeared to be in average condition and are usually desired to be replaced for appearance sake.*

TO PROTECT YOUR INVESTMENT: *Maintenance would entail periodically checking the fixtures to make sure that they are secure. Also, occasional examination for, and changing of burned out bulbs would be prudent. In addition, cleaning of the fixtures is recommended on an as-needed basis.*

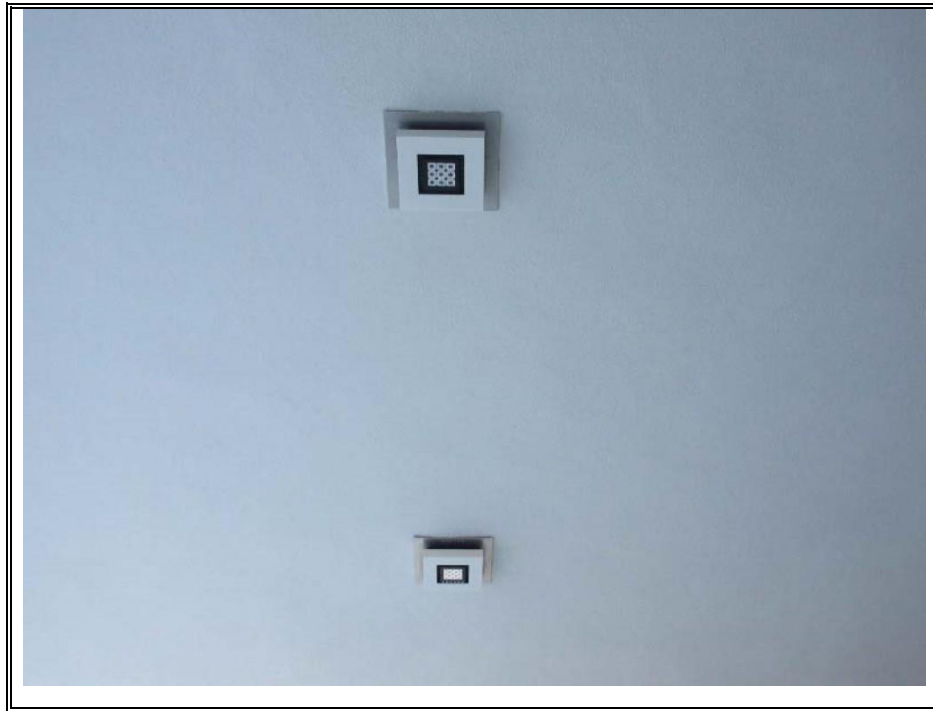
LIGHTING-EXTERIOR (DECORATIVE) (TYPICAL)

OBSERVATIONS: *This component includes the wall and ceiling mounted decorative light fixtures at the balconies and exterior of the building. They appeared to be in good to average condition. The external location of these fixtures usually makes them subject to a greater rate of deterioration due to exposure to the elements. Also, it is often desirable to replace these fixtures as they eventually become dated and/or more energy efficient options become available.*

TO PROTECT YOUR INVESTMENT: *Maintenance would entail periodically checking the fixtures to make sure that they are secure. Also, occasional examination for, and changing of burned out bulbs would be prudent. In addition, cleaning of the fixtures is recommended on an as-needed basis.*

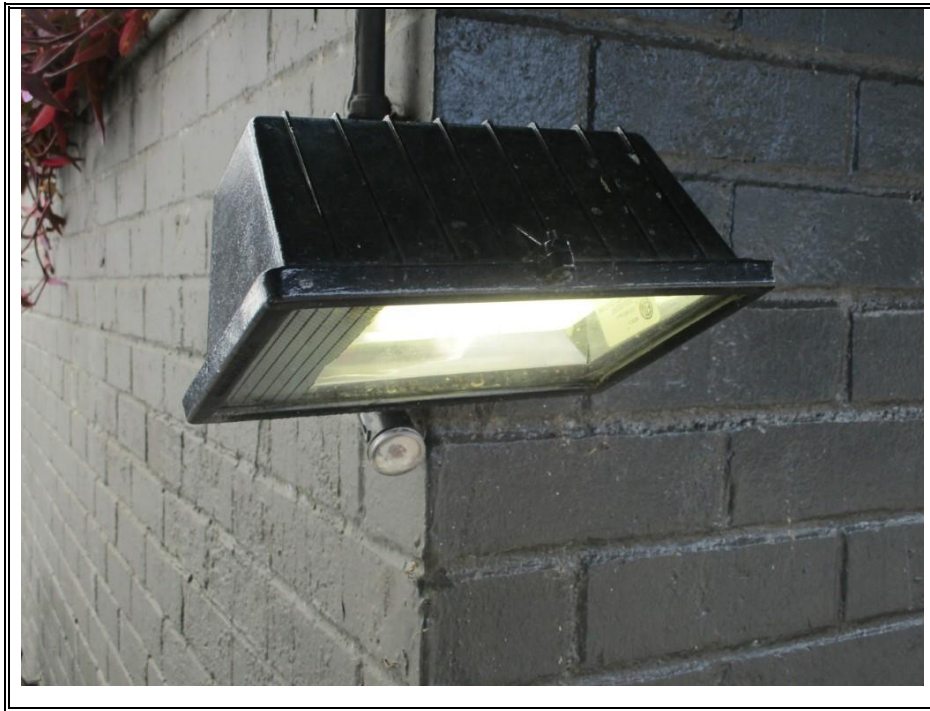
LIGHTING-EXTERIOR (UTILITARIAN) (TYPICAL)

OBSERVATIONS: *This component includes the utilitarian light fixtures at the exterior of the building. They appeared to be in average condition. It is recommended that repairs/replacement be done on an as-needed basis and funded from the operating account. The external location of these fixtures usually makes them subject to a greater rate of deterioration due to exposure to the elements. Also, it is often desirable to replace these fixtures as they eventually become dated and/or more energy efficient options become available.*

TO PROTECT YOUR INVESTMENT: *Maintenance would entail periodically checking the fixtures to make sure that they are secure. Also, occasional examination for, and changing of burned out bulbs would be prudent. In addition, cleaning of the fixtures is recommended on an as-needed basis.*

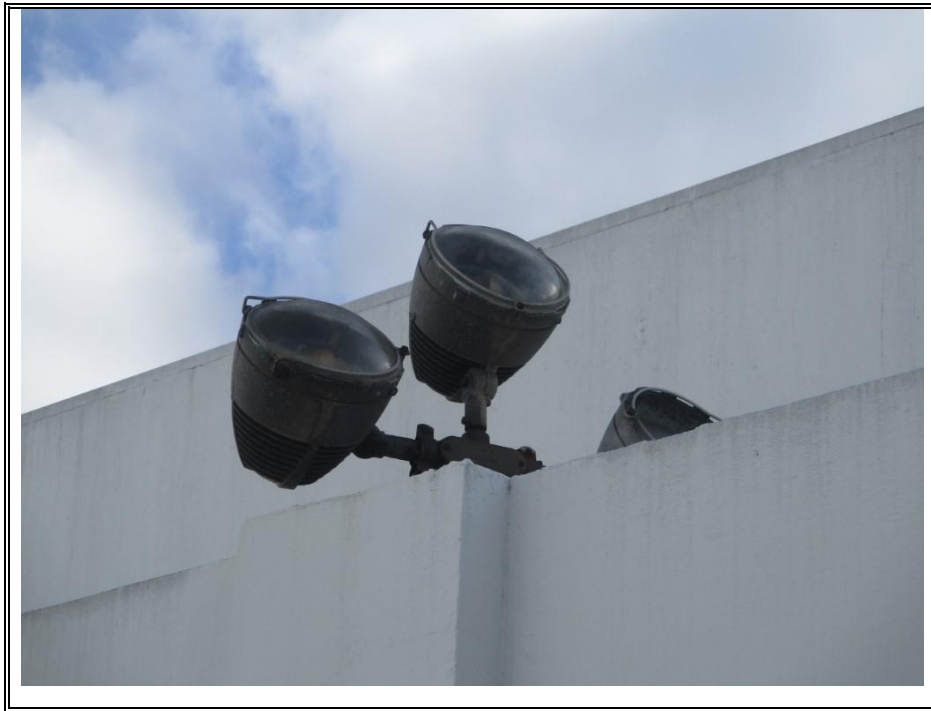
LIGHTING-EXTERIOR (SECURITY) (TYPICAL)

OBSERVATIONS: *This component includes the high intensity discharge type floodlight fixtures at the exterior of the building. They appeared to be in average condition. It is recommended that repairs/replacement be done on an as-needed basis and funded from the operating account. The external location of these fixtures usually makes them subject to a greater rate of deterioration due to exposure to the elements. Also, it is often desirable to replace these fixtures as they eventually become dated and/or more energy efficient options become available.*

TO PROTECT YOUR INVESTMENT: *Maintenance would entail periodically checking the fixtures to make sure that they are secure. Also, occasional examination for, and changing of burned out bulbs would be prudent. In addition, cleaning of the fixtures is recommended on an as-needed basis.*

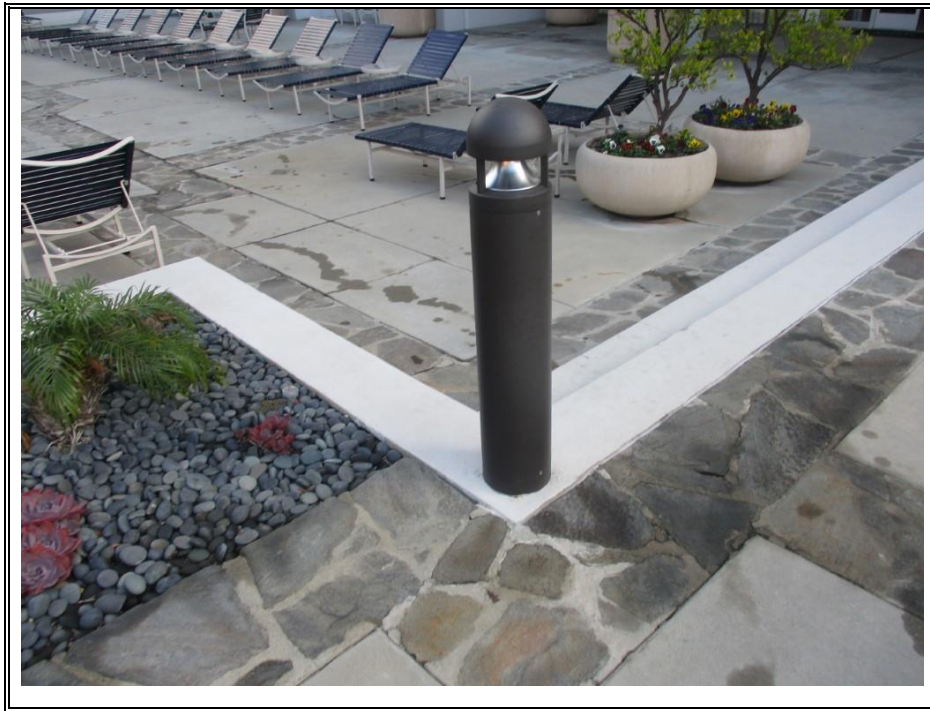
LIGHTING-WALKWAYS (TYPICAL)

OBSERVATIONS: *This component includes the coach type light fixtures at the pool area. They appeared to be in average condition. These types of fixtures are typically subject to a greater level of deterioration from the elements.*

TO PROTECT YOUR INVESTMENT: *Maintenance would entail periodically checking the fixtures to make sure that they are secure. Also, occasional examination for, and changing of burned out bulbs would be prudent. In addition, cleaning of the fixtures is recommended on an as-needed basis.*

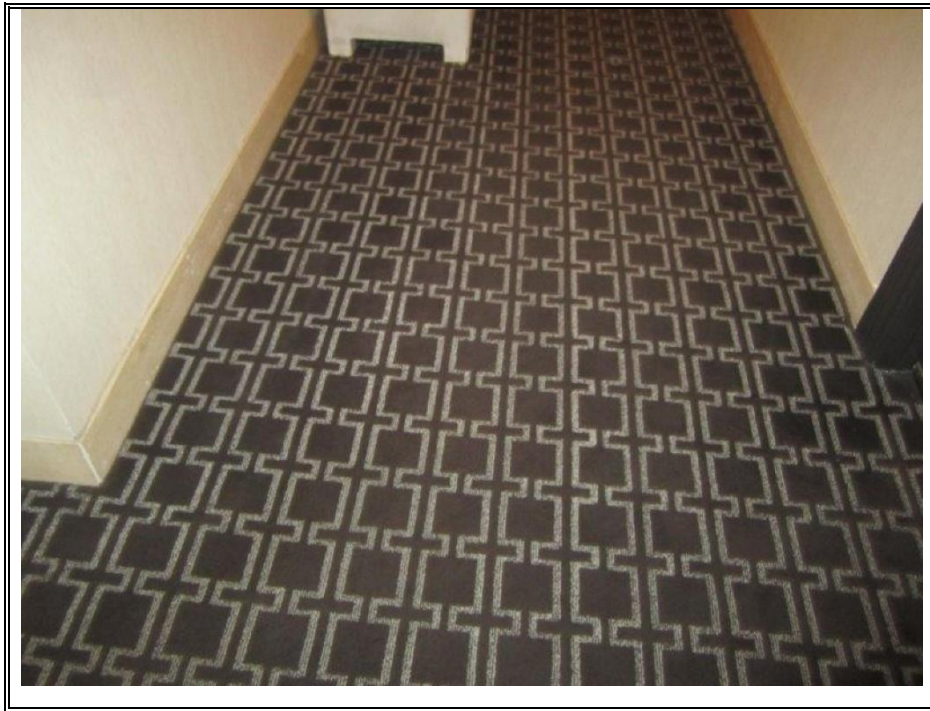
CARPETING-HALLWAYS (TYPICAL)

OBSERVATIONS: *This component includes the carpeting in the internal hallways. It appeared to be in average to aging condition*

TO PROTECT YOUR INVESTMENT: *Maintenance should entail regular vacuum cleaning (from once weekly to as often as daily for high traffic areas). Power pile lifting is recommended at least once a month for high traffic areas. Mats are suggested to remove dirt from shoes before it can be tracked onto carpeted areas (should be cleaned and rotated regularly to prevent soil build-up that may spread to the carpet). Spots and spills should be removed as soon as possible to prevent permanent staining. Deep cleaning should be performed on an as-needed basis (before soil is noticeable – usually not more than once every one or two years) and fluorochemical treatment applied immediately after. It is recommended that before applying any topical treatments, the carpet manufacturer be contacted to prevent voiding of the warranty. Damaged areas should be repaired as they can create a trip hazard resulting in association liability.*

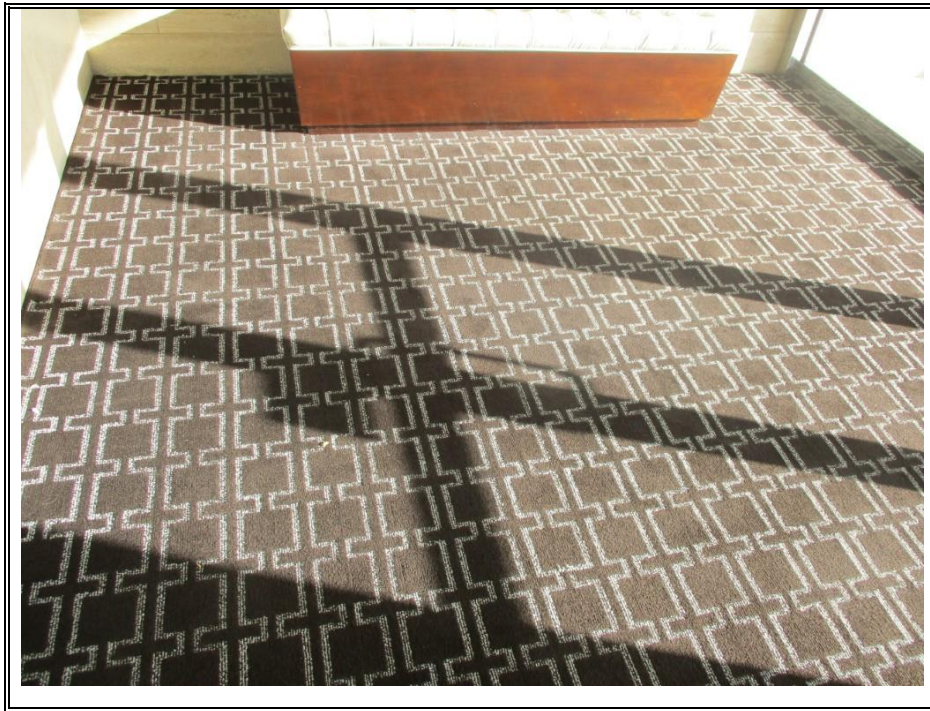
CARPETING-LOBBY /OFFICE (TYPICAL)

OBSERVATIONS: *This component includes the carpeting in the, office, lobby, and miscellaneous common areas. It appeared to be in average to aging condition.*

TO PROTECT YOUR INVESTMENT: *Maintenance should entail regular vacuum cleaning (from once weekly to as often as daily for high traffic areas). Power pile lifting is recommended at least once a month for high traffic areas. Mats are suggested to remove dirt from shoes before it can be tracked onto carpeted areas (should be cleaned and rotated regularly to prevent soil build-up that may spread to the carpet). Spots and spills should be removed as soon as possible to prevent permanent staining. Deep cleaning should be performed on an as-needed basis (before soil is noticeable – usually not more than once every one or two years) and fluorochemical treatment applied immediately after. It is recommended that before applying any topical treatments, the carpet manufacturer be contacted to prevent voiding of the warranty. Damaged areas should be repaired as they can create a trip hazard resulting in association liability.*

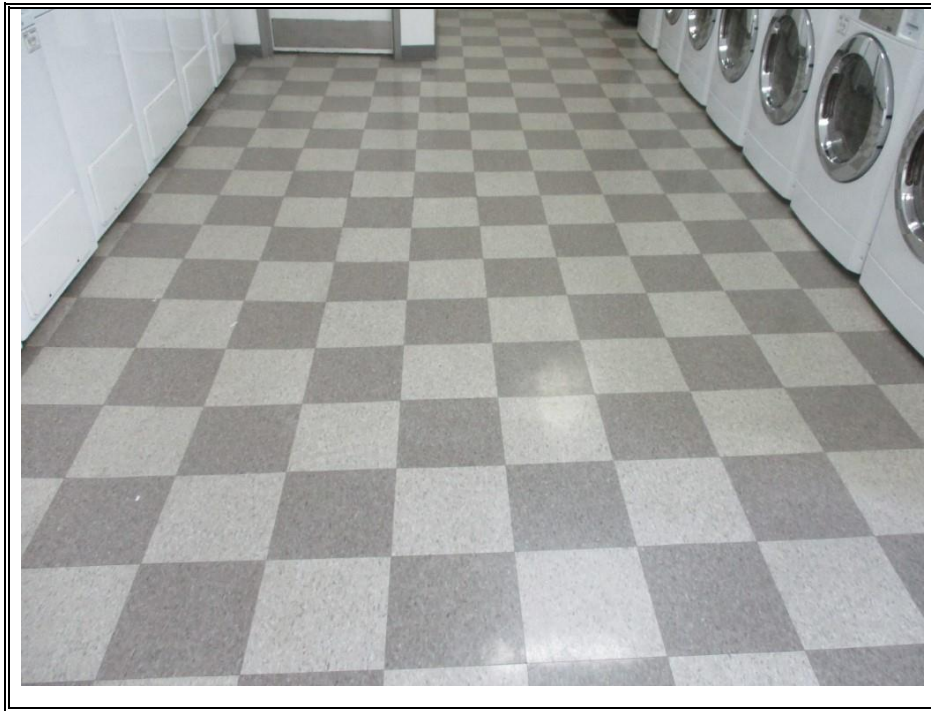
VINYL (TYPICAL)

OBSERVATIONS: *This component includes the vinyl squares flooring in the laundry room, hallways, trash chutes, and miscellaneous common areas. We were previously informed that it was installed in 2013 and it appeared to be in good condition.*

TO PROTECT YOUR INVESTMENT: *Maintenance would entail regular cleaning with a mild detergent solution and warm water (care should be exercised to not flood the flooring). Do not use paste or solvent-based wax. Rubber backed rugs should be avoided as they can discolor the vinyl flooring. Soil collecting mats are recommended to remove dirt from shoe soles before it can be tracked onto the vinyl (they should be cleaned and rotated regularly to prevent soil build-up that will spread to the vinyl). Lifting seams, corners, etc. should be re-glued and damaged areas repaired as necessary.*

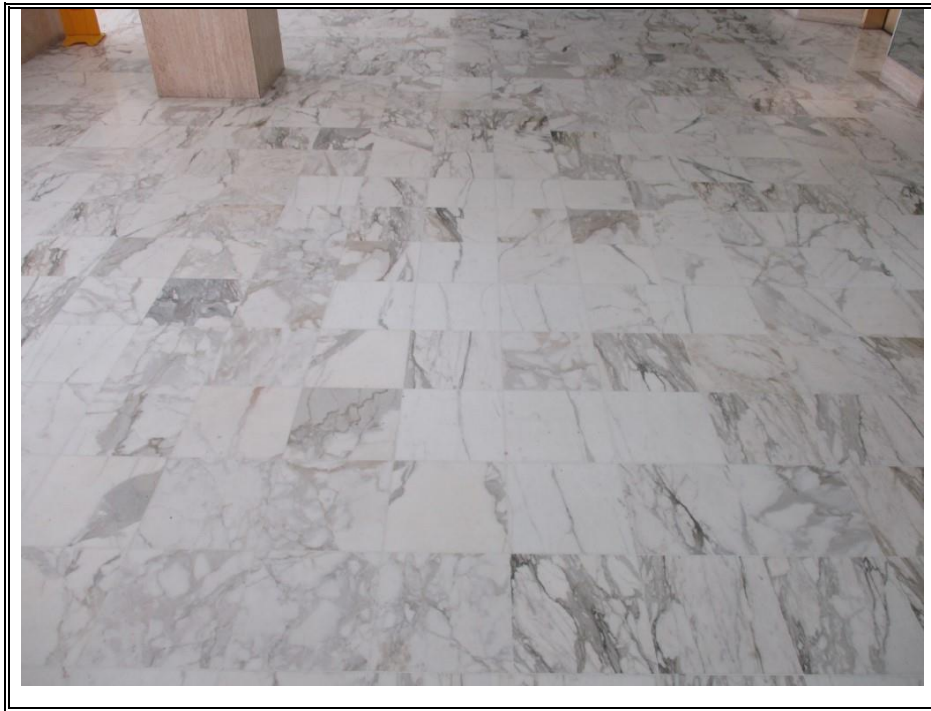
MARBLE-RESTORATION (TYPICAL)

OBSERVATIONS: *This component provides for the restoration of the marble flooring in the lobby and pedestrian entry to the building. Included would be epoxy grout, heavy buff, polish, buff & seal. With regular maintenance (See component ID #0705), the cycle for restoration should be at approximately 15-year intervals. If restored, this material would be considered to be a lifetime component. Therefore, no amount has been provided for its replacement.*

TO PROTECT YOUR INVESTMENT: *Only a mild soap and water solution should be used. Proprietary cleaners and sealers are discouraged. It is suggested that the marble be professionally cleaned on an annual basis.*

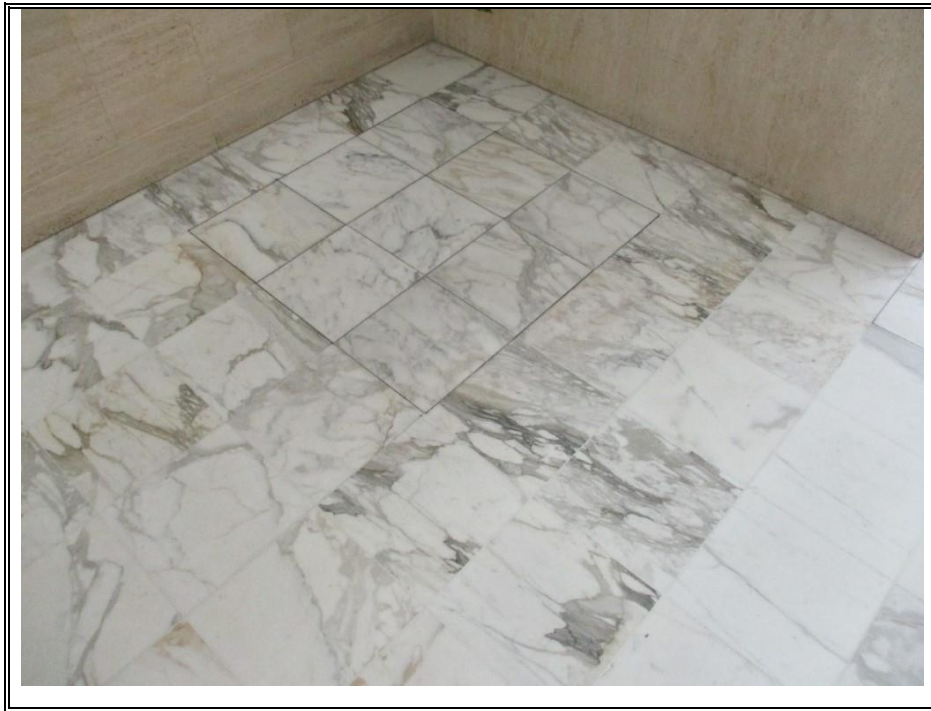
MARBLE-POLISHING (TYPICAL)

OBSERVATIONS: *This component provides for more frequent buffing and polishing of the flooring mentioned in component ID #0704. Frequent polishing is suggested to maintain the high aesthetic value projected by this complex. It appeared to be in average condition.*

TO PROTECT YOUR INVESTMENT: *Only a mild soap and water solution should be used. Proprietary cleaners and sealers are discouraged. It is suggested that the marble be professionally cleaned on an annual basis.*

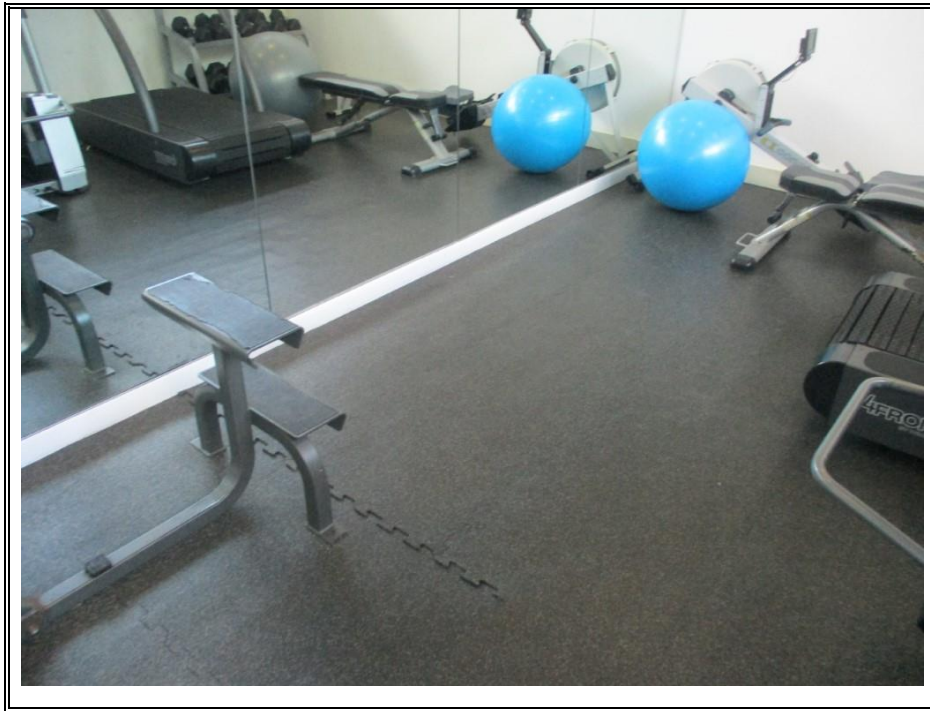
RUBBER-FLOORING-GYM (TYPICAL)

OBSERVATIONS: *This component includes the rubber flooring in the gym. We were previously informed that it was installed in 2012, and it appeared to be in average condition.*

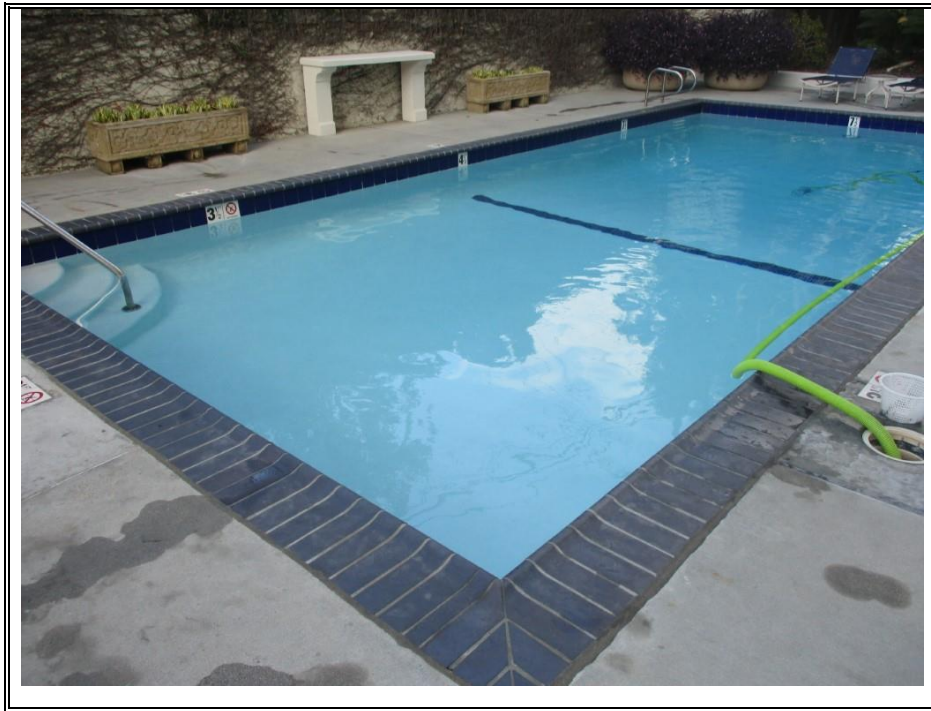
PLASTER-POOL (TYPICAL)

OBSERVATIONS: *This component includes the plaster lining of the pool. We were previously informed that it was applied in 2016 and it appeared to be in good condition. Coarseness of the plaster, which occurs over time, is conducive to algae growth and can be injurious to users of the pool (potential association liability).*

TO PROTECT YOUR INVESTMENT: *Maintenance of a clean surface and proper chemical balance is essential for the longevity of the plaster lining.*

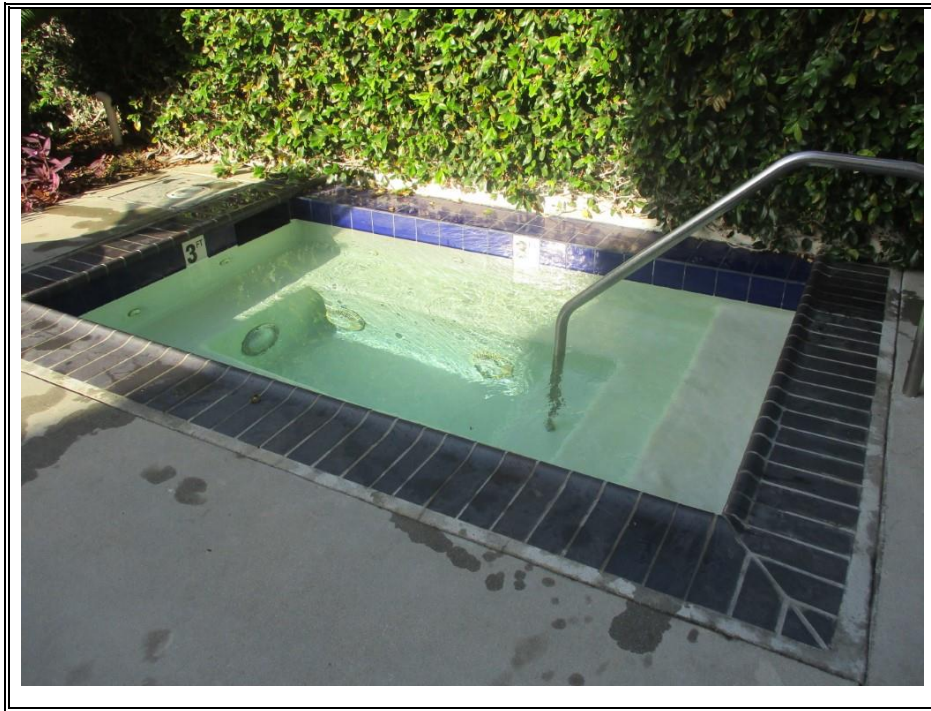
PLASTER- SPA (TYPICAL)

OBSERVATIONS: *This component includes the plaster lining of the spa. We were previously informed that it was applied in 2016 and it appeared to be in good condition. Coarseness of the plaster, which occurs over time, is conducive to algae growth and can be injurious to users of the pool (potential association liability).*

TO PROTECT YOUR INVESTMENT: *Maintenance of a clean surface and proper chemical balance is essential for the longevity of the fiberglass shell.*

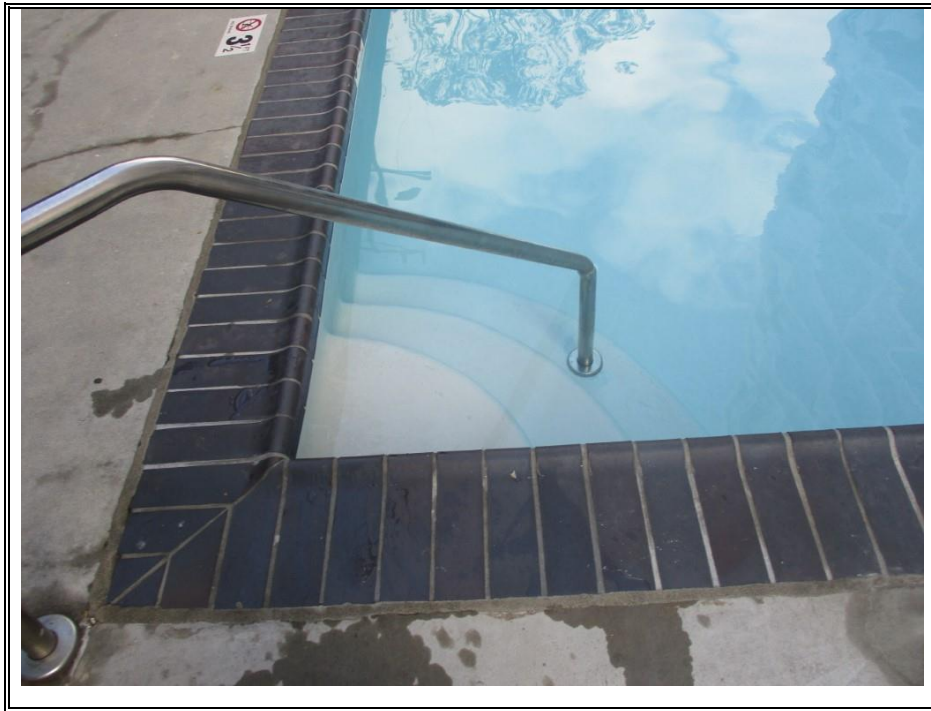
COPING JOINT (TYPICAL)

OBSERVATIONS: *This component includes the caulking for the control joint (gap) between the pool and spa decking and the coping. We were previously informed that it was installed in 2016 and it appeared to be in average condition.*

TO PROTECT YOUR INVESTMENT: *Maintenance of a well-sealed joint will reduce the potential for cracking and settlement of the pool decks. Prior to subsequent re-caulking of the coping joint, the existing caulk should be removed first. Otherwise, little by way of maintenance can be performed for this component.*

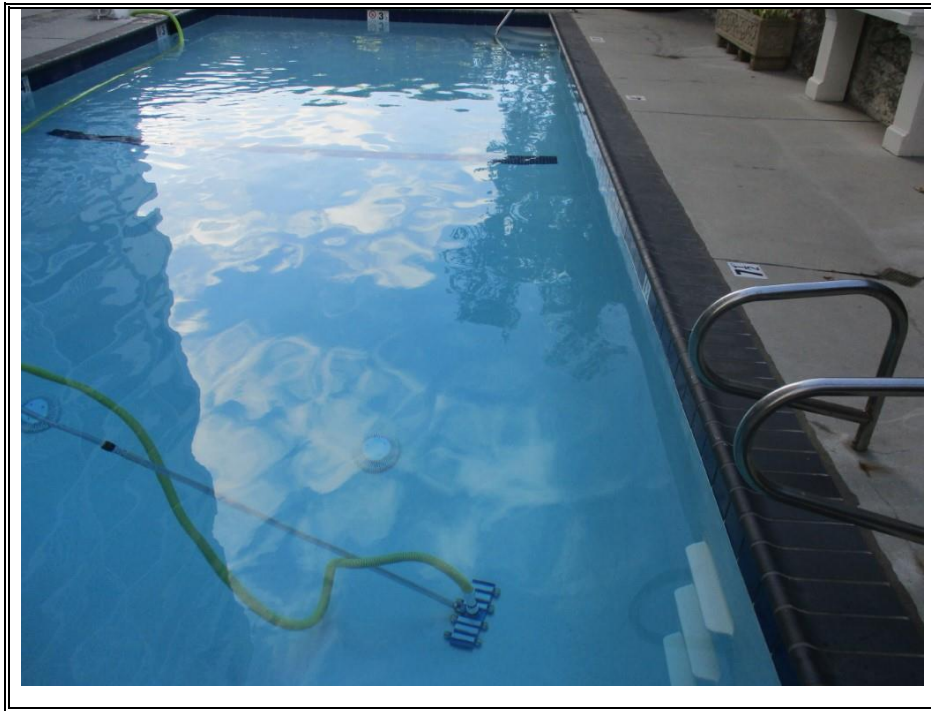
COPING/TILE (TYPICAL)

OBSERVATIONS: *This component includes the coping and tile around the perimeter of the pool and spa. We were previously informed that it was installed in 2016 and it appeared to be in good condition. It is suggested that replacement be coordinated with alternate re-plastering cycles.*

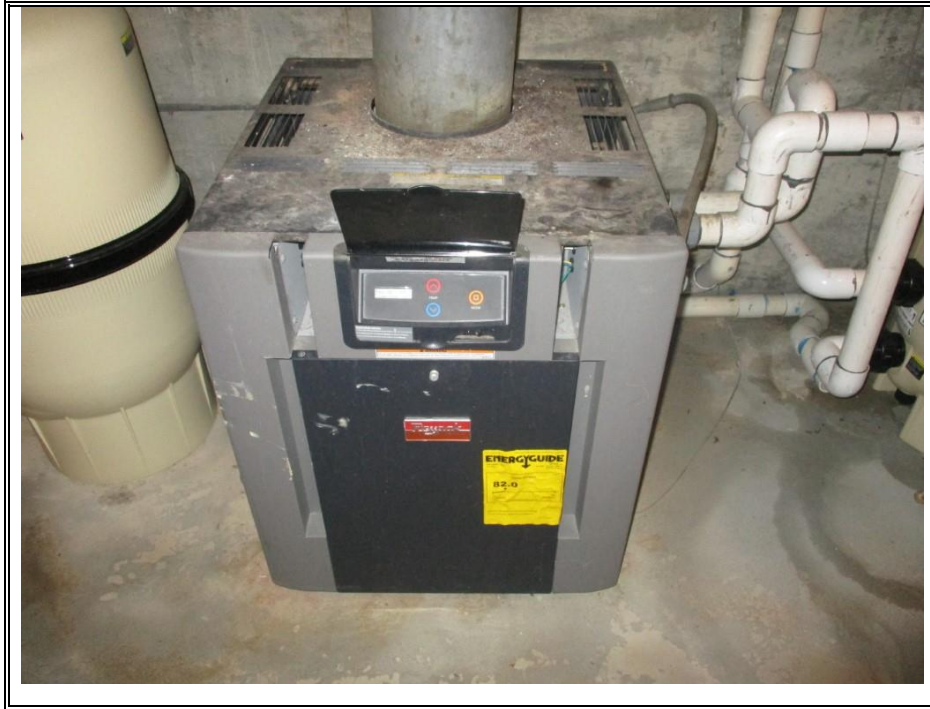
HEATERS (TYPICAL)

OBSERVATIONS: This component includes the heaters for the pool and spa, comprised of 1 at 332,500 BTU and 1 at 399,000 BTU. We were informed that one was installed in 2016 and for reporting purposes the remaining lives have been averaged.

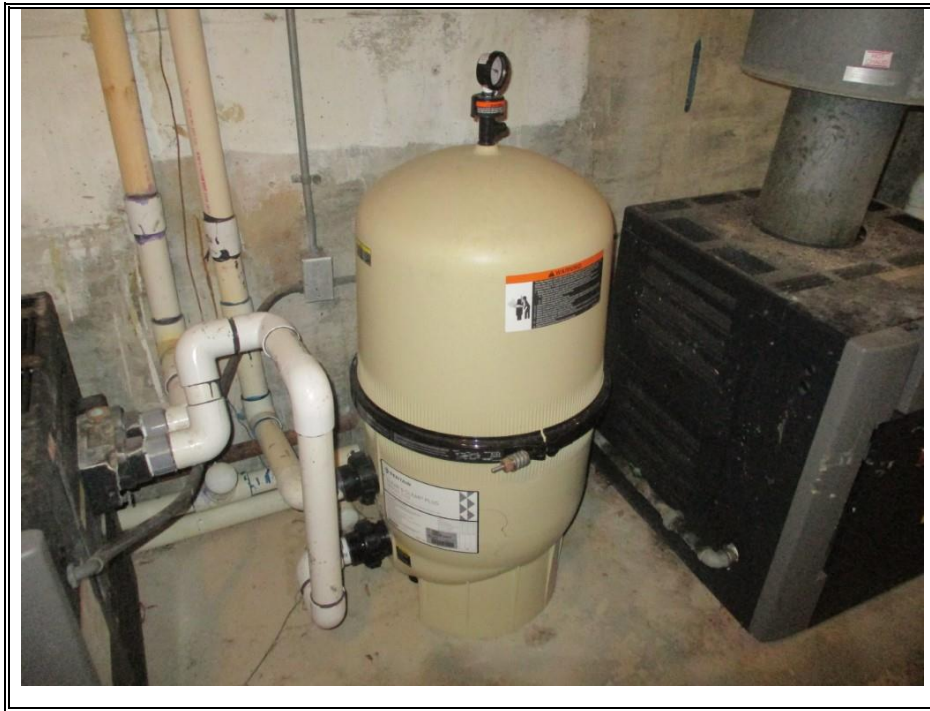
FILTERS (TYPICAL)

OBSERVATIONS: *This component includes the "Pentair" diatomaceous earth filters for the pool and spa. They appeared to be in varying conditions and for reporting purposes the remaining lives have been averaged.*

TO PROTECT YOUR INVESTMENT: *The filters should be regularly cleaned and the media re-charged or replaced (back-washed).*

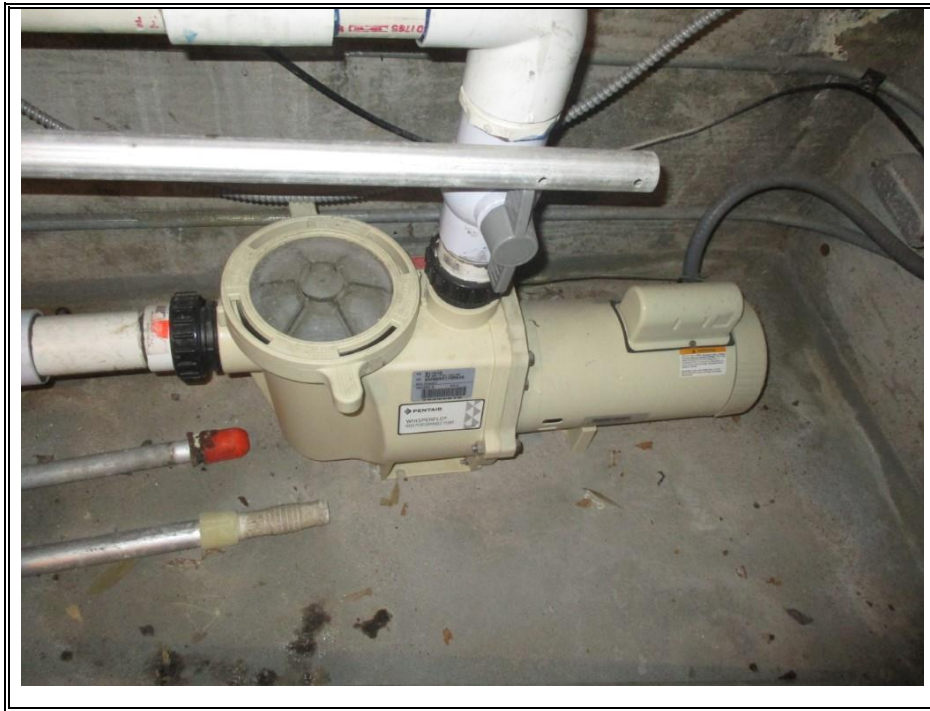
MOTORS (TYPICAL)

OBSERVATIONS: *This component includes the "A. O. Smith" motors for the pool and spa, comprised of 1 at 1 horsepower and 2 at 2 horsepower. They appeared to be in average condition.*

TO PROTECT YOUR INVESTMENT: *The motors should be regularly examined, lubricated and serviced as necessary.*

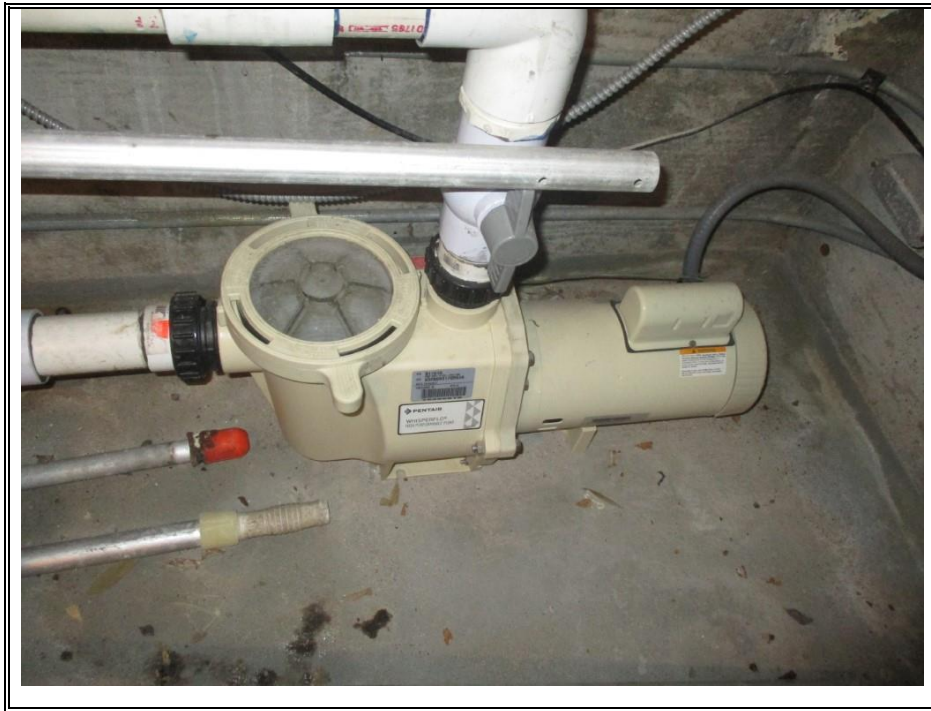
PUMPS (TYPICAL)

OBSERVATIONS: *This component includes the “Whisper Flo” and “Stealth” pumps for the pool and spa, comprised of 1 at 1 horsepower and 2 at 2 horsepower. They appeared to be of varying ages and conditions and, for reporting purposes their remaining lives have been averaged.*

TO PROTECT YOUR INVESTMENT: *The pumps should be regularly examined, lubricated and serviced as necessary.*

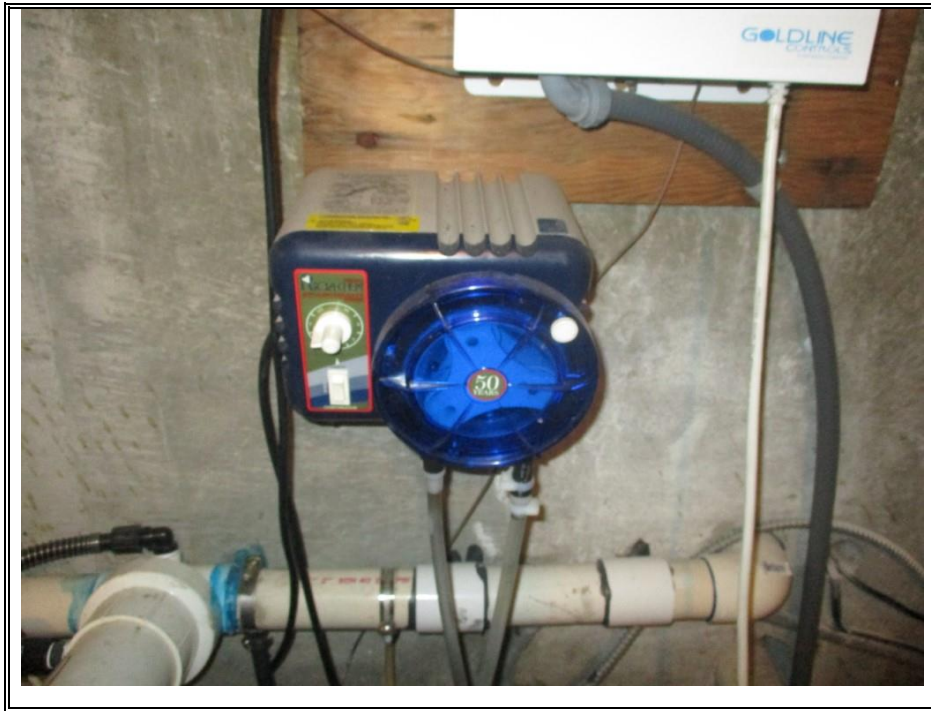
CHLORINATORS (TYPICAL)

OBSERVATIONS: *This component includes the liquid chlorinators, which add chlorine to the pool and spa water. It is recommended that any repairs / replacement be funded from the operating account on an as-needed basis.*

TO PROTECT YOUR INVESTMENT: *Little by way of maintenance can be performed for this component.*

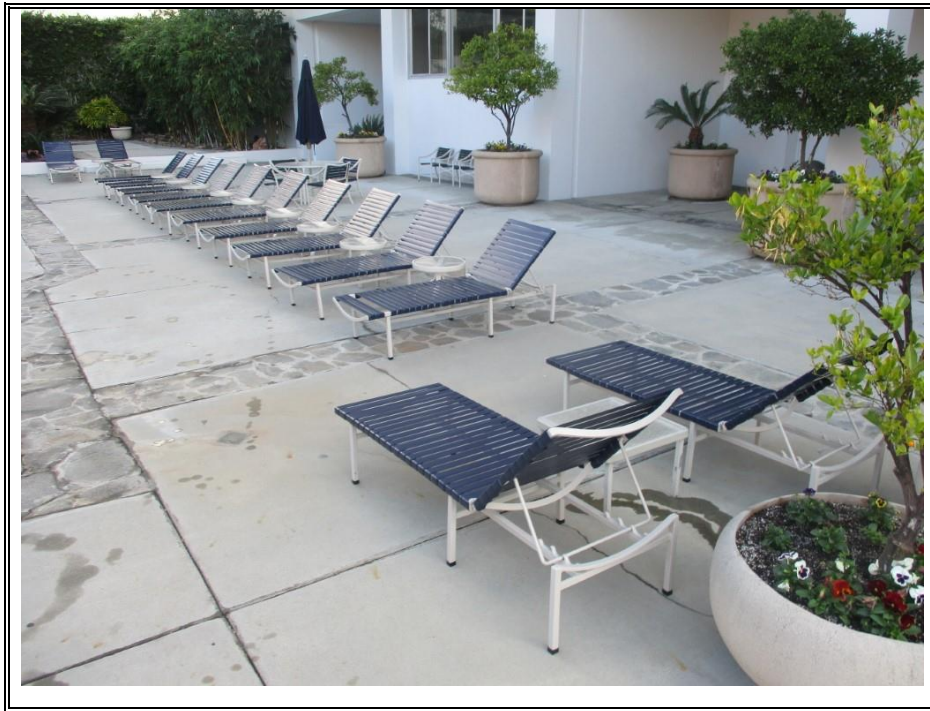
FURNITURE-REPLACE (TYPICAL)

OBSERVATIONS: This component provides for the replacement of the furniture around the pool and spa, comprised of tables, vinyl strapped chairs, vinyl strapped chaises, and umbrellas. We were previously informed that the pool furniture was installed in 2015 and it appeared to be in good condition for its age. Exposure to dirt, dust, suntan oils, tree sap, pool chemicals, insecticide sprays, and environmental factors (especially ultraviolet light); contribute significantly to the deterioration of this type of furniture. Proper maintenance can significantly enhance its longevity.

TO PROTECT YOUR INVESTMENT: Vinyl strapped furniture should be hosed down on a weekly basis and a vinyl protection product applied regularly (cleansers, undiluted bleach, scouring agents, solvents, and gasoline should never be used). The painted metal frames should occasionally be cleaned with a mild soap and water solution, and an automotive wax applied seasonally. Acrylic/plastic tabletops can be protected / restored with automotive wax as well. Umbrella fabrics can be cleaned with a solution of 1cup of bleach mixed with 1cup of dish detergent in 3 gallons of water. Corrosion on aluminum umbrella poles can be removed with an aluminum brightener. If possible, the furniture should be covered/put in storage when not in use (especially during off-season).

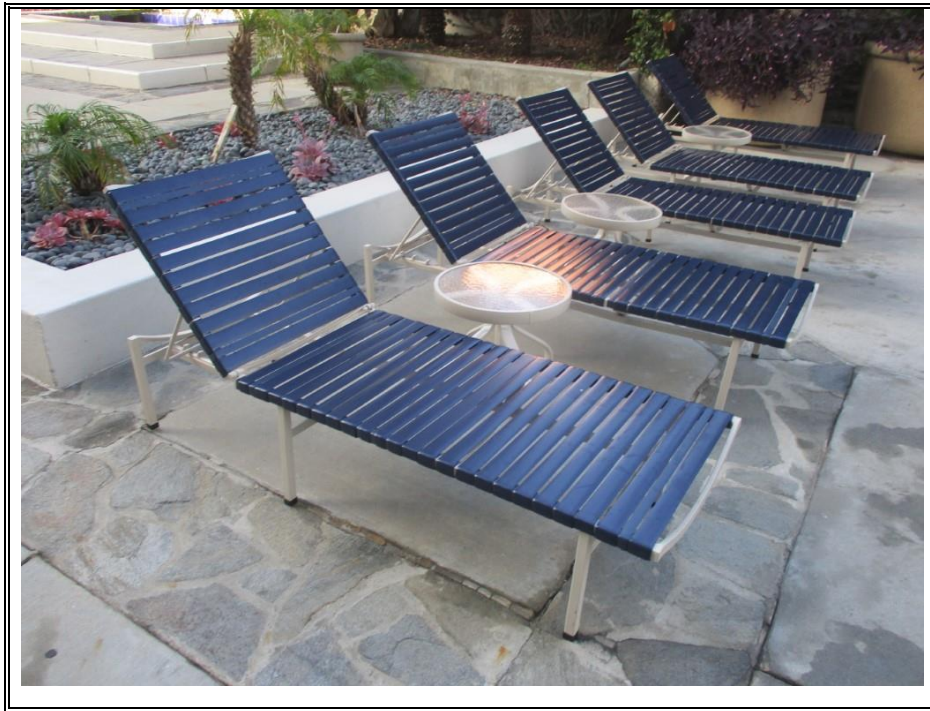
FURNITURE-REFURBISH (TYPICAL)

OBSERVATIONS: *This component provides for the refurbishment of the furniture identified in component ID #0810. As this furniture is of an average quality, it would lend itself towards refurbishment, usually at 5-year intervals, prior to complete replacement becoming necessary.*

TO PROTECT YOUR INVESTMENT: *Vinyl strapped furniture should be hosed down on a weekly basis and a vinyl protection product applied regularly (cleansers, undiluted bleach, scouring agents, solvents, and gasoline should never be used). The painted metal frames should occasionally be cleaned with a mild soap and water solution, and an automotive wax applied seasonally. Acrylic/plastic tabletops can be protected / restored with automotive wax as well. Umbrella fabrics can be cleaned with a solution of 1cup of bleach mixed with 1cup of dish detergent in 3 gallons of water. Corrosion on aluminum umbrella poles can be removed with an aluminum brightener. If possible, the furniture should be covered/put in storage when not in use (especially during off-season).*

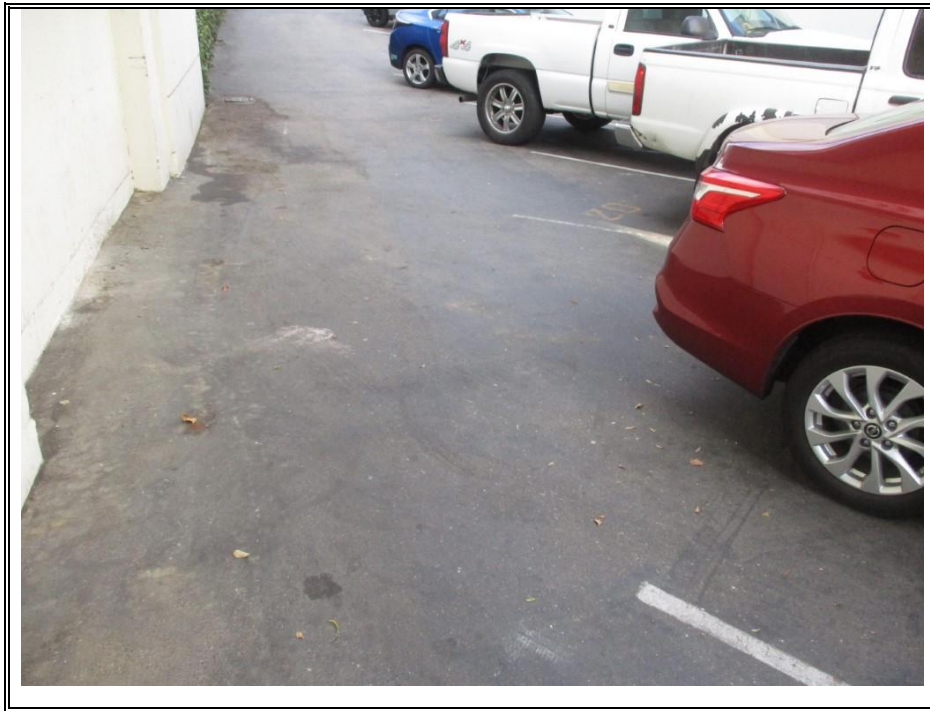
ASPHALT SEAL COAT (TYPICAL)

OBSERVATIONS: *This component includes the seal coat for the asphalt parking area at the east end of the property. We were previously informed that it was applied in 2012 and it appeared to be in aging condition. While a relatively inexpensive procedure, the seal coat serves to enhance the longevity of the underlying asphalt as well as its appearance by replenishing the oil and fine aggregates of the underlying asphalt. It is important that this procedure always be undertaken within 6 months of any overlay or resurfacing and performed thereafter on a 3 – 5 year cycle (typically a warranty requirement). See component ID #0902 for further comments.*

TO PROTECT YOUR INVESTMENT: *All asphalt areas should be examined at least annually and any cracks exceeding ¼ inch should be repaired with a rubberized sealant compound. Irrigation run-off can accelerate degradation and should be prevented / diverted.*
