RESERVE STUDY - FEBRUARY 1, 2020

High Rise Homeowners Association (Sample Only)
3525 Main Street
Los Angeles, California

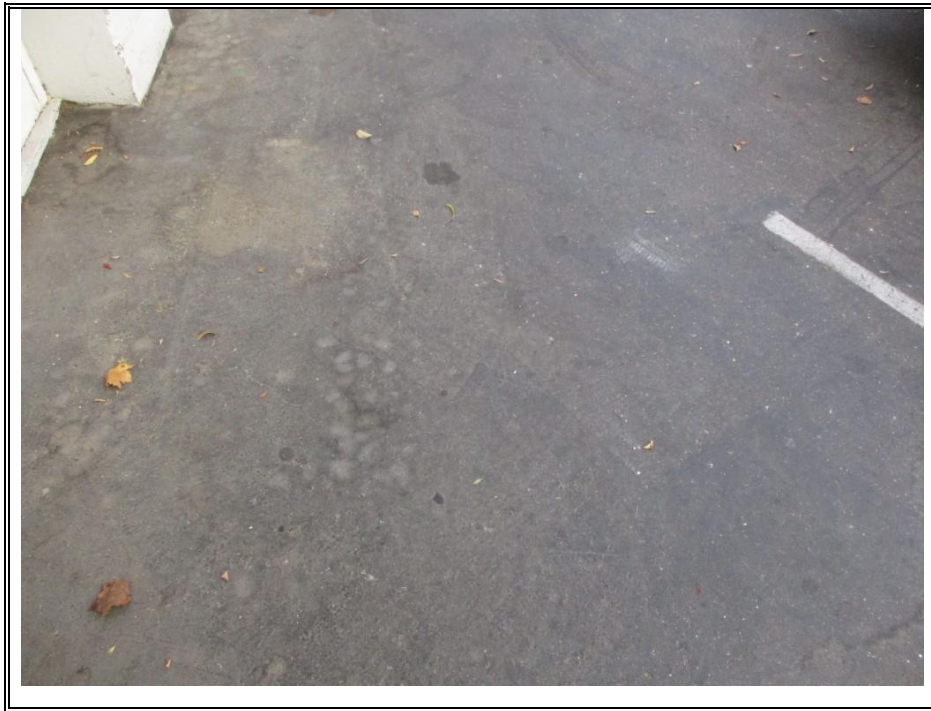
ASPHALT REPLACEMENT (TYPICAL)

OBSERVATIONS: *This component provides for replacement of the asphalt surfaces described in component ID #0901. We were previously informed they were replaced in 2012 and they appeared to be in good to average condition. Aging, oxidation, and vehicle traffic eventually cause cracking, ponding and uneven pavement. Such surface irregularities may result in improper drainage and compromised driving surfaces. Asphalt replacement entails removal of the existing pavement, grading and compaction of the existing aggregate base material, and the installation of hot asphalt pavement. It is recommended that pavement engineering be obtained prior to replacement in order to guarantee that new pavement specifications will meet or exceed the needs of the common area pavement. In conjunction with replacement, seal coat should be performed within 6 months and then at 3 – 5 year intervals thereafter (see component ID #0901). It is recommended that prior to replacement, further evaluation be obtained from a soils/geotechnical engineer.*

TO PROTECT YOUR INVESTMENT: *All asphalt areas should be examined at least annually and any cracks exceeding ¼ inch should be repaired with a rubberized sealant compound. Irrigation run-off can accelerate degradation and should be prevented / diverted.*

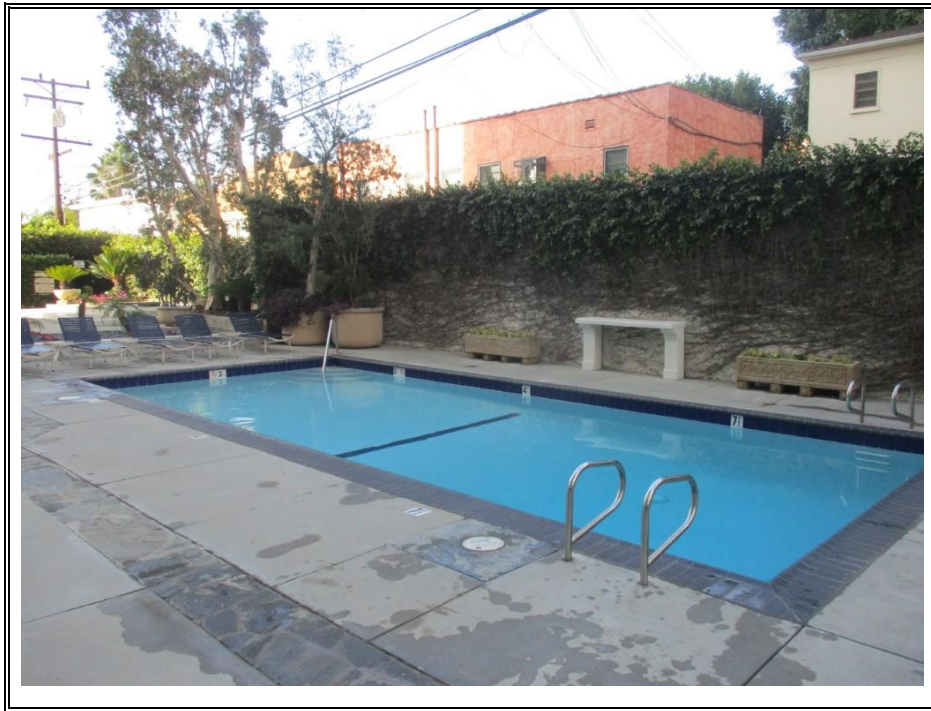
CONCRETE FLATWORK/BLOCK WALLS (TYPICAL)

OBSERVATIONS: *This component includes the concrete flatwork and block walls throughout the property. Although they appeared to be in average condition, they should be regularly monitored for cracking and vertical displacement, which can create potential trip hazards (and liability for the association). Otherwise, concrete areas are generally considered a lifetime component and therefore no amount has been budgeted replacement. Occasional repairs would typically be funded from the operating account.*

TO PROTECT YOUR INVESTMENT: *Any sections observed to be vertically displaced should be repaired immediately upon discovery. Emphasis should be placed on areas adjacent to trees, as their roots are often the culprits of such damage. As the need for such repairs is difficult to predict, the associated costs should be disbursed either from the association's operating account or the contingency reserve (see "Component Replacement Schedule" in the Reserve Funding section of this report as well as the Glossary for more on the contingency reserve).*

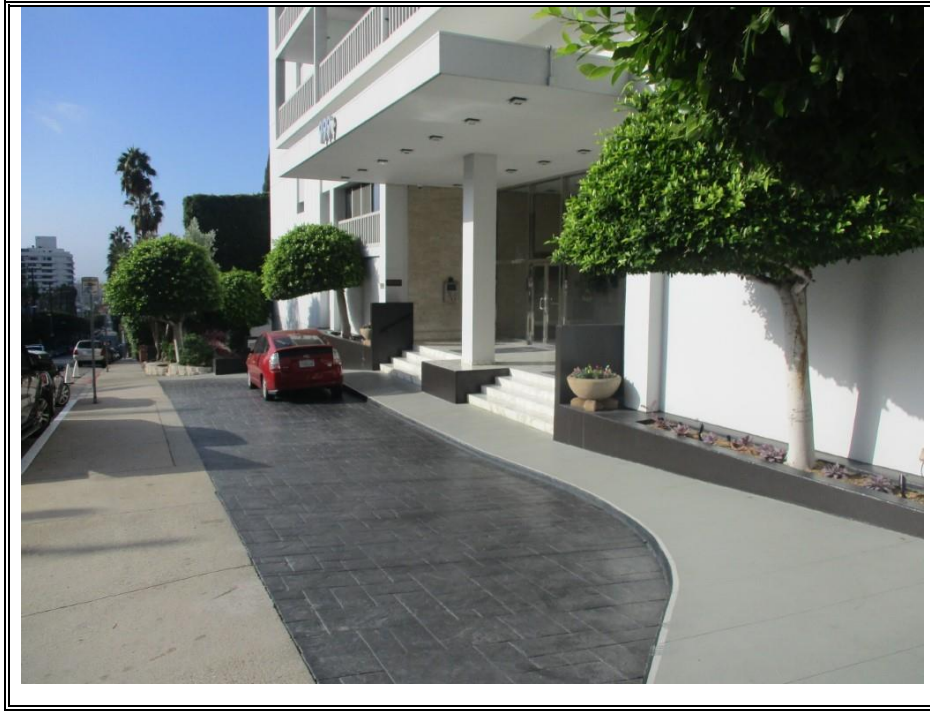
CONCRETE PAVERS VALET PARKING (TYPICAL)

OBSERVATIONS: *This component includes the concrete pavers at the valet parking area at the front of the building. We were previously informed that they were installed in 2012, and they appeared to be in good condition.*

TO PROTECT YOUR INVESTMENT: *Little by way of maintenance can be performed for this component.*

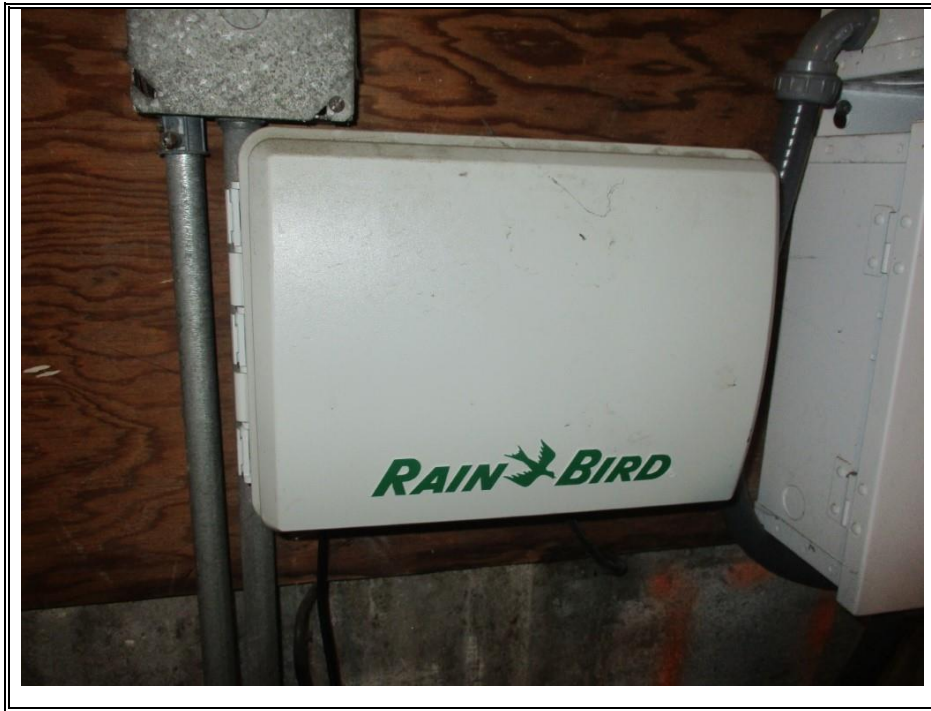
IRRIGATION CONTROLLERS (TYPICAL)

OBSERVATIONS: *This component includes the irrigation controllers at the pool equipment area and in the maintenance closet. We were previously informed that they were installed in 2014 and they appeared to be in average condition. They tend to have a more predictable life expectancy, and the average component cost provides for their replacement. However, average life expectancies cannot be predicted for the other sprinkler components or automatic valve actuation systems. Repairs / replacements of such systems usually occur on an ongoing basis and should be covered under the operating account.*

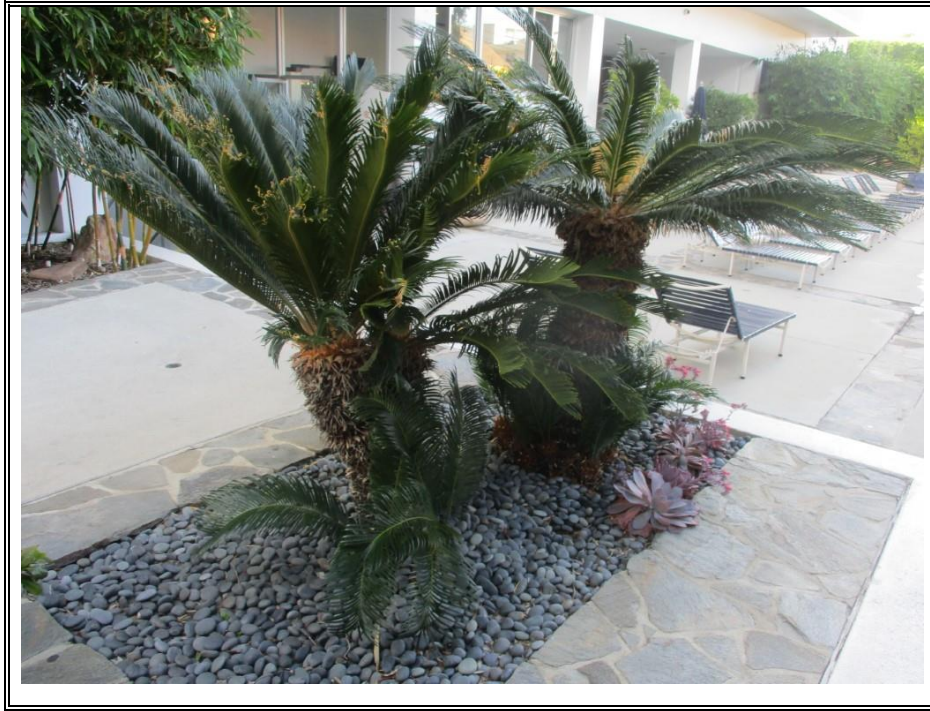
LANDSCAPE REMODEL (TYPICAL)

OBSERVATIONS: *This component provides an allowance for landscape remodeling. We were previously informed it was performed in 2015. It is recommended that the amount be periodically reviewed for adequacy.*

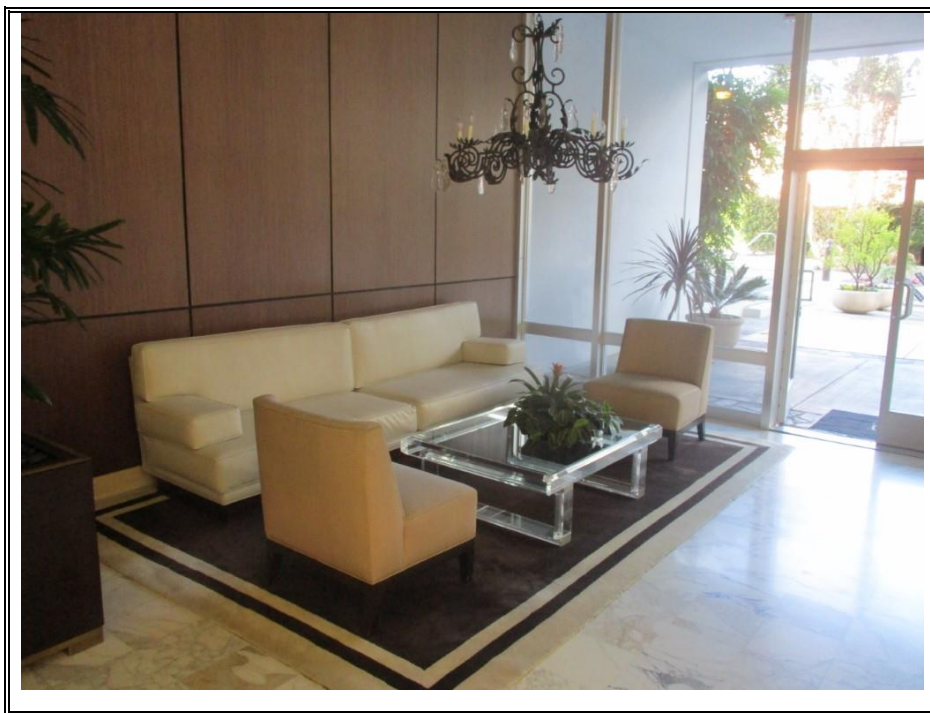
FURNISHINGS-LOBBY (TYPICAL)

OBSERVATIONS: This component includes the furnishings in the lobby, comprised of sofas, chairs, benches, tables, wall hangings, planters, credenzas, ceiling lights, hanging lights, ash trays, and mirrors. We were previously informed the lobby was refurbished in 2006 and the furnishings appeared to be in average condition. The average component cost is general for the type of furnishings in use.

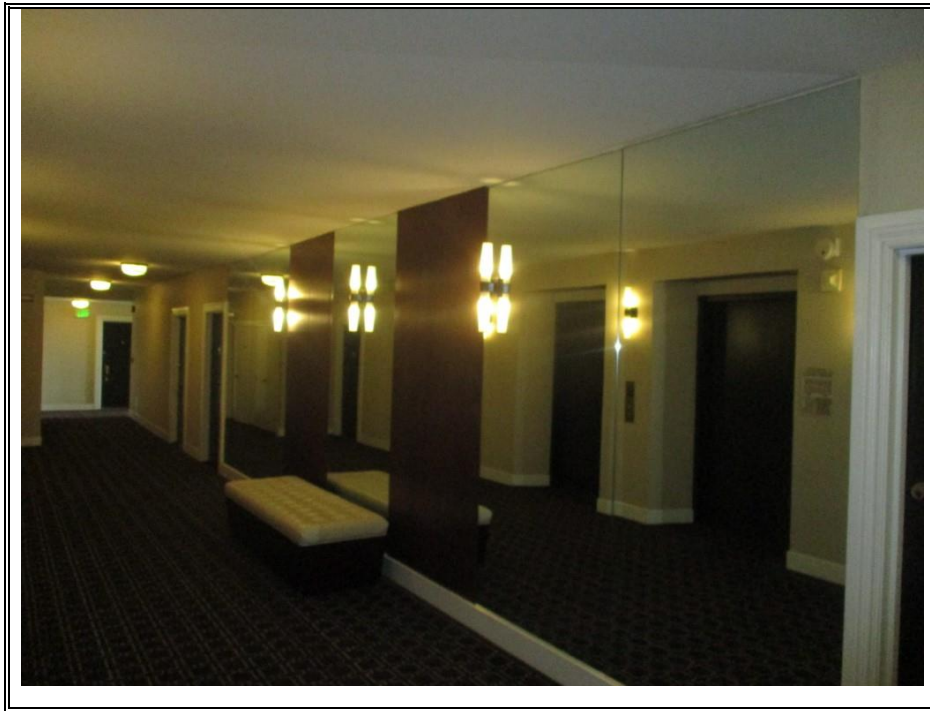
FURNISHINGS-HALLWAYS (TYPICAL)

OBSERVATIONS: *This component includes the furnishings in the hallways, comprised of wall mirrors and benches. They appeared to be in average condition for their age. The average component cost is general for the type of furnishings in use.*

TO PROTECT YOUR INVESTMENT: *General cleaning should be performed on a regular basis. Wood surfaces should be cleaned with a standard furniture polish. Upholstered areas should be vacuumed periodically and cleaned as necessary with a mild soap solution or professionally steam cleaned simultaneously with carpeted areas.*

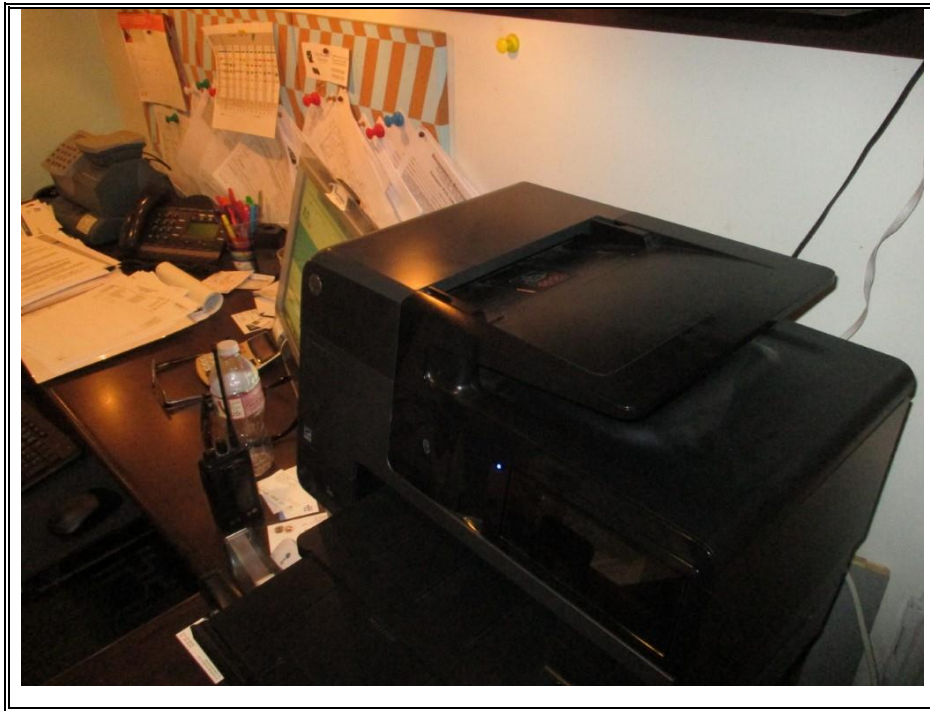
FURNISHINGS-OFFICE (TYPICAL)

OBSERVATIONS: *This component includes the office equipment in the manager's office; comprised of built-in cabinets, a wood filing cabinet, a wood book cabinet, a computer, a monitor, a copier/scanner/fax/printer, a small desk, and a desk chair. They appeared to be in average condition for their age. The average component cost is general for the type of equipment in use.*

TO PROTECT YOUR INVESTMENT: *Maintenance should be performed according to the various manufacturer's specifications (refer to the respective operating manuals for same).*

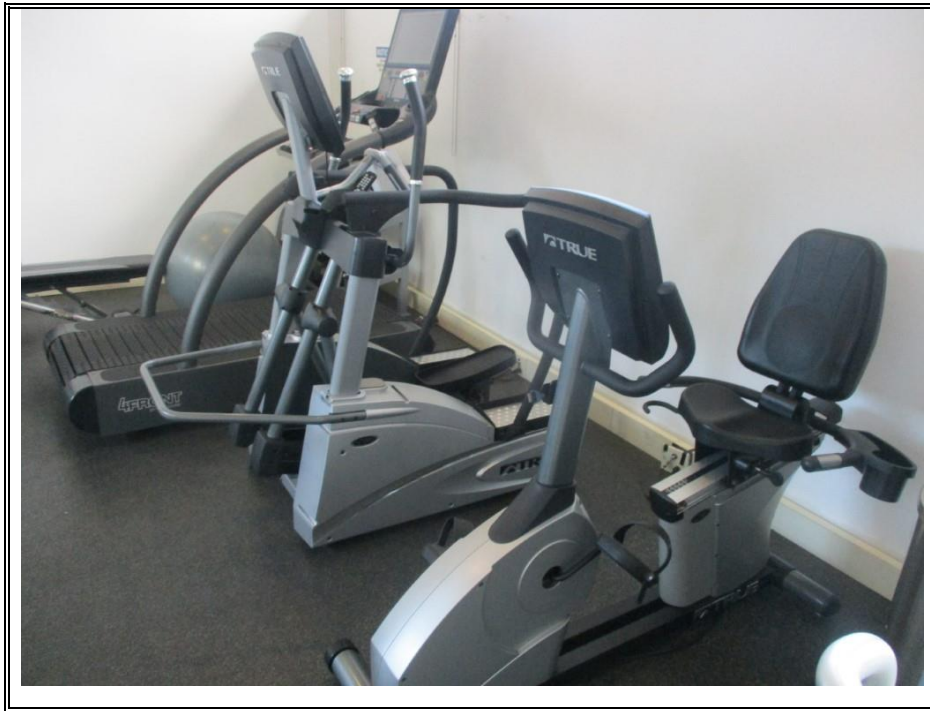
FITNESS EQUIPMENT (TYPICAL)

OBSERVATIONS: *This component includes the fitness equipment in the gym, comprised of a treadmill, an elliptical machine, a lifecycle, weight machines/benches, a newer rack with dumbbells, a resistance tower, a mirror, window treatments, a television and a fan. They appeared to be of varying ages and conditions and, for reporting purposes their remaining lives have been averaged. Some of the equipment would most likely be replaced while other items may lend themselves to being refurbished. The average component cost is general for this type of equipment.*

TO PROTECT YOUR INVESTMENT: *The equipment should be maintained in a sanitary condition. Applicable instructions as well as warnings should be posted with respect to proper use of the equipment.*

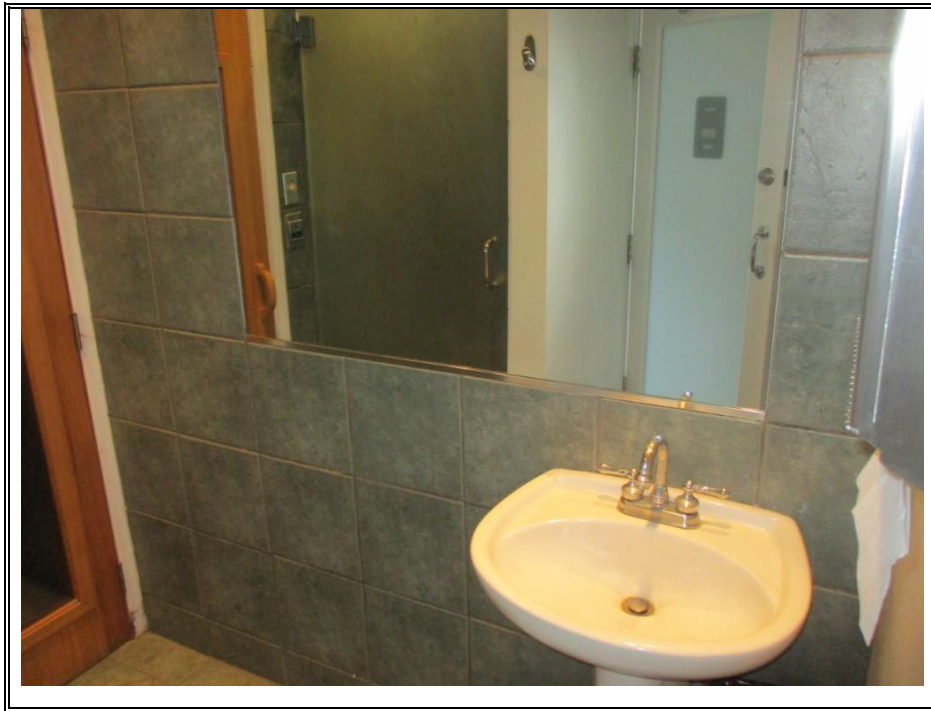
RESTROOMS (TYPICAL)

OBSERVATIONS: *This component includes the remodeling of the common area restrooms, comprised of sinks, toilets, partitions, mirrors, showers, towel dispensers, soap dispensers, and wall and floor tile. They appeared to be in average condition.*

TO PROTECT YOUR INVESTMENT: *The restroom should be maintained in a sanitized condition.*

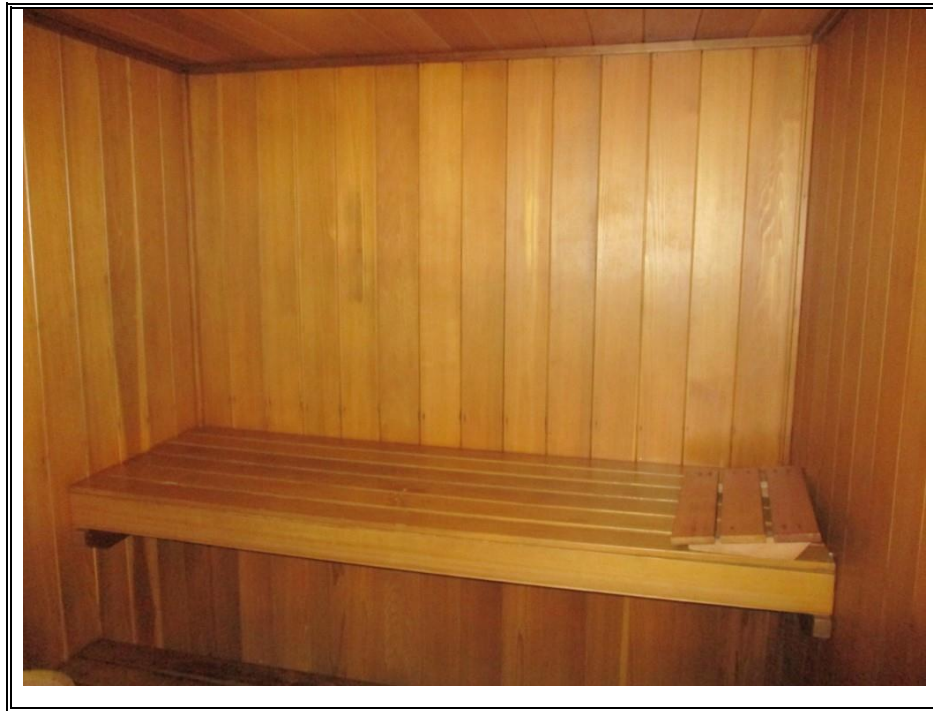
SAUNAS-REFINISH (TYPICAL)

OBSERVATIONS: *This component includes the refinishing of the 2 wooden sauna enclosures at the pool area restrooms. They appeared to be in average condition. Longevity of this component is a function of level of usage and refinishing is recommended for aesthetic as well as hygienic reasons.*

TO PROTECT YOUR INVESTMENT: *Maintenance of the sauna enclosure entails periodically sealing with a preservative, dependent upon level of use.*

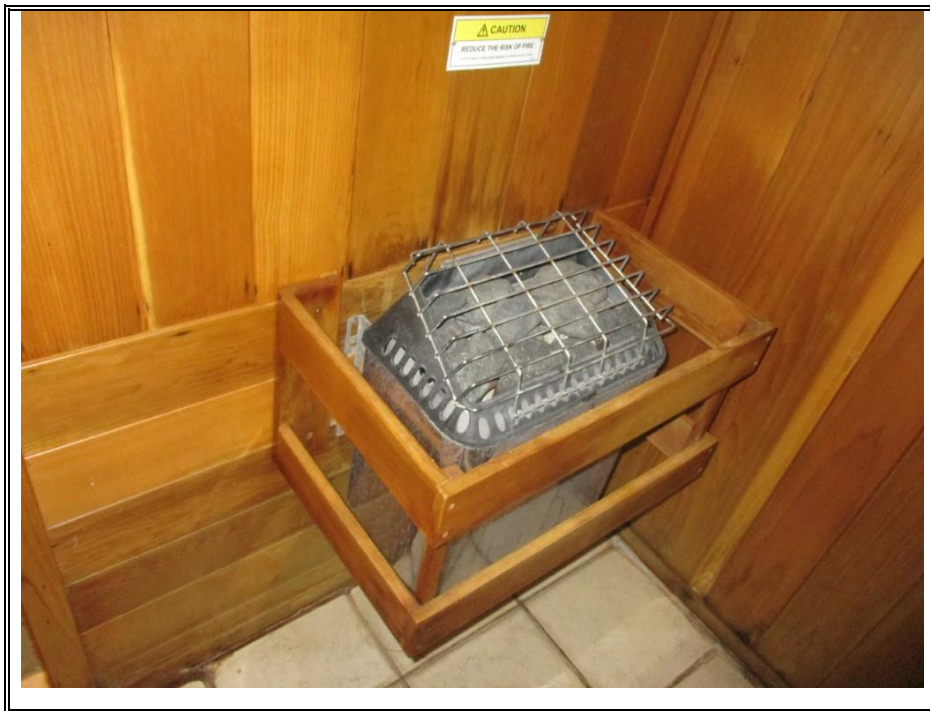
SAUNAS-HEATERS (TYPICAL)

OBSERVATIONS: *This component includes the electric sauna heaters, at 8 kilowatts each. They appeared to be in average condition. Frequency and sporadic usage are factors affecting the longevity of this component.*

TO PROTECT YOUR INVESTMENT: *Little by way of maintenance can be performed for the sauna heater.*

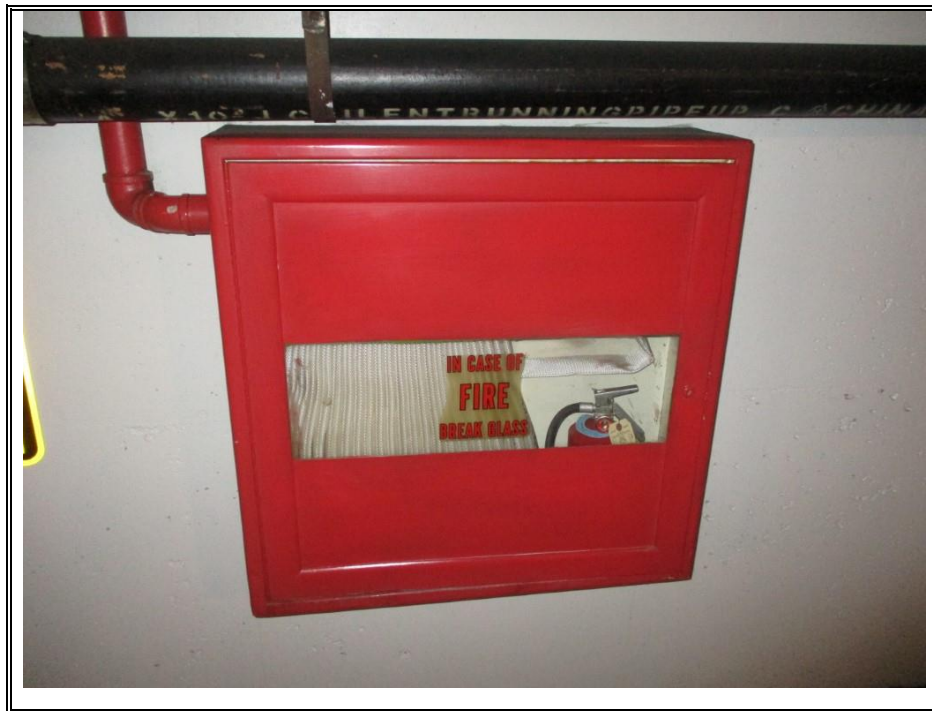
FIRE EXTINGUISHERS (TYPICAL)

OBSERVATIONS: *This component includes the fire extinguishers throughout the property. It was noted they were last serviced on 07/25/2018 and they appeared to be in good to average condition.*

TO PROTECT YOUR INVESTMENT: *The extinguishers should be inspected and re-charged by a State Fire Marshall approved company at a maximum of 1-year intervals (or as required by law).*

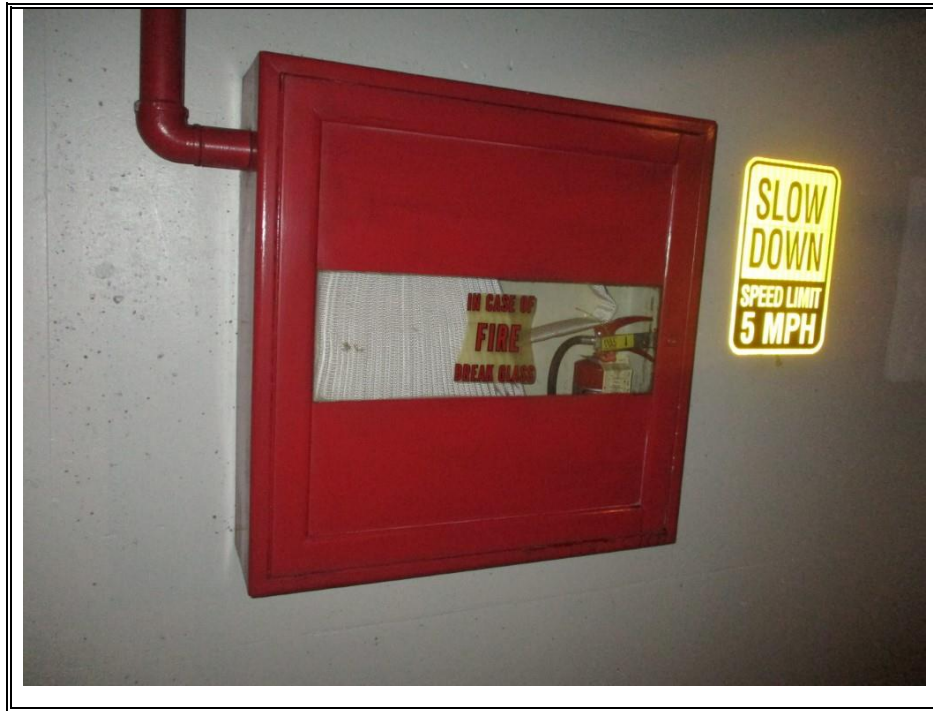
FIREHOSES (TYPICAL)

OBSERVATIONS: *This component includes the fire hoses throughout the property. They appeared to be in varying condition and, for reporting purposes their remaining lives have been averaged. The average component cost provides for replacement of only the hoses and nozzles.*

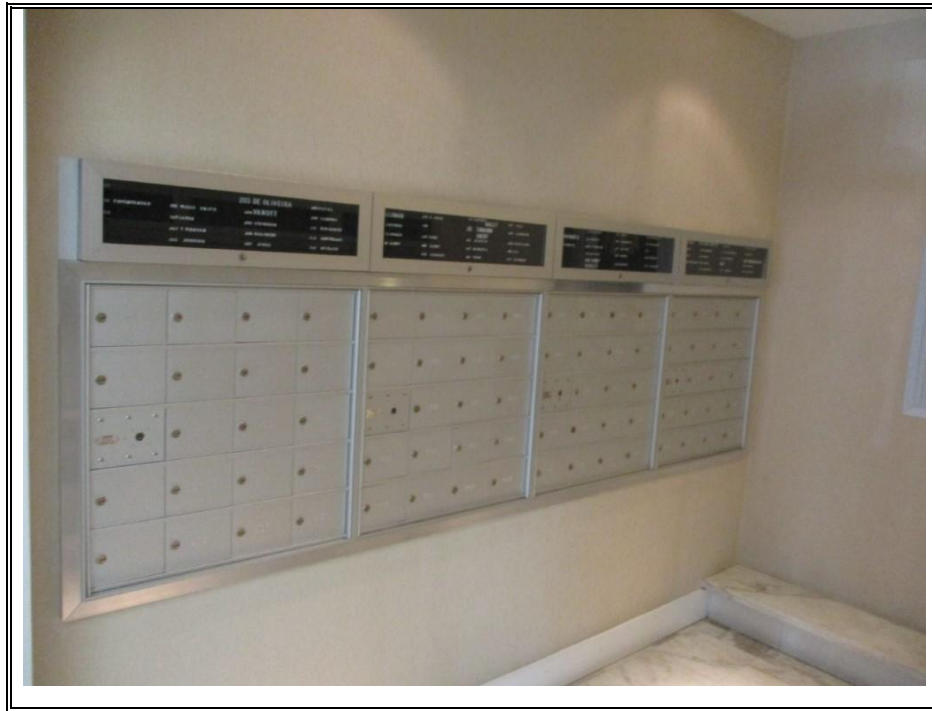
MAILBOXES (TYPICAL)

OBSERVATIONS: *This component includes the clusters of individual mailboxes at the mailbox center in the main lobby. We were previously informed that they were installed in 2013 and they appeared to be in good condition.*

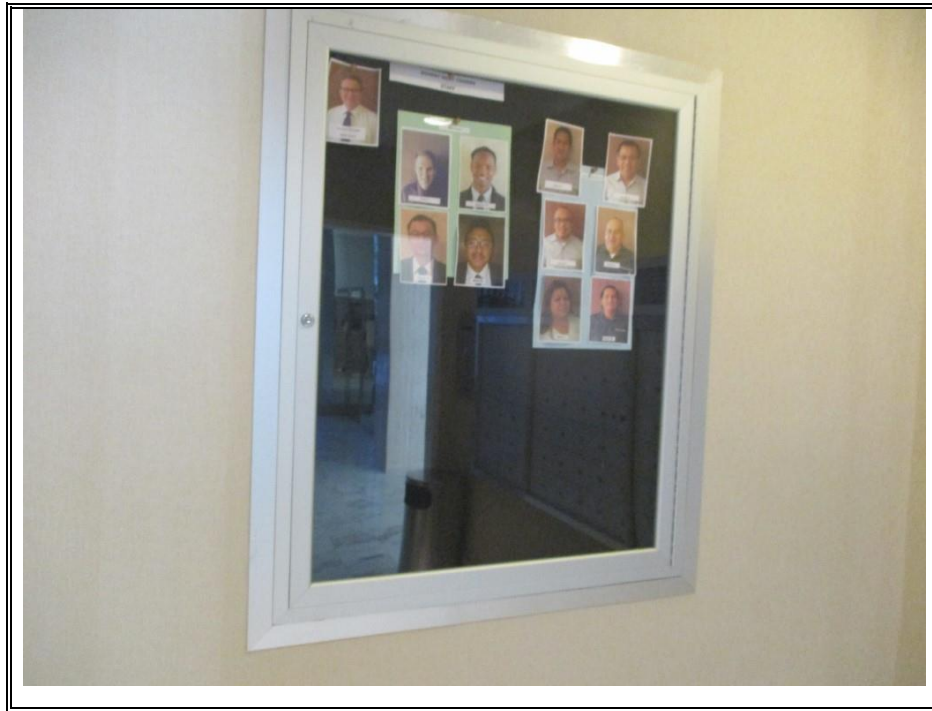
DIRECTORY BOARDS (TYPICAL)

OBSERVATIONS: *This component includes 6 medium size and 1 large size glass faced aluminum case directory boards, at the mailbox center in the main lobby. We were previously informed that they were installed in 2013 and they appeared to be in good condition.*

TO PROTECT YOUR INVESTMENT: *Little can be performed by way of maintenance for this type of component.*

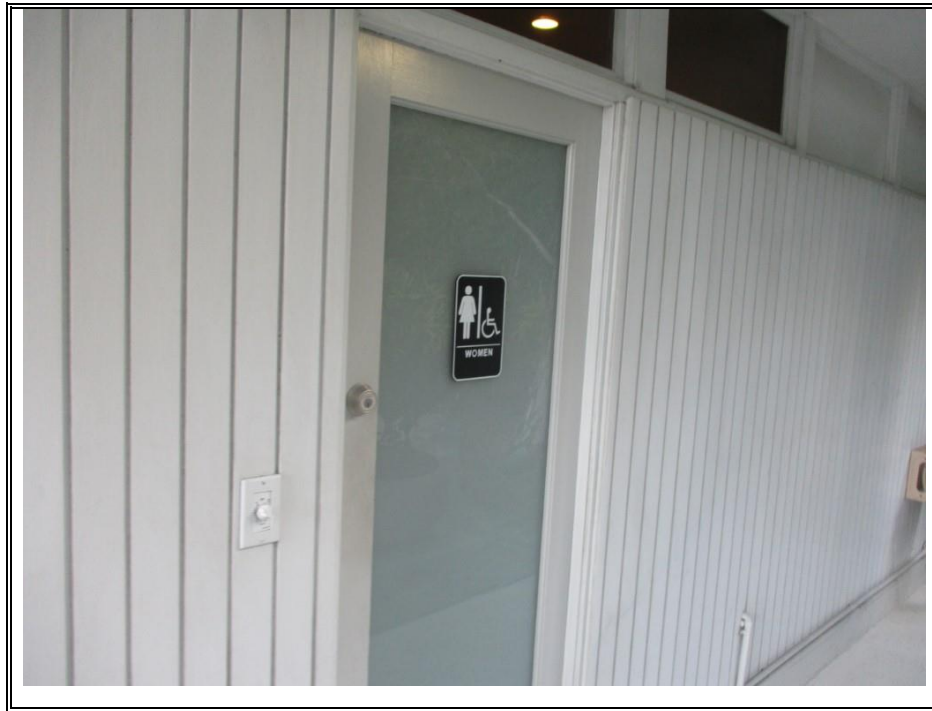
SIGNS (TYPICAL)

OBSERVATIONS: *This component includes the plastic signs throughout the property. They appeared to be in average condition. It is recommended that replacement be done on an as-needed basis and funded from the operating account.*

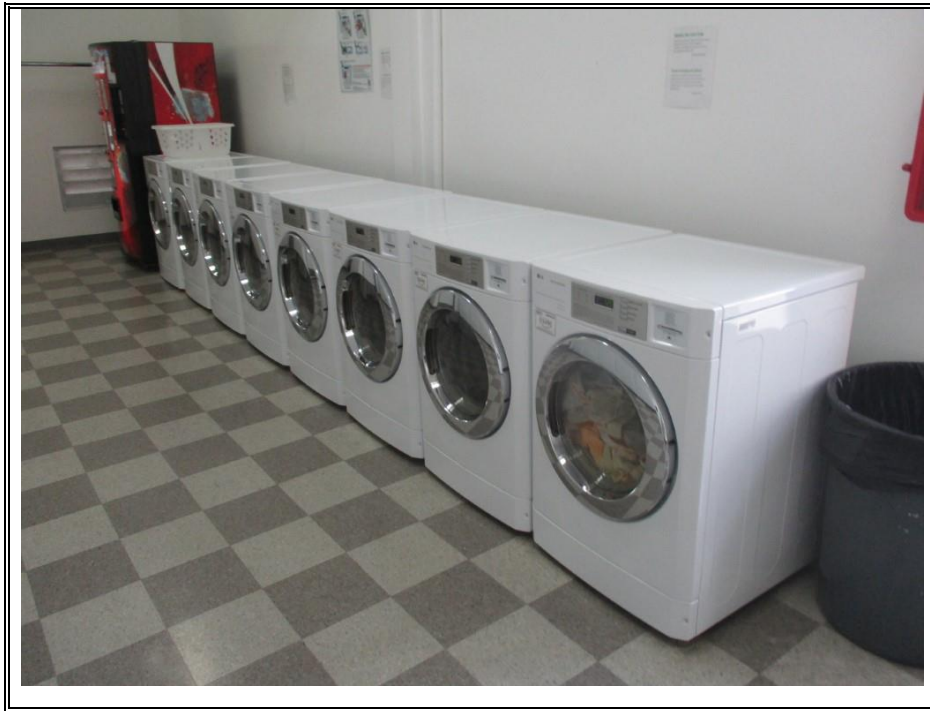
LAUNDRY EQUIPMENT (TYPICAL)

OBSERVATIONS: *This component includes the coin operated washers and dryers in the laundry rooms of the apartment buildings. We were informed they are leased.*
