RESERVE STUDY - MARCH 9, 2023

High Rise Homeowners Association (Sample Only)  
3525 Main Street  
Los Angeles, California

# TABLE OF CONTENTS

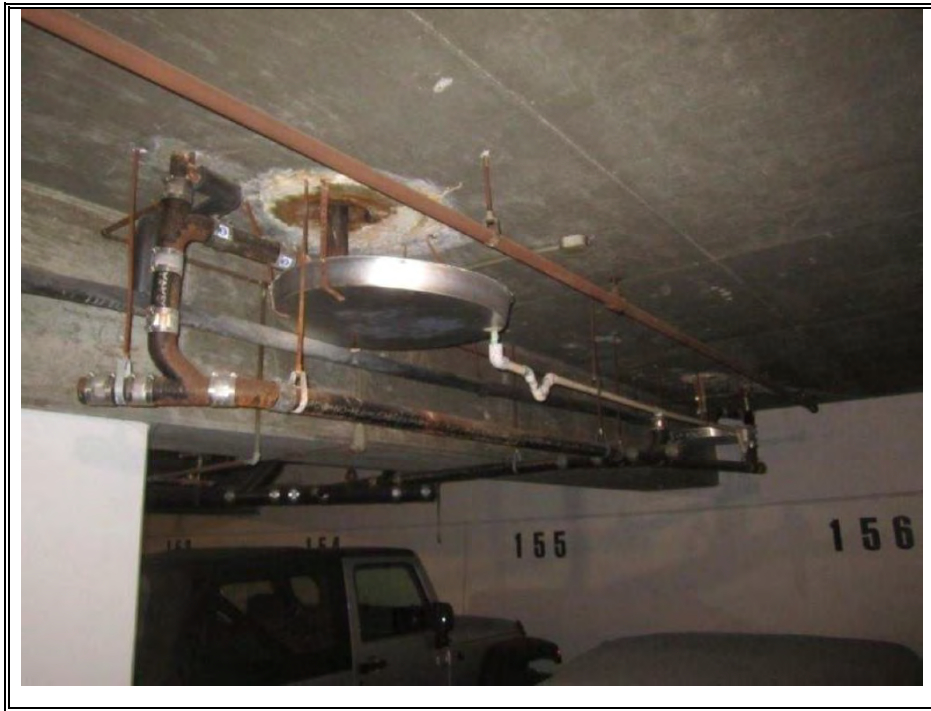
#### WATERPROOFING (TYPICAL)

**OBSERVATIONS:** *This component addresses the waterproofing of the building. The existing waterproofing appeared to be questionable, based on what was visible and evidenced by sub-grade leakage. If left unchecked, there is a likelihood that structural damage and/or mold infestation could result. Further evaluation of the drainage should be obtained from a qualified waterproofing consultant regarding this situation (See Component ID# 0508). Bids should be obtained for any corrective work deemed necessary, and adjustments can be incorporated into a future Reserve Study Update.*

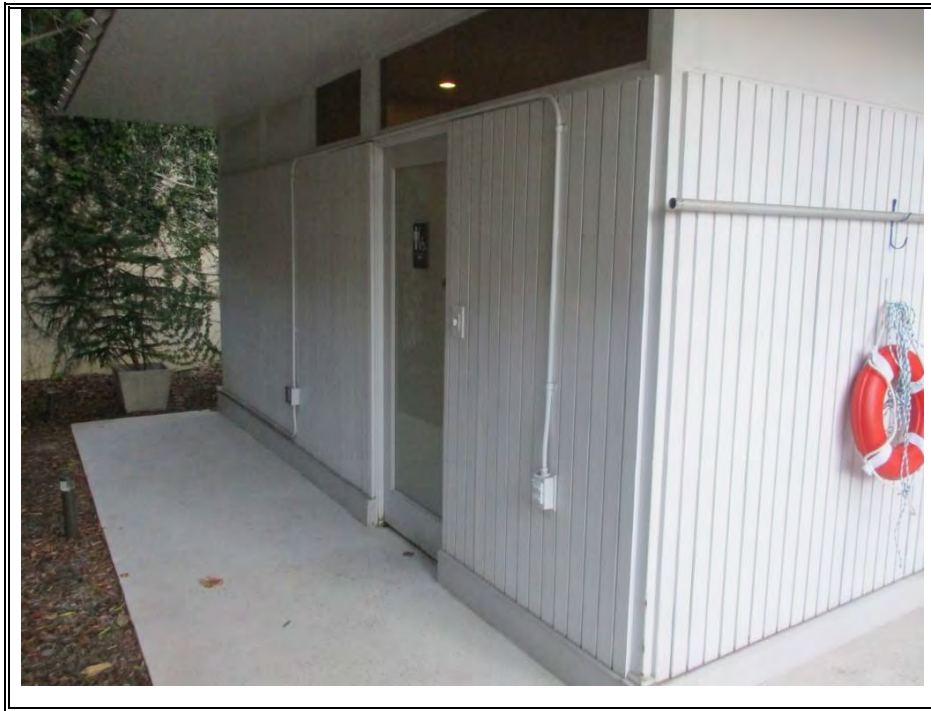
**SIDING (TYPICAL)**

**OBSERVATIONS:** *This component includes the T-11 plywood siding on the exterior of the pool restroom building. We were informed that maintenance was performed in 2017 and it generally appeared to be in average condition for its age.*

**TO PROTECT YOUR INVESTMENT:** *Maintenance of the siding is not only important from an aesthetics aspect but critical with respect to prevention of termite infestation as well. It should be regularly painted at a maximum of 4-year intervals. Regular examination for and repair of any cracks and splits should be performed as necessary. Any protruding nails should also be re-driven and sealed.*

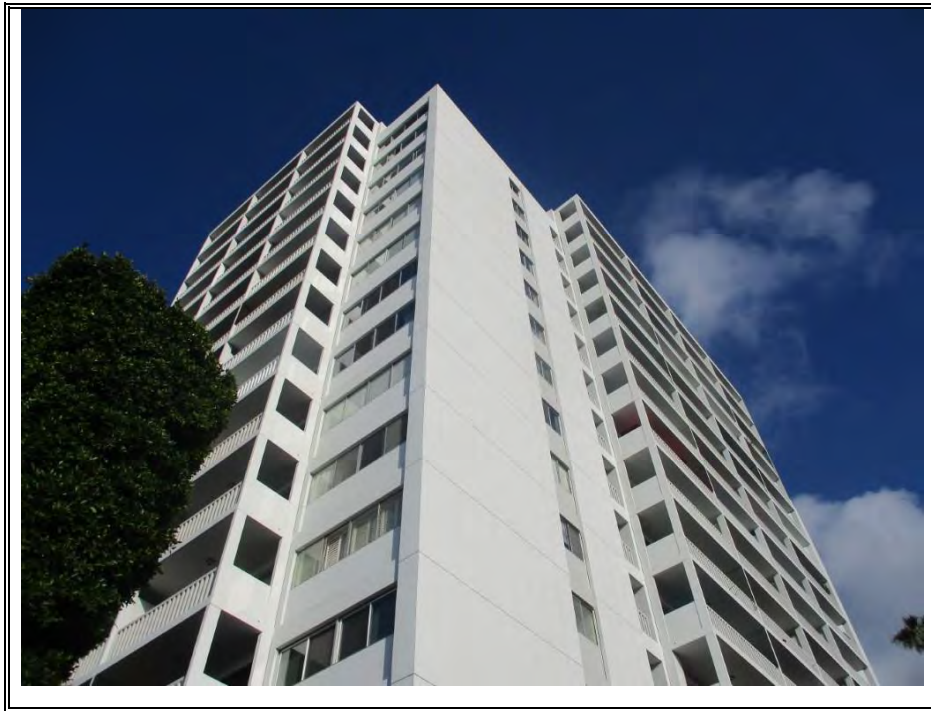
**EXTERIOR FLATWORK (TYPICAL)**

**OBSERVATIONS:** *This component includes the painted surfaces of the concrete, on the exterior of the high-rise building and on the adjacent masonry walls. We were previously informed that it was painted in 2012 and appeared to be in average condition for its age.*

**TO PROTECT YOUR INVESTMENT:** *Cleaning and periodic "touch-up" of peeling and damaged surfaces is recommended for appearance, protection of the underlying component and prevention of termite infestation. All peeling paint should be sanded / scraped and bare areas properly primed prior to any finish paint. Any splits and cracks should be sealed with appropriate materials. In addition, all openings of windows and doors should be examined prior to painting and re-caulked if required.*

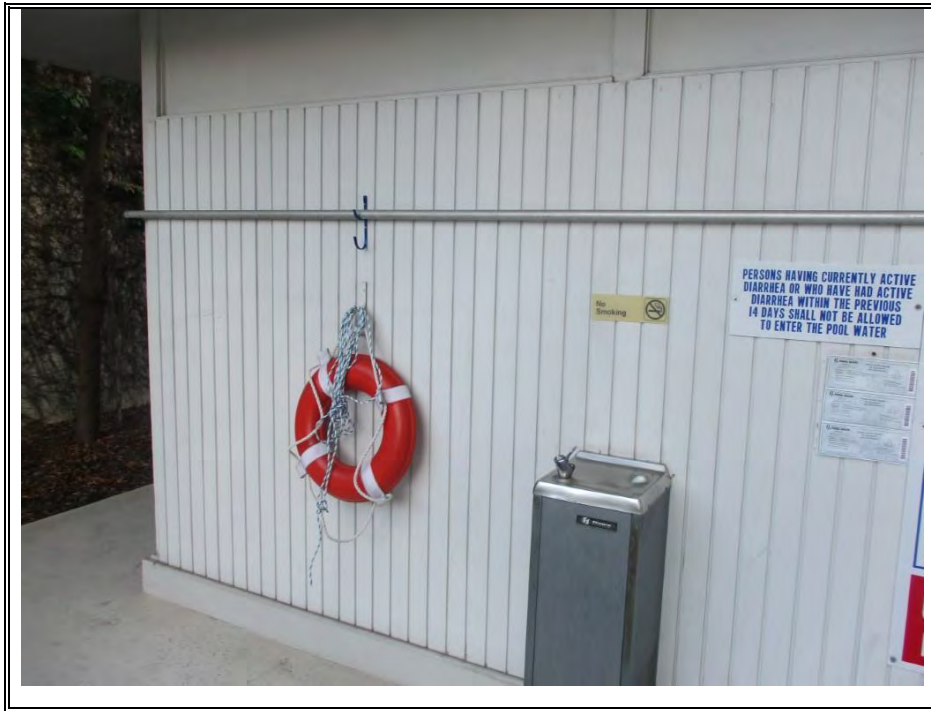
**SIDING & TRIM (TYPICAL)**

**OBSERVATIONS:** *This component includes the painted surfaces of the plywood siding at the pool restroom building, and other miscellaneous wood trim. We were informed of touch up painting in 2017 and they generally appeared to be in average condition.*

**TO PROTECT YOUR INVESTMENT:** *Cleaning and periodic "touch-up" of peeling and damaged surfaces is recommended for appearance, protection of the underlying component and prevention of termite infestation. All peeling paint should be sanded / scraped and bare areas properly primed prior to any finish paint. Any splits and cracks should be sealed with appropriate materials. In addition, all openings of windows and doors should be examined prior to painting and re-caulked if required.*

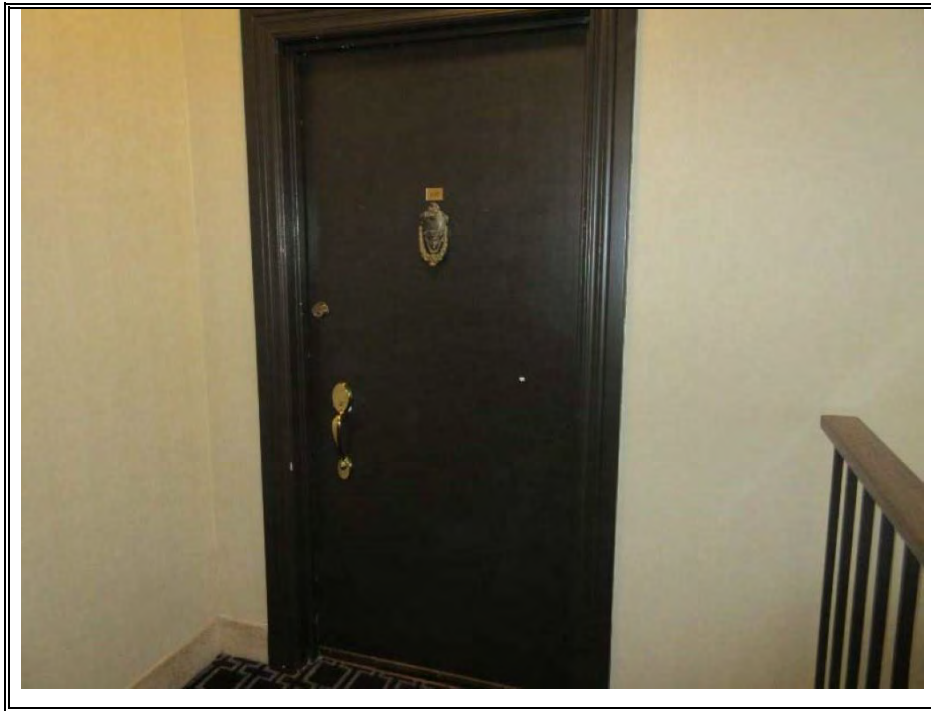
**DOORS (TYPICAL)**

**OBSERVATIONS:** *This component includes the painted surfaces of the exteriors of the individual unit doors, as well as both sides of the common area doors. We were informed of touch up painting in 2017 and they generally appeared to be in average condition.*

**TO PROTECT YOUR INVESTMENT:** *Cleaning and periodic "touch-up" of peeling and damaged surfaces is recommended for appearance, protection of the underlying component and prevention of termite infestation. All peeling paint should be sanded / scraped and bare areas properly primed prior to any finish paint. Any splits and cracks should be sealed with appropriate materials. In addition, all openings of doors should be examined prior to painting and re-caulked if required.*

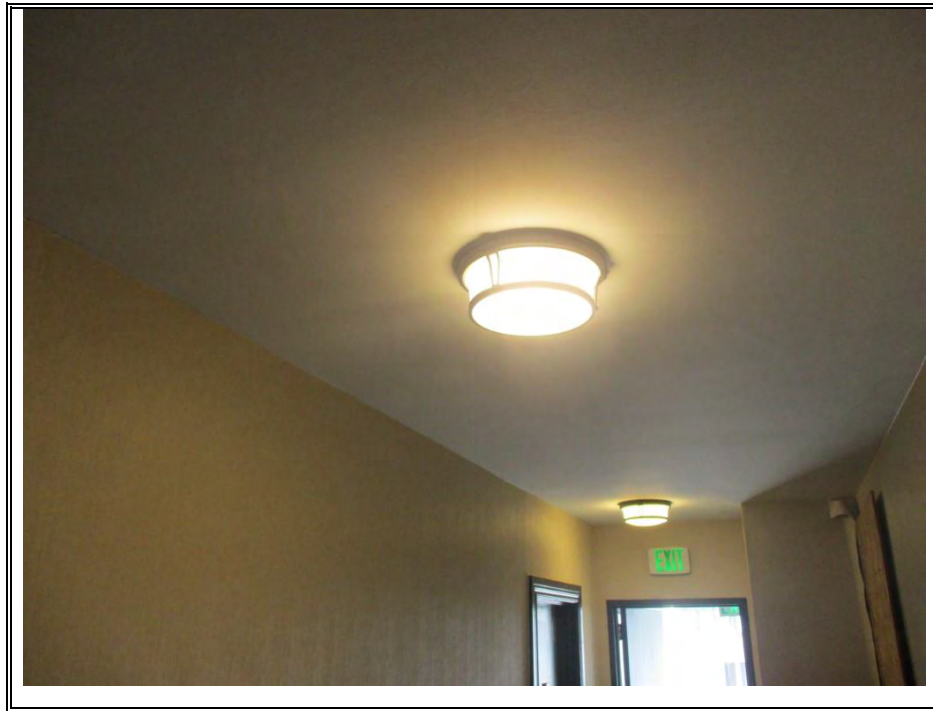
**INTERIOR FLATWORK-HALLWAY (TYPICAL)**

**OBSERVATIONS:** *This component includes the painted surfaces of the internal hallways (ceilings and trim). We were informed of touch up painting in 2017 and they generally appeared to be in average condition for their age.*

**TO PROTECT YOUR INVESTMENT:** *Cleaning and periodic "touch-up" of peeling and damaged surfaces is recommended for appearance, protection of the underlying component and prevention of termite infestation. All peeling paint should be sanded / scraped and bare areas properly primed prior to any finish paint. Any splits and cracks should be sealed with appropriate materials. In addition, all openings of windows and doors should be examined prior to painting and re-caulked if required.*

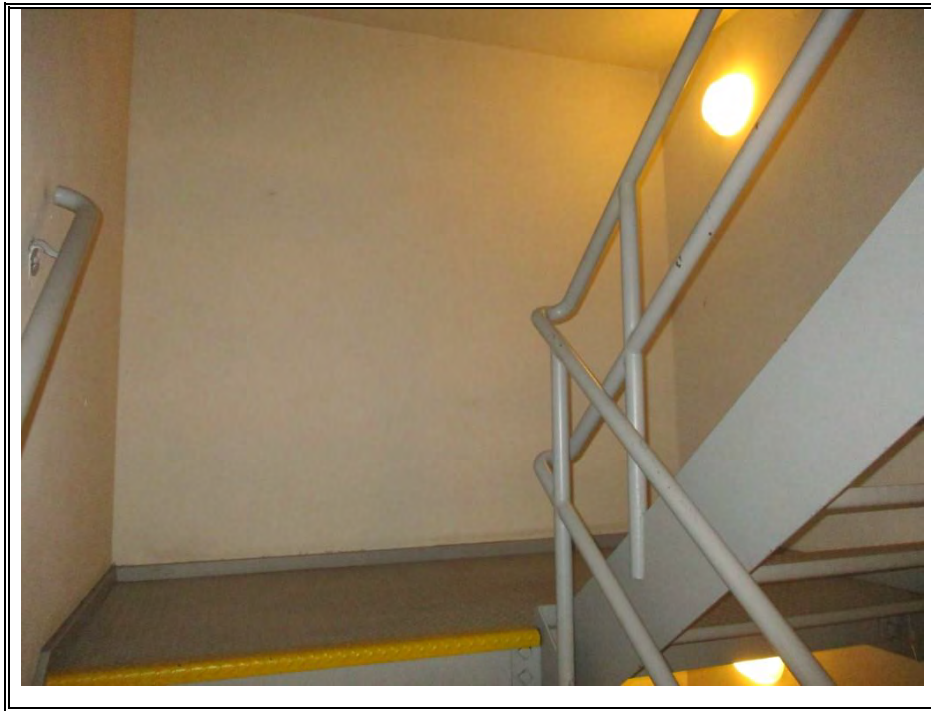
**INTERIOR FLATWORK-STAIRWELLS (TYPICAL)**

**OBSERVATIONS:** *This component includes the painted surfaces of the stairwells (walls and ceilings). We were informed of touch up painting in 2017 and they generally appeared to be in average condition for their age.*

**TO PROTECT YOUR INVESTMENT:** *Cleaning and periodic "touch-up" of peeling and damaged surfaces is recommended for appearance, protection of the underlying component and prevention of termite infestation. All peeling paint should be sanded / scraped and bare areas properly primed prior to any finish paint. Any splits and cracks should be sealed with appropriate materials. In addition, all openings of windows and doors should be examined prior to painting and re-caulked if required.*

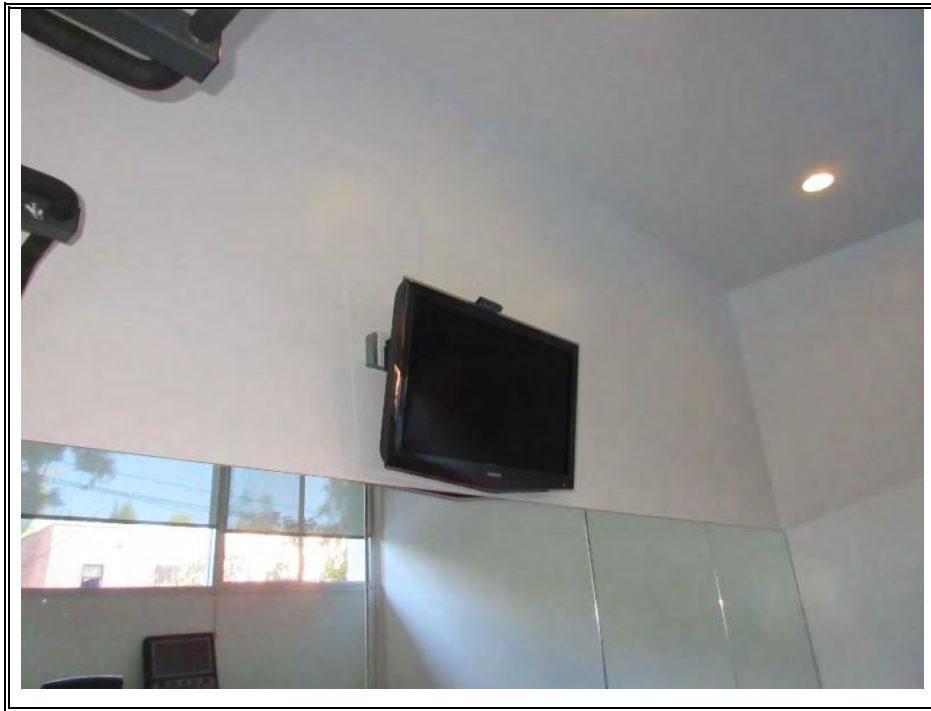
**INTERIOR FLATWORK-RECREATION (TYPICAL)**

**OBSERVATIONS:** *This component includes the painted surfaces of the gym, restrooms, lobby, office, and other miscellaneous common areas. We were informed of touch up painting in 2017 and they generally appeared to be in average condition for their age.*

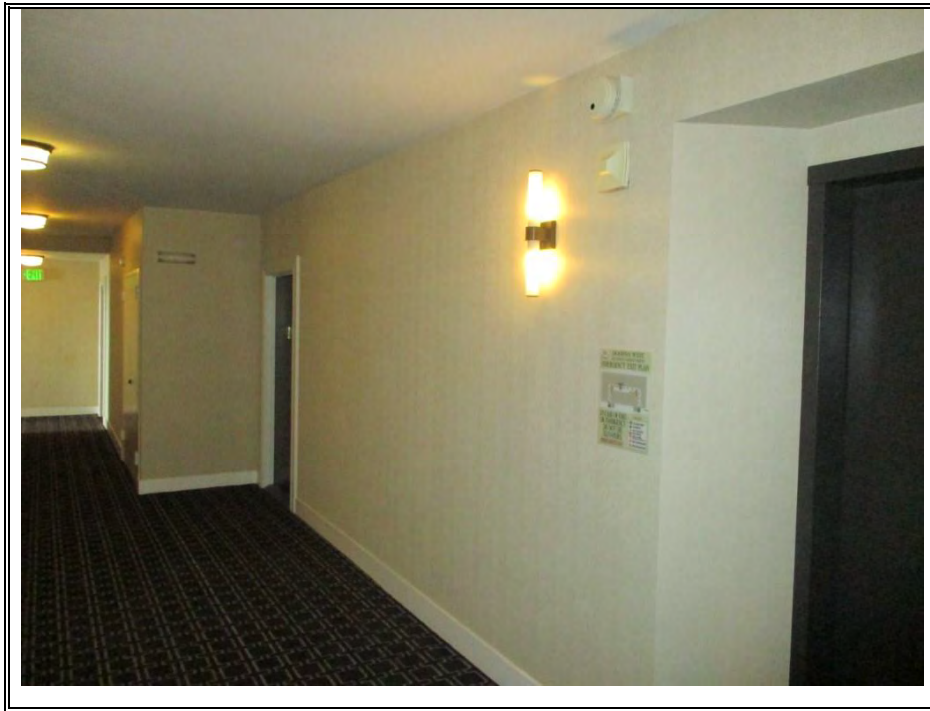
**WALLPAPER (TYPICAL)**

**OBSERVATIONS:** *This component includes the wallpapered surfaces of the internal hallways and common areas. We were informed that maintenance was performed in 2017 and they generally appeared to be in average to aging condition.*

**TO PROTECT YOUR INVESTMENT:** *Any peeling sections of wallpaper should be re-glued upon discovery in order to preserve the integrity of the remaining sections.*

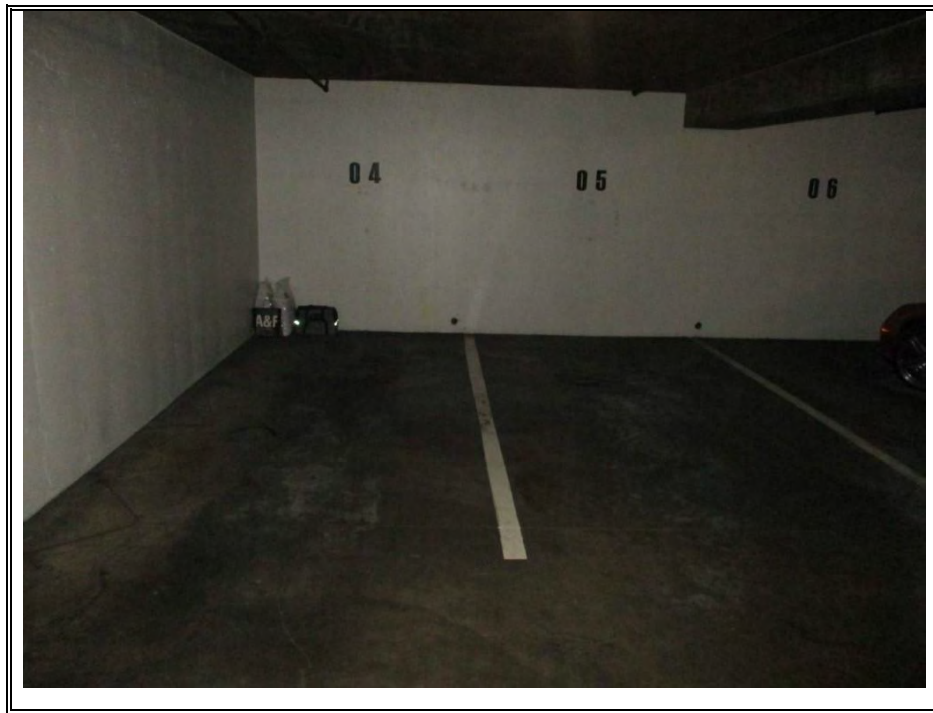
**GARAGE INTERIOR (TYPICAL)**

**OBSERVATIONS:** *This component includes the painted surfaces of the interior walls of the garages. We were previously informed that they were painted in 2012 and they appeared to be in good to average condition.*

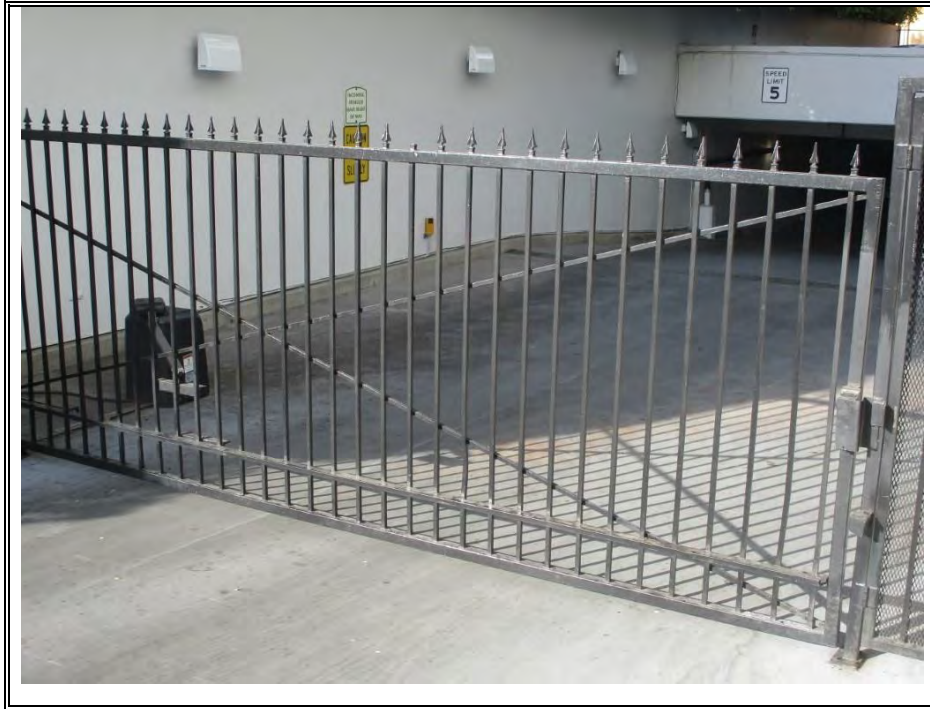
**IRONWORK-EXTERIOR (TYPICAL)**

**OBSERVATIONS:** *This component includes the painted surfaces of the wrought iron fencing and gates at the exterior of the building. They appeared to be in various conditions and for reporting purposes their remaining lives have been averaged.*

**TO PROTECT YOUR INVESTMENT:** *Cleaning and periodic "touch-up" of peeling and damaged surfaces is recommended for appearance, and for protection of the underlying component. All peeling paint should be sanded / scraped and bare areas properly primed prior to any finish paint. Any splits and cracks should be sealed with appropriate materials.*

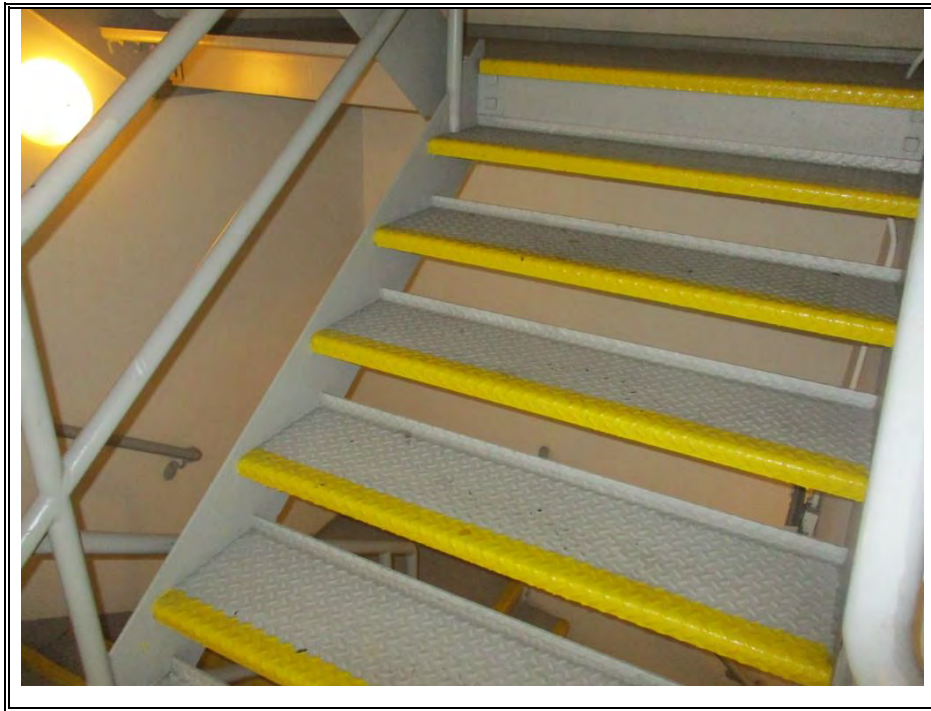
**IRONWORK-INTERIOR (TYPICAL)**

**OBSERVATIONS:** *This component includes the painted surfaces of the wrought iron rails at the stairwells, steps, and landings. They appeared to be in various conditions and for reporting purposes their remaining lives have been averaged*

**TO PROTECT YOUR INVESTMENT:** *Cleaning and periodic "touch-up" of peeling and damaged surfaces is recommended for appearance, and for protection of the underlying component. All peeling paint should be sanded / scraped and bare areas properly primed prior to any finish paint.*

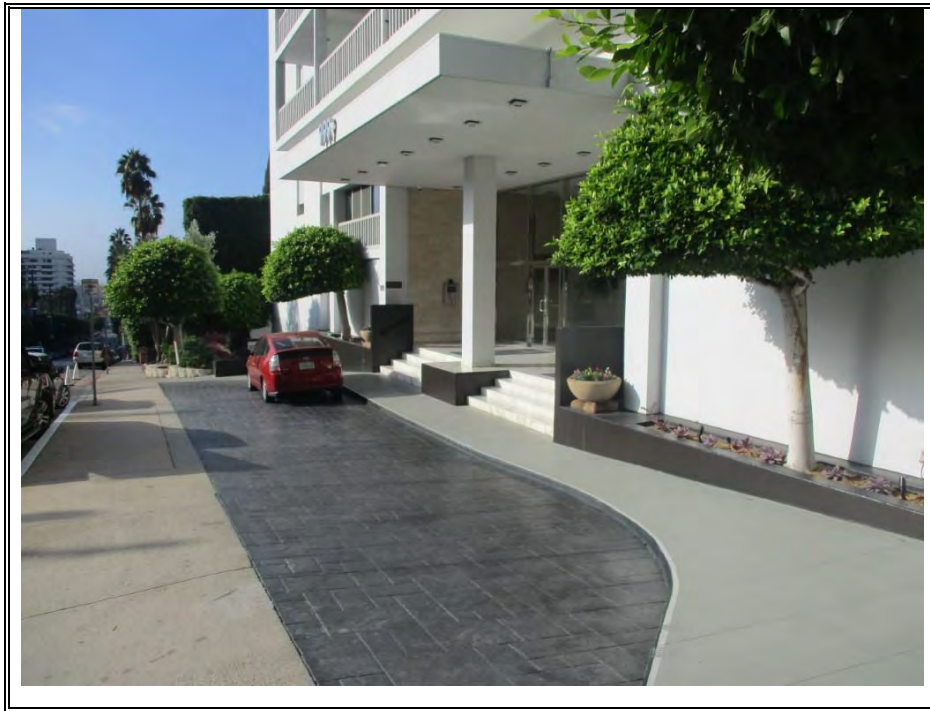
**ENTRIES WALKWAY (TYPICAL)**

**OBSERVATIONS:** *This component includes the epoxy painted surfaces of the entry walkway and garage driveways. We were previously informed that they were painted in 2017 and they appeared to be in good to average condition.*

**TO PROTECT YOUR INVESTMENT:** *Cleaning and periodic "touch-up" of peeling and damaged surfaces is recommended for appearance. All peeling paint should be sanded / scraped prior to any finish paint.*

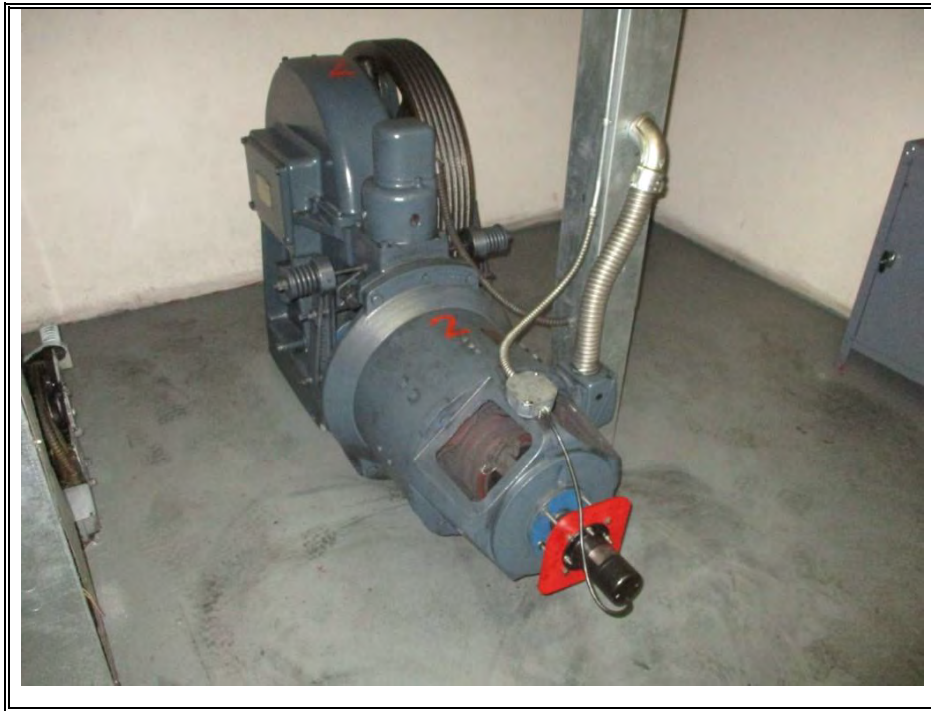
**ELEVATORS-MECHANICAL (TYPICAL)**

**OBSERVATIONS:** *This component includes the mechanical aspects of the elevators. We were previously informed by the elevator maintenance company that the elevators had been completely modernized in 2004.*

**TO PROTECT YOUR INVESTMENT:** *We recommend obtaining a maintenance contract with a qualified specialist.*

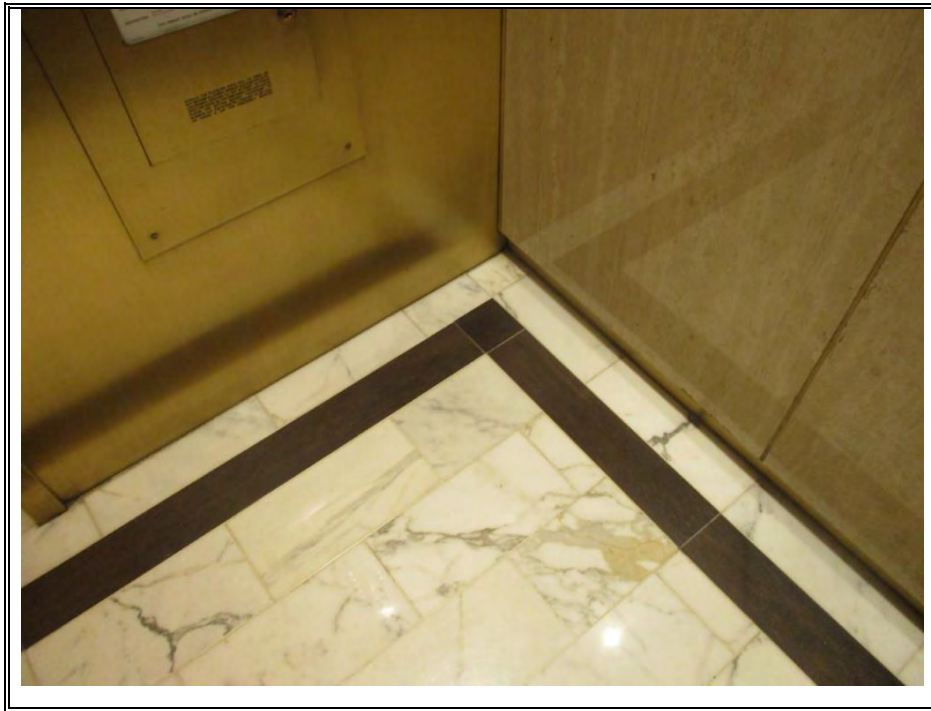
**ELEVATORS-CAB REMODEL (TYPICAL)**

**OBSERVATIONS:** *This component provides for the remodeling of the elevator cabs, comprised of marble interior and flooring. We were informed that maintenance was performed in 2017 and they appeared to be in average condition for their age.*

**TO PROTECT YOUR INVESTMENT:** *General surface cleaning of the elevator cab interior would be the extent of any maintenance necessary by the association.*

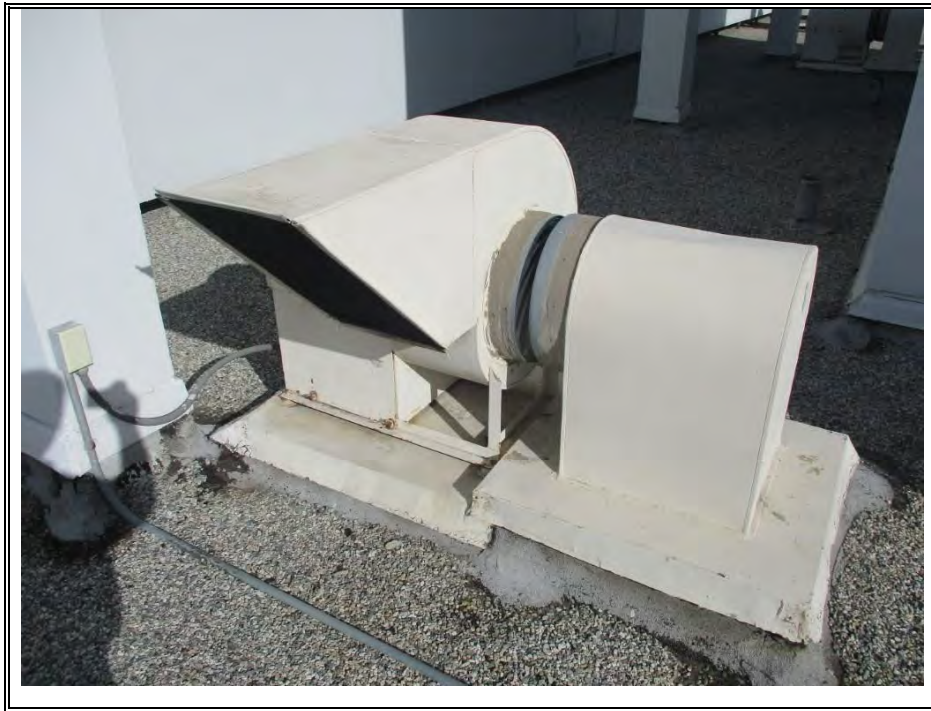
**EXHAUST FANS-GARAGE (TYPICAL)**

**OBSERVATIONS:** *This component includes the inline exhaust blowers on the roof and at garage level 2, comprised of 2 at 10 hp and 2 estimated at 2 hp, which serve the purpose of ventilating the common garage area. The fans on the roof were inaccessible for inspection (encased) and for reporting purposes the remaining lives have been estimated. It is recommended that a carbon monoxide detector be installed in conjunction with an auto-start mechanism in the interest of safety.*

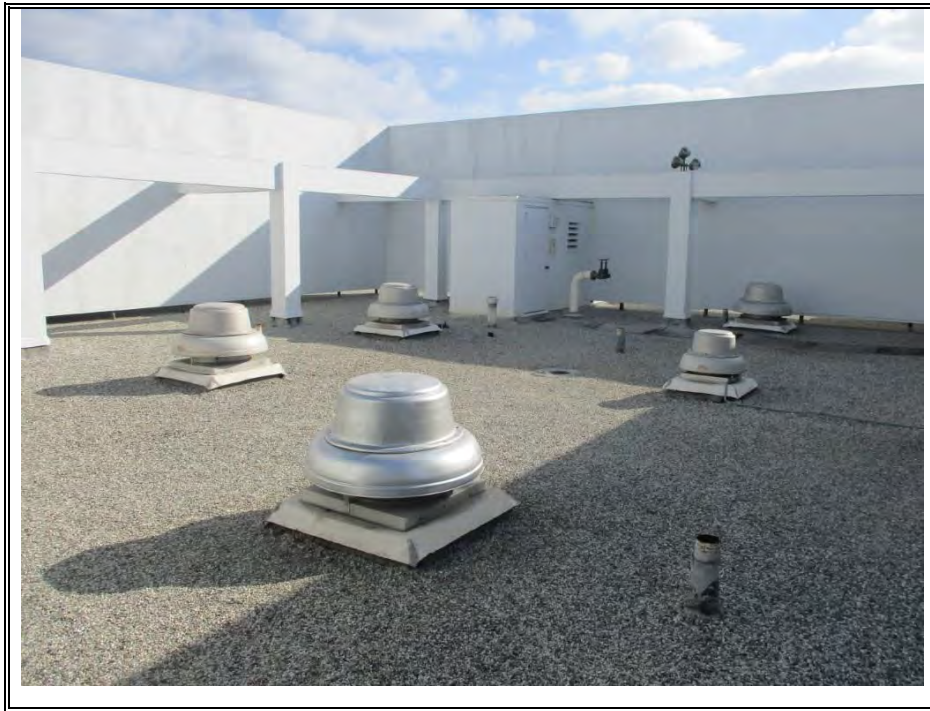
**EXHAUST FANS-INTERIORS (TYPICAL)**

**OBSERVATIONS:** *This component includes the mushroom type exhaust fans on the roof, estimated at ½ horsepower, which serve the purpose of ventilating the internal hallways. They were inaccessible for inspection (encased) and for reporting purposes the remaining lives have been estimated.*

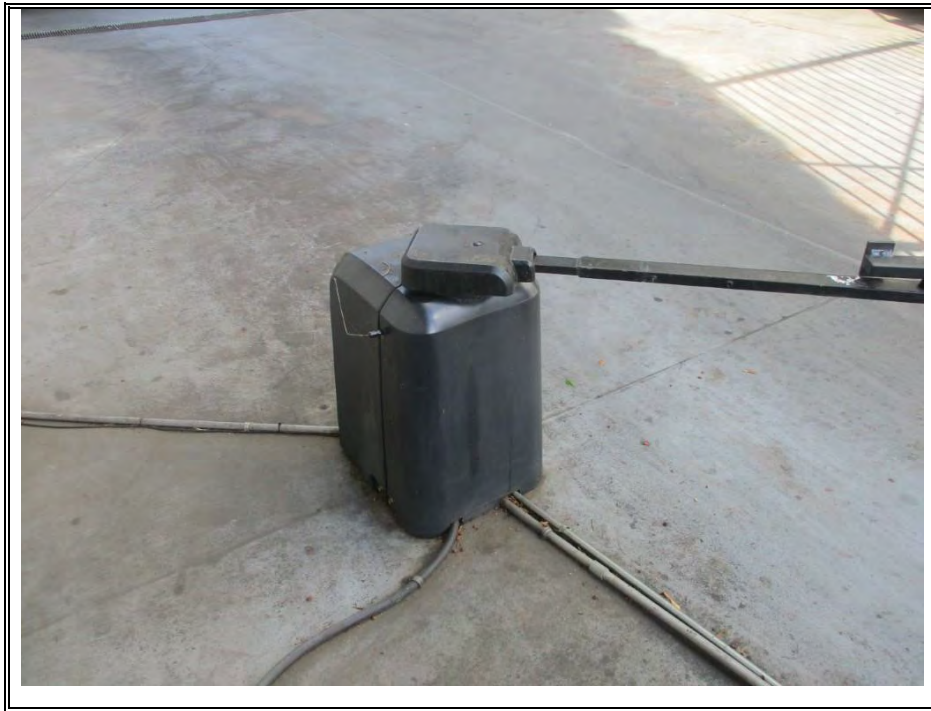
**GATE OPERATOR (TYPICAL)**

**OBSERVATIONS:** *This component includes a swing arm-type vehicle gate operator at the vehicle gate. We were previously informed it was installed in 2016 and appeared to be in good to average condition.*

**TO PROTECT YOUR INVESTMENT:** *Maintenance should include regular lubrication of all moving parts. It is suggested that a maintenance contract be obtained with a qualified specialist.*

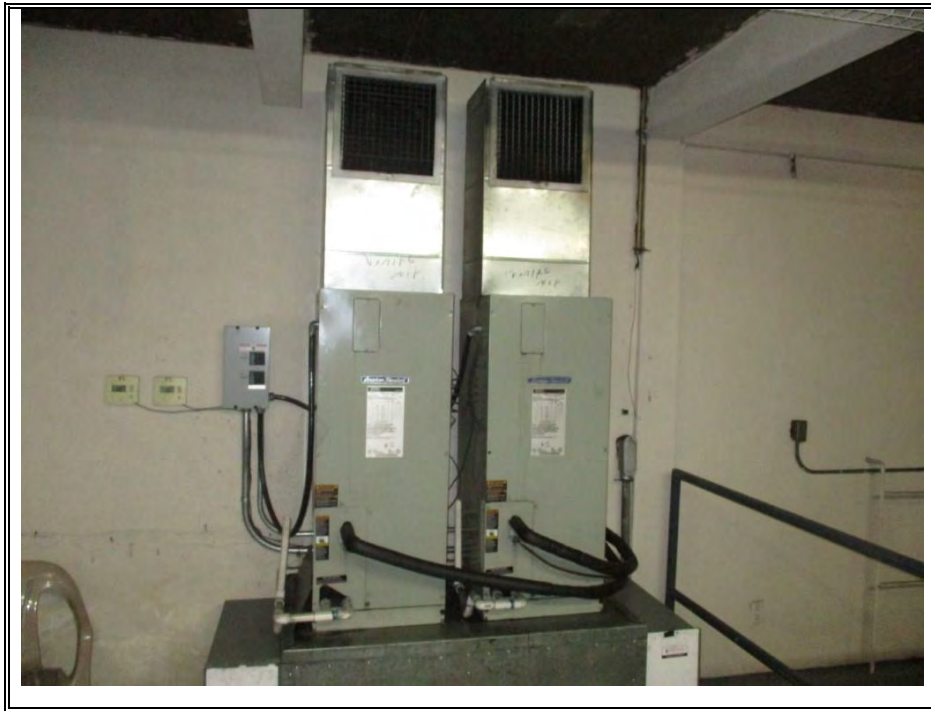
**HEAT PUMPS-EVAPORATIVE COILS (TYPICAL)**

**OBSERVATIONS:** *This component includes the evaporative coils for the “American Standard” heat pumps (split systems), dated 5/2002 and located at the elevator rooms. We were previously informed that maintenance was performed in 2017. They appeared to be in average condition for their age and performing well.*

**TO PROTECT YOUR INVESTMENT:** *The heat pumps should be serviced twice a year. We recommend obtaining a maintenance contract with a reputable licensed heating/air conditioning company.*

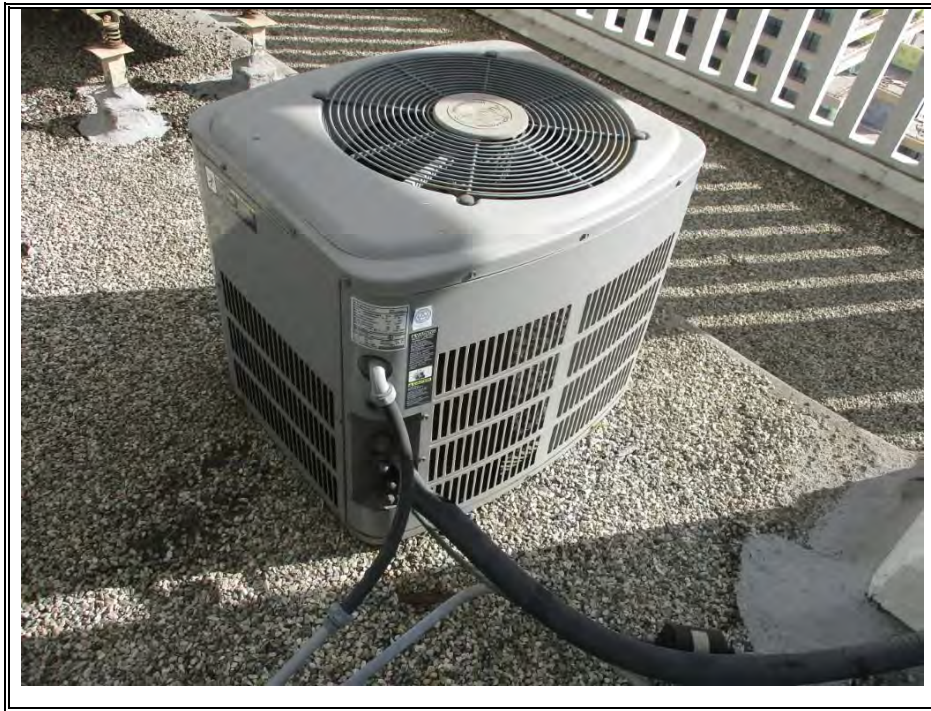
**HEAT PUMPS-CONDENSERS (TYPICAL)**

**OBSERVATIONS:** *This component includes the condensers for the “American Standard” heat pumps (split systems), dated 2001 and located on the roof. We were previously informed that maintenance was performed in 2017. They appeared to be in average condition for their age and performing well.*

**TO PROTECT YOUR INVESTMENT:** *The condensers should be serviced twice a year. We recommend obtaining a maintenance contract with a reputable licensed heating/air conditioning company.*

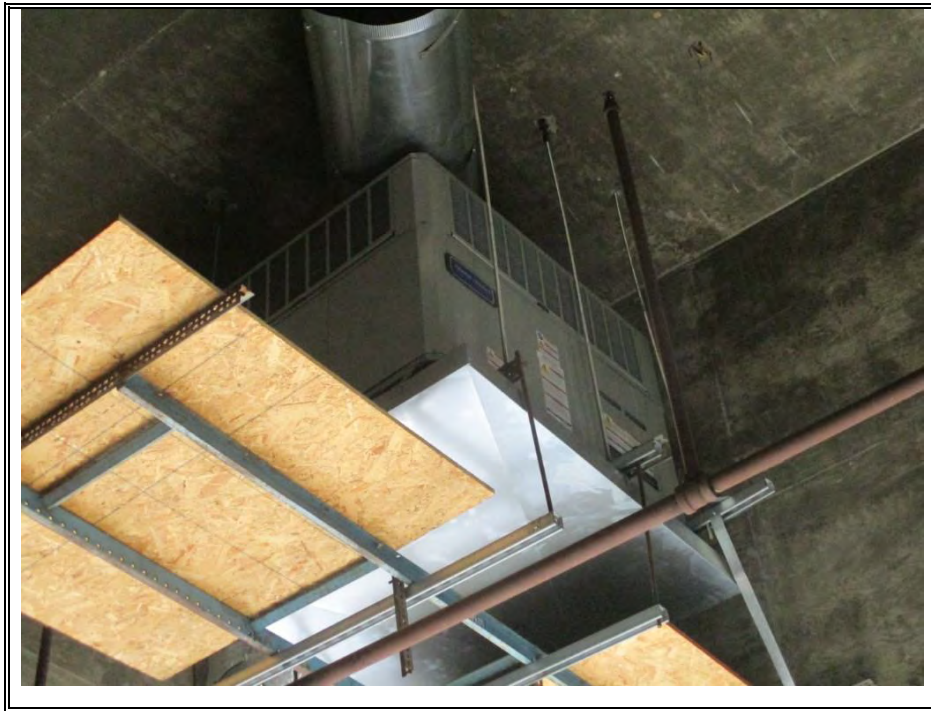
**HEAT PUMPS-DUAL PACKS (TYPICAL)**

**OBSERVATIONS:** *This component includes the dual pack electric heat pumps in the garage. They were inaccessible for inspection (requiring a 16' ladder) and, for reporting purposes, the remaining life has been estimated.*

**TO PROTECT YOUR INVESTMENT:** *The heat pumps should be serviced twice a year. We recommend obtaining a maintenance contract with a reputable licensed heating/air conditioning company.*

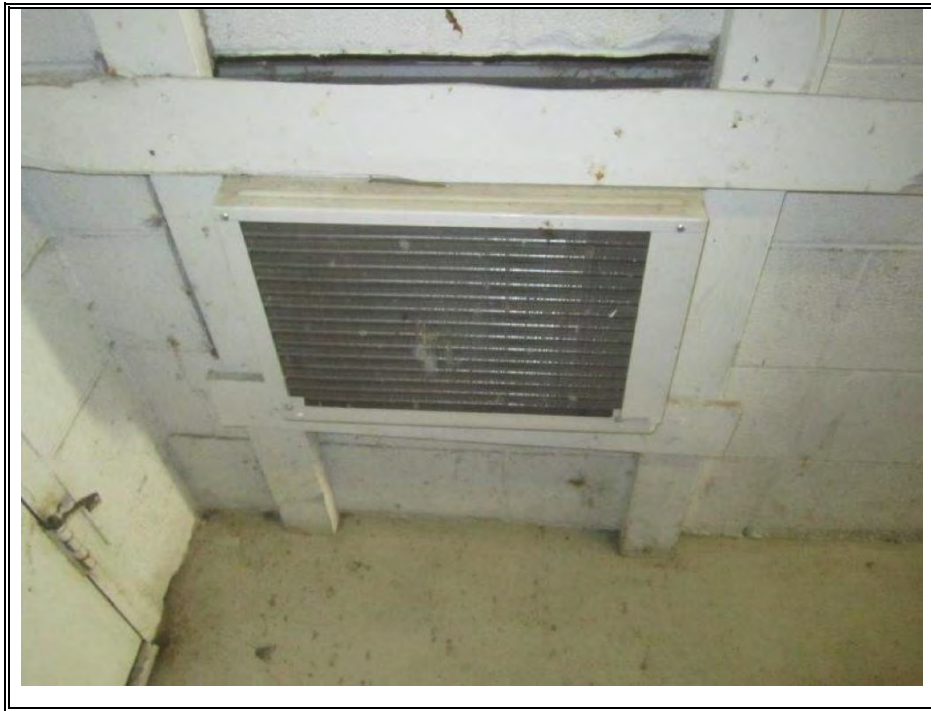
**WINDOW AIR CONDITIONER (TYPICAL)**

**OBSERVATIONS:** *This component includes an “LG” window air conditioning unit in the manager’s office. We were previously informed it was to be installed in 2018 and it appeared to be in good condition.*

**TO PROTECT YOUR INVESTMENT:** *The air conditioner should be serviced twice a year. We recommend obtaining a maintenance contract with a reputable licensed heating/air conditioning company.*

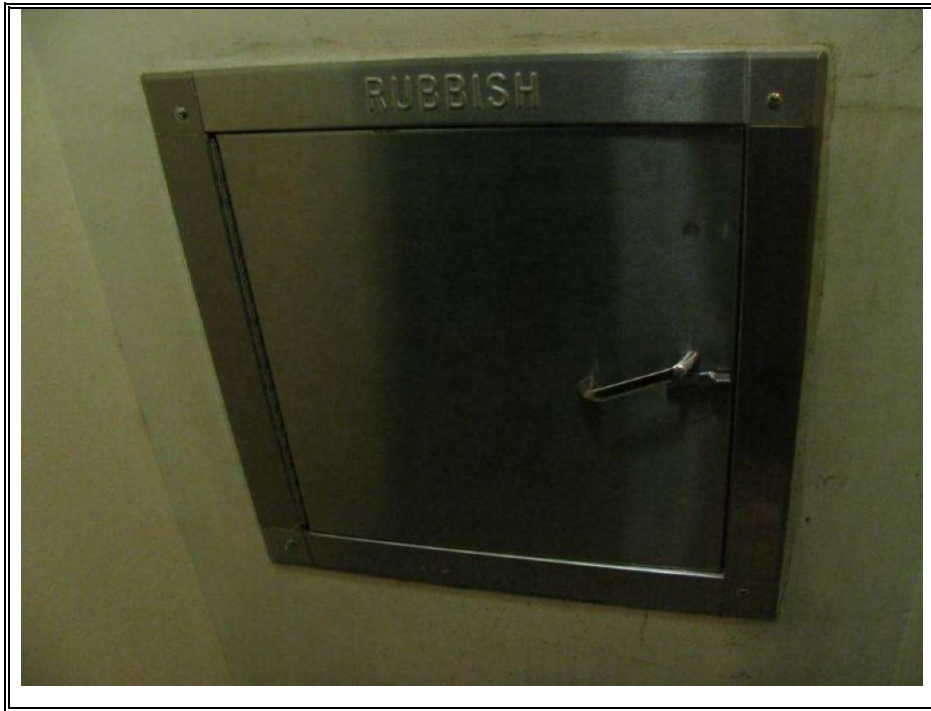
**TRASH CHUTES (TYPICAL)**

**OBSERVATIONS:** *This component provides for the replacement of the doors and other miscellaneous repairs, to the trash chutes in the hallways. They appeared to be in various conditions and for reporting purposes the remaining lives have been averaged.*

**TO PROTECT YOUR INVESTMENT:** *Periodic lubrication of the hinges and latches is recommended. Self-closing devices, if present, should be tested to ensure they are operating properly. In addition, handles and other hardware should be tightened if necessary.*

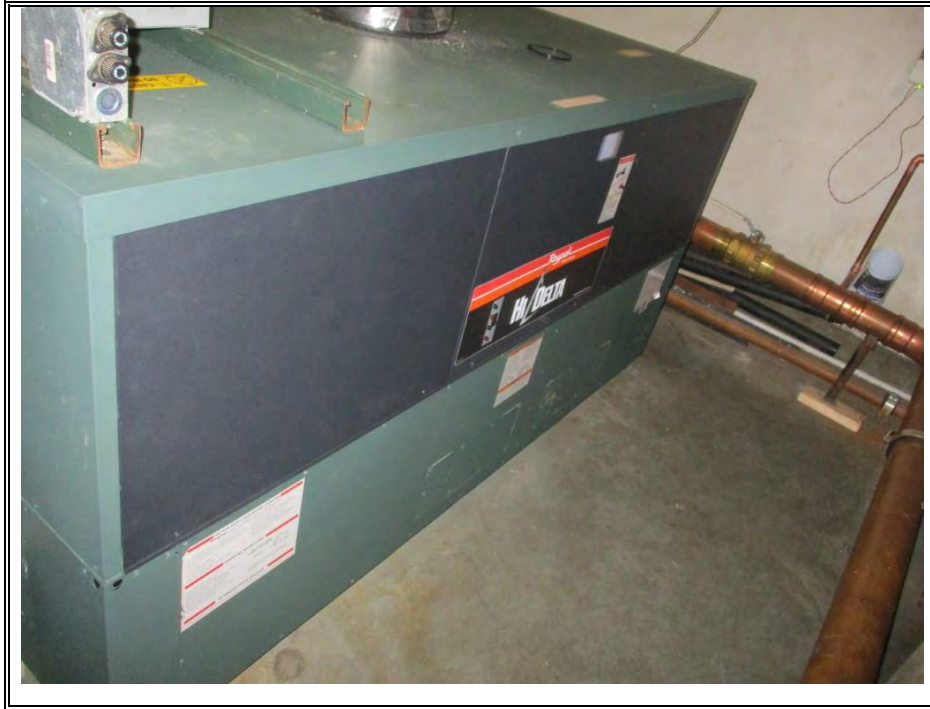
**BOILER-REPLACE (TYPICAL)**

**OBSERVATIONS:** This component includes an "Raypak Hi-Delta" 1,530,000 BTU boiler in the boiler equipment room. We were informed that it was installed in 2018 and it appeared to be in good condition. This type of equipment can fail without warning, often as a result of improper maintenance. See component ID #0502 for further comments.

**TO PROTECT YOUR INVESTMENT:** It is recommended that a full-service maintenance contract be obtained with a reputable licensed plumbing contractor. Also, the addition of a water treatment system would serve to enhance the longevity of this component.

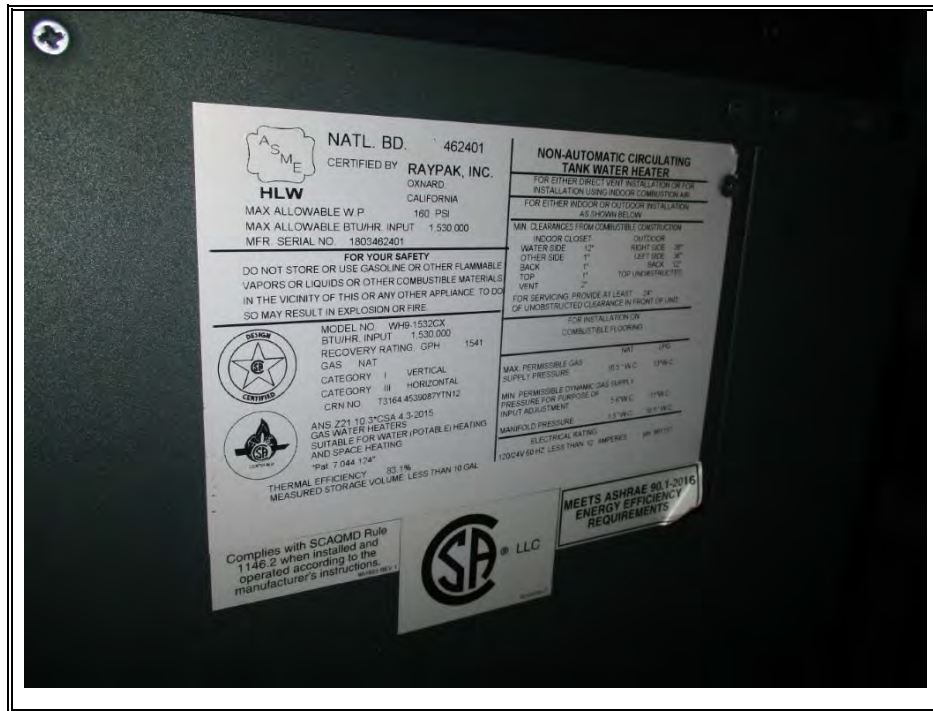
### BOILER-OVERHAUL (TYPICAL)

**OBSERVATIONS:** This component includes the overhauling of the boiler identified in component ID #0501. Such overhaul should include reaming of the header/tube pack replacement to obtain maximum efficiency and service life from the boiler. This typically occurs at about mid-life of the boiler (i.e. 8 years). A life cycle of 16 years is therefore used for purposes of reporting. It should be noted that a visual examination can make no predictions as to future performance (i.e. even with correct maintenance, this unit can fail without warning).

**TO PROTECT YOUR INVESTMENT:** It is recommended that a full-service maintenance contract be obtained with a reputable licensed plumbing contractor. Also, the addition of a water treatment system would serve to enhance the longevity of this component.

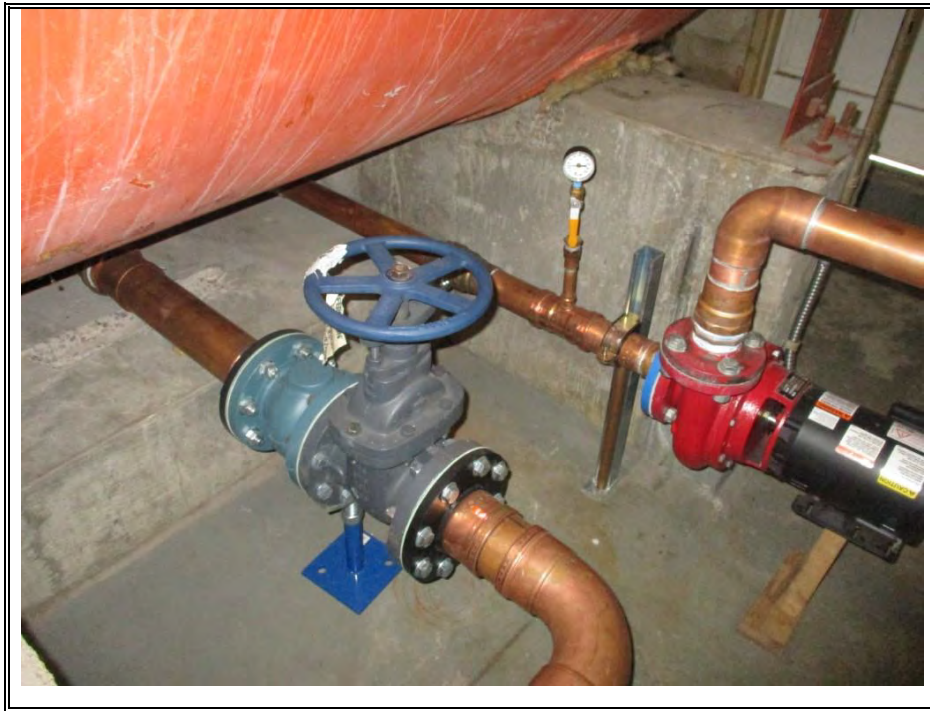
**CIRCULATION PUMPS (TYPICAL)**

**OBSERVATIONS:** *This component includes the circulation pumps, comprised of 1 at 1 hp and 1 at ½ hp, which serve to expedite hot water provision to the individual units. We were informed that one was installed in 2018 and for reporting purposes the remaining lives have been averaged.*

**TO PROTECT YOUR INVESTMENT:** *Maintenance should include periodic lubrication (which can considerably extend its life expectancy).*

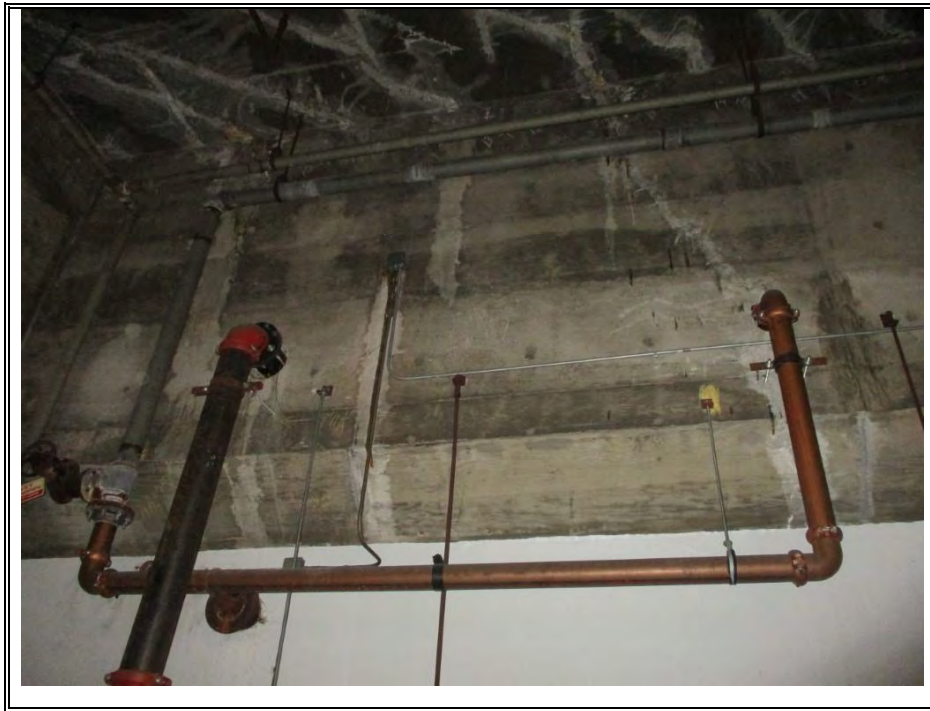
**DISTRIBUTION PIPING-PHASE1 (TYPICAL)**

**OBSERVATIONS:** *This component includes phase 1 of the copper distribution piping that provides potable water to the individual units throughout the complex. We were previously informed of limited replacements, and it generally appeared to be in aging condition and nearing the end of its anticipated useful service life. We were informed that the piping is anticipated to be replaced over the next 3 years, and for reporting purposes it has been split into 3 phases. Although previously considered to be a lifetime component, copper piping has more recently been found to fail as early as 15 years after installation. This is suspected to be primarily caused by changes in the chemical makeup of potable water due to the U.S. Environmental Protection Agency's (EPA) Safe Water Drinking Act and the Lead and Copper Rule (LCR). For purposes of reporting, an approximate time frame of 40 years has been assumed for future replacement. A rough cost estimate, based on number of units, has been provided. It is recommended that further evaluation be obtained from a licensed plumbing consultant / contractor, as well as consideration of an epoxy pipe lining system, and adjustments can be included in a future Reserve Study Update.*

**TO PROTECT YOUR INVESTMENT:** *Little by way of maintenance is needed for the piping other than periodic examination for leaking, especially in the garage area. Any leaks should be promptly repaired upon discovery, as any wood or soil that is kept constantly moist provides ideal conditions for termites. The association may consider professionally installing a water treatment system and / or an epoxy pipe lining system, which would serve to enhance the longevity of the piping.*
