RESERVE STUDY - MARCH 9, 2023

High Rise Homeowners Association (Sample Only)  
3525 Main Street  
Los Angeles, California

# TABLE OF CONTENTS

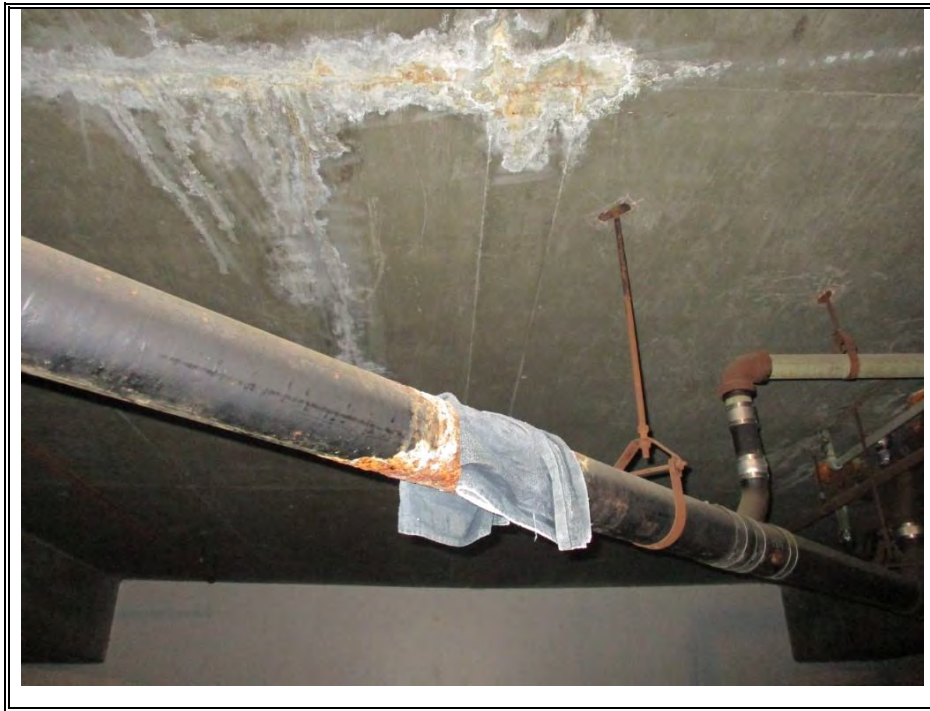
**DRAINAGE/SEWER PIPING (TYPICAL)**

**OBSERVATIONS:** *This component addresses the sewer and drainage piping. An allowance has been established for the periodic cleaning and repairs. No amount has been provided for complete replacement as the piping would typically have a life well in excess of the scope of this projection and would therefore be considered a lifetime component.*

**TO PROTECT YOUR INVESTMENT:** *Occasional routing should be performed to ensure that the drainage system is free flowing.*

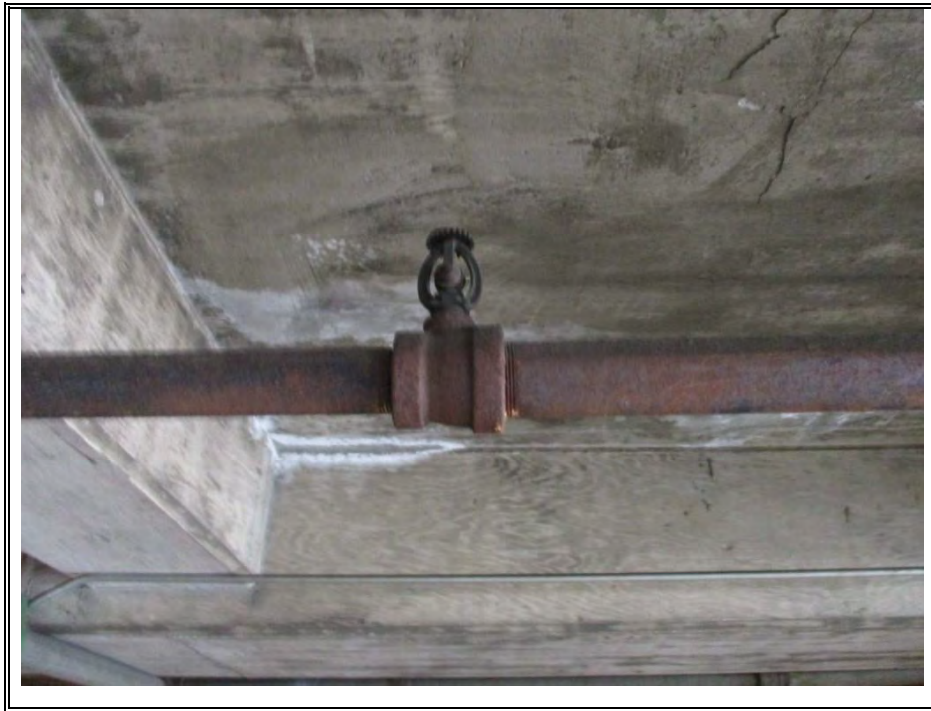
**FIRE SPRINKLERS (TYPICAL)**

**OBSERVATIONS:** *This component includes the fire sprinklers in the garage. They appeared to be in average condition. The fire sprinkler system would be considered to be a lifetime component and for purposes of reporting no amount has been provided for its future replacement. It is recommended that repairs be made on an as-needed basis and funded from the operating account.*

**TO PROTECT YOUR INVESTMENT:** *Periodic inspection and maintenance should be performed by a State Fire Marshall approved company.*

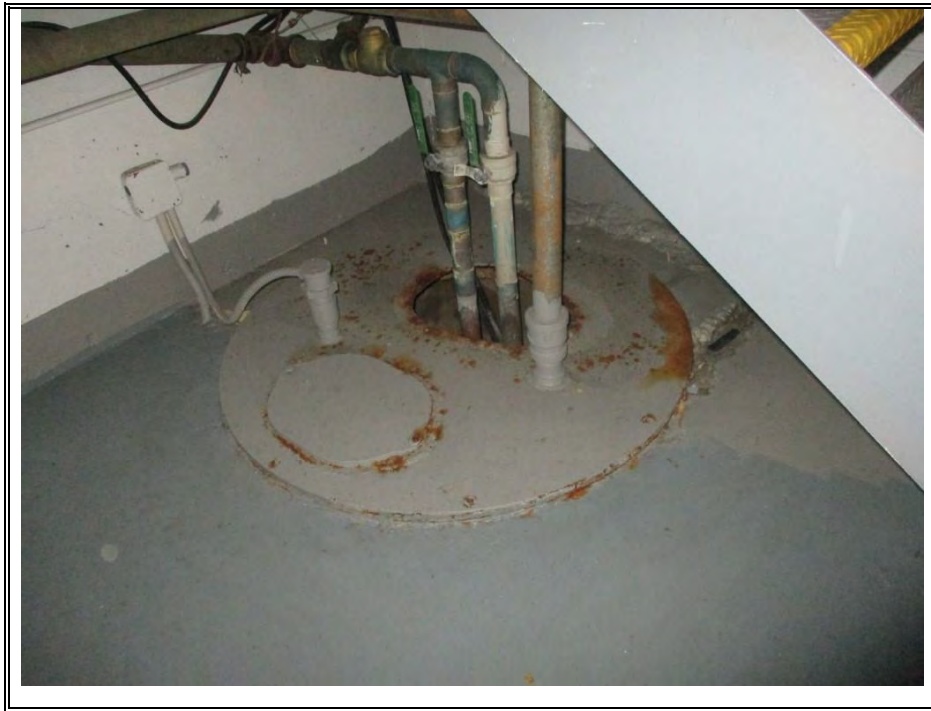
**SUMP PUMPS (TYPICAL)**

**OBSERVATIONS:** *This component includes the sump pumps in the garage/stairwell. They were inaccessible for inspection (covered by a steel plate), however we were previously informed they were installed in 2015. The pumps serve the purpose of preventing flooding by pumping water out to the street. These types of pumps are designed to operate automatically and are imperative for water removal during rainstorms. Failure of the pumps can also lead to over-saturation of the sub-surface soils and associated foundation and concrete slab settlement/cracking.*

**TO PROTECT YOUR INVESTMENT:** *Maintenance should include regular cleaning of the sumps along with verification that the pumps are operational. This should be specifically performed prior to the onset of the rainy season.*

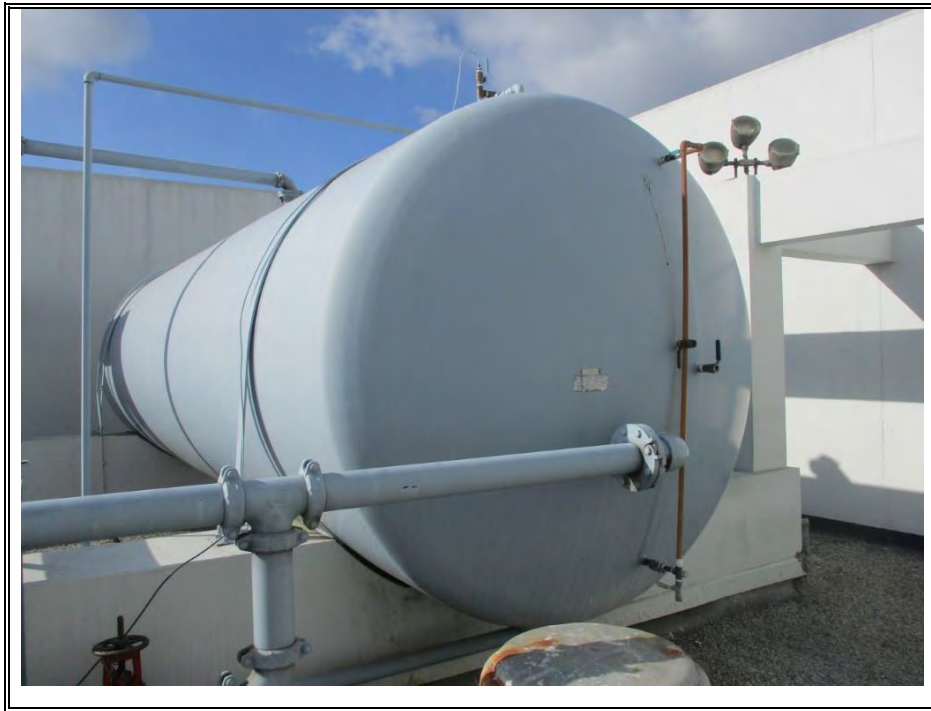
**COLD WATER STORAGE TANK-RELINING (TYPICAL)**

**OBSERVATIONS:** This component provides for re-lining the ceramic lined cold water storage tank on the roof. We were previously informed that with re-lining, the tank should have a life of 30+ years and would therefore be considered a lifetime component. We previously informed that re-lining was last performed circa 2015.

**TO PROTECT YOUR INVESTMENT:** Maintenance should include periodic draining of a few gallons of water from the drain cock to relieve sediment build-up. It is also essential that the sacrificial anodes be checked at least every three months. A service contract with a reputable licensed plumbing contractor is again recommended for longevity of the system. The association may consider professionally installing a water treatment system, which would serve to enhance the longevity of the piping.

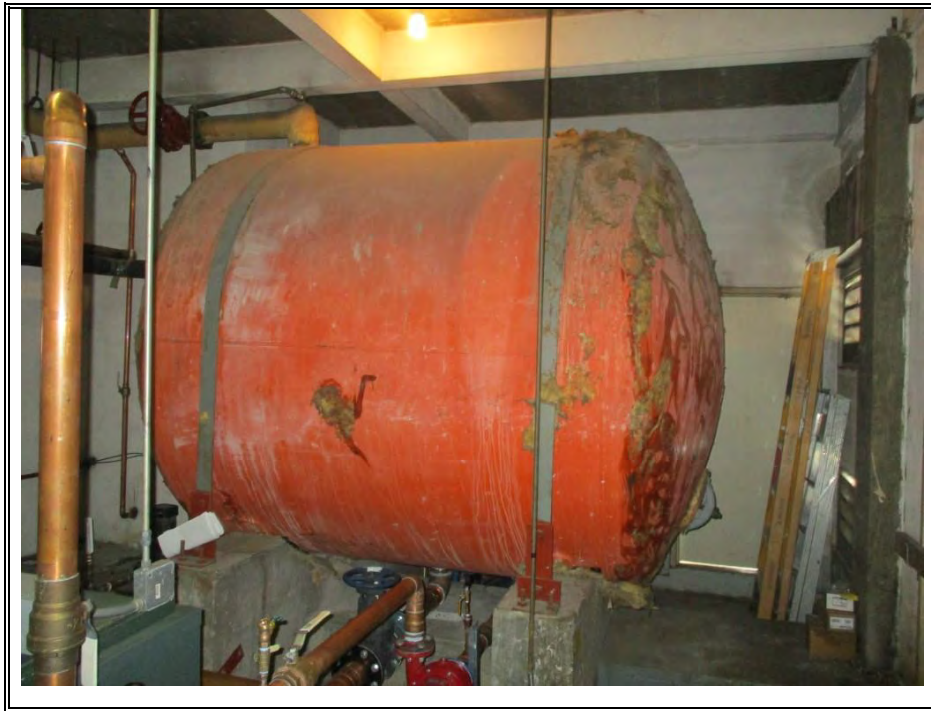
**HOT WATER STORAGE TANK (TYPICAL)**

**OBSERVATIONS:** *This component includes a hot water storage tank in the boiler equipment room. The lining was inaccessible for inspection (encased) and for reporting purposes the remaining life has been estimated. This type of equipment can fail without warning, often as a result of improper maintenance.*

**TO PROTECT YOUR INVESTMENT:** *Maintenance should include periodic draining of a few gallons of water from the drain cock to relieve sediment build-up. It is also essential that the sacrificial anodes be checked at least every three months. A service contract with a reputable licensed plumbing contractor is again recommended for longevity of the system. The association may consider professionally installing a water treatment system, which would serve to enhance the longevity of the piping.*

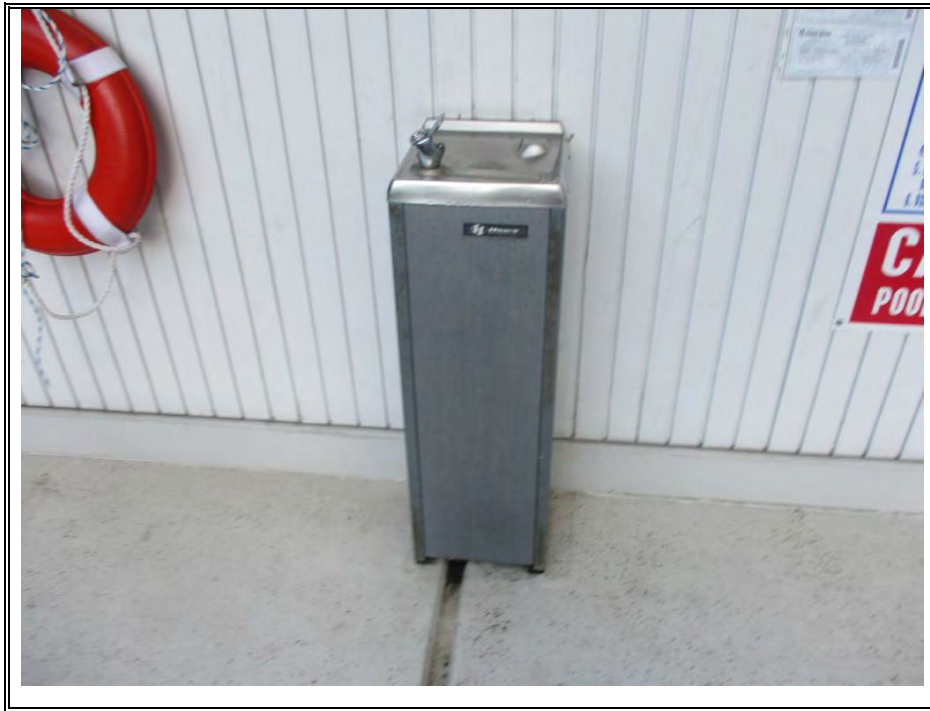
**DRINKING FOUNTAIN (TYPICAL)**

**OBSERVATIONS:** *This component includes a stainless-steel basin, chilled water drinking fountain in the pool restroom building. It appeared to be in average to aging condition.*

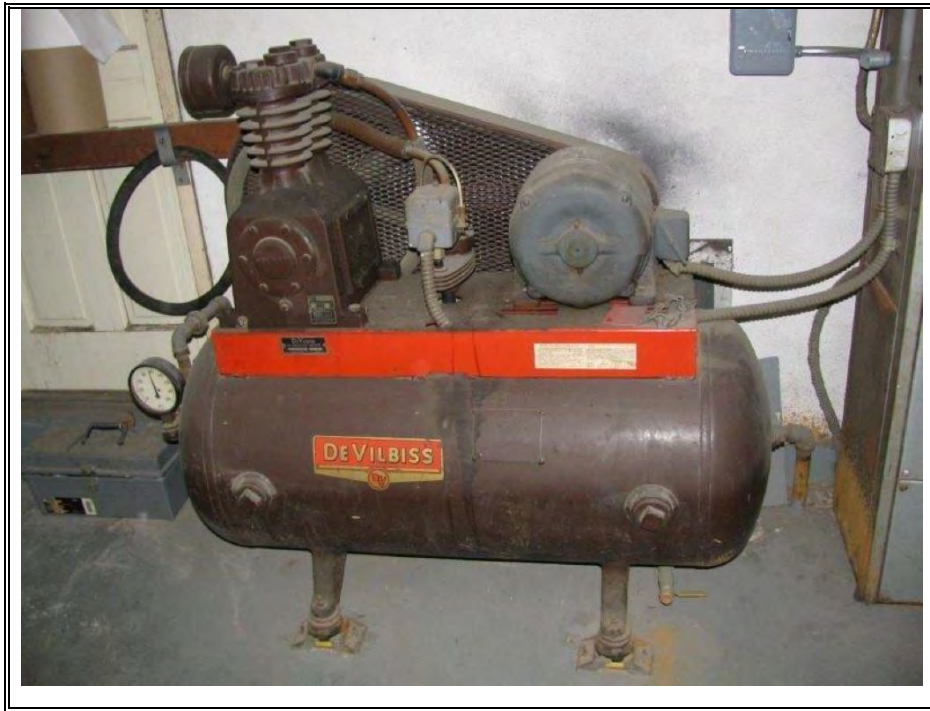
**AIR COMPRESSOR (TYPICAL)**

**OBSERVATIONS:** *This component includes the 3-horsepower air compressor in the boiler equipment room, manufactured in 1994, which services the boiler system. We were previously informed it was overhauled in 2017 and for reporting purposes the remaining life has been averaged.*

**TO PROTECT YOUR INVESTMENT:** *It is recommended that a full-service maintenance contract be obtained with a reputable licensed contractor.*

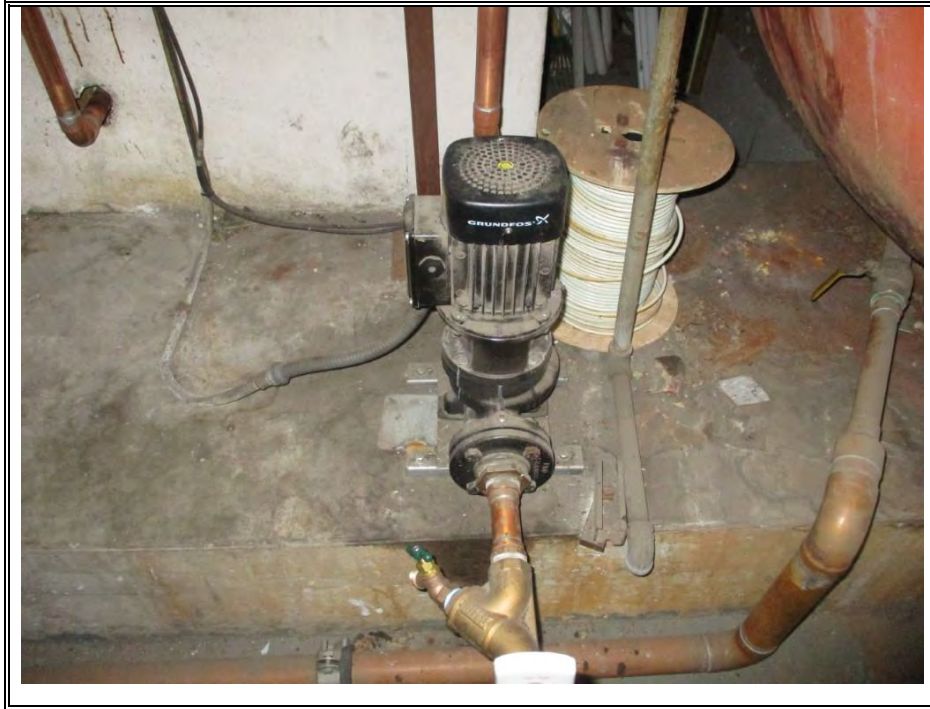
**BOOSTER PUMP (TYPICAL)**

**OBSERVATIONS:** *This component includes the "Grundfos" booster pump and motor in a maintenance closet at garage level two, which serves to increase water pressure provision to the individual units. It appeared to be in average to aging condition.*

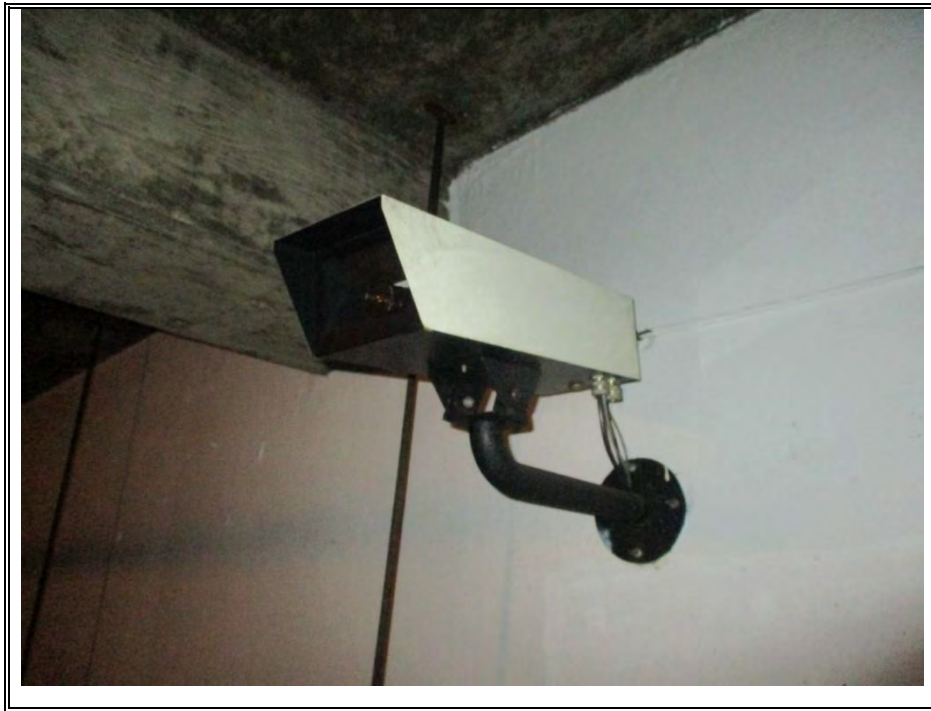
**CCTV SYSTEM (TYPICAL)**

**OBSERVATIONS:** *This component includes the cameras, monitor and recorder for the closed-circuit television system. They appeared to be in good condition*

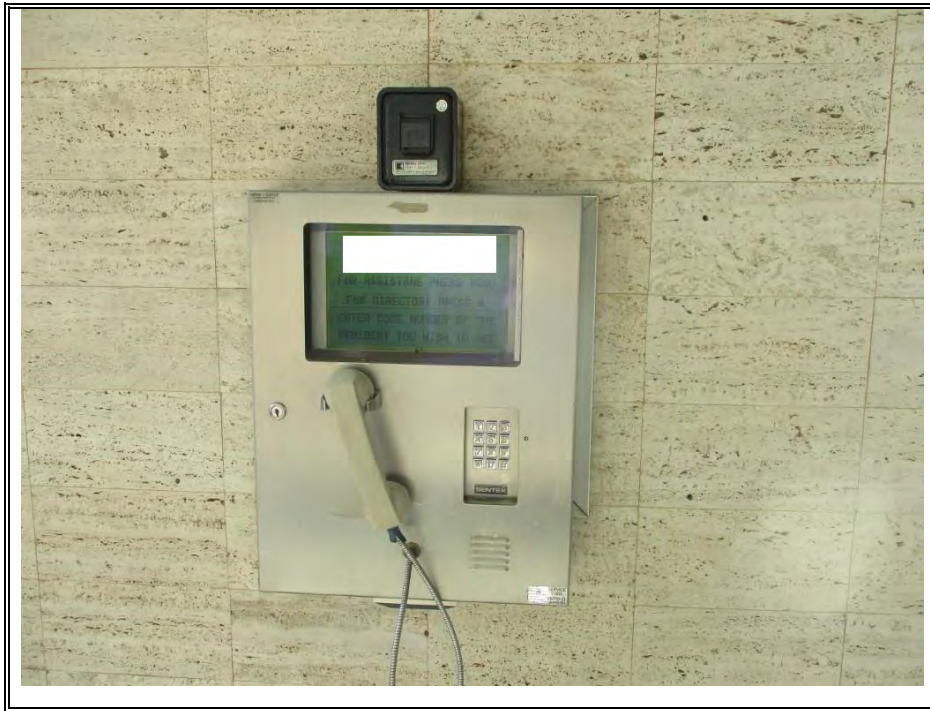
**INTERCOM (TYPICAL)**

**OBSERVATIONS:** *This component includes a telephone-type entry intercom system with LCD scroll, at the pedestrian entry to the building. We were informed it was serviced in 2017 and appeared to be in average condition for its age.*

**TO PROTECT YOUR INVESTMENT:** *Little by way of maintenance can be performed for this component, although minor operational problems are typically encountered (operating cost).*

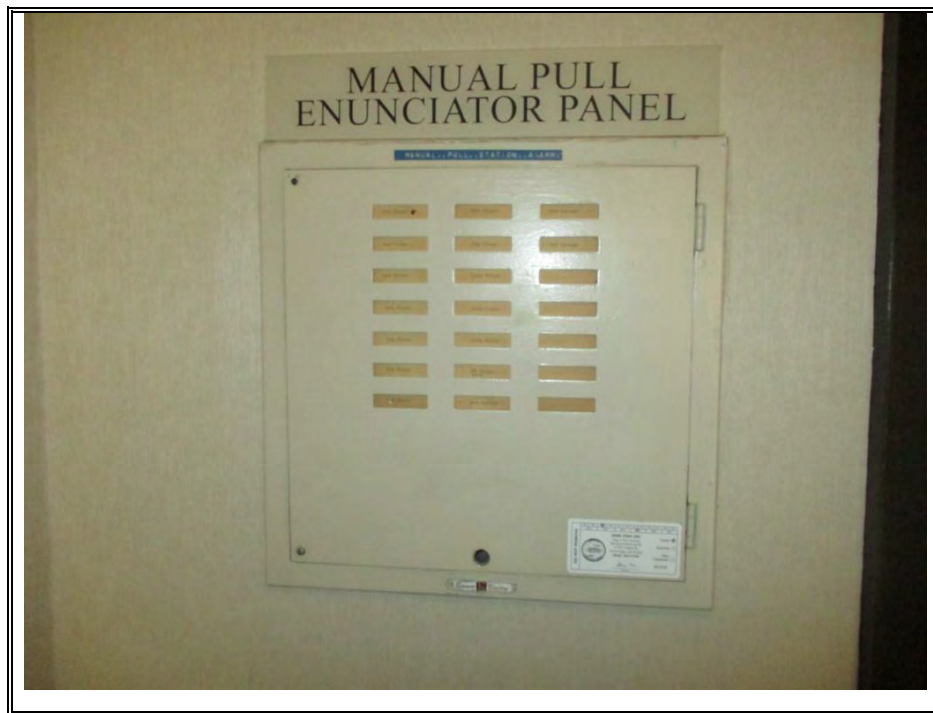
**FIRE ANNUNCIATOR SYSTEM (TYPICAL)**

**OBSERVATIONS:** *This component includes a fire annunciator system (panel) adjacent to the manager's office. We were informed it was serviced in 2017 and it appeared to be in average condition for its age.*

**TO PROTECT YOUR INVESTMENT:** *Little by way of maintenance can be performed for this component. However, it should be professionally inspected on a regular (suggested annual) basis.*

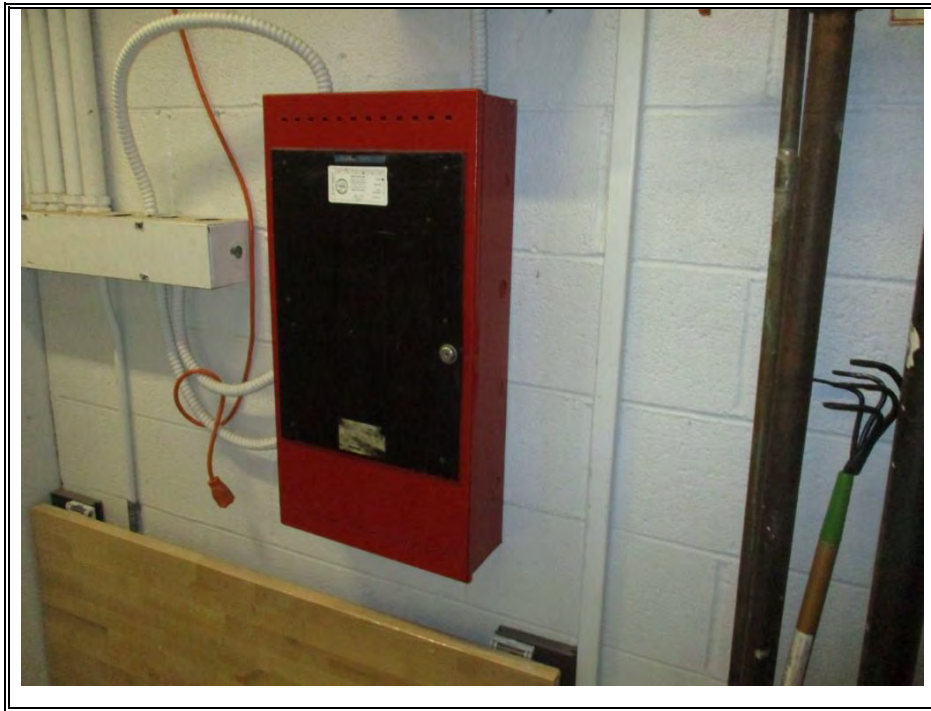
**FIRE ALARM SYSTEM (TYPICAL)**

**OBSERVATIONS:** *This component includes a fire alarm system in the service hallway at the east end of the building. It appeared to be in good condition for its age. We were informed it receives regular service and the remaining life has been arbitrarily extended. We were also previously informed by the service company that the current system is “grandfathered” from existing codes. To upgrade/replace the system would require re-wiring the entire building and substantial additional equipment such as audible speakers, smoke alarms, etc., and it would have to conform to the “2 door rule” mode. In addition, a potential asbestos removal problem may exist. A rough estimate for replacement with a new system has been provided. As additional information is obtained, adjustments can be included in a future Reserve Study Update.*

**TO PROTECT YOUR INVESTMENT:** *Little by way of maintenance can be performed for this component. However, it should be professionally inspected on a regular (suggested annual) basis.*

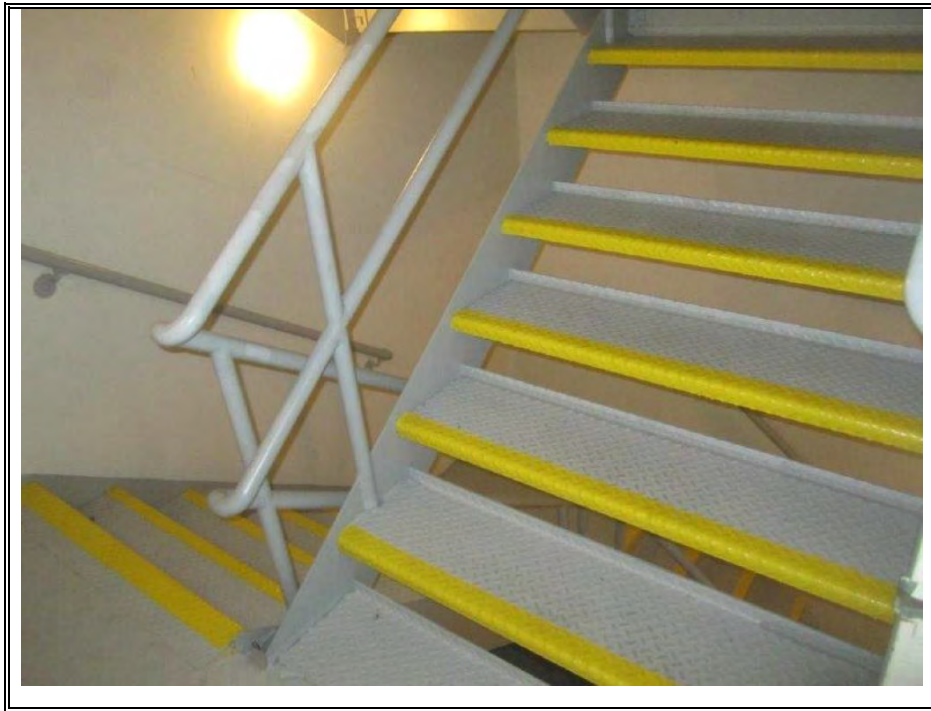
**LIGHTING-EMERGENCY (TYPICAL)**

**OBSERVATIONS:** *This component includes the emergency light fixtures throughout the building. They appeared to be in average condition and are usually desired to be replaced for appearance sake. It is recommended that replacement be made on an as-needed basis and funded from the operating account.*

**TO PROTECT YOUR INVESTMENT:** *Maintenance would entail periodically checking the fixtures to make sure that they are secure and that the batteries are fully charged. Also, occasional examination for, and changing of burned out bulbs would be prudent. In addition, cleaning of the fixtures is recommended on an as-needed basis.*

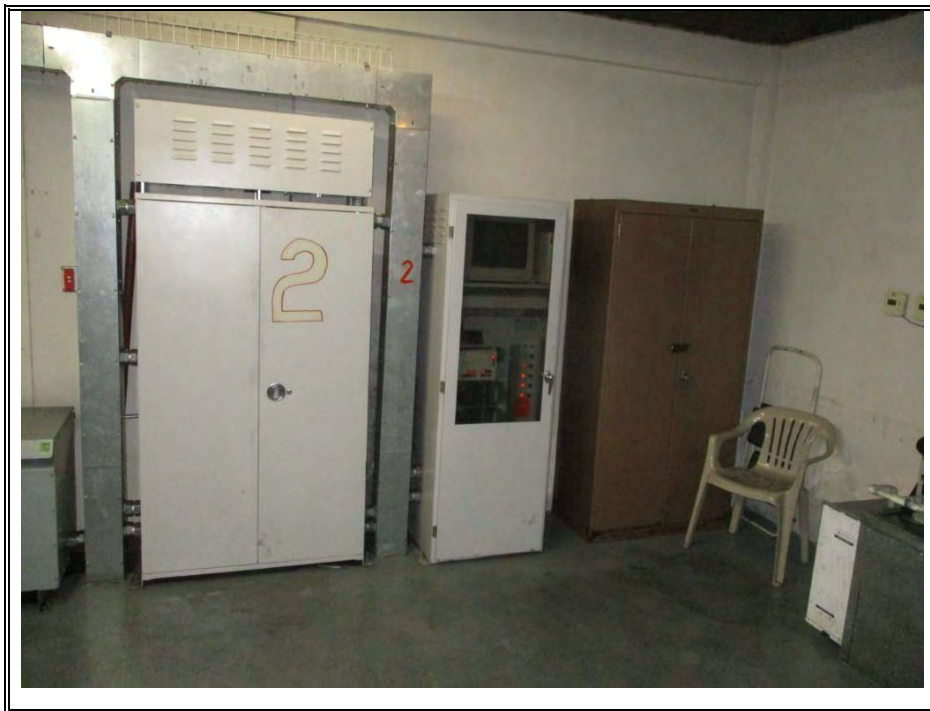
**LIGHTING-EMERGENCY LIGHT BACK-UP POWER (TYPICAL)**

**OBSERVATIONS:** This component includes the battery pack back-up power systems for the emergency lights in the elevator equipment room. They were inaccessible for inspection (the cabinets were locked). For reporting purposes, their remaining lives have been estimated. A rough estimate has been provided for replacement. It is recommended that further information be obtained from the service provider, and adjustments can be included in a future Reserve Study Update if necessary.

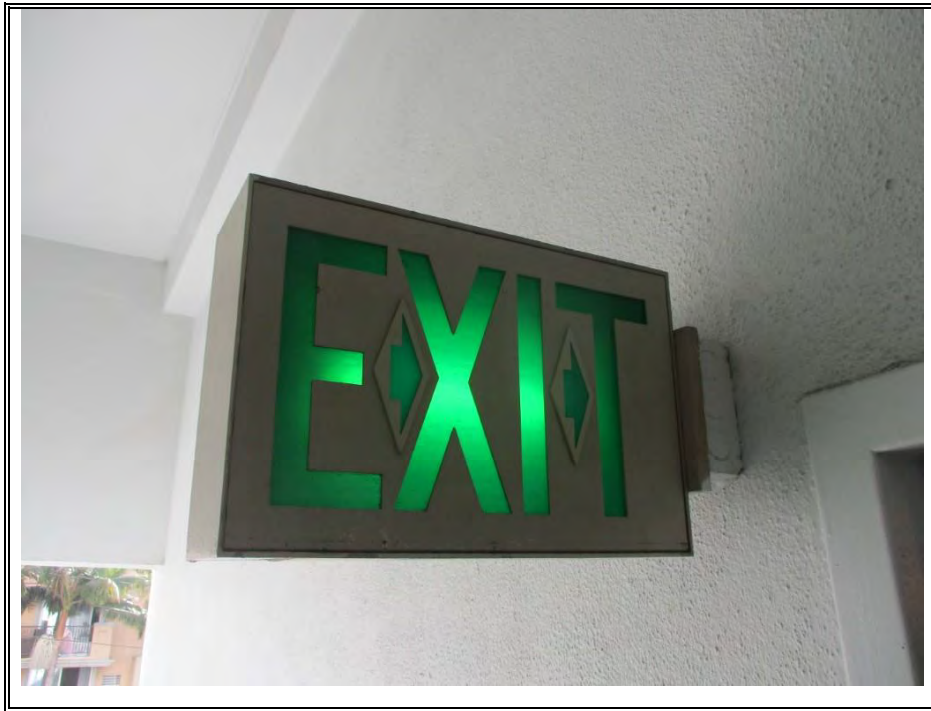
**LIGHTING-EXIT SIGNS (TYPICAL)**

**OBSERVATIONS:** *This component includes the lighted exit signs throughout the complex. They appeared to be in average condition and are usually desired to be replaced for appearance sake.*

**TO PROTECT YOUR INVESTMENT:** *Maintenance would entail periodically checking the fixtures to make sure that they are secure. Also, occasional examination for, and changing of burned out bulbs would be prudent. In addition, cleaning of the fixtures is recommended on an as-needed basis.*

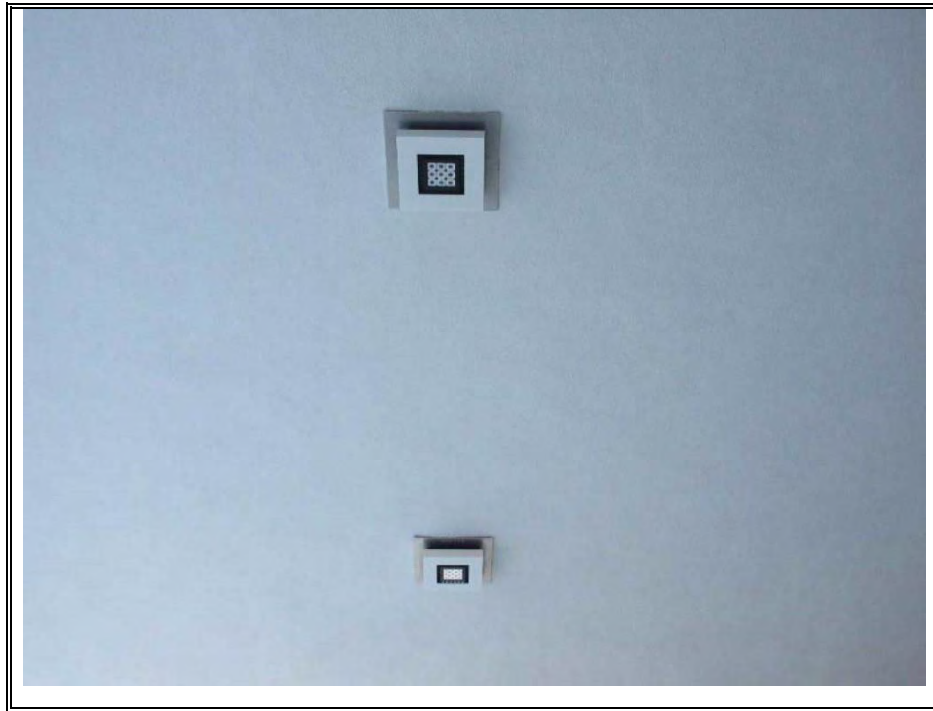
**LIGHTING-EXTERIOR (DECORATIVE) (TYPICAL)**

**OBSERVATIONS:** *This component includes the wall and ceiling mounted decorative light fixtures at the balconies and exterior of the building. They appeared to be in good to average condition. The external location of these fixtures usually makes them subject to a greater rate of deterioration due to exposure to the elements. Also, it is often desirable to replace these fixtures as they eventually become dated and/or more energy efficient options become available.*

**TO PROTECT YOUR INVESTMENT:** *Maintenance would entail periodically checking the fixtures to make sure that they are secure. Also, occasional examination for, and changing of burned out bulbs would be prudent. In addition, cleaning of the fixtures is recommended on an as-needed basis.*

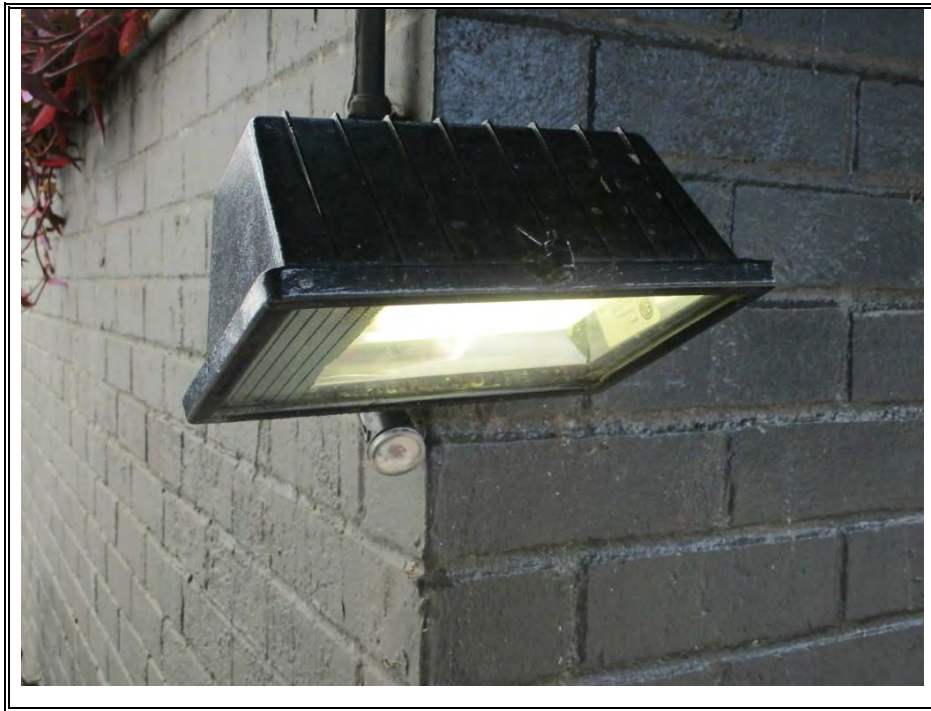
**LIGHTING-EXTERIOR (UTILITARIAN) (TYPICAL)**

**OBSERVATIONS:** *This component includes the utilitarian light fixtures at the exterior of the building. They appeared to be in average condition. It is recommended that repairs/replacement be done on an as-needed basis and funded from the operating account. The external location of these fixtures usually makes them subject to a greater rate of deterioration due to exposure to the elements. Also, it is often desirable to replace these fixtures as they eventually become dated and/or more energy efficient options become available.*

**TO PROTECT YOUR INVESTMENT:** *Maintenance would entail periodically checking the fixtures to make sure that they are secure. Also, occasional examination for, and changing of burned out bulbs would be prudent. In addition, cleaning of the fixtures is recommended on an as-needed basis.*

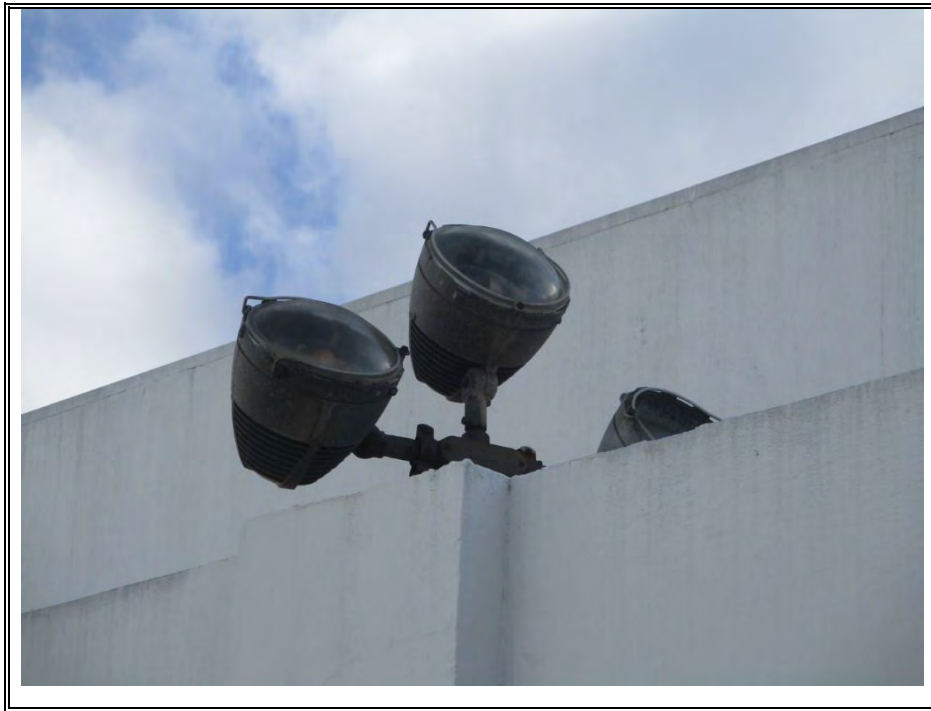
**LIGHTING-EXTERIOR (SECURITY) (TYPICAL)**

**OBSERVATIONS:** *This component includes the high intensity discharge type floodlight fixtures at the exterior of the building. They appeared to be in average condition. It is recommended that repairs/replacement be done on an as-needed basis and funded from the operating account. The external location of these fixtures usually makes them subject to a greater rate of deterioration due to exposure to the elements. Also, it is often desirable to replace these fixtures as they eventually become dated and/or more energy efficient options become available.*

**TO PROTECT YOUR INVESTMENT:** *Maintenance would entail periodically checking the fixtures to make sure that they are secure. Also, occasional examination for, and changing of burned out bulbs would be prudent. In addition, cleaning of the fixtures is recommended on an as-needed basis.*

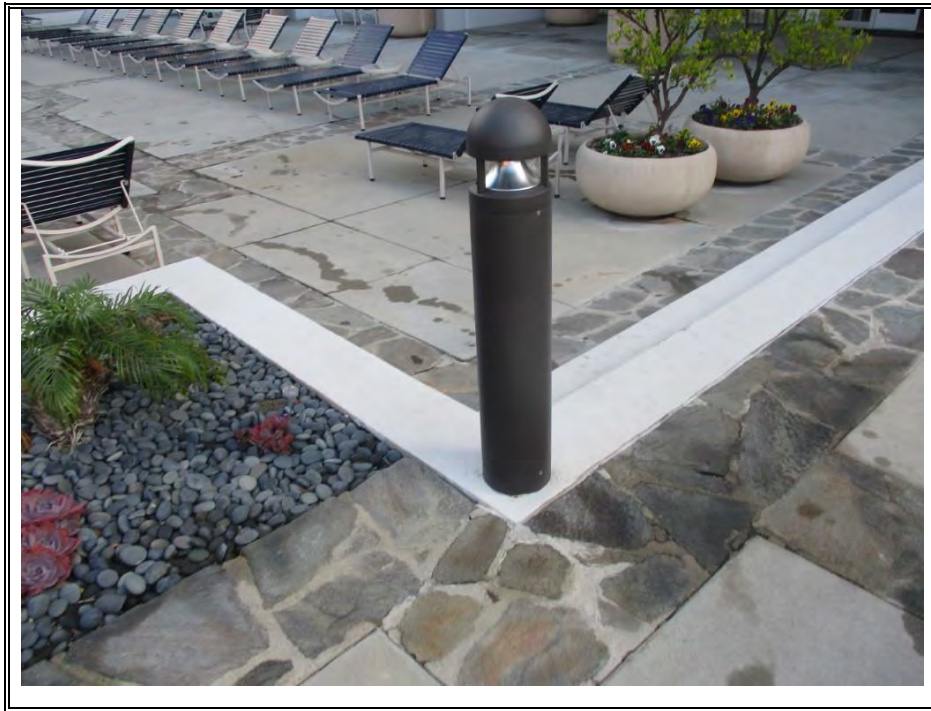
**LIGHTING-WALKWAYS (TYPICAL)**

**OBSERVATIONS:** *This component includes the coach type light fixtures at the pool area. They appeared to be in average condition. These types of fixtures are typically subject to a greater level of deterioration from the elements.*

**TO PROTECT YOUR INVESTMENT:** *Maintenance would entail periodically checking the fixtures to make sure that they are secure. Also, occasional examination for, and changing of burned out bulbs would be prudent. In addition, cleaning of the fixtures is recommended on an as-needed basis.*

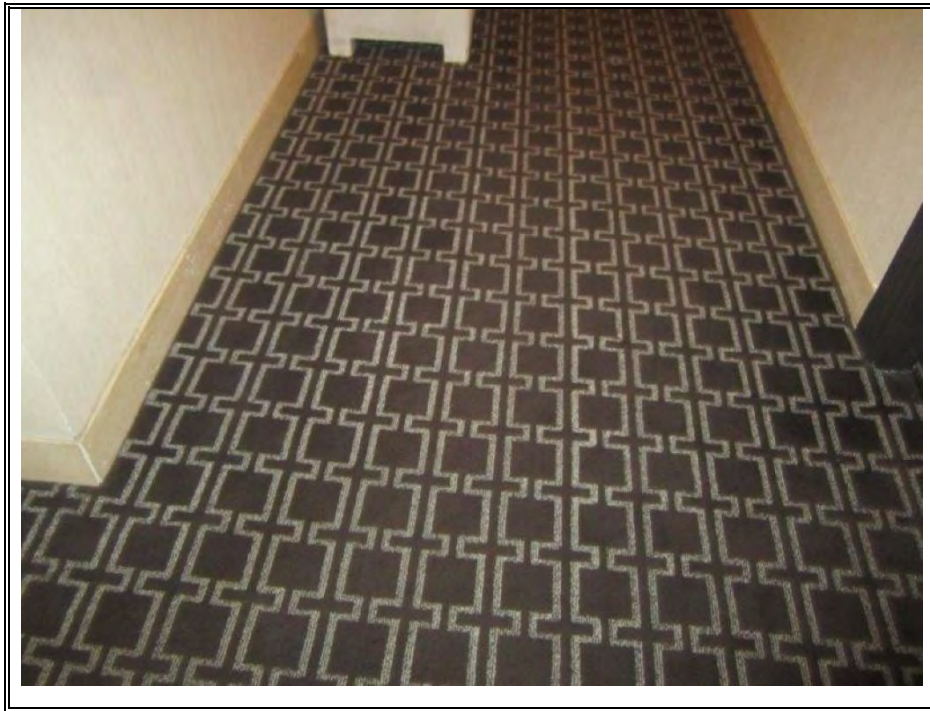
**CARPETING-HALLWAYS (TYPICAL)**

**OBSERVATIONS:** *This component includes the carpeting in the internal hallways. It appeared to be in average to aging condition*

**TO PROTECT YOUR INVESTMENT:** *Maintenance should entail regular vacuum cleaning (from once weekly to as often as daily for high traffic areas). Power pile lifting is recommended at least once a month for high traffic areas. Mats are suggested to remove dirt from shoes before it can be tracked onto carpeted areas (should be cleaned and rotated regularly to prevent soil build-up that may spread to the carpet). Spots and spills should be removed as soon as possible to prevent permanent staining. Deep cleaning should be performed on an as-needed basis (before soil is noticeable – usually not more than once every one or two years) and fluorochemical treatment applied immediately after. It is recommended that before applying any topical treatments, the carpet manufacturer be contacted to prevent voiding of the warranty. Damaged areas should be repaired as they can create a trip hazard resulting in association liability.*

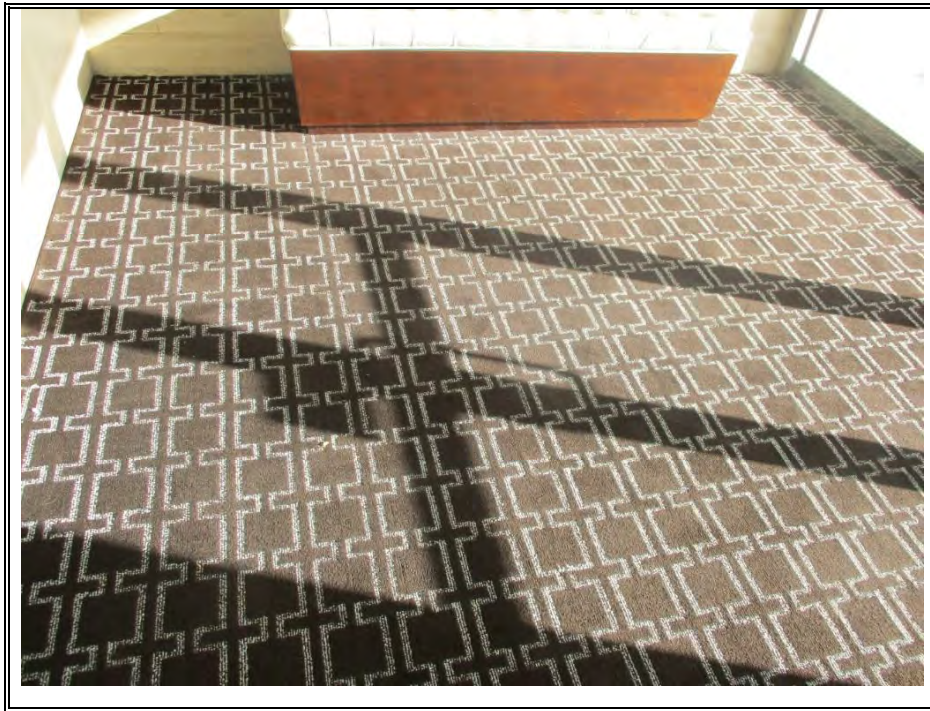
**CARPETING-LOBBY /OFFICE (TYPICAL)**

**OBSERVATIONS:** *This component includes the carpeting in the, office, lobby, and miscellaneous common areas. It appeared to be in average to aging condition.*

**TO PROTECT YOUR INVESTMENT:** *Maintenance should entail regular vacuum cleaning (from once weekly to as often as daily for high traffic areas). Power pile lifting is recommended at least once a month for high traffic areas. Mats are suggested to remove dirt from shoes before it can be tracked onto carpeted areas (should be cleaned and rotated regularly to prevent soil build-up that may spread to the carpet). Spots and spills should be removed as soon as possible to prevent permanent staining. Deep cleaning should be performed on an as-needed basis (before soil is noticeable – usually not more than once every one or two years) and fluorochemical treatment applied immediately after. It is recommended that before applying any topical treatments, the carpet manufacturer be contacted to prevent voiding of the warranty. Damaged areas should be repaired as they can create a trip hazard resulting in association liability.*

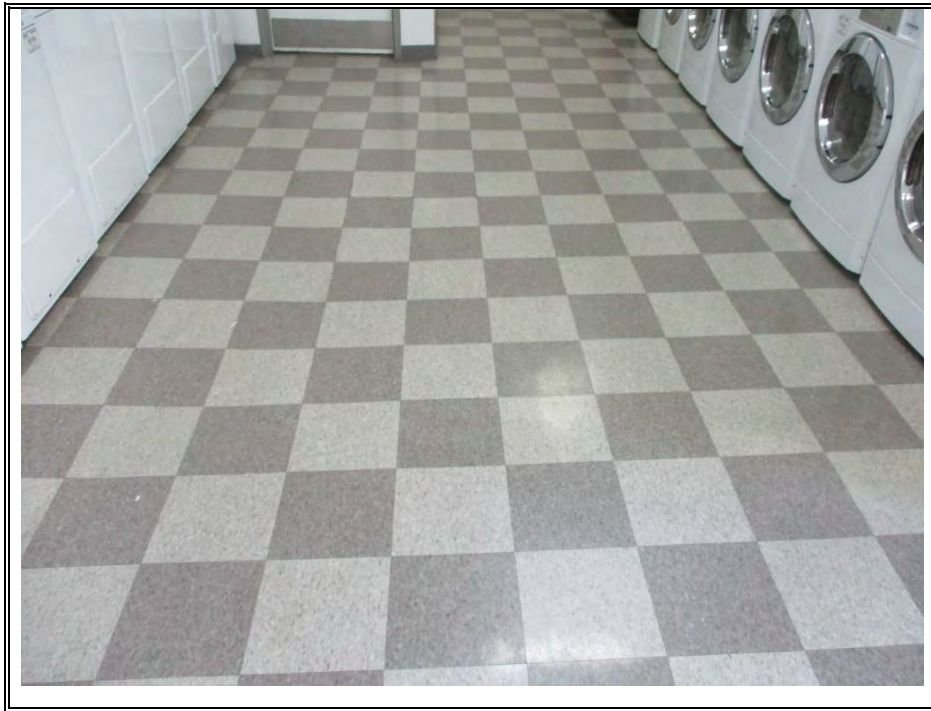
**VINYL (TYPICAL)**

**OBSERVATIONS:** *This component includes the vinyl squares flooring in the laundry room, hallways, trash chutes, and miscellaneous common areas. We were previously informed that it was installed in 2013 and it appeared to be in good condition.*

**TO PROTECT YOUR INVESTMENT:** *Maintenance would entail regular cleaning with a mild detergent solution and warm water (care should be exercised to not flood the flooring). Do not use paste or solvent-based wax. Rubber backed rugs should be avoided as they can discolor the vinyl flooring. Soil collecting mats are recommended to remove dirt from shoe soles before it can be tracked onto the vinyl (they should be cleaned and rotated regularly to prevent soil build-up that will spread to the vinyl). Lifting seams, corners, etc. should be re-glued and damaged areas repaired as necessary.*

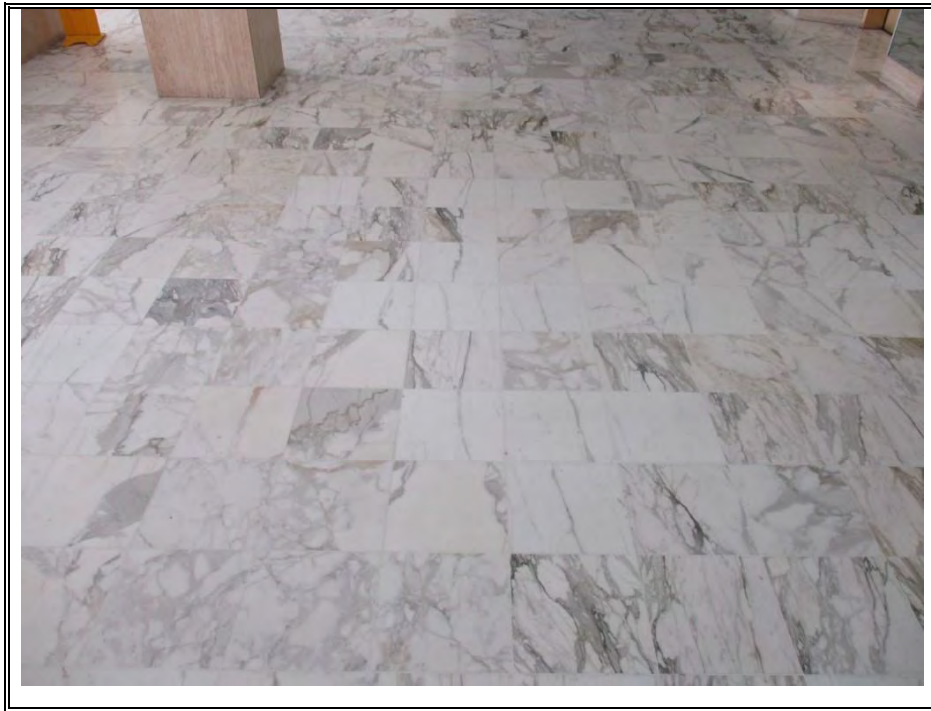
**MARBLE-RESTORATION (TYPICAL)**

**OBSERVATIONS:** *This component provides for the restoration of the marble flooring in the lobby and pedestrian entry to the building. Included would be epoxy grout, heavy buff, polish, buff & seal. With regular maintenance (See component ID #0705), the cycle for restoration should be at approximately 15-year intervals. If restored, this material would be considered to be a lifetime component. Therefore, no amount has been provided for its replacement.*

**TO PROTECT YOUR INVESTMENT:** *Only a mild soap and water solution should be used. Proprietary cleaners and sealers are discouraged. It is suggested that the marble be professionally cleaned on an annual basis.*

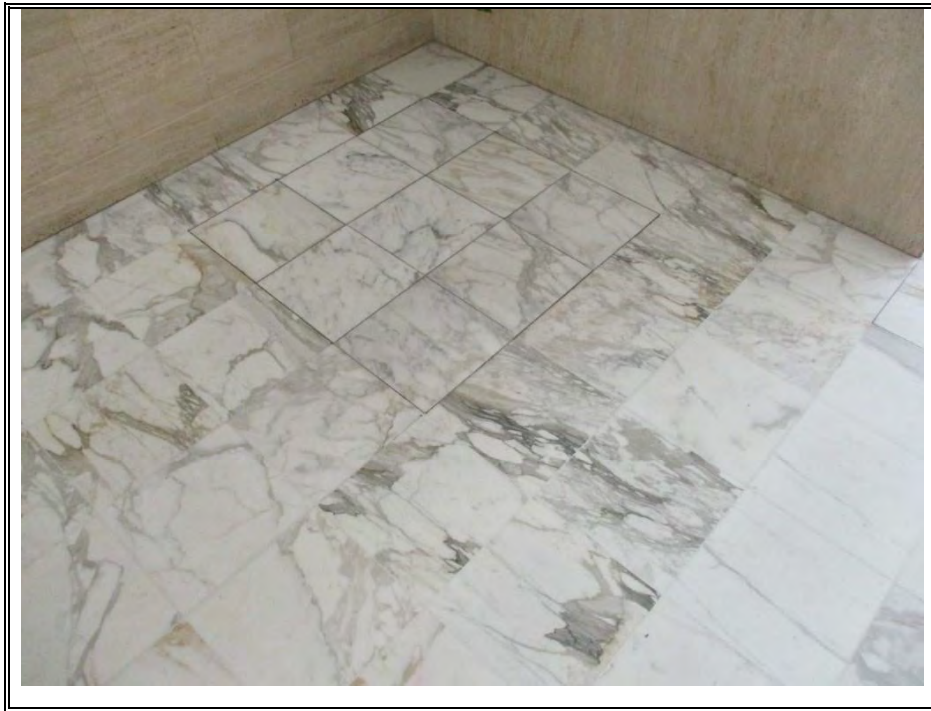
**MARBLE-POLISHING (TYPICAL)**

**OBSERVATIONS:** *This component provides for more frequent buffing and polishing of the flooring mentioned in component ID #0704. Frequent polishing is suggested to maintain the high aesthetic value projected by this complex. It appeared to be in average condition.*

**TO PROTECT YOUR INVESTMENT:** *Only a mild soap and water solution should be used. Proprietary cleaners and sealers are discouraged. It is suggested that the marble be professionally cleaned on an annual basis.*

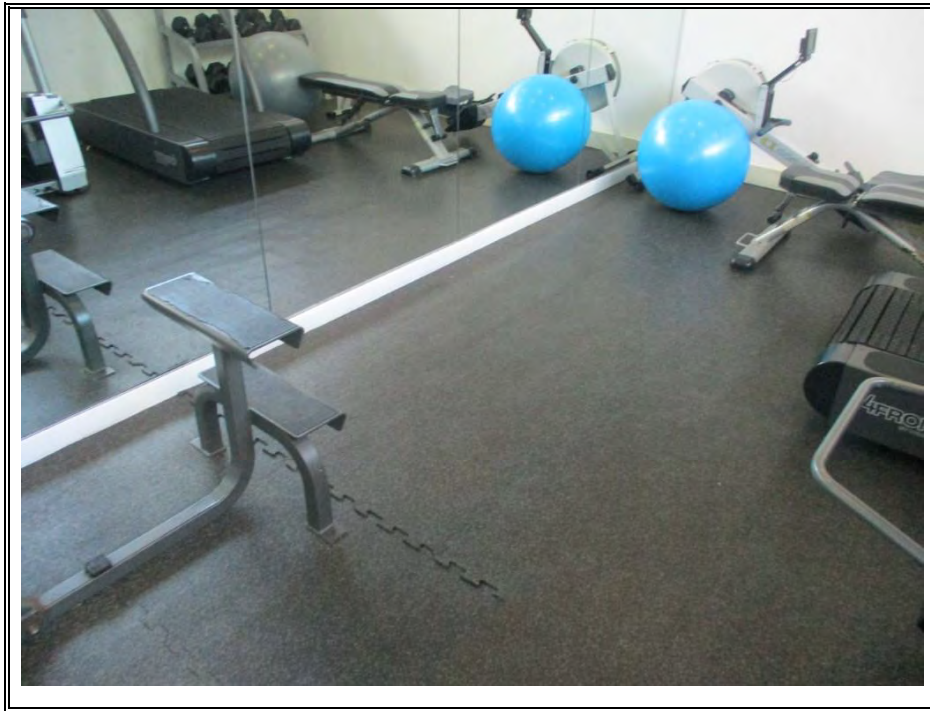
**RUBBER-FLOORING-GYM (TYPICAL)**

**OBSERVATIONS:** *This component includes the rubber flooring in the gym. We were previously informed that it was installed in 2012, and it appeared to be in average condition.*

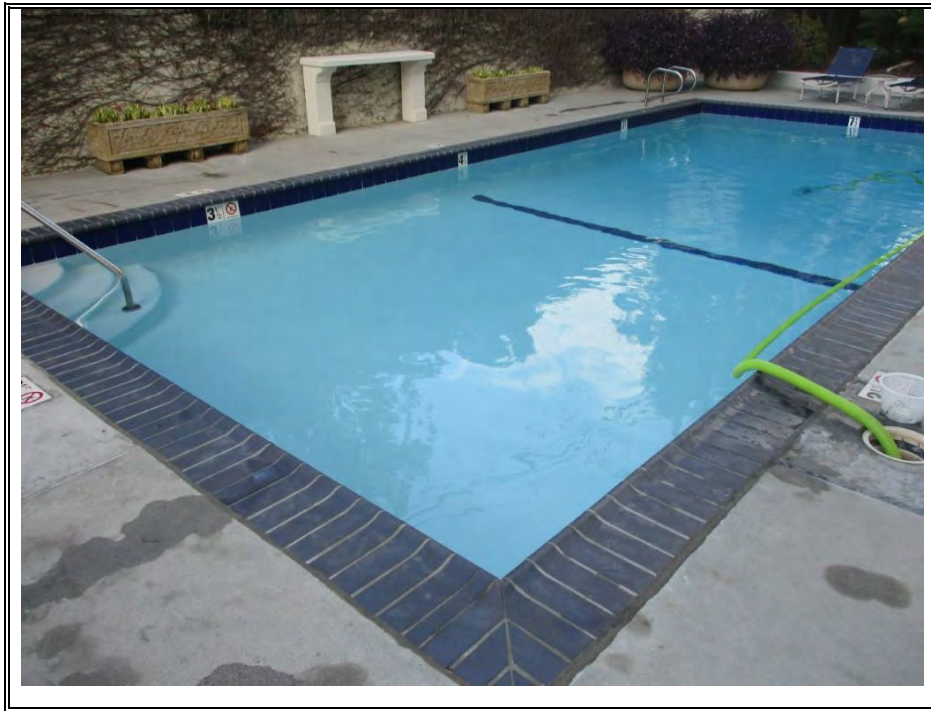
**PLASTER-POOL (TYPICAL)**

**OBSERVATIONS:** *This component includes the plaster lining of the pool. We were previously informed that it was applied in 2016 and it appeared to be in good condition. Coarseness of the plaster, which occurs over time, is conducive to algae growth and can be injurious to users of the pool (potential association liability).*

**TO PROTECT YOUR INVESTMENT:** *Maintenance of a clean surface and proper chemical balance is essential for the longevity of the plaster lining.*

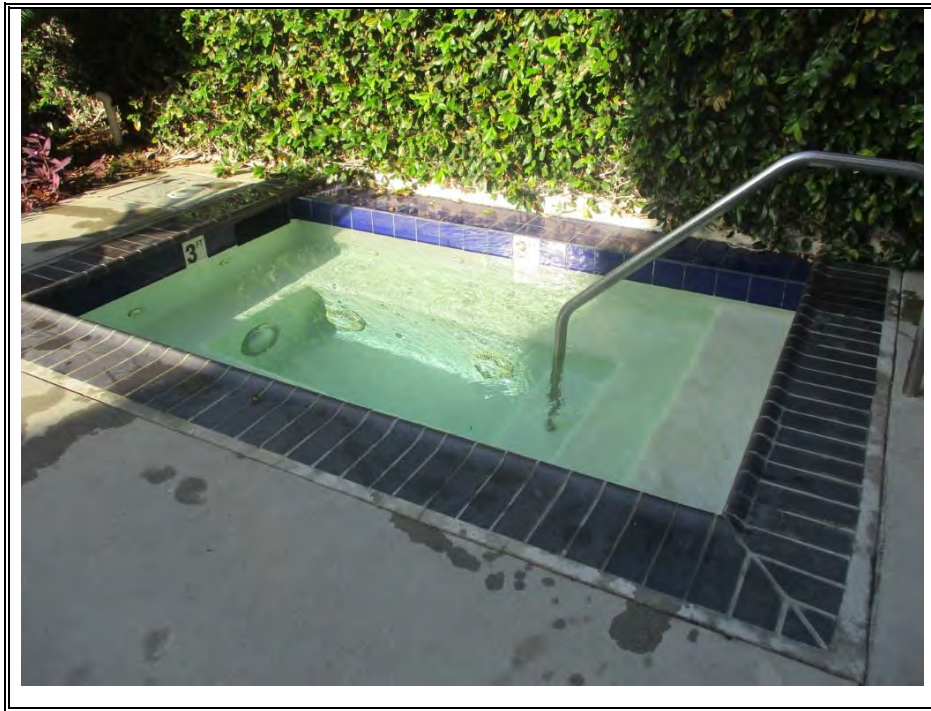
**PLASTER- SPA (TYPICAL)**

**OBSERVATIONS:** *This component includes the plaster lining of the spa. We were previously informed that it was applied in 2016 and it appeared to be in good condition. Coarseness of the plaster, which occurs over time, is conducive to algae growth and can be injurious to users of the pool (potential association liability).*

**TO PROTECT YOUR INVESTMENT:** *Maintenance of a clean surface and proper chemical balance is essential for the longevity of the fiberglass shell.*
