RESERVE STUDY - MARCH 9, 2023

High Rise Homeowners Association (Sample Only)  
3525 Main Street  
Los Angeles, California

# TABLE OF CONTENTS

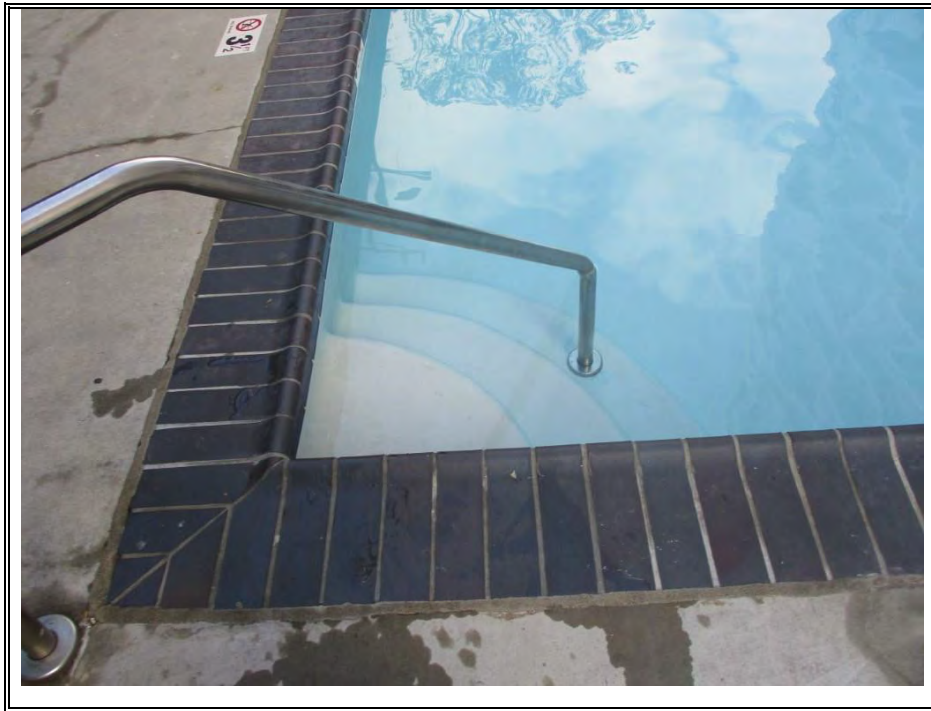
**COPING JOINT (TYPICAL)**

**OBSERVATIONS:** *This component includes the caulking for the control joint (gap) between the pool and spa decking and the coping. We were previously informed that it was installed in 2016 and it appeared to be in average condition.*

**TO PROTECT YOUR INVESTMENT:** *Maintenance of a well-sealed joint will reduce the potential for cracking and settlement of the pool decks. Prior to subsequent re-caulking of the coping joint, the existing caulk should be removed first. Otherwise, little by way of maintenance can be performed for this component.*

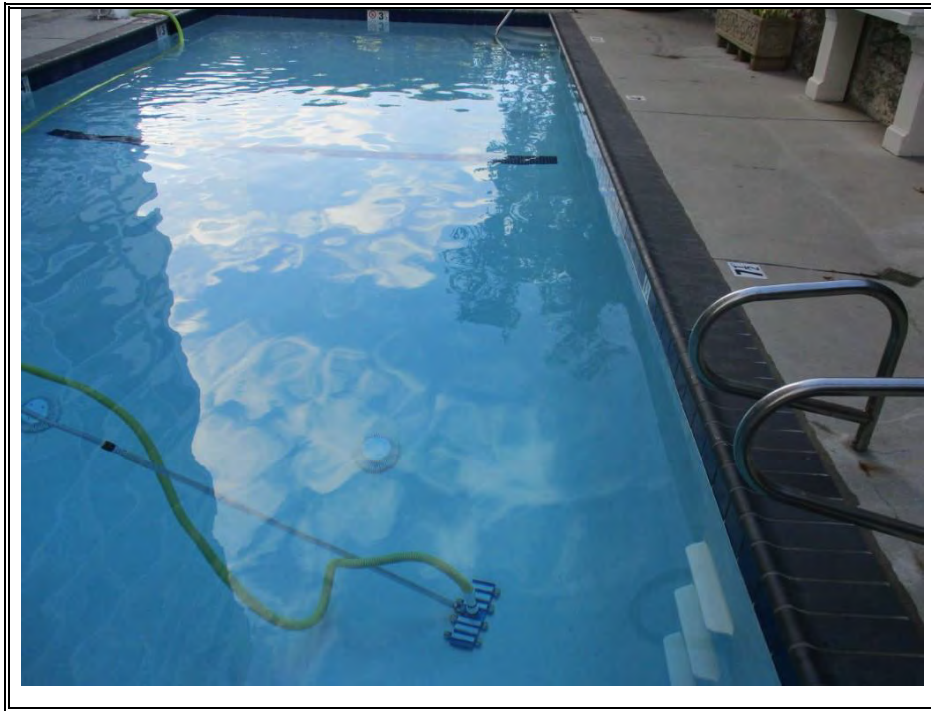
**COPING/TILE (TYPICAL)**

**OBSERVATIONS:** *This component includes the coping and tile around the perimeter of the pool and spa. We were previously informed that it was installed in 2016 and it appeared to be in good condition. It is suggested that replacement be coordinated with alternate re-plastering cycles.*

**TO PROTECT YOUR INVESTMENT:** *Little by way of maintenance can be performed for the coping and tile other than regular cleaning.*

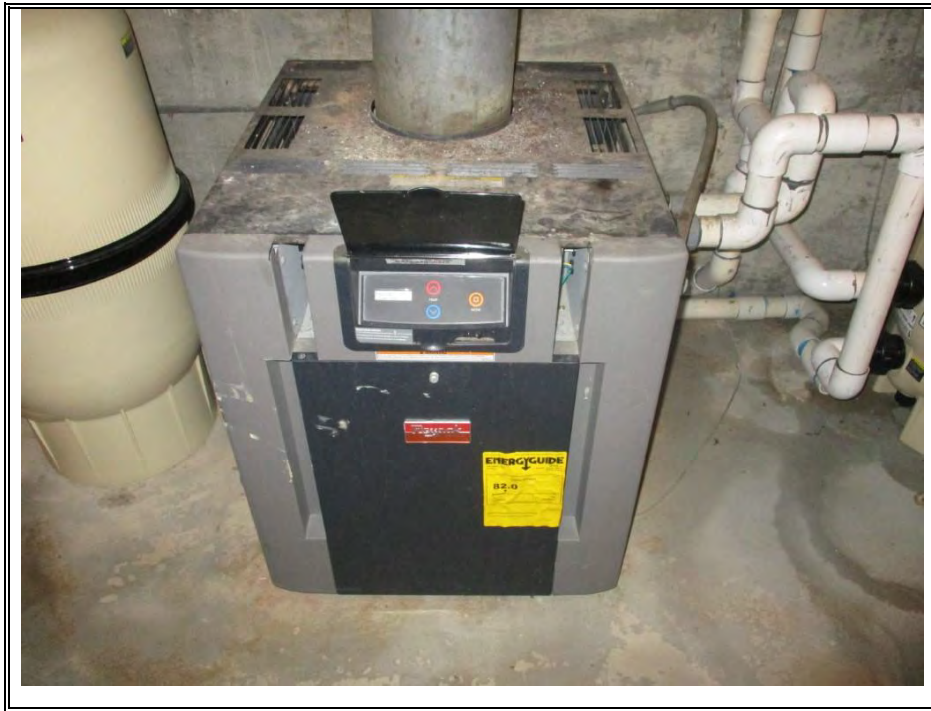
**HEATERS (TYPICAL)**

**OBSERVATIONS:** *This component includes the heaters for the pool and spa, comprised of 1 at 332,500 BTU and 1 at 399,000 BTU. We were informed that one was installed in 2016 and for reporting purposes the remaining lives have been averaged.*

**TO PROTECT YOUR INVESTMENT:** *The heaters should be professionally cleaned and serviced on an annual basis.*

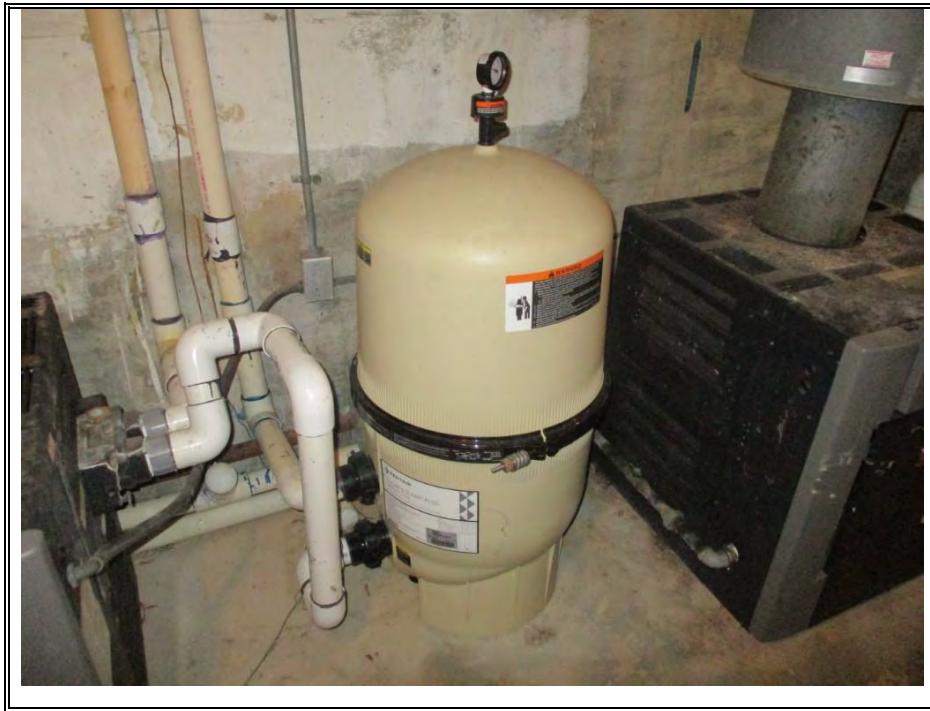
**FILTERS (TYPICAL)**

**OBSERVATIONS:** *This component includes the "Pentair" diatomaceous earth filters for the pool and spa. They appeared to be in varying conditions and for reporting purposes the remaining lives have been averaged.*

**TO PROTECT YOUR INVESTMENT:** *The filters should be regularly cleaned and the media re-charged or replaced (back-washed).*

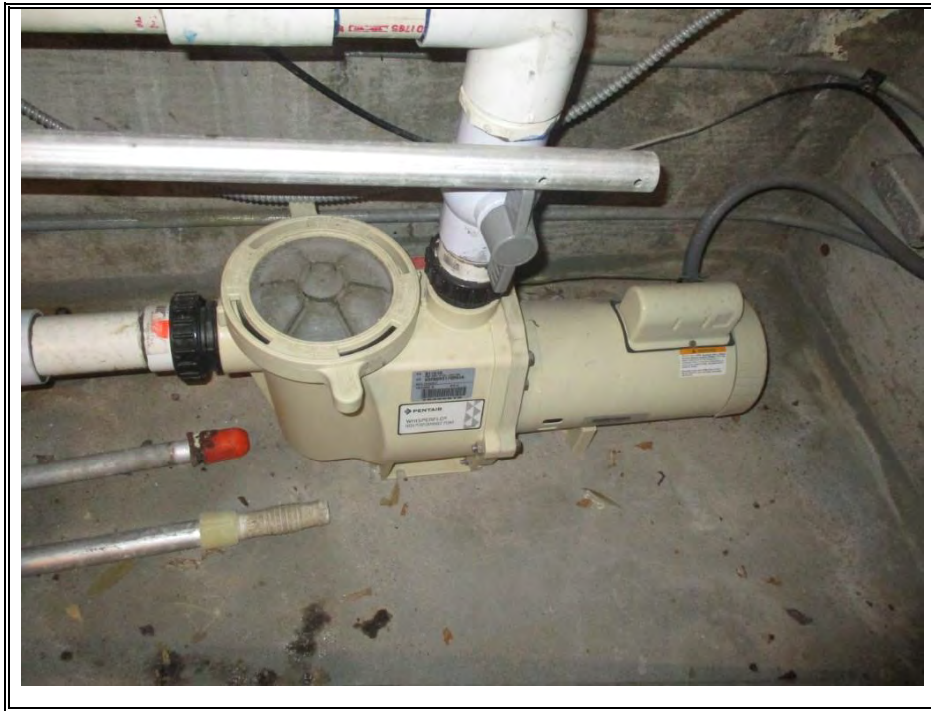
**MOTORS (TYPICAL)**

**OBSERVATIONS:** *This component includes the "A. O. Smith" motors for the pool and spa, comprised of 1 at 1 horsepower and 2 at 2 horsepower. They appeared to be in average condition.*

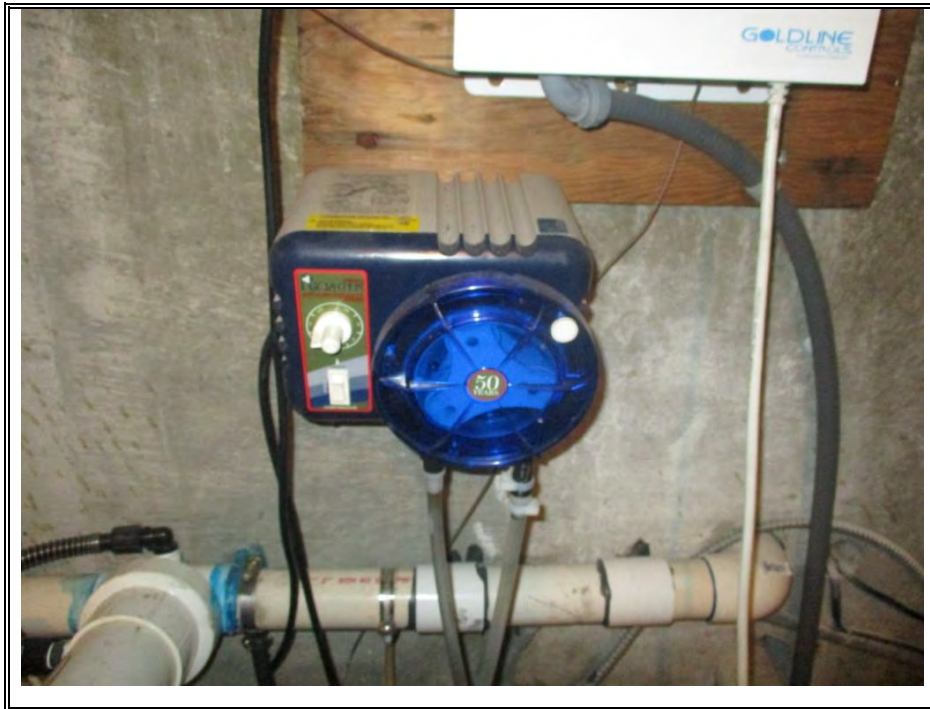
#### CHLORINATORS (TYPICAL)

**OBSERVATIONS:** *This component includes the liquid chlorinators, which add chlorine to the pool and spa water. It is recommended that any repairs / replacement be funded from the operating account on an as-needed basis.*

**TO PROTECT YOUR INVESTMENT:** *Little by way of maintenance can be performed for this component.*

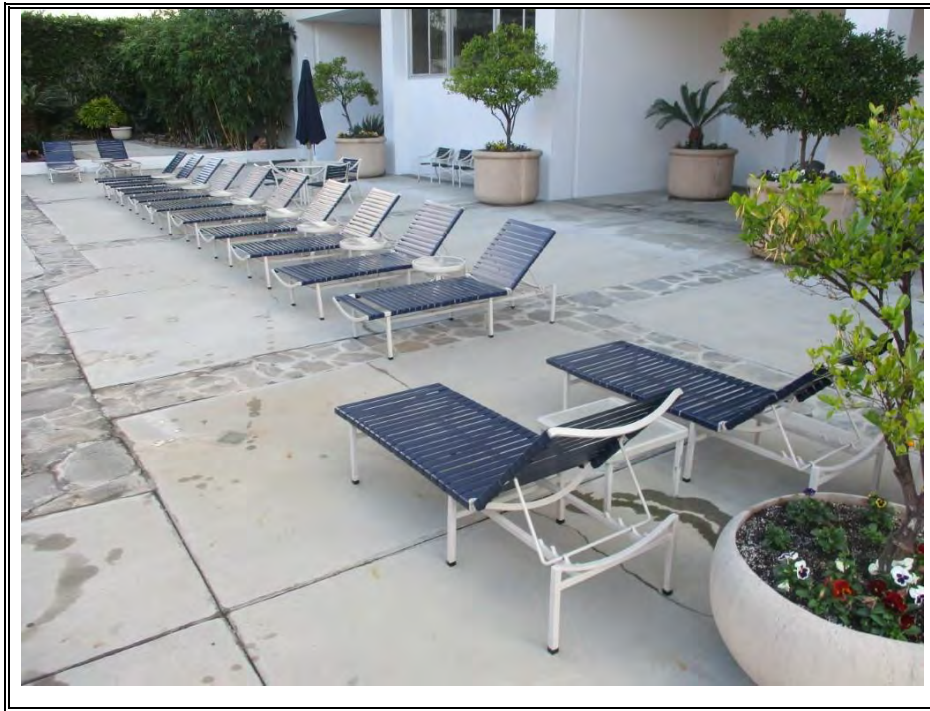
**FURNITURE-REPLACE (TYPICAL)**

**OBSERVATIONS:** *This component provides for the replacement of the furniture around the pool and spa, comprised of tables, vinyl strapped chairs, vinyl strapped chaises, and umbrellas. We were previously informed that the pool furniture was installed in 2015 and it appeared to be in good condition for its age. Exposure to dirt, dust, suntan oils, tree sap, pool chemicals, insecticide sprays, and environmental factors (especially ultraviolet light); contribute significantly to the deterioration of this type of furniture. Proper maintenance can significantly enhance its longevity.*

**TO PROTECT YOUR INVESTMENT:** *Vinyl strapped furniture should be hosed down on a weekly basis and a vinyl protection product applied regularly (cleansers, undiluted bleach, scouring agents, solvents, and gasoline should never be used). The painted metal frames should occasionally be cleaned with a mild soap and water solution, and an automotive wax applied seasonally. Acrylic/plastic tabletops can be protected / restored with automotive wax as well. Umbrella fabrics can be cleaned with a solution of 1cup of bleach mixed with 1cup of dish detergent in 3 gallons of water. Corrosion on aluminum umbrella poles can be removed with an aluminum brightener. If possible, the furniture should be covered/put in storage when not in use (especially during off-season).*

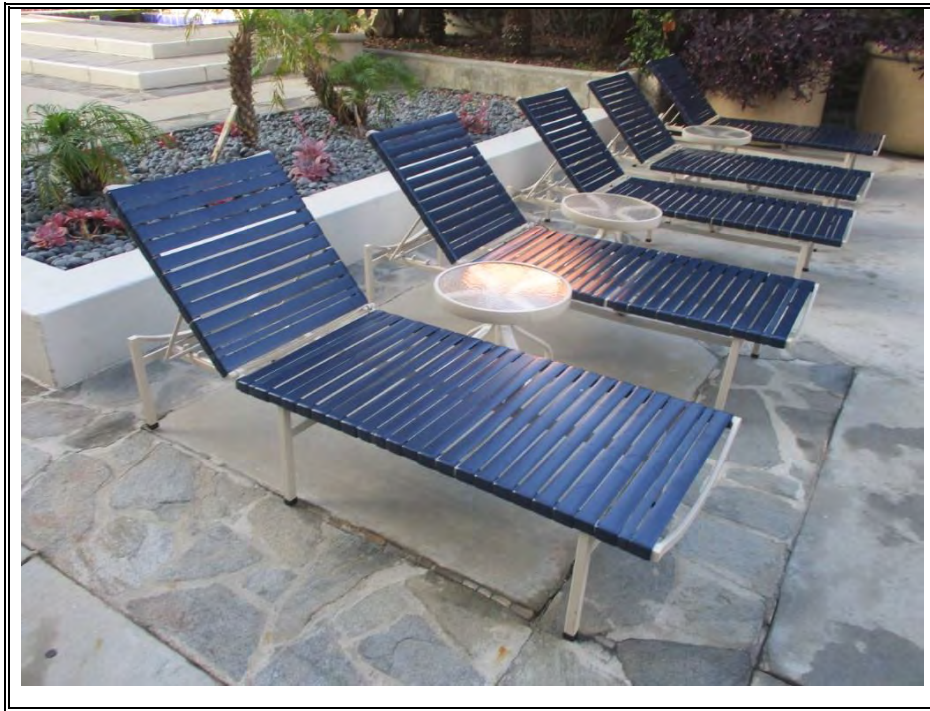
**FURNITURE-REFURBISH (TYPICAL)**

**OBSERVATIONS:** *This component provides for the refurbishment of the furniture identified in component ID #0810. As this furniture is of an average quality, it would lend itself towards refurbishment, usually at 5-year intervals, prior to complete replacement becoming necessary.*

**TO PROTECT YOUR INVESTMENT:** *Vinyl strapped furniture should be hosed down on a weekly basis and a vinyl protection product applied regularly (cleansers, undiluted bleach, scouring agents, solvents, and gasoline should never be used). The painted metal frames should occasionally be cleaned with a mild soap and water solution, and an automotive wax applied seasonally. Acrylic/plastic tabletops can be protected / restored with automotive wax as well. Umbrella fabrics can be cleaned with a solution of 1cup of bleach mixed with 1cup of dish detergent in 3 gallons of water. Corrosion on aluminum umbrella poles can be removed with an aluminum brightener. If possible, the furniture should be covered/put in storage when not in use (especially during off-season).*

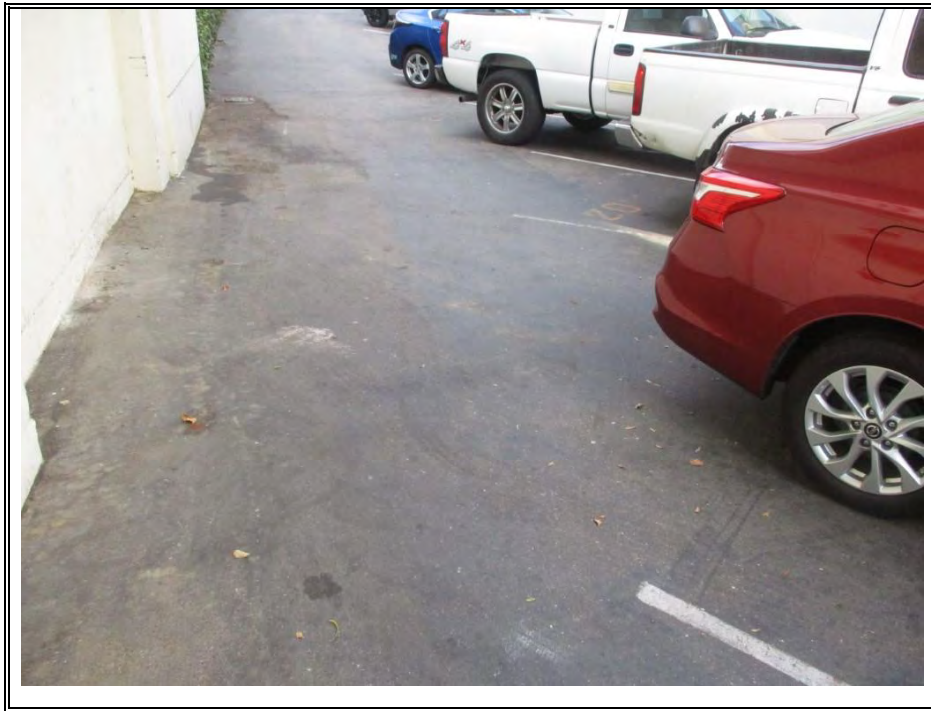
**ASPHALT SEAL COAT (TYPICAL)**

**OBSERVATIONS:** *This component includes the seal coat for the asphalt parking area at the east end of the property. We were previously informed that it was applied in 2012 and it appeared to be in aging condition. While a relatively inexpensive procedure, the seal coat serves to enhance the longevity of the underlying asphalt as well as its appearance by replenishing the oil and fine aggregates of the underlying asphalt. It is important that this procedure always be undertaken within 6 months of any overlay or resurfacing and performed thereafter on a 3 – 5 year cycle (typically a warranty requirement). See component ID #0902 for further comments.*

**TO PROTECT YOUR INVESTMENT:** *All asphalt areas should be examined at least annually and any cracks exceeding ¼ inch should be repaired with a rubberized sealant compound. Irrigation run-off can accelerate degradation and should be prevented / diverted.*

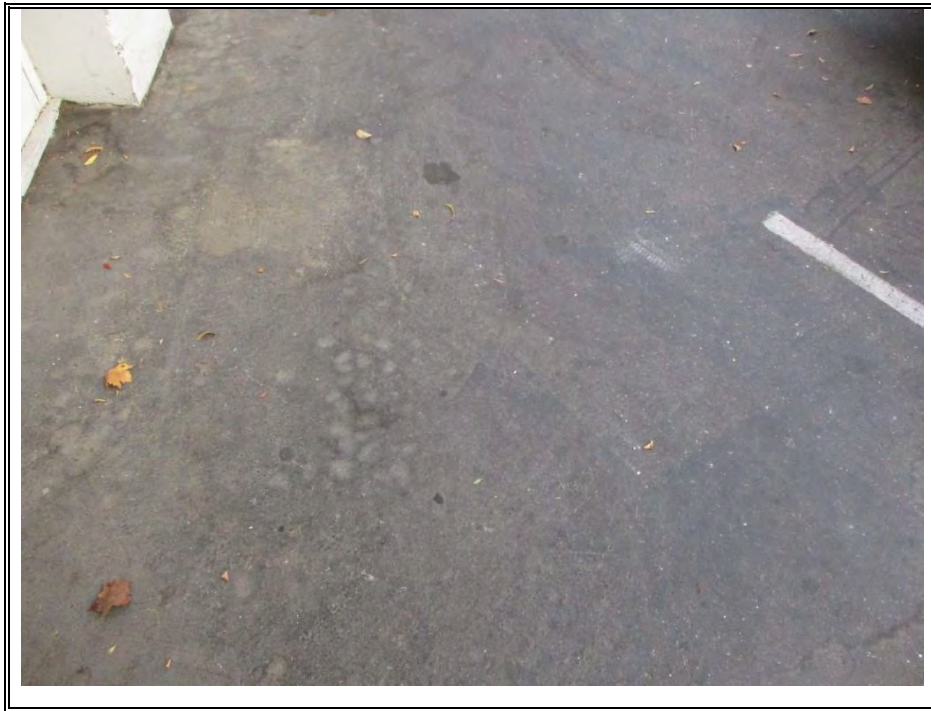
**ASPHALT REPLACEMENT (TYPICAL)**

**OBSERVATIONS:** *This component provides for replacement of the asphalt surfaces described in component ID #0901. We were previously informed they were replaced in 2012 and they appeared to be in good to average condition. Aging, oxidation, and vehicle traffic eventually cause cracking, ponding and uneven pavement. Such surface irregularities may result in improper drainage and compromised driving surfaces. Asphalt replacement entails removal of the existing pavement, grading and compaction of the existing aggregate base material, and the installation of hot asphalt pavement. It is recommended that pavement engineering be obtained prior to replacement in order to guarantee that new pavement specifications will meet or exceed the needs of the common area pavement. In conjunction with replacement, seal coat should be performed within 6 months and then at 3 – 5 year intervals thereafter (see component ID #0901). It is recommended that prior to replacement, further evaluation be obtained from a soils/geotechnical engineer.*

**TO PROTECT YOUR INVESTMENT:** *All asphalt areas should be examined at least annually and any cracks exceeding ¼ inch should be repaired with a rubberized sealant compound. Irrigation run-off can accelerate degradation and should be prevented / diverted.*

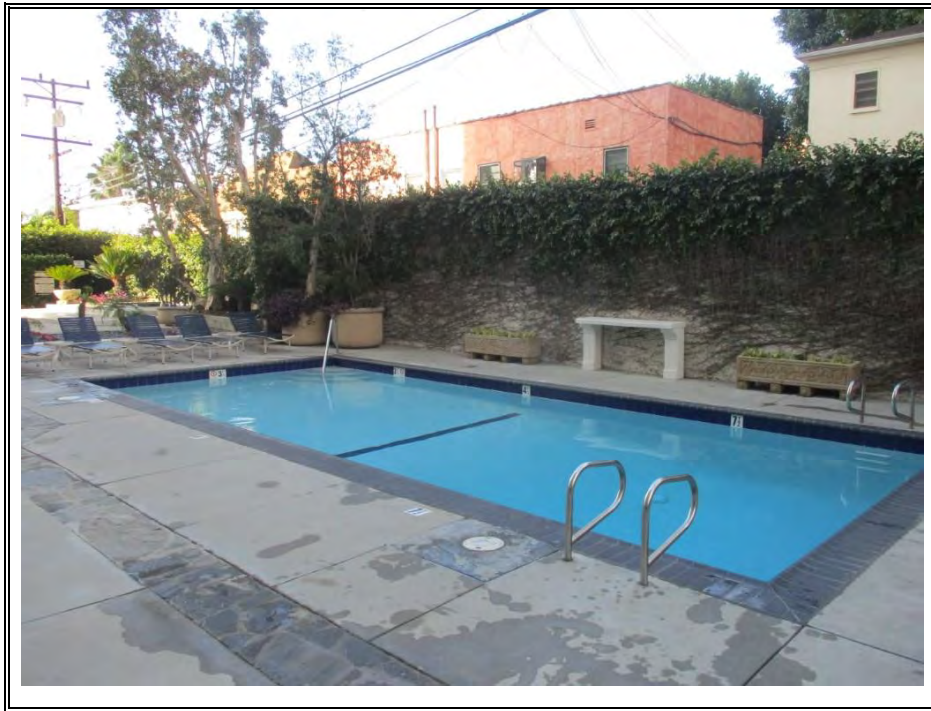
**CONCRETE FLATWORK/BLOCK WALLS (TYPICAL)**

**OBSERVATIONS:** *This component includes the concrete flatwork and block walls throughout the property. Although they appeared to be in average condition, they should be regularly monitored for cracking and vertical displacement, which can create potential trip hazards (and liability for the association). Otherwise, concrete areas are generally considered a lifetime component and therefore no amount has been budgeted replacement. Occasional repairs would typically be funded from the operating account.*

**TO PROTECT YOUR INVESTMENT:** *Any sections observed to be vertically displaced should be repaired immediately upon discovery. Emphasis should be placed on areas adjacent to trees, as their roots are often the culprits of such damage. As the need for such repairs is difficult to predict, the associated costs should be disbursed either from the association's operating account or the contingency reserve (see "Component Replacement Schedule" in the Reserve Funding section of this report as well as the Glossary for more on the contingency reserve).*

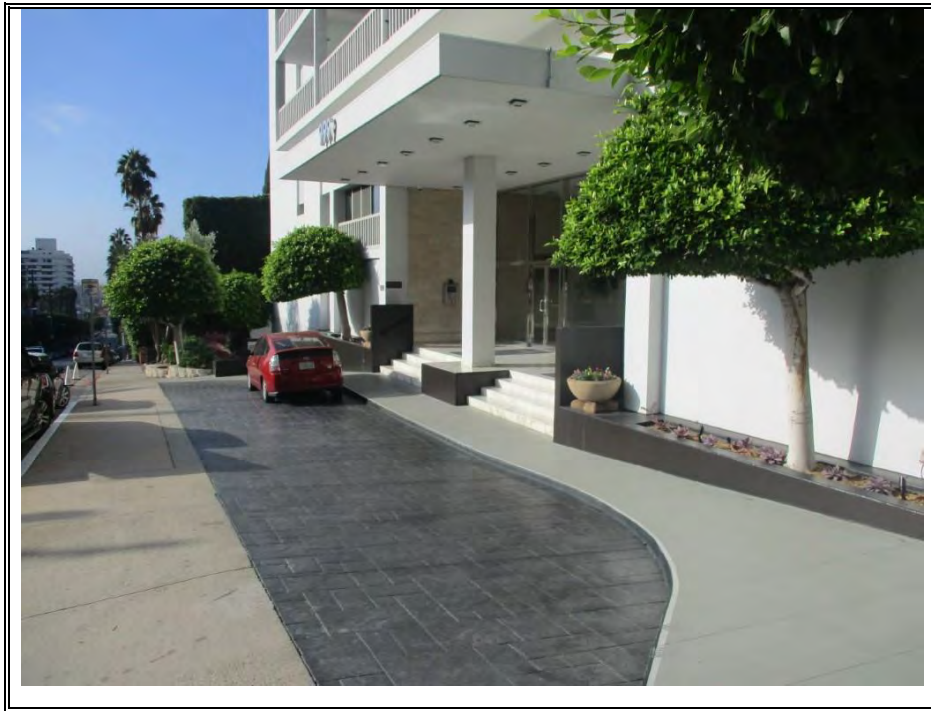
**CONCRETE PAVERS VALET PARKING (TYPICAL)**

**OBSERVATIONS:** *This component includes the concrete pavers at the valet parking area at the front of the building. We were previously informed that they were installed in 2012, and they appeared to be in good condition.*

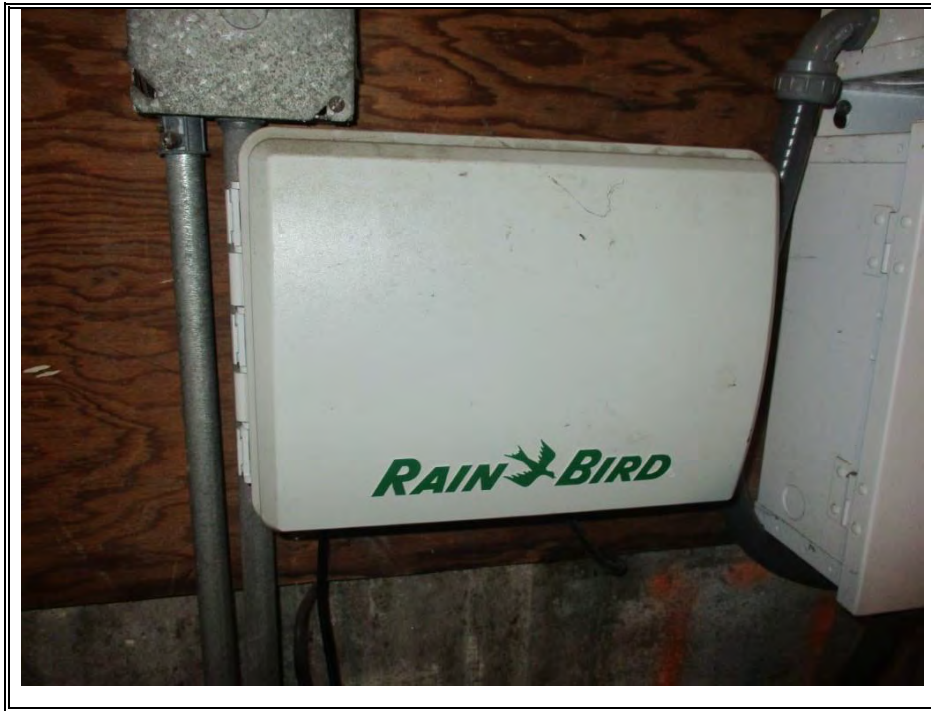
#### IRRIGATION CONTROLLERS (TYPICAL)

**OBSERVATIONS:** *This component includes the irrigation controllers at the pool equipment area and in the maintenance closet. We were previously informed that they were installed in 2014 and they appeared to be in average condition. They tend to have a more predictable life expectancy, and the average component cost provides for their replacement. However, average life expectancies cannot be predicted for the other sprinkler components or automatic valve actuation systems. Repairs / replacements of such systems usually occur on an ongoing basis and should be covered under the operating account.*

**TO PROTECT YOUR INVESTMENT:** *The irrigation system should be maintained in such a manner so as to prevent overspray onto, and water accumulations adjacent to the structures. Occasional removal and cleaning of sprinkler heads that become clogged with debris may be performed by the gardening service in order to prevent premature death of shrubbery/ground cover.*

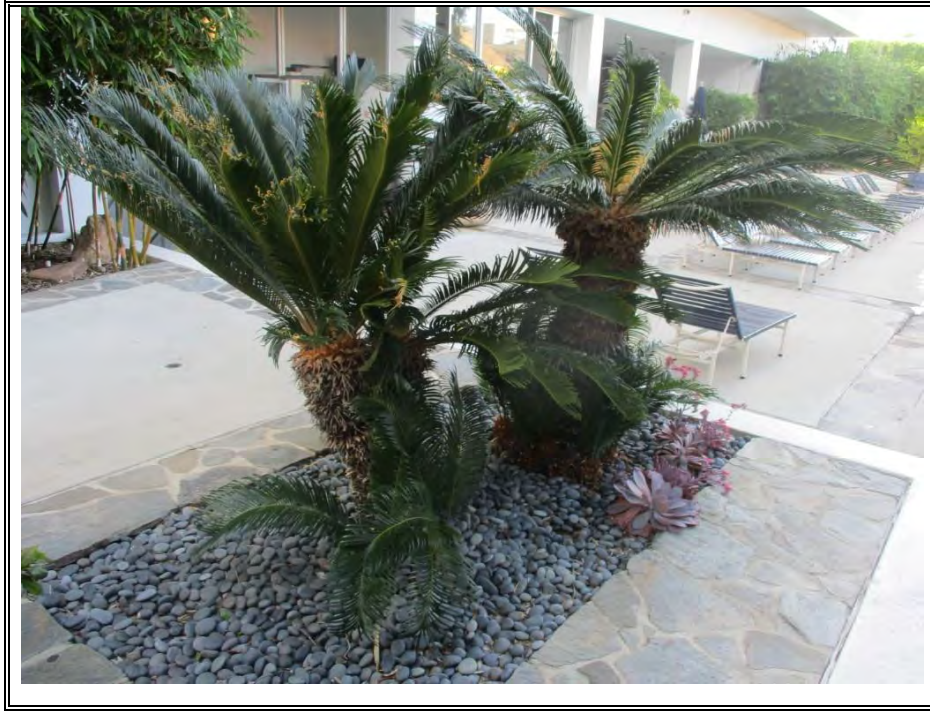
**LANDSCAPE REMODEL (TYPICAL)**

**OBSERVATIONS:** *This component provides an allowance for landscape remodeling. We were previously informed it was performed in 2015. It is recommended that the amount be periodically reviewed for adequacy.*

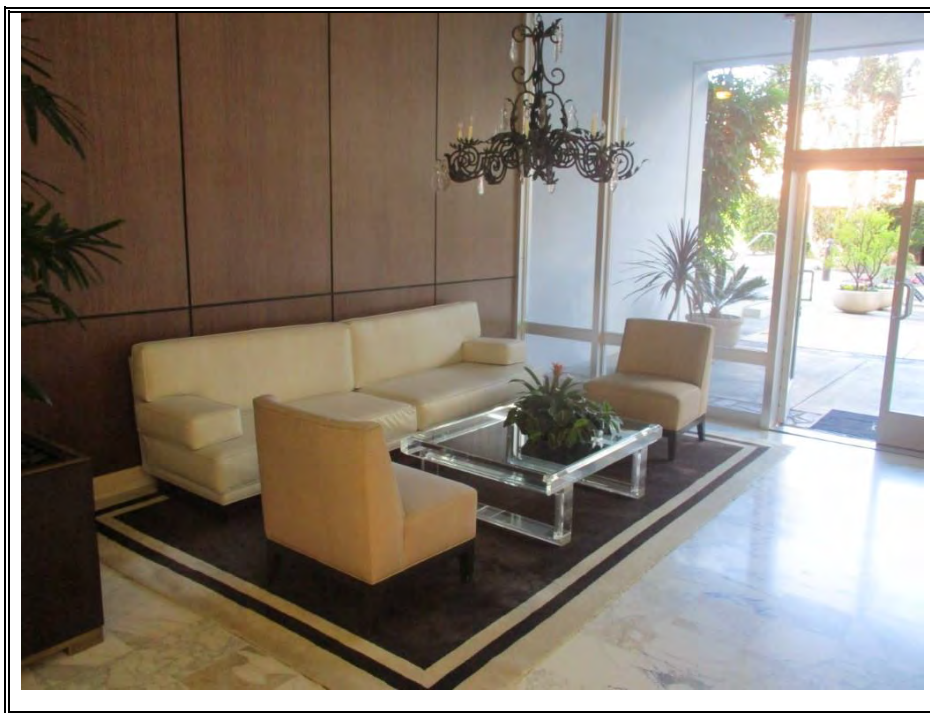
**FURNISHINGS-LOBBY (TYPICAL)**

**OBSERVATIONS:** *This component includes the furnishings in the lobby, comprised of sofas, chairs, benches, tables, wall hangings, planters, credenzas, ceiling lights, hanging lights, ash trays, and mirrors. We were previously informed the lobby was refurbished in 2006 and the furnishings appeared to be in average condition. The average component cost is general for the type of furnishings in use.*

**TO PROTECT YOUR INVESTMENT:** *General cleaning should be performed on a regular basis. Wood surfaces should be cleaned with a standard furniture polish. Upholstered areas should be vacuumed periodically and cleaned as necessary with a mild soap solution or professionally steam cleaned simultaneously with carpeted areas.*

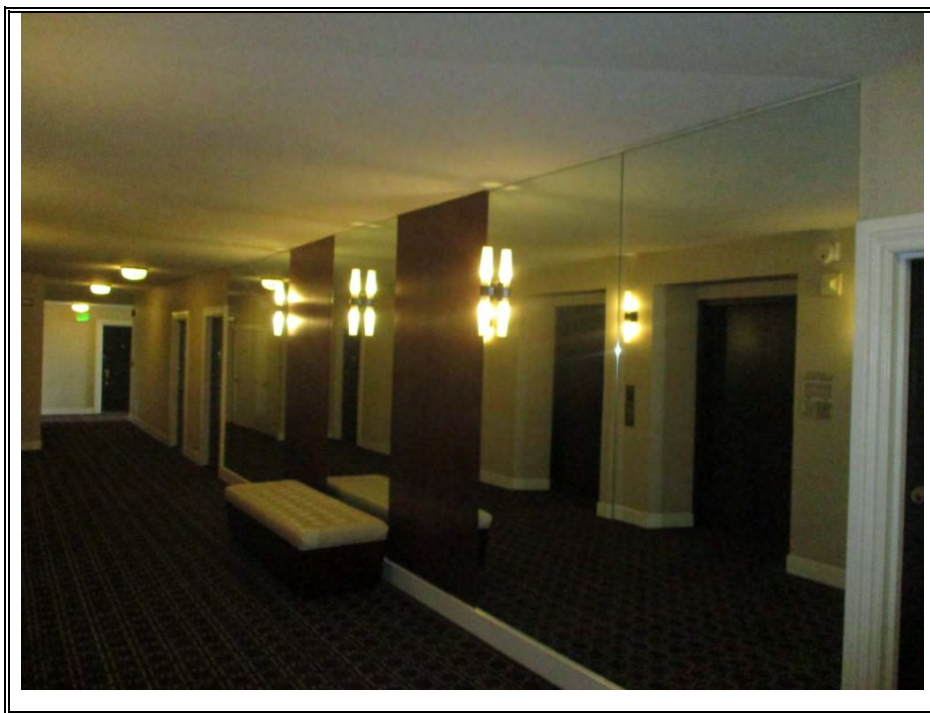
**FURNISHINGS-HALLWAYS (TYPICAL)**

**OBSERVATIONS:** *This component includes the furnishings in the hallways, comprised of wall mirrors and benches. They appeared to be in average condition for their age. The average component cost is general for the type of furnishings in use.*

**TO PROTECT YOUR INVESTMENT:** *General cleaning should be performed on a regular basis. Wood surfaces should be cleaned with a standard furniture polish. Upholstered areas should be vacuumed periodically and cleaned as necessary with a mild soap solution or professionally steam cleaned simultaneously with carpeted areas.*

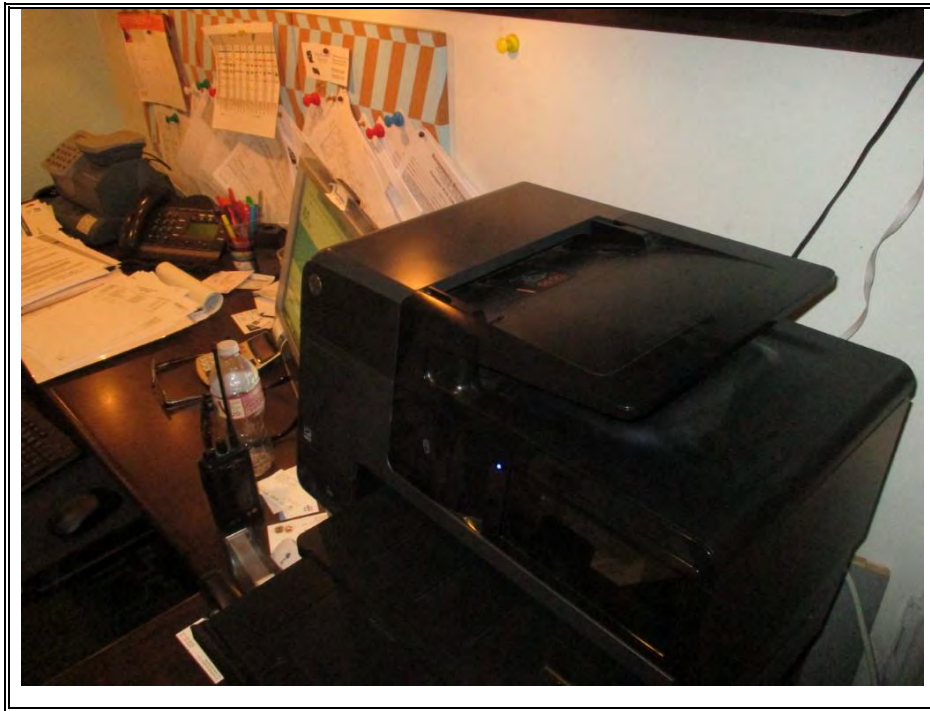
**FURNISHINGS-OFFICE (TYPICAL)**

**OBSERVATIONS:** *This component includes the office equipment in the manager's office; comprised of built-in cabinets, a wood filing cabinet, a wood book cabinet, a computer, a monitor, a copier/scanner/fax/printer, a small desk, and a desk chair. They appeared to be in average condition for their age. The average component cost is general for the type of equipment in use.*

**TO PROTECT YOUR INVESTMENT:** *Maintenance should be performed according to the various manufacturer's specifications (refer to the respective operating manuals for same).*

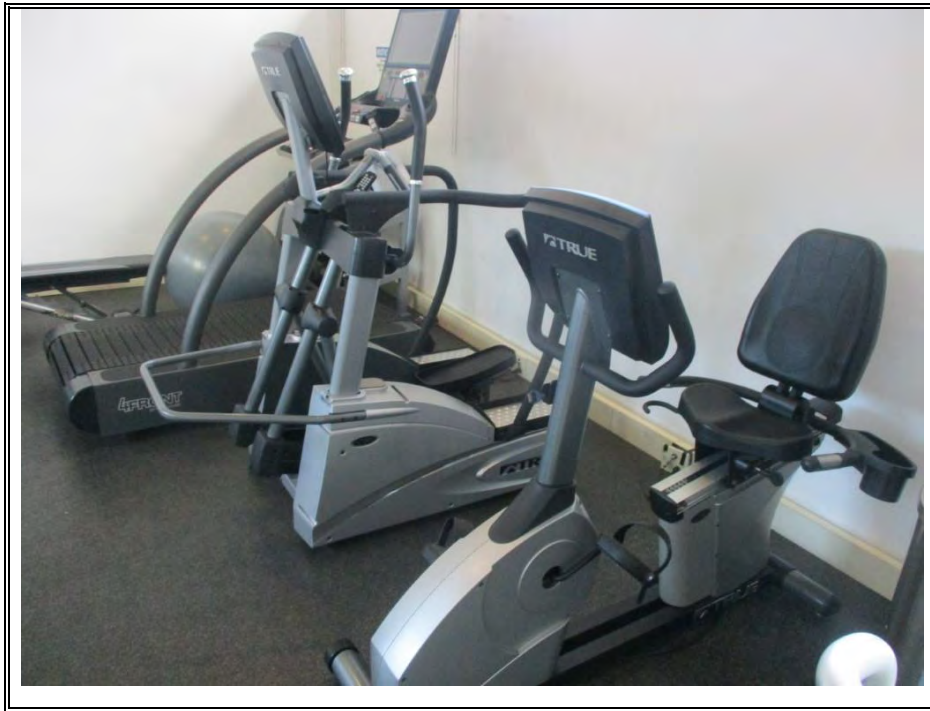
**FITNESS EQUIPMENT (TYPICAL)**

**OBSERVATIONS:** *This component includes the fitness equipment in the gym, comprised of a treadmill, an elliptical machine, a lifecycle, weight machines/benches, a newer rack with dumbbells, a resistance tower, a mirror, window treatments, a television and a fan. They appeared to be of varying ages and conditions and, for reporting purposes their remaining lives have been averaged. Some of the equipment would most likely be replaced while other items may lend themselves to being refurbished. The average component cost is general for this type of equipment.*

**TO PROTECT YOUR INVESTMENT:** *The equipment should be maintained in a sanitary condition. Applicable instructions as well as warnings should be posted with respect to proper use of the equipment.*

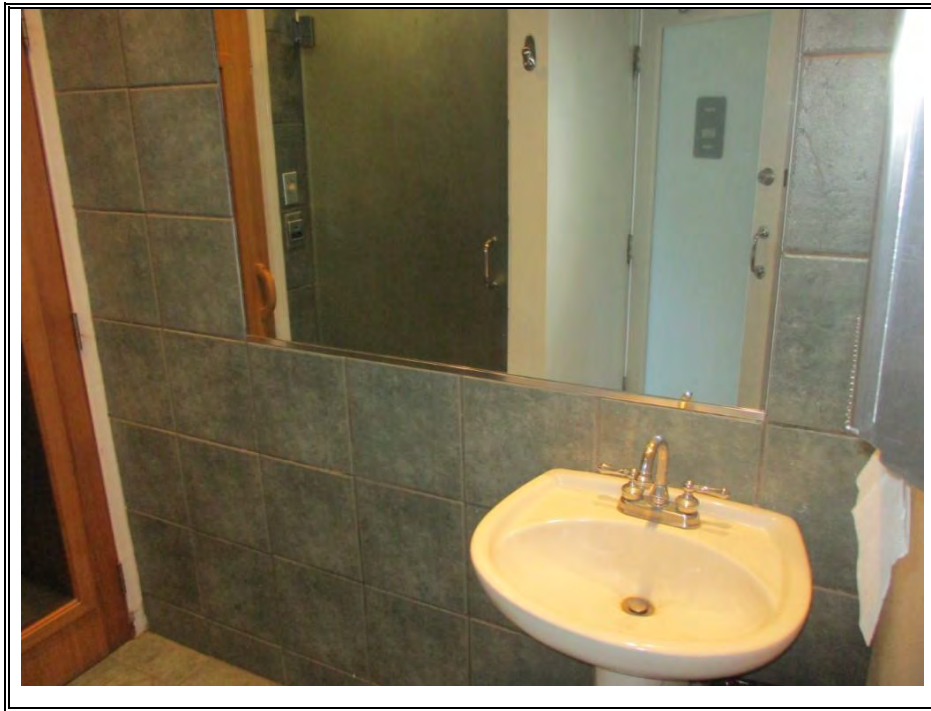
**RESTROOMS (TYPICAL)**

**OBSERVATIONS:** *This component includes the remodeling of the common area restrooms, comprised of sinks, toilets, partitions, mirrors, showers, towel dispensers, soap dispensers, and wall and floor tile. They appeared to be in average condition.*

**TO PROTECT YOUR INVESTMENT:** *The restroom should be maintained in a sanitized condition.*

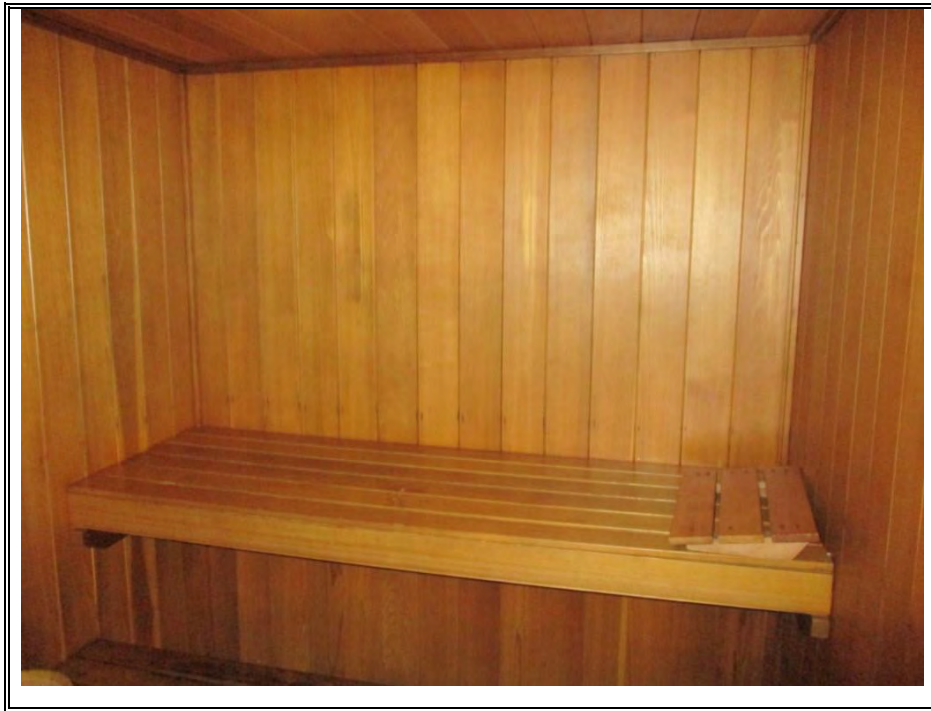
**SAUNAS-REFINISH (TYPICAL)**

**OBSERVATIONS:** *This component includes the refinishing of the 2 wooden sauna enclosures at the pool area restrooms. They appeared to be in average condition. Longevity of this component is a function of level of usage and refinishing is recommended for aesthetic as well as hygienic reasons.*

**TO PROTECT YOUR INVESTMENT:** *Maintenance of the sauna enclosure entails periodically sealing with a preservative, dependent upon level of use.*

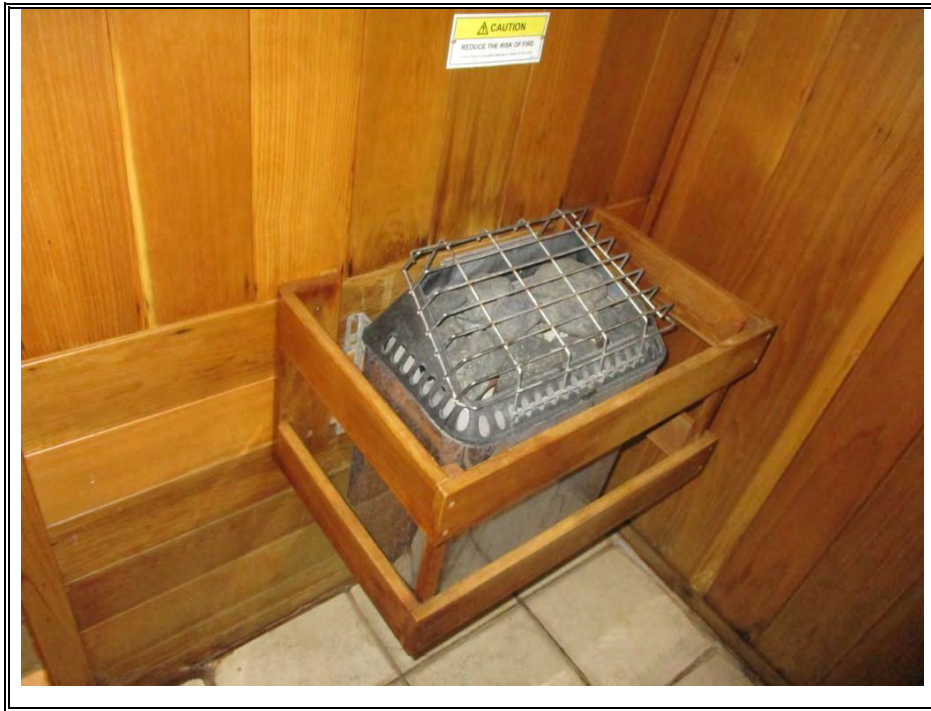
**SAUNAS-HEATERS (TYPICAL)**

**OBSERVATIONS:** *This component includes the electric sauna heaters, at 8 kilowatts each. They appeared to be in average condition. Frequency and sporadic usage are factors affecting the longevity of this component.*

**TO PROTECT YOUR INVESTMENT:** *Little by way of maintenance can be performed for the sauna heater.*

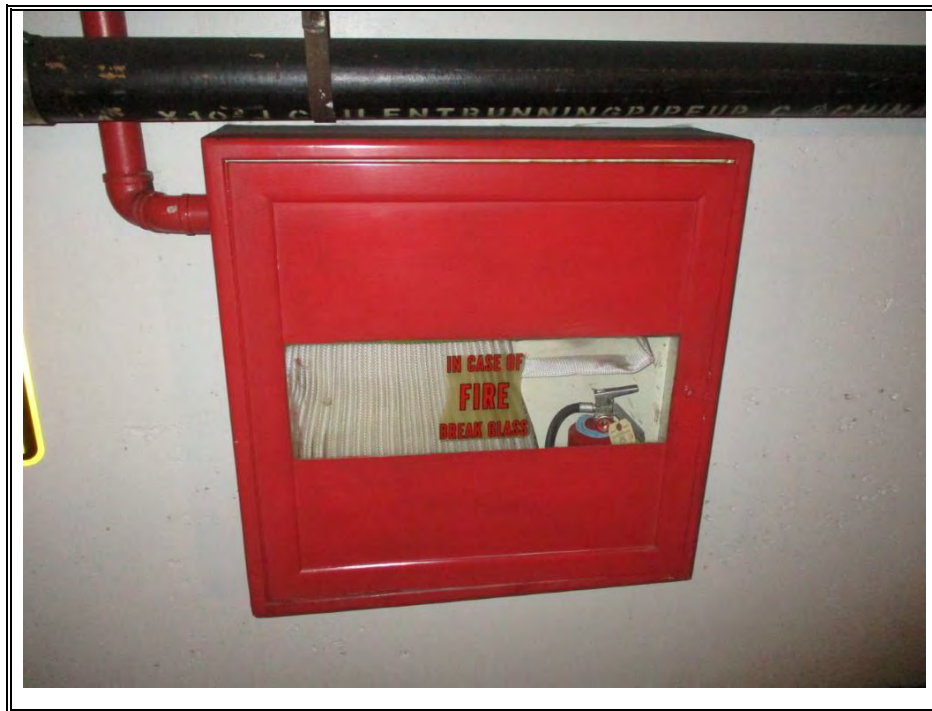
**FIRE EXTINGUISHERS (TYPICAL)**

**OBSERVATIONS:** *This component includes the fire extinguishers throughout the property. It was noted they were last serviced on 07/25/2018 and they appeared to be in good to average condition.*

**TO PROTECT YOUR INVESTMENT:** *The extinguishers should be inspected and re-charged by a State Fire Marshall approved company at a maximum of 1-year intervals (or as required by law).*

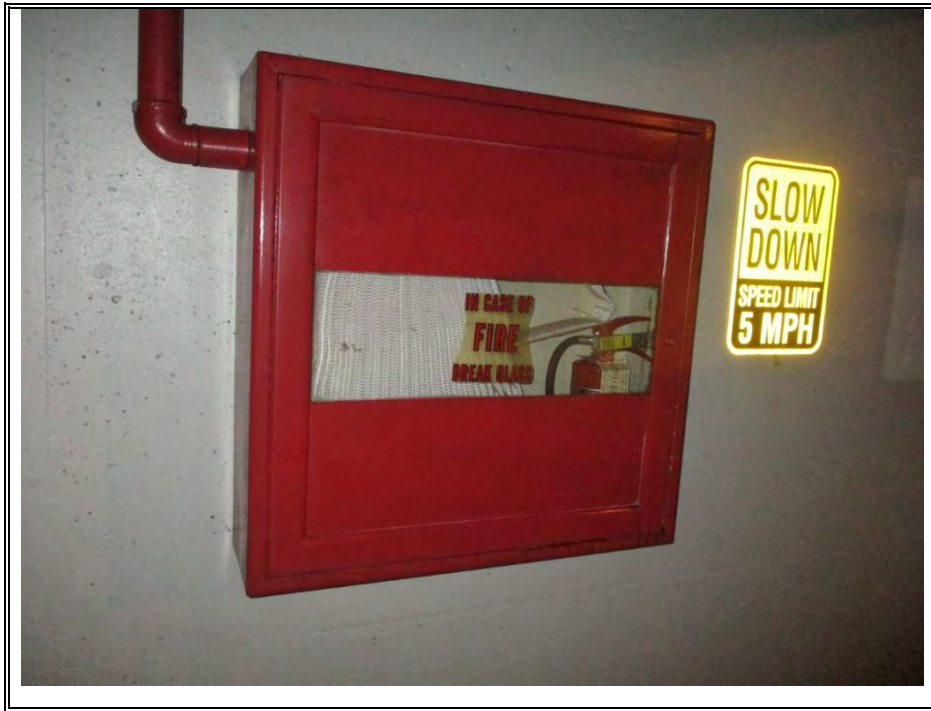
**FIREHOSES (TYPICAL)**

**OBSERVATIONS:** *This component includes the fire hoses throughout the property. They appeared to be in varying condition and, for reporting purposes their remaining lives have been averaged. The average component cost provides for replacement of only the hoses and nozzles.*

**TO PROTECT YOUR INVESTMENT:** *The fire hoses should be inspected by a State Fire Marshall approved company at a maximum of 1-year intervals (or as required by law).*

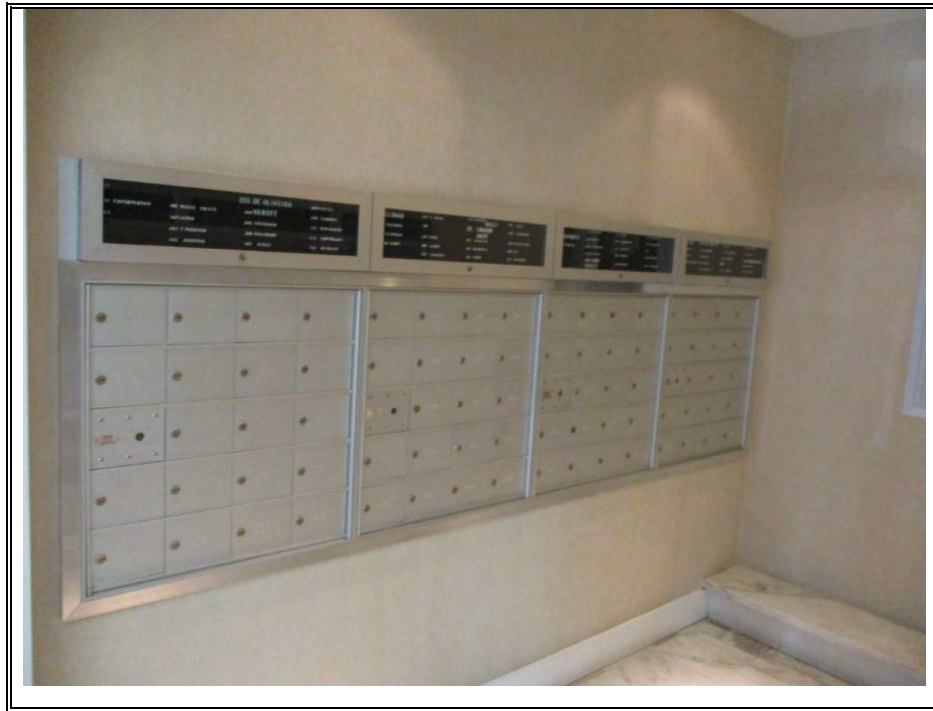
**MAILBOXES (TYPICAL)**

**OBSERVATIONS:** *This component includes the clusters of individual mailboxes at the mailbox center in the main lobby. We were previously informed that they were installed in 2013 and they appeared to be in good condition.*

**TO PROTECT YOUR INVESTMENT:** *Other than occasional lubrication of the locks, little can be performed by way of maintenance for this type of equipment.*

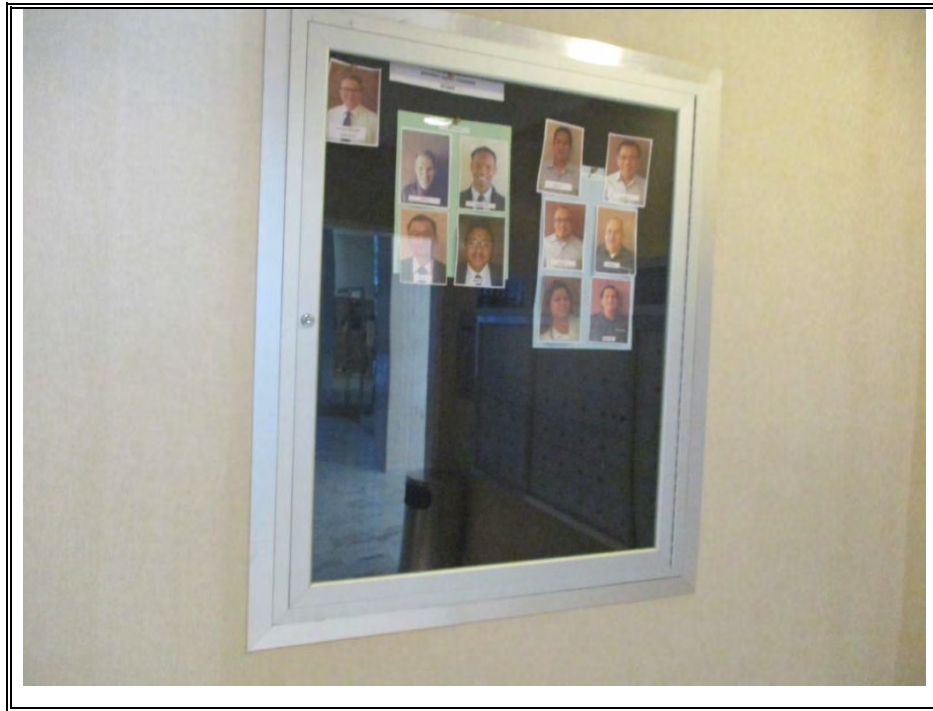
**DIRECTORY BOARDS (TYPICAL)**

**OBSERVATIONS:** *This component includes 6 medium size and 1 large size glass faced aluminum case directory boards, at the mailbox center in the main lobby. We were previously informed that they were installed in 2013 and they appeared to be in good condition.*

**TO PROTECT YOUR INVESTMENT:** *Little can be performed by way of maintenance for this type of component.*

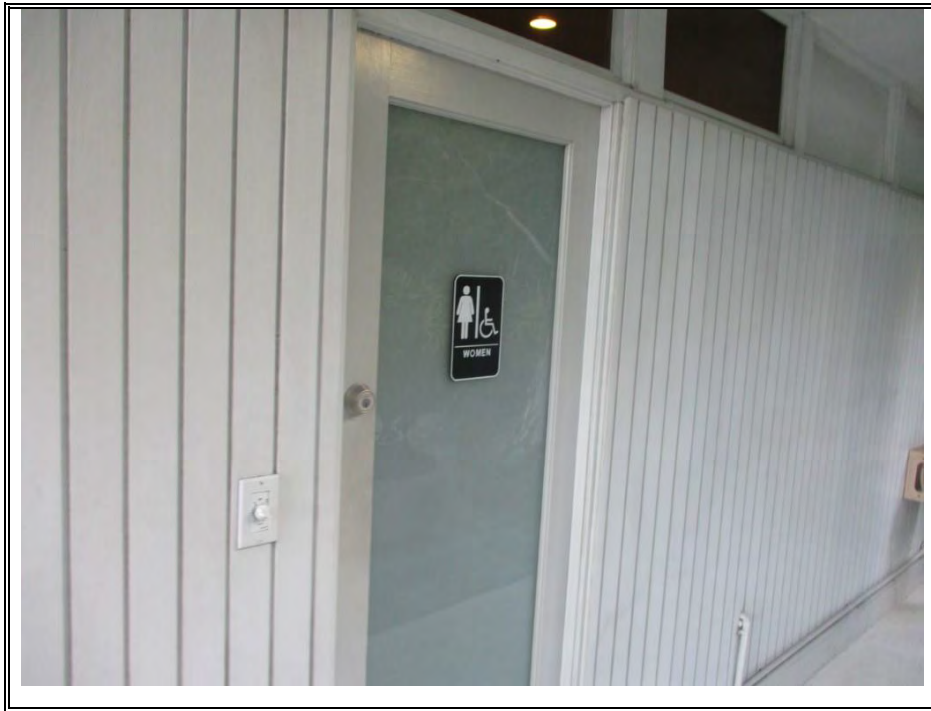
**SIGNS (TYPICAL)**

**OBSERVATIONS:** *This component includes the plastic signs throughout the property. They appeared to be in average condition. It is recommended that replacement be done on an as-needed basis and funded from the operating account.*

**TO PROTECT YOUR INVESTMENT:** *Little can be performed by way of maintenance for this type of component.*

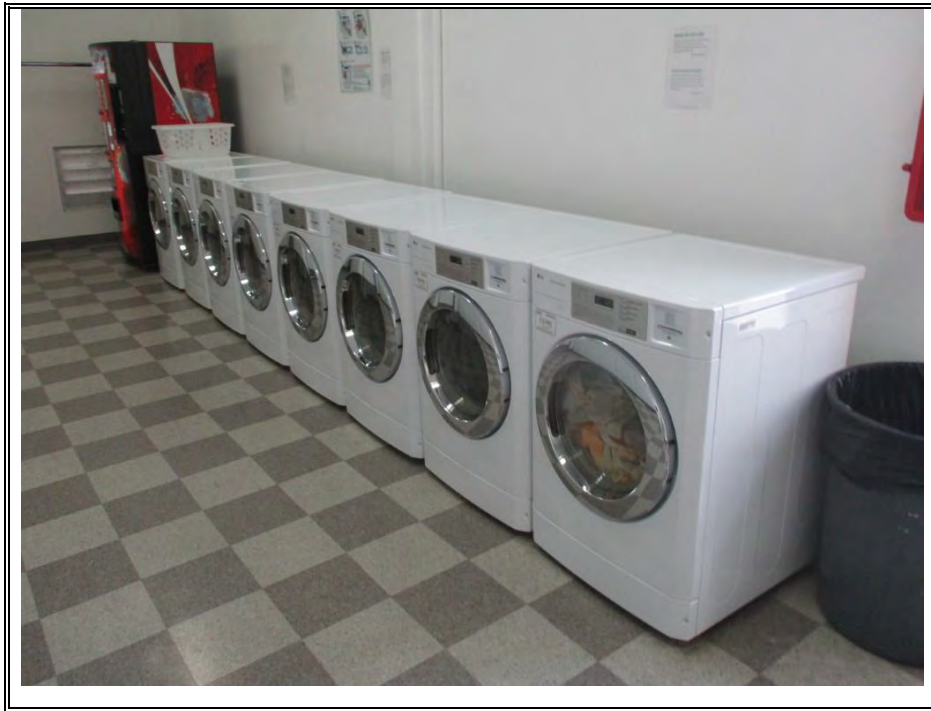
**LAUNDRY EQUIPMENT (TYPICAL)**

**OBSERVATIONS:** *This component includes the coin operated washers and dryers in the laundry rooms of the apartment buildings. We were informed they are leased.*
