RESERVE STUDY - MARCH 9, 2023

Planned Unit Development Homeowners Association (Sample Only)

1234 Main Street

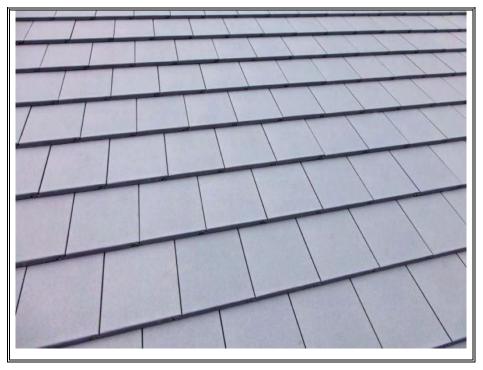
CONCRETE TILE ROOF (TYPICAL)

OBSERVATIONS: This component includes the concrete tile roofing (sloped) on the caretaker building. It appeared to be in average condition. Although the tile itself has a life expectancy of more than 25 years, replacement typically becomes necessary because of degradation of the underlayment. The remaining life expectancy is based upon the estimated age of the roofing, as the underlayment was not visible.

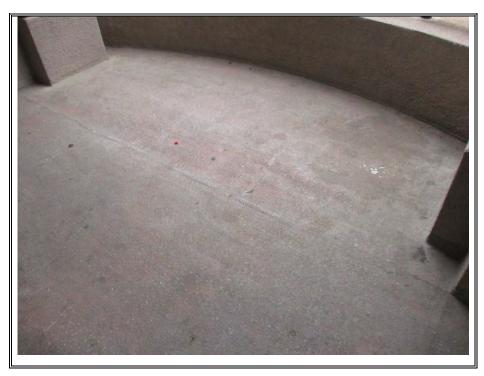
MEMBRANE DECKS-COATING (TYPICAL)

OBSERVATIONS: This component includes the coating for the membrane deck surfaces. We were informed they are scheduled for resurfacing.

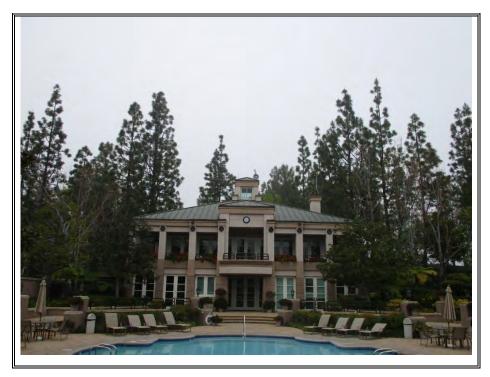
STRUCTURAL PEST CONTROL (TYPICAL)

OBSERVATIONS: This component addresses the potential fumigation of the clubhouse, guardhouse, and caretaker building. When and where an infestation of wood destroying pests or organisms occurs, and how severe the infestation will be, is difficult to predict. The California Bureau of Real Estate (BRE), per the "Operating Cost Manual", suggests that annual inspections be performed to discover any infestation in its early stages before it becomes a serious problem. It previously required that associations establish a reserve for fumigation of all structures on at least a 12-year basis. This is now considered optional; however, it would be prudent to budget for future fumigation in the event it becomes necessary. The frequency for fumigation tends to be greater in ocean environments, while decreasing further inland, especially in desert environments. It is suggested that further evaluation be obtained from a licensed pest control operator.

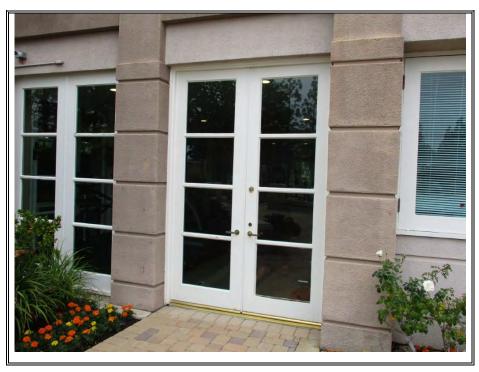
DOORS (TYPICAL)

OBSERVATIONS: This component includes the painted surfaces of the doors. They appeared to be in average condition.

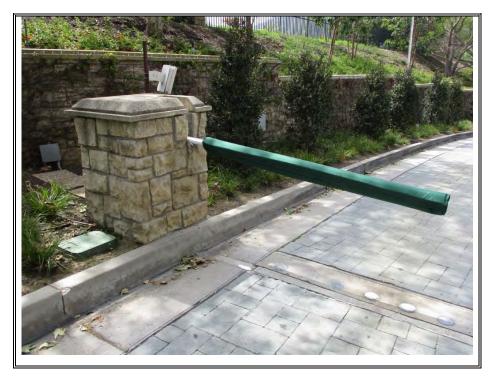
GATE OPERATORS-BARRIER (TYPICAL)

OBSERVATIONS: This component includes the barrier-type vehicle gate operators at the guard house checkpoint. They were inaccessible for inspection (encased) and for reporting purposed their remaining lives have been estimated.

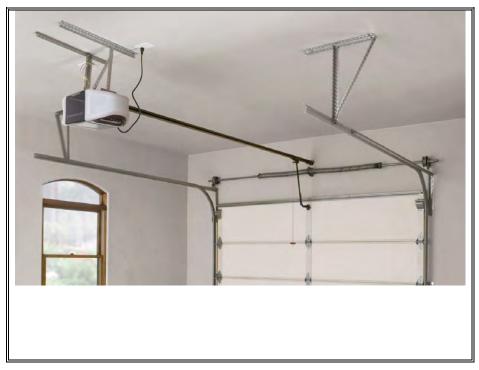
GATE OPERATOR-OVERHEAD (TYPICAL)

OBSERVATIONS: This component includes an overhead-type vehicle gate operator in the guardhouse garage. It appeared to be in good condition.

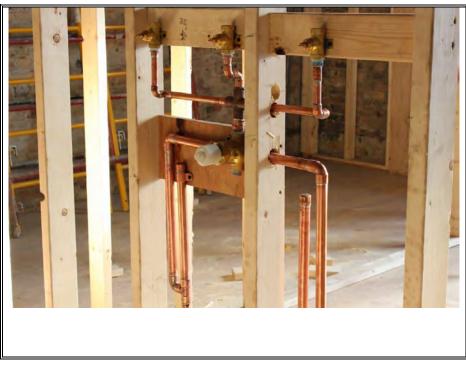
DISTRIBUTION PIPING (TYPICAL)

OBSERVATIONS: This component includes the copper distribution piping that provides potable water to the three buildings. The visible portions appeared to be in average condition and no problems were observed or reported. Although previously considered to be a lifetime component, copper piping has more recently been found to fail as early as 15 years after installation. This is suspected to be primarily caused by changes in the chemical makeup of potable water due to the U.S. Environmental Protection Agency's (EPA) Safe Water Drinking Act and the Lead and Copper Rule (LCR). For purposes of reporting, an approximate time frame of 40 years has been assumed for future replacement. A rough cost estimate has been provided. It is recommended that further evaluation be obtained from a licensed plumbing consultant / contractor, as well as consideration of an epoxy pipe lining system.

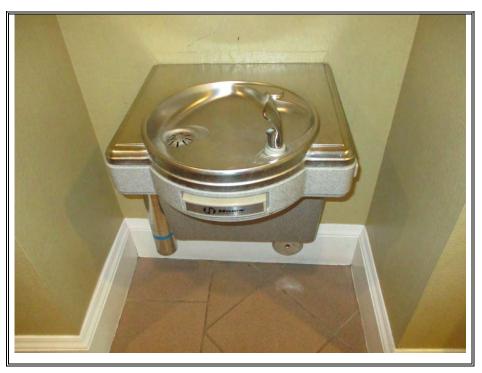
DRINKING FOUNTAINS (TYPICAL)

OBSERVATIONS: This component includes the chilled water drinking fountains at the clubhouse. They appeared to be in average condition.

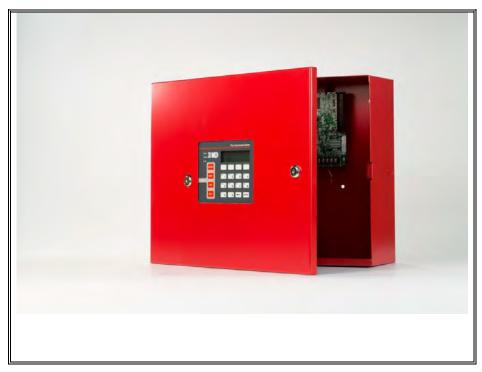
FIRE ALARM SYSTEM (TYPICAL)

OBSERVATIONS: This component includes the fire alarm system at the clubhouse. It appeared to be in an aging condition.

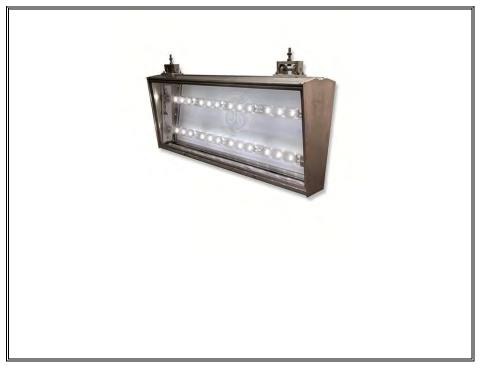
LIGHTING-STREET LAMP POST SIGNS (TYPICAL)

OBSERVATIONS: This component includes the lighted street signs atop street lamp posts. They appeared to be in average condition.

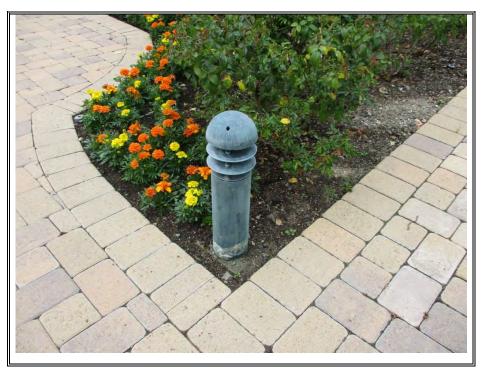
LIGHTING-LANDSCAPE (TYPICAL)

OBSERVATIONS: This component includes an allowance for the periodic repair and replacement of the light fixtures in the landscaped areas. They appeared to be in average condition.

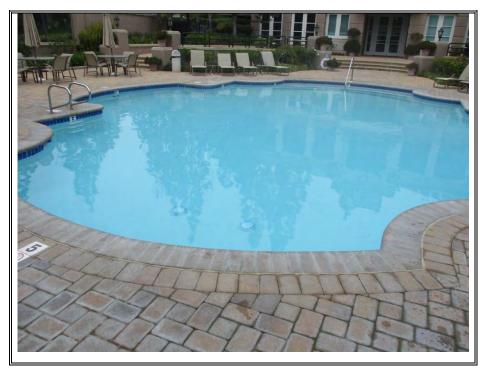
PLASTER-POOL (TYPICAL)

OBSERVATIONS: This component includes the plaster lining of the pool. It appeared to be in an aging condition. Coarseness of the plaster, which occurs over time, is conducive to algae growth and can be injurious to users of the pool (potential association liability).

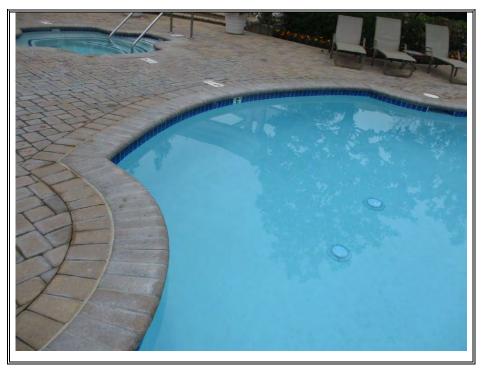
COPING JOINT (TYPICAL)

OBSERVATIONS: This component includes the caulking for the control joint (gap) between the pool and spa decking and the coping. It appeared be in average condition.

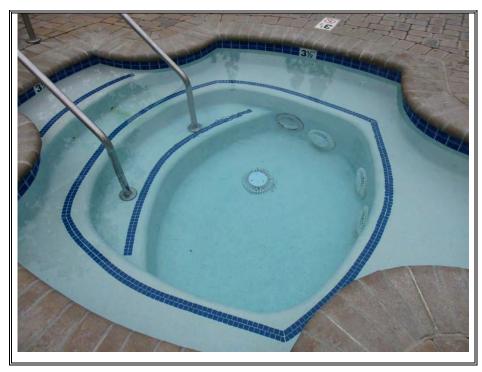
COPING/TILE (TYPICAL)

OBSERVATIONS: This component includes the coping and tile around the perimeter of the pool and spa. It appeared to be in average condition. It is suggested that replacement be coordinated with alternate re-plastering cycles.

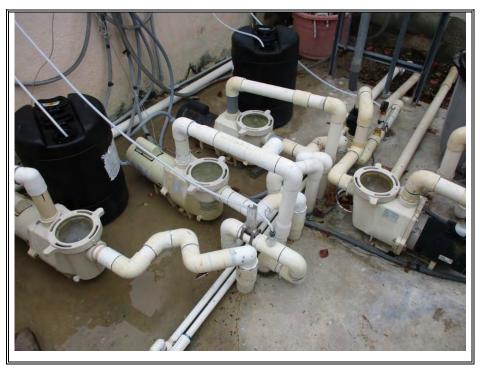
MOTORS (TYPICAL)

OBSERVATIONS: This component includes the motors for the pool and spa. They appeared to be in average condition.

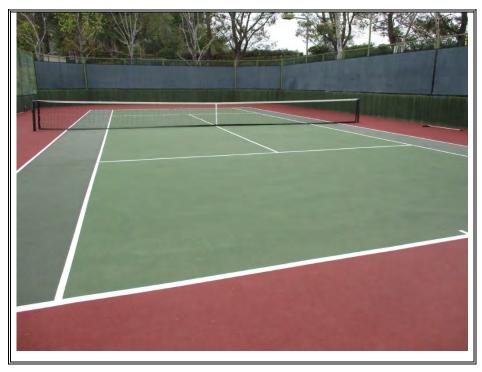
PLAYING SURFACES-TENNIS (TYPICAL)

OBSERVATIONS: This component includes the playing surfaces of the tennis courts. It appeared to be in average condition. Re-surfacing is critical to ensure the proper "speed of play" for the tennis players.

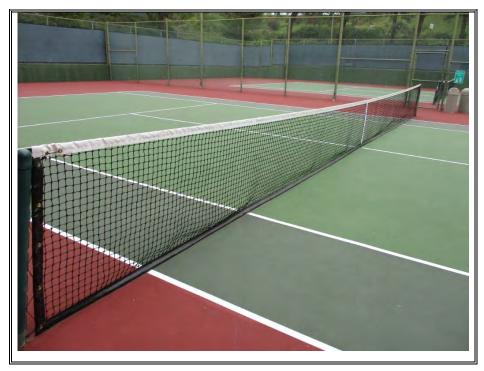
NETS-TENNIS (TYPICAL)

OBSERVATIONS: This component includes the nets for the tennis courts. They appeared to be in average condition.

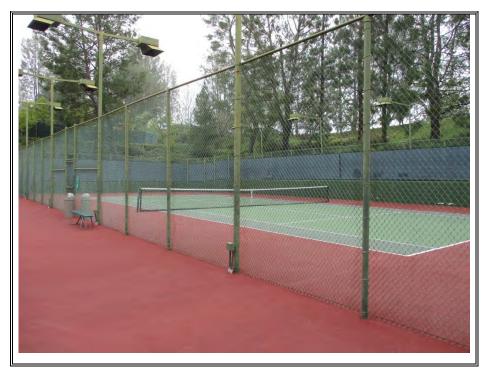
CHAIN LINK FENCING (TYPICAL)

OBSERVATIONS: This component includes the chain link fencing around the tennis and basketball courts. It appeared to be in average condition.

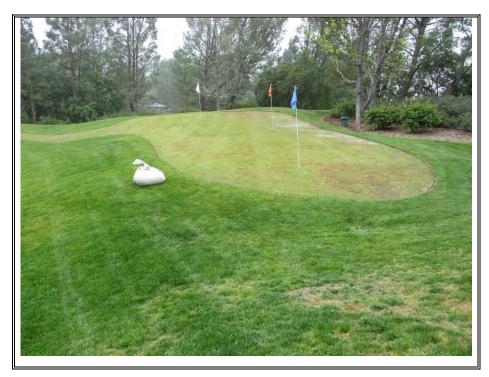
GOLF STATIONS (TYPICAL)

OBSERVATIONS: This component includes an allowance to maintain the greens and the small golf area adjacent to the dog park. They appeared to be in average condition.

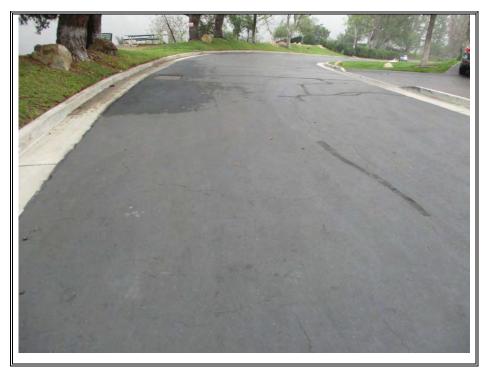
ASPHALT SEAL COAT (TYPICAL)

OBSERVATIONS: This component includes the seal coat for the asphalt streets. It appeared to be in aging condition. While a relatively inexpensive procedure, the seal coat serves to enhance the longevity of the underlying asphalt as well as its appearance by replenishing the oil and fine aggregates of the underlying asphalt. It is important that this procedure be undertaken within 6 months of any overlay or resurfacing and performed thereafter on a 3 – 5-year cycle (typically a warranty requirement).

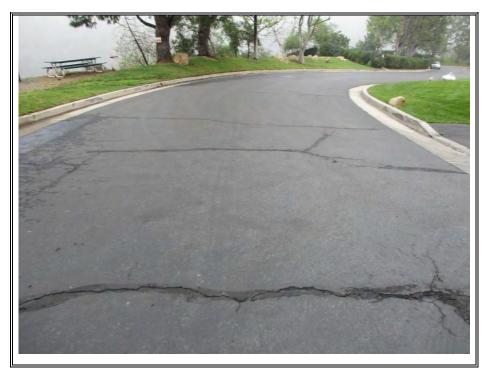
ASPHALT REPLACEMENT (TYPICAL)

OBSERVATIONS: This component provides for replacement of the asphalt surfaces, which we were informed contained 8" to 12" base material. The surfaces appeared to be in average condition and we were informed that the roads were of substantial construction (thicker layer than average). Aging, oxidation, and vehicle traffic eventually cause cracking, ponding and uneven pavement. Such surface irregularities may result in improper drainage and compromised driving surfaces. Asphalt replacement entails removal of the existing pavement, grading and compaction of the existing aggregate base material, and the installation of hot asphalt pavement. It is recommended that pavement engineering be obtained prior to replacement to guarantee that new pavement specifications will meet or exceed the needs of the common area pavement. In conjunction with replacement, seal coating should be performed within 6 months and then at 3 – 5-year intervals thereafter. It is recommended that prior to replacement, further evaluation be obtained from a soils/geotechnical engineer.

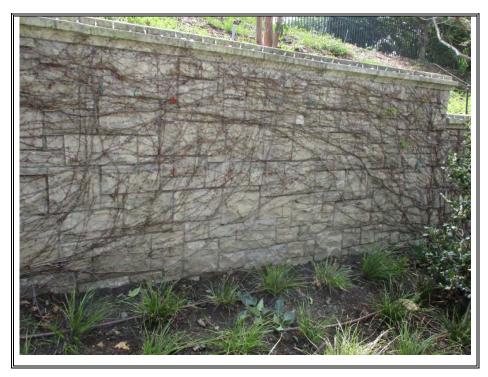
CONCRETE BLOCK WALLS (TYPICAL)

OBSERVATIONS: This component includes the concrete block walls throughout the development. They appeared to be in average condition. It is recommended that any repair / replacement be performed on an as-needed basis and funded from the operating account. No amount has been provided for complete replacement as they would typically have a life well in excess of the scope of this projection and would therefore be considered lifetime components.

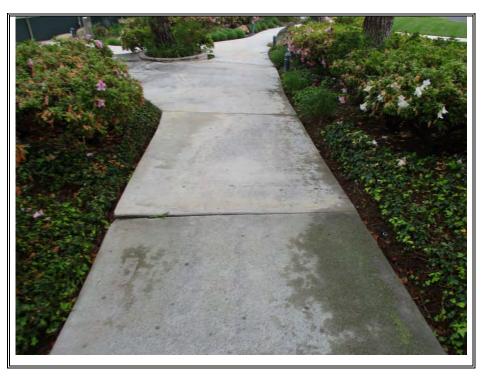
CONCRETE WALKWAYS (TYPICAL)

OBSERVATIONS: This component includes an allowance for the repair and replacement of the concrete walkways throughout the property. They generally appeared to be in average condition.

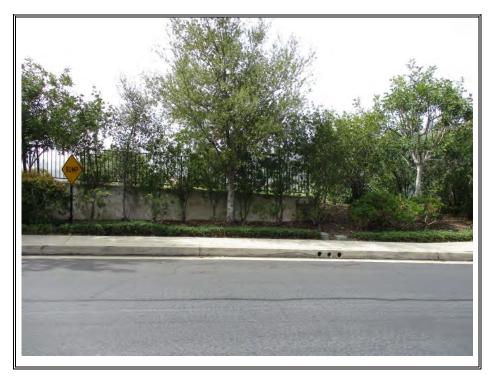
CONCRETE CURBS (TYPICAL)

OBSERVATIONS: This component includes an allowance for the repair and replacement of the concrete curbs throughout the property. They generally appeared to be in average condition.

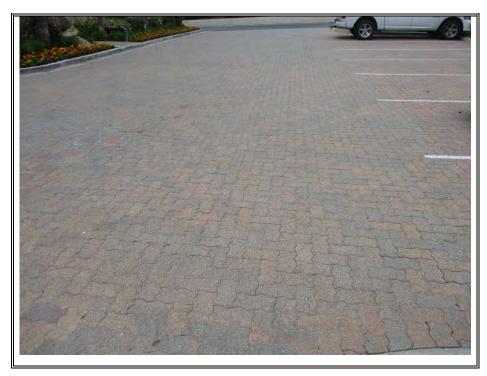
CONCRETE PAVERS – PARKING LOT (TYPICAL)

OBSERVATIONS: This component includes the cleaning and repair of the concrete pavers in the clubhouse parking lot. They appeared to be in average to aging condition.

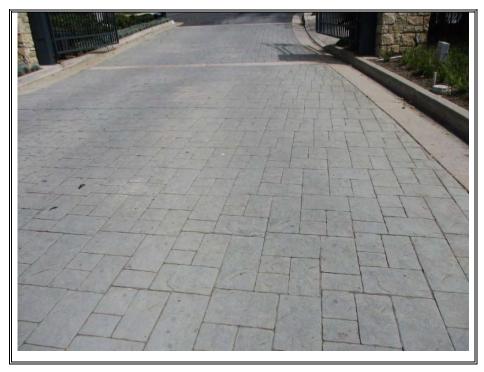
CONCRETE PAVERS – DRIVEWAY (TYPICAL)

OBSERVATIONS: This component includes the cleaning and repair of the concrete pavers in the various driveways. They appeared to be in average to aging condition.

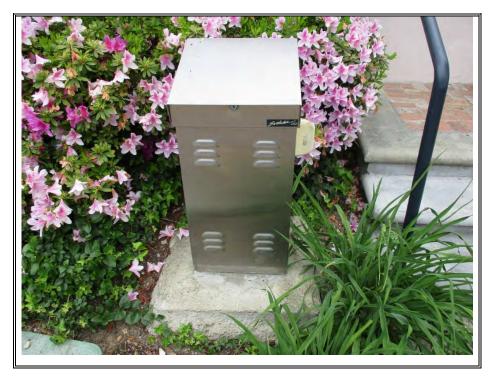
IRRIGATION CONTROLLERS (TYPICAL)

OBSERVATIONS: This component includes the irrigation controllers. They appeared to be in average condition. They tend to have a more predictable life expectancy, and the average component cost provides for their replacement. However, average life expectancies cannot be predicted for the other sprinkler components or automatic valve actuation systems. Repairs/replacements of such systems usually occur on an ongoing basis and should be covered under the operating account.

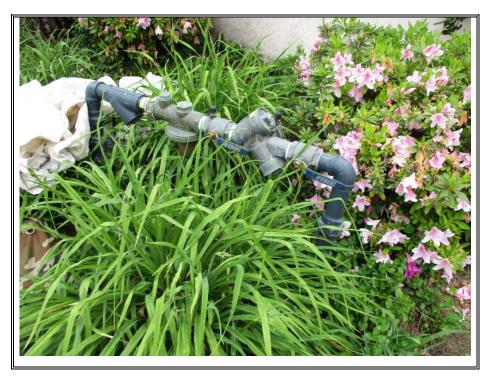
BACK FLOW PREVENTERS (TYPICAL)

OBSERVATIONS: This component includes the back-flow preventers, which are part of the irrigation system. The actual performance life would be difficult to determine. However, a rough time frame has been provided for budgeting purposes.

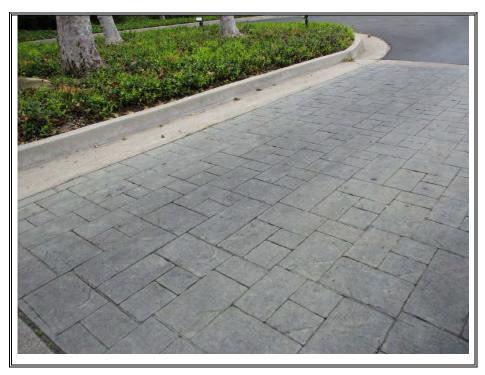
STAMPED CONCRETE (TYPICAL)

OBSERVATIONS: This component includes an allowance for periodic replacement of approximately 25% of the stamped (decorative) concrete street aprons. Although they appeared to be in average condition, they should be regularly monitored for cracking and vertical displacement, which can create potential trip hazards (and liability for the association). Future replacement is recommended to maintain appearance.

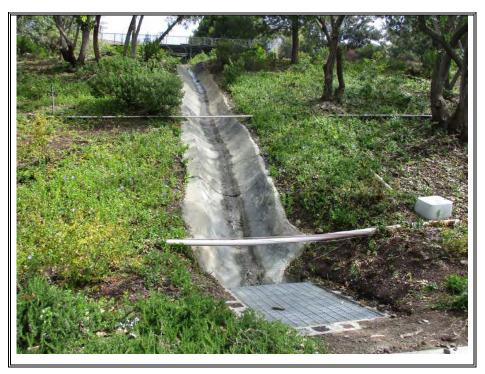
IRRIGATION PIPING REPAIR (TYPICAL)

OBSERVATIONS: This component includes an allowance for repairs to the irrigation piping throughout the property

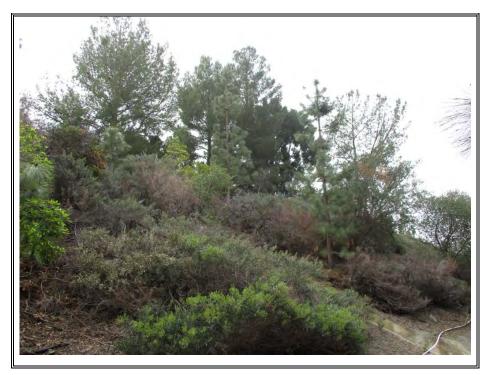
LANDSCAPE – ANNUAL REFURBISHMENT (TYPICAL)

OBSERVATIONS: This component includes an annual allowance for landscape refurbishment.

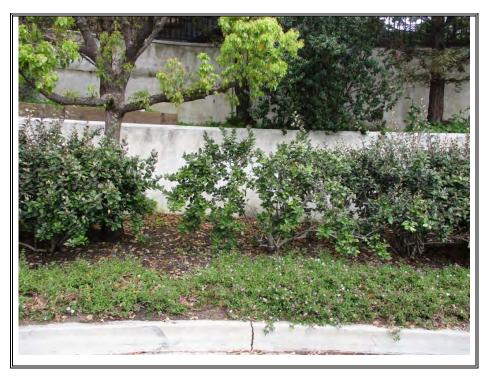
LANDSCAPE-RENOVATION (TYPICAL)

OBSERVATIONS: This component includes a rough allowance for long-term / extensive updating/remodeling the landscaping, and it is suggested that the adequacy of this allowance be reviewed on a periodic basis in conjunction with the landscape maintenance company.

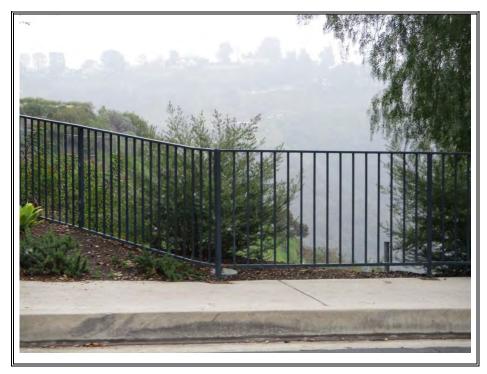
WROUGHT IRON (TYPICAL)

OBSERVATIONS: This component includes an allowance for the regular maintenance of the wrought iron fencing throughout the property. It appeared to be in average condition. If it is regularly painted and exposure to moisture kept to a minimum, most of the wrought iron should have a life well in excess of 30 years. However, based upon our opinion and prior experience, repair and replacement of a portion of the wrought iron should be anticipated due to inevitable corrosion from exposure of some sections to constant sprinkler spray as well as proximity to the ground.

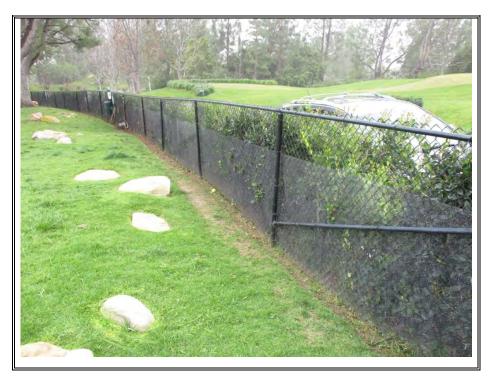
CHAIN LINK FENCING (TYPICAL)

OBSERVATIONS: This component includes the galvanized chain link fencing around the perimeter of the dog park. It appeared to be in average condition.

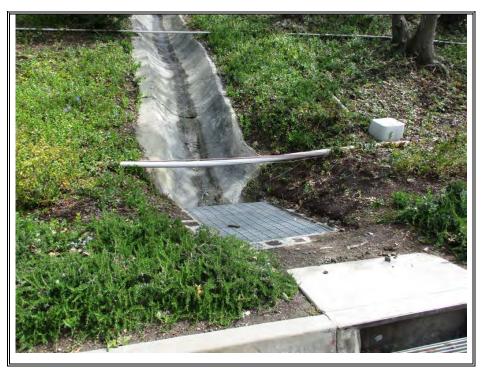
BENCH/DOWNDRAINS (TYPICAL)

OBSERVATIONS: This component includes an allowance for repairs to the bench and down drains throughout the slopes. With correct slope maintenance, including annual geotechnical inspections, future major repair/replacement expenditures for the bench and down the drain should be significantly reduced. General maintenance and smaller repairs should be a part of the slope maintenance program and funded from the operating account.

TO PROTECT YOUR INVESTMENT: It is suggested that a complete inspection be performed at least annually. Ongoing maintenance and repairs should be anticipated and funded from the operating account.

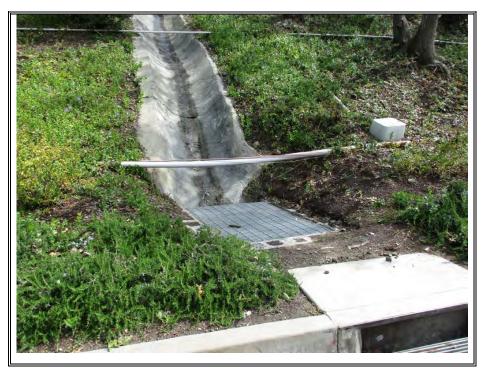
SWALE GRATES (TYPICAL)

OBSERVATIONS: This component includes the grates at the base of various down drains along the common area slopes. They appeared to be in average condition.

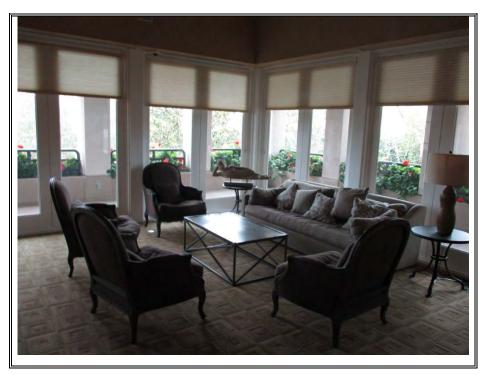
FURNISHING-RECREATION ROOM (TYPICAL)

OBSERVATIONS: This component includes the furniture in the recreation room. It appeared to be in average condition. The average component cost is general for the type of furnishings in use.

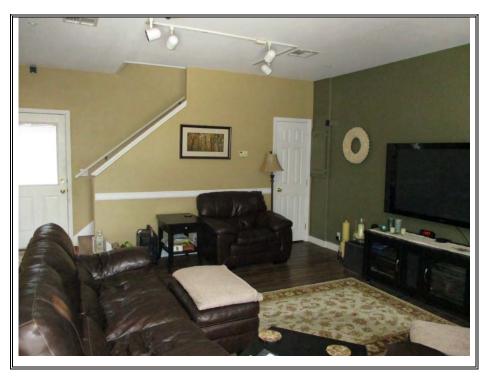
FURNISHINGS-CARETAKER BUILDING (TYPICAL)

OBSERVATIONS: This component includes an allowance to furnish the caretaker building (current furnishings are tenants). It appeared to be in average condition. The average component cost is general for the type of furnishings in use.

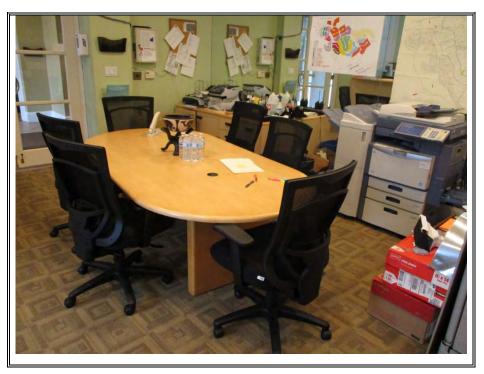
FURNISHINGS-OFFICE (TYPICAL)

OBSERVATIONS: This component includes the furniture in the offices. It appeared to be in average condition. The average component cost is general for the type of furnishings in use.

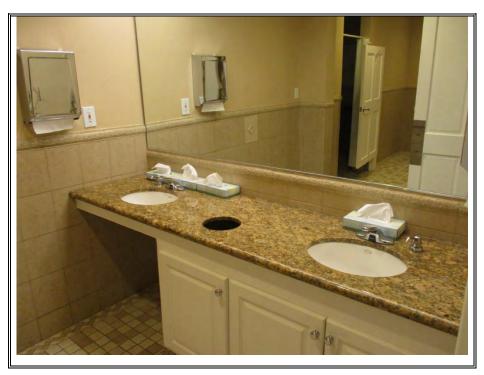
RESTROOMS-CLUBHOUSE (TYPICAL)

OBSERVATIONS: This component includes the remodeling of the restrooms at the clubhouse. They appeared to be in average condition.

TO PROTECT YOUR INVESTMENT: The restrooms should be maintained in a sanitized condition.

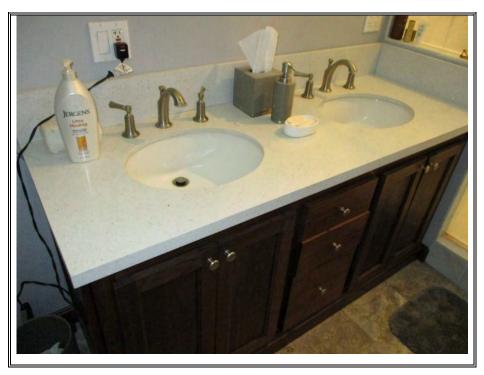
RESTROOMS-CARETAKER BUILDING (TYPICAL)

OBSERVATIONS: This component includes the remodeling of the restrooms in the caretaker building. They appeared to be in average condition. We were informed they are refurbished as needed and funded from the operating budget.

TO PROTECT YOUR INVESTMENT: The restrooms should be maintained in a sanitized condition.

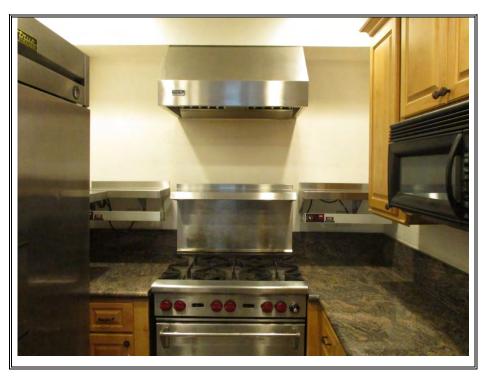
KITCHEN-CLUBHOUSE (TYPICAL)

OBSERVATIONS: This component includes the remodeling of the kitchen in the clubhouse. It appeared to be in average condition.

TO PROTECT YOUR INVESTMENT: The recreation room kitchen should be maintained in a sanitized condition. Occasional cleaning and verification of operation is generally the extent of any maintenance necessary for the appliances. It is recommended that the respective operating manuals be consulted with respect to more specific types of maintenance suggested for these appliances.

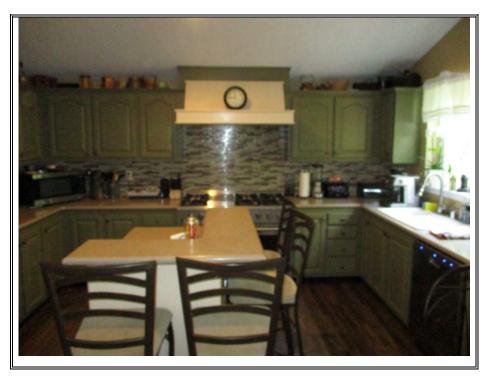
KITCHEN-CARETAKER BUILDING (TYPICAL)

OBSERVATIONS: This component includes the remodeling of the kitchen in the caretaker building. It appeared to be in average condition.

TO PROTECT YOUR INVESTMENT: The recreation room kitchen should be maintained in a sanitized condition. Occasional cleaning and verification of operation is generally the extent of any maintenance necessary for the appliances. It is recommended that the respective operating manuals be consulted with respect to more specific types of maintenance suggested for these appliances.

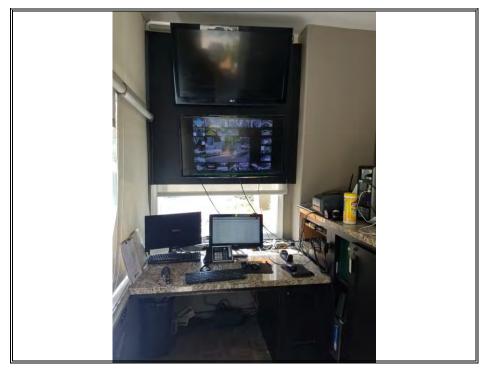
GUARD HOUSE-REFURBISH (TYPICAL)

OBSERVATIONS: This component includes an allowance for the periodic refurbishment of the guardhouse at the main entrance to the property. It appeared to be in average condition and well maintained.

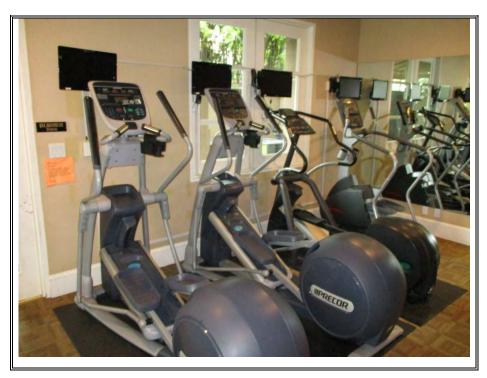
FITNESS EQUIPMENT (TYPICAL)

OBSERVATIONS: This component includes the fitness equipment in the gym. It appeared to be in average condition. Some of the equipment would most likely be replaced while other items may lend themselves to being refurbished. The average component cost is general for this type of equipment.

TO PROTECT YOUR INVESTMENT: The equipment should be maintained in a sanitary condition. Applicable instructions as well as warnings should be posted with respect to proper use of the equipment.

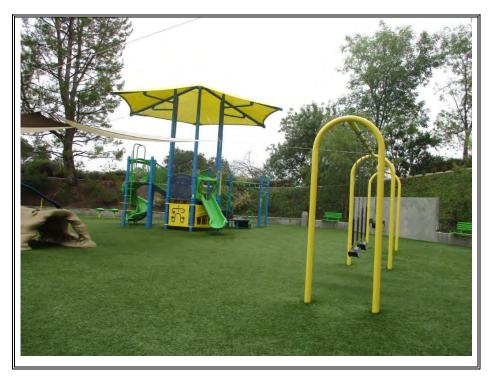
PLAY STRUCTURE (TYPICAL)

OBSERVATIONS: This component includes the custom play structure and its accessories. It appeared to be in good condition. Play structures can range in price from just under \$5,000 for a simple swing set to well over \$75,000 for a more elaborate modular system with swings, slides, bridges, climbers, tubes and towers. The various options should be evaluated prior to replacement. Per the Health & Safety Code, playground equipment must be inspected by a playground safety inspector certified by the National Playground Safety Institute. Equipment installed prior to 1994 must either be replaced or upgraded to State Regulations; equipment installed between the years 1994 and 1999 need only be upgraded to meet standards set forth by the Consumer Product Safety Commission.

TO PROTECT YOUR INVESTMENT: Per the U.S. Consumer Product Safety Commission, play structures should be regularly checked to ensure they are in good condition. This includes examination for sharp points or edges, dangerous hardware (such as open "S" hooks or protruding bolt ends), and tripping hazards (including exposed concrete footings, tree stumps, rocks, etc.). In the case of adjacent structures that are over 30 inches high, they should be spaced at least 9 feet apart. Elevated surfaces, including platforms and ramps, should have guardrails to prevent falls. Spaces that could trap children, such as openings in guardrails or between ladder rungs, should measure either less than 3.5 inches or more than 9 inches. Surfaces around the equipment should have at least 12 inches of loose-fill material, or are mats made of safety-tested rubber-like materials. These surfaces should extend at least 6 feet in all directions, and in the case of swings at least twice the height of the suspending bar in back and in front.

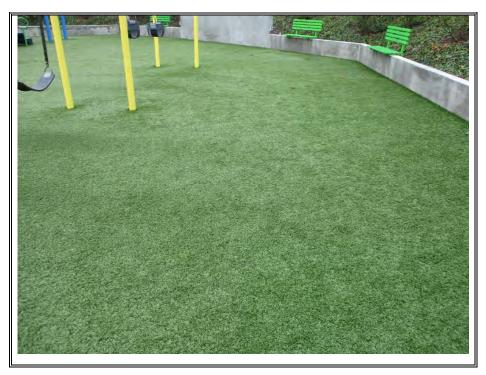
PLAYGROUND SURFACING (TYPICAL)

OBSERVATIONS: This component includes the multilayer playground surfacing beneath the play structure. It appeared to be in average condition.

TO PROTECT YOUR INVESTMENT: Per the U.S. Consumer Product Safety Commission, acceptable playground surfacing includes loose-fill (i.e. wood chips, mulch, sand, gravel, etc.) and unitary materials (i.e. shredded tires, rubber, or rubber-like mats). Loose-fill materials tend to get displaced due to activity/wind, as well decompose and compact over time, requiring periodic replenishment. Unitary materials typically have a higher initial cost, however afford low maintenance, longer life expectancy and consistent shock absorbency. For further information it is recommended that the "Handbook for Public Playground Safety" be obtained from the CPSC at (800) 638-2772.

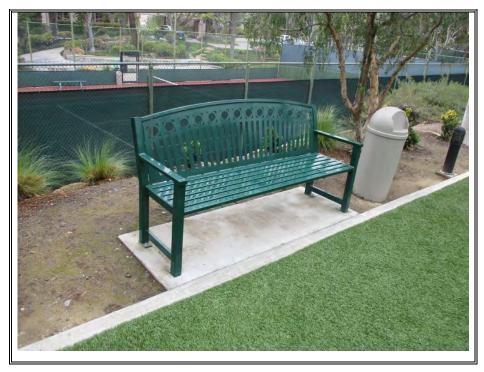
BENCHES (TYPICAL)

OBSERVATIONS: This component includes the coated metal benches at the park. They appeared to be in good condition.

TO PROTECT YOUR INVESTMENT: Little by way of maintenance can be performed for this component.

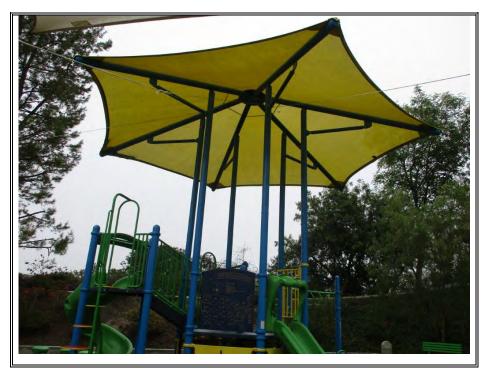
SHADE STRUCTURE (TYPICAL)

OBSERVATIONS: This provides an allowance for maintenance of the shade structures. We were informed the system is to be modified.

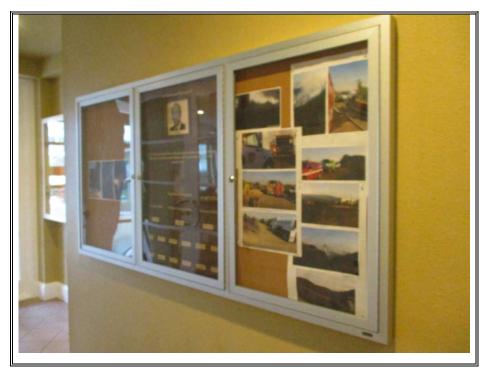
DIRECTORY BOARDS (TYPICAL)

OBSERVATIONS: This component includes the glass faced aluminum and wood framed directory boards. They appeared to be in good condition.

TO PROTECT YOUR INVESTMENT: Little by way of maintenance can be performed for this component other than routine cleaning.

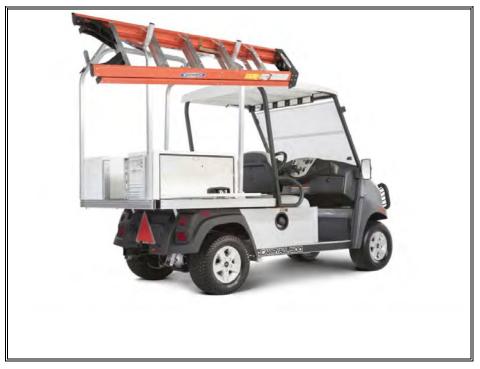
UTILITY CART (TYPICAL)

OBSERVATIONS: This component includes the utility cart used by the maintenance staff. It appeared to be in aging condition.

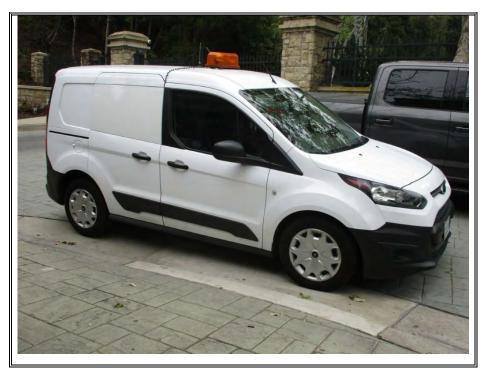
PATROL VEHICLE (TYPICAL)

OBSERVATIONS: This component includes the patrol vehicle. It appeared to be in good condition.

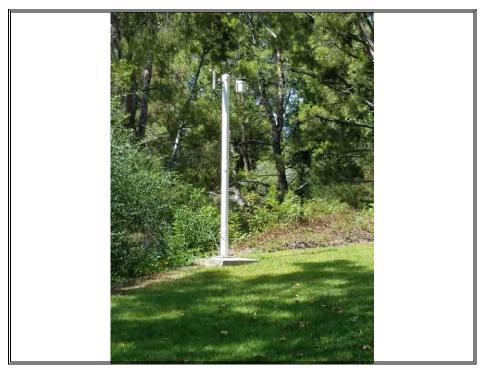
WEATHER STATIONS (TYPICAL)

OBSERVATIONS: This component includes an allowance to maintain the weather stations. They appeared to be in average to aging condition.

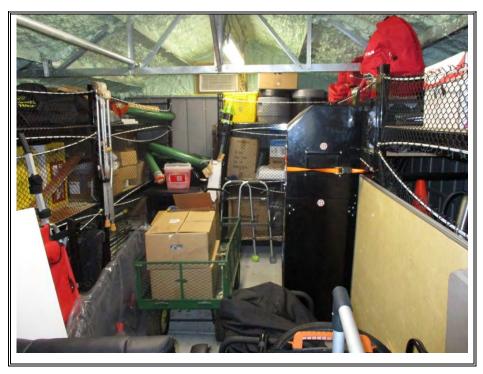
EMERGENCY EQUIPMENT (TYPICAL)

OBSERVATIONS: This component includes the emergency preparedness equipment in the large shed near the tennis and basketball courts.

TO PROTECT YOUR INVESTMENT: Little by way of maintenance can be performed for this component other than routine cleaning.

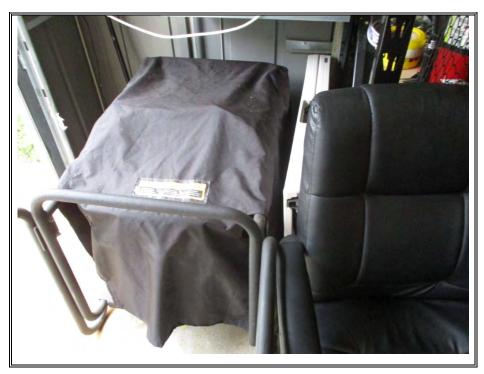
ELECTRIC GENERATOR (TYPICAL)

OBSERVATIONS: This component includes the Honda emergency generator in the emergency equipment shed.
