COMPLETE RSI RESERVE STUDY WITH SITE VISIT

HIGH RISE HOMEOWNERS' ASSOCIATION

1234 Main Street
Anywhere, California

2/10/2026

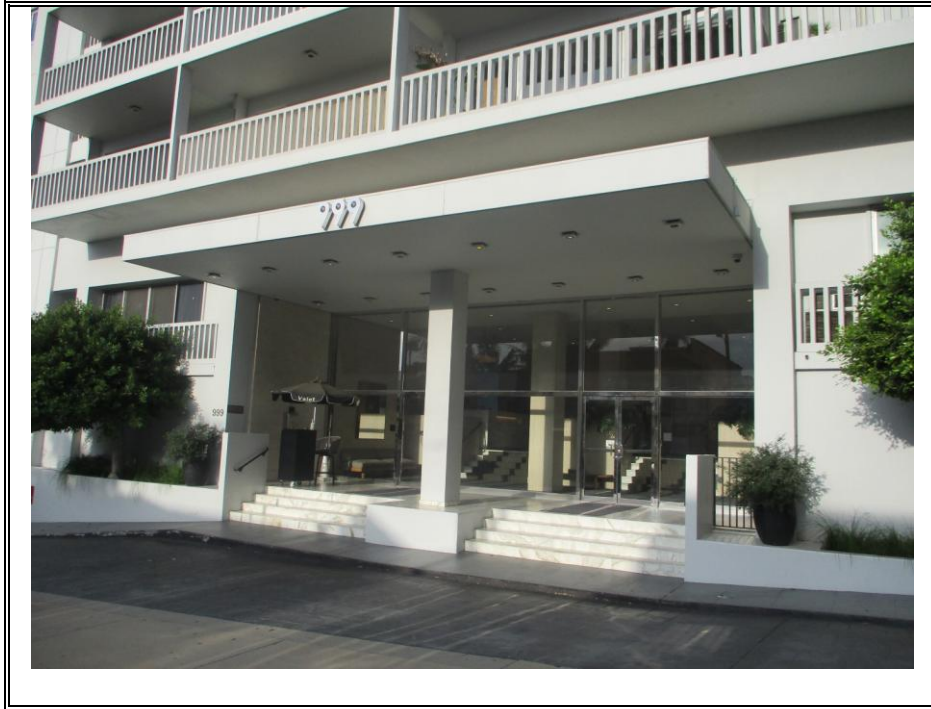
LOBBY ENTRY DOORS (TYPICAL)

OBSERVATIONS: *This component addresses the framed glass doors at the entrance to the main lobby. We were previously informed that they were installed in 2017 and they appeared to be in good condition.*

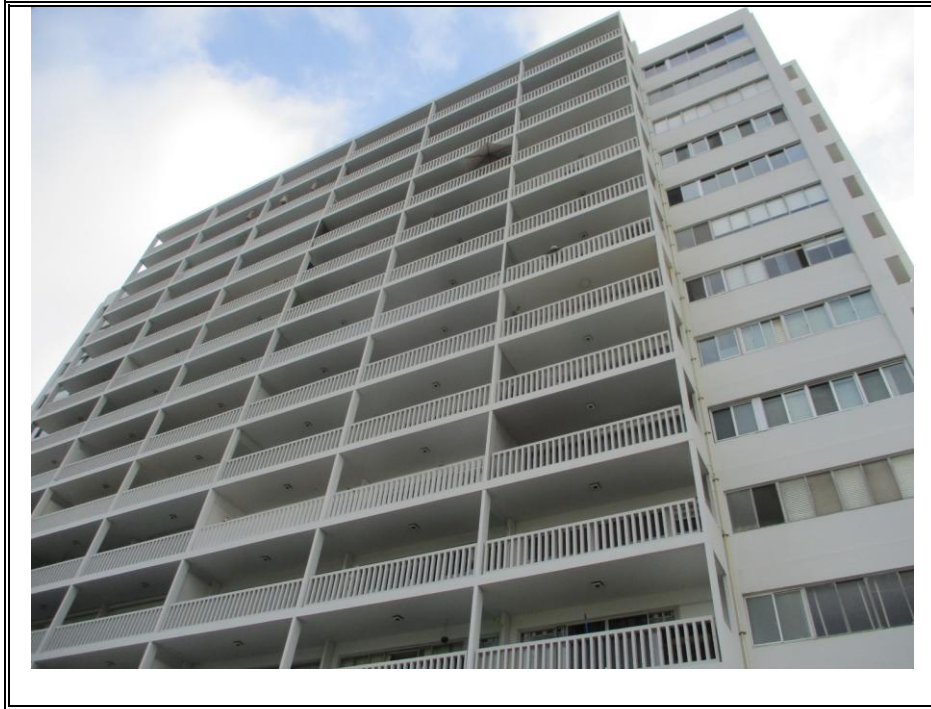
SIDING & TRIM (TYPICAL)

OBSERVATIONS: *This component addresses the painted surfaces of miscellaneous wood trim. They appeared to be in an average condition for their age.*

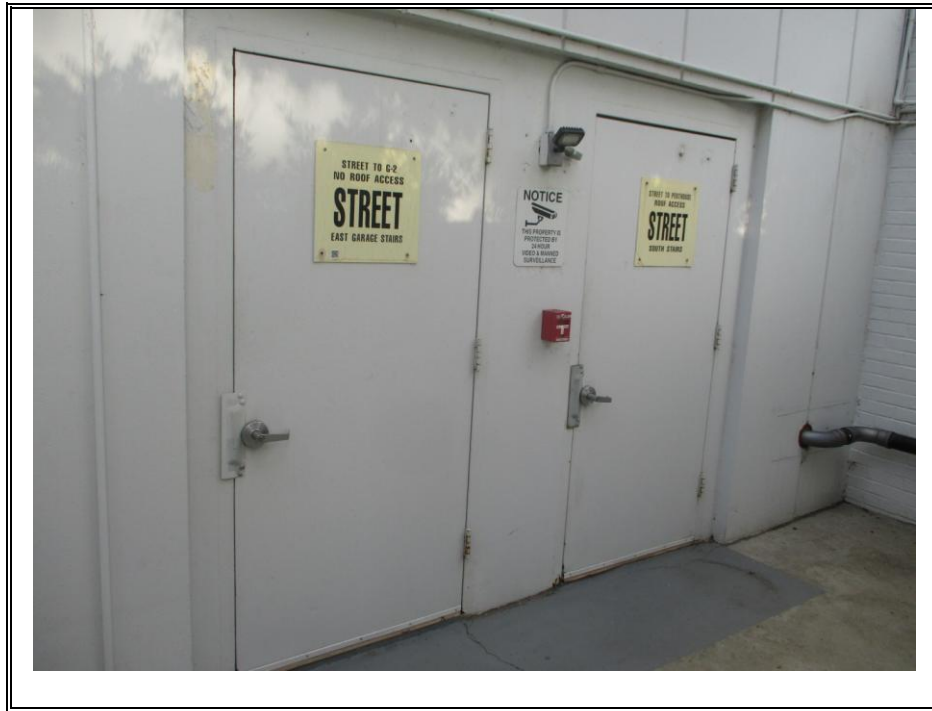
DOORS-PAINT (TYPICAL)

OBSERVATIONS: *This component addresses the painted surfaces of the exteriors of some of the individual unit doors, as well as both sides of the common area doors. We were informed they were refurbished in 2024, and they appeared to be in good condition.*

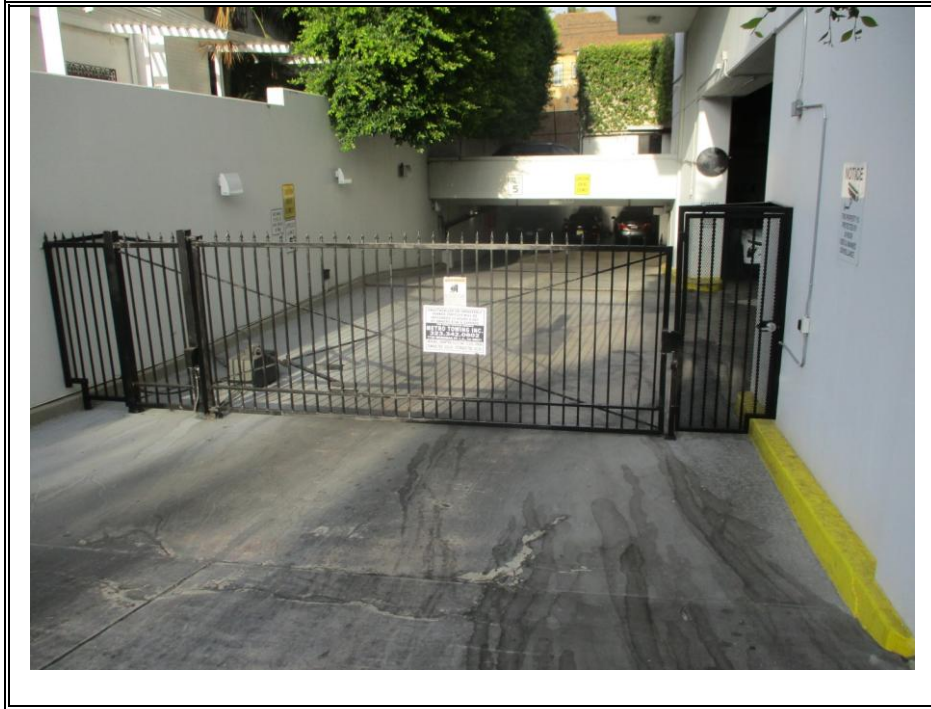
IRONWORK-EXTERIOR (TYPICAL)

OBSERVATIONS: This component addresses the painted surfaces of the wrought iron fencing and gates at the exterior of the building. They appeared to be in an average condition for their age.

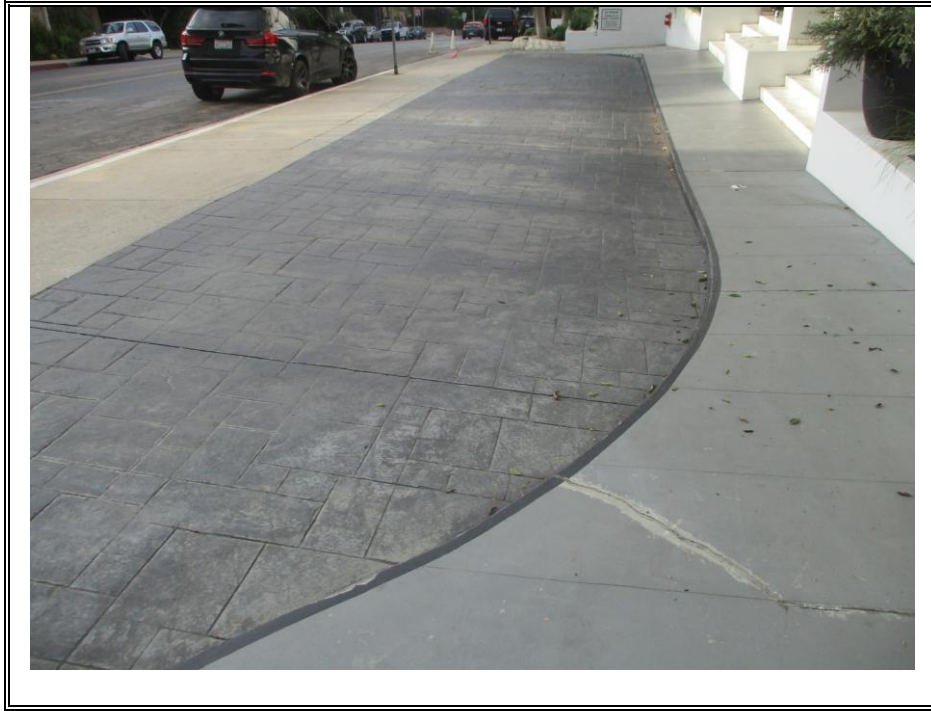
ENTRIES/WALKWAY (TYPICAL)

OBSERVATIONS: *This component addresses the epoxy painted surfaces of the entry walkway and garage driveways. They appeared to be in an average condition for their age.*

TO PROTECT YOUR INVESTMENT: *Cleaning and periodic "touch-up" of peeling and damaged surfaces is recommended for appearance. All peeling paint should be sanded / scraped prior to any finish paint.*

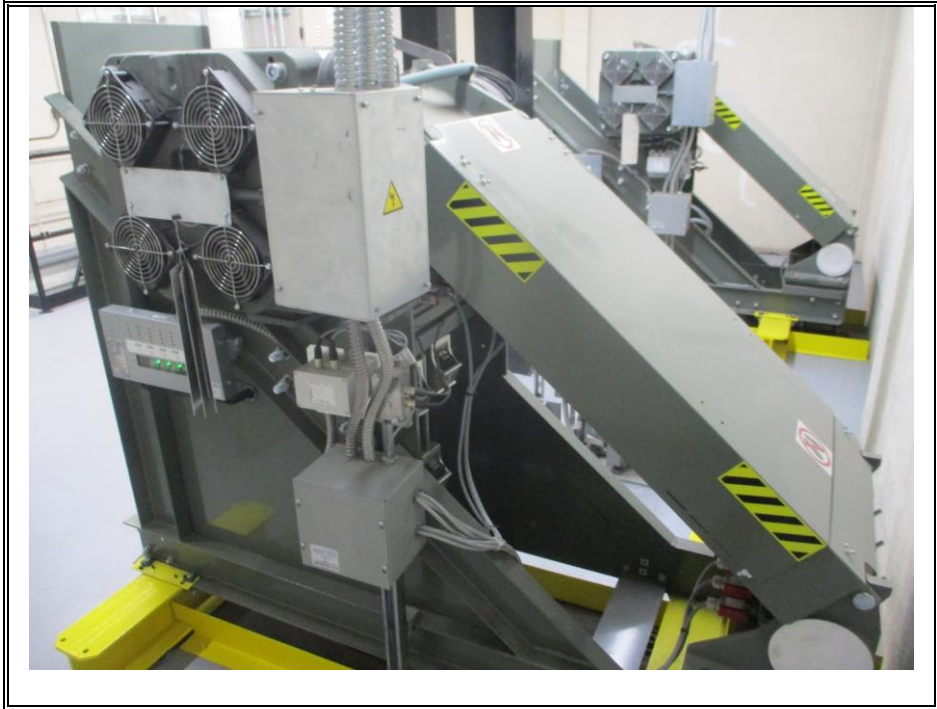
ELEVATORS-MECHANICAL (TYPICAL)

OBSERVATIONS: *This component comprises the mechanical aspects of the elevators. Included would be the motors, pumps (if applicable), starter, control panel, door operator and car operating panel. There are numerous elements, such as cylinders, rams, cages, door slides, pistons/cables, and guide rails that are not commonly replaced, and therefore not included in a standard modernization. However, these types of items may need replacement. As elevators have a wide range of restoration costs it is recommended that further evaluation and cost estimates be obtained from an elevator specialist. We were informed that they were installed in 2024, and they appeared to be in good condition.*

TO PROTECT YOUR INVESTMENT: *We recommend obtaining a maintenance contract with a qualified specialist.*

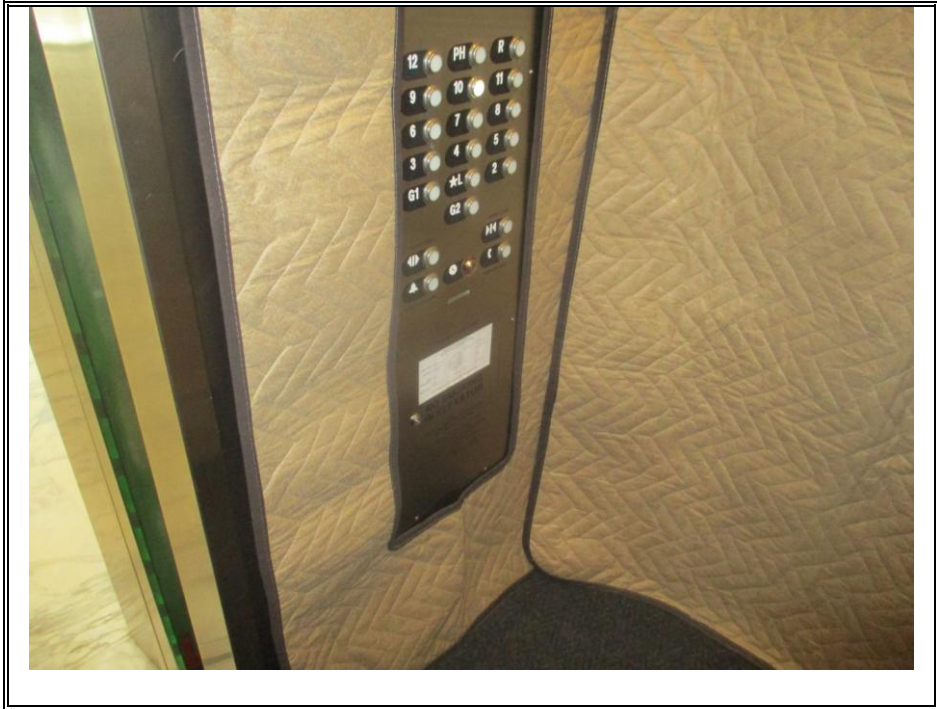
ELEVATORS-CAB REMODEL (TYPICAL)

OBSERVATIONS: *This component provides for the remodeling of the elevator cabs, comprised of marble interior and flooring. We were informed that they were refurbished in 2023, and they appeared to be in good condition.*

TO PROTECT YOUR INVESTMENT: *General surface cleaning of the elevator cab interior would be the extent of any maintenance necessary by the association.*

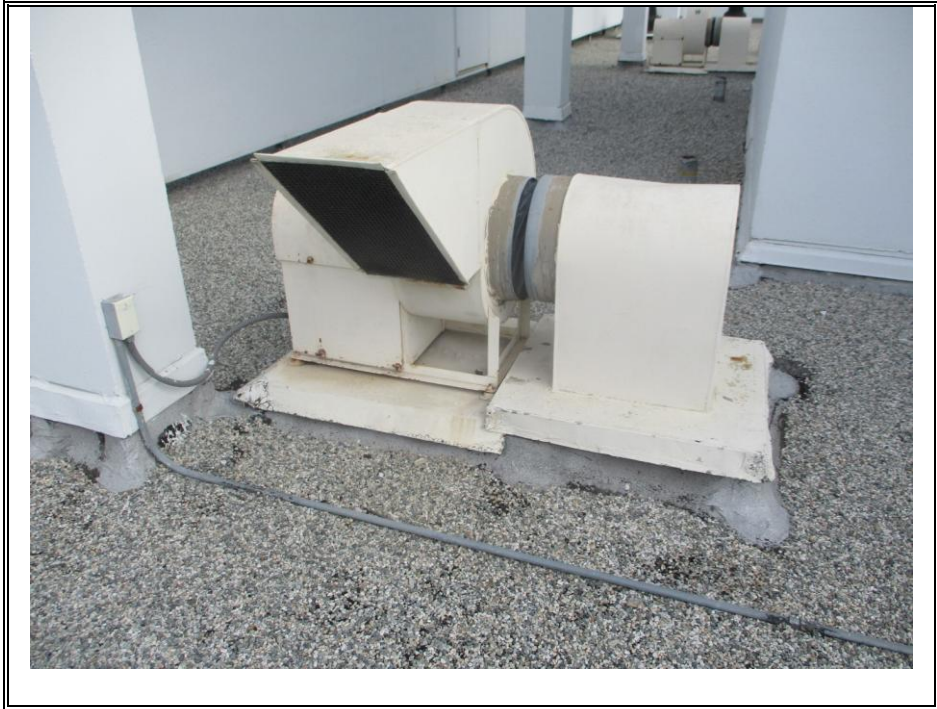
EXHAUST FANS-GARAGE (TYPICAL)

OBSERVATIONS: *This component addresses the inline exhaust blowers on the roof and at garage level 2, comprised of 2 at 10 hp and 2 estimated at 2 hp, which serve the purpose of ventilating the common garage area. The fans on the roof were inaccessible for inspection (encased) and for the purposes of reporting, the condition and remaining life has been estimated. It is recommended that a carbon monoxide detector be installed in conjunction with an auto-start mechanism in the interest of safety.*

TO PROTECT YOUR INVESTMENT: *The bearings should be oiled / greased on a periodic basis as well as occasional verification of operation of the fan. It is suggested that the association consider installing a carbon monoxide sensor, which would cause the fan to operate automatically only when necessary. We recommend obtaining a maintenance contract with a qualified specialist.*

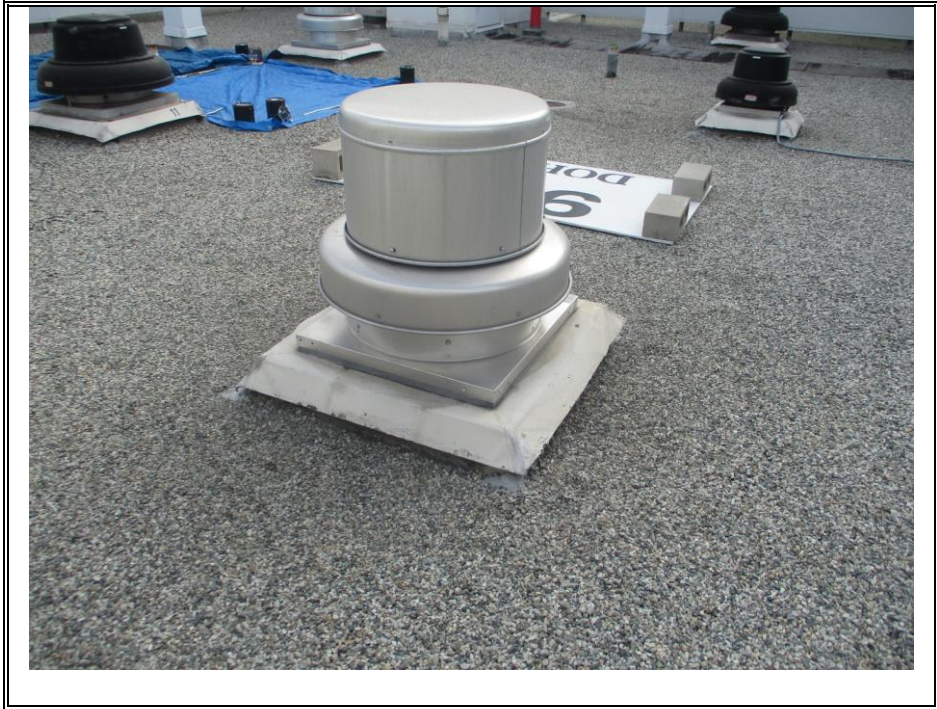
EXHAUST FANS-INTERIORS (TYPICAL)

OBSERVATIONS: *This component addresses the mushroom type exhaust fans on the roof, estimated at ½ horsepower, which serve the purpose of ventilating the internal hallways. We were informed that they were refurbished in 2020 and repairs done post-refurbishment. They appeared to be in an average condition.*

TO PROTECT YOUR INVESTMENT: *The bearings should be oiled / greased on a periodic basis as well as occasional verification of operation of the fan. We recommend obtaining a maintenance contract with a qualified specialist.*

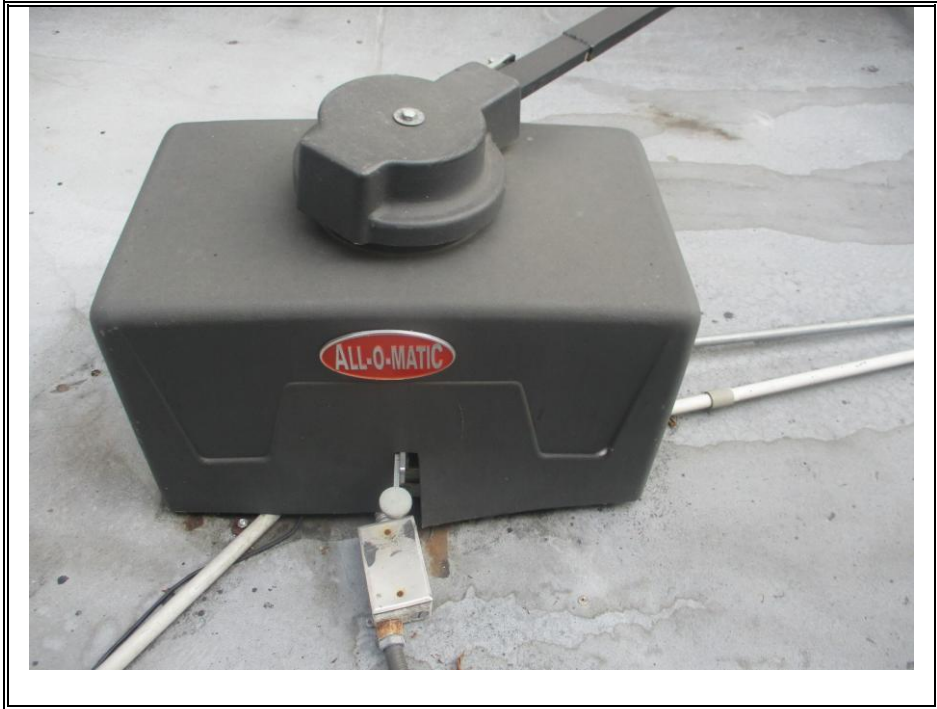
GATE OPERATOR (TYPICAL)

OBSERVATIONS: *This component addresses a swing arm-type vehicle gate operator at the vehicle gate. We were previously informed it was installed in 2025 and appeared to be in good condition.*

TO PROTECT YOUR INVESTMENT: *Maintenance should include regular lubrication of all moving parts. It is suggested that a maintenance contract be obtained with a qualified specialist.*

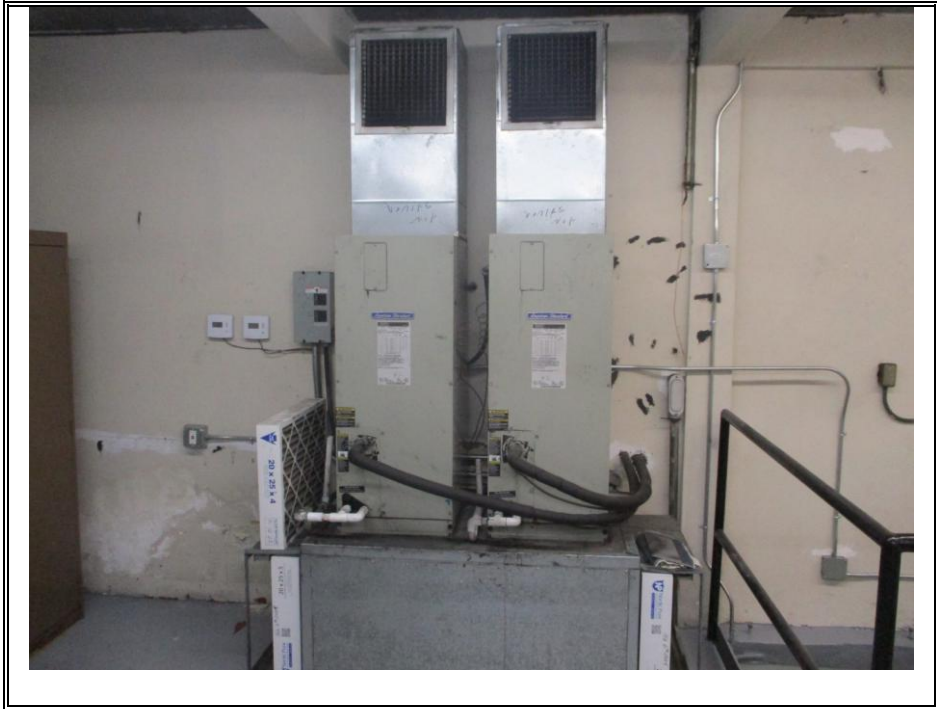
HEAT PUMPS-EVAPORATIVE COILS (TYPICAL)

OBSERVATIONS: *This component addresses the evaporative coils for the “American Standard” heat pumps (split systems), dated 5/2002 and located at the elevator rooms. They appeared to be in functional condition, however, past their anticipated lifespan.*

TO PROTECT YOUR INVESTMENT: *The heat pumps should be serviced twice a year. We recommend obtaining a maintenance contract with a reputable licensed heating/air conditioning company.*

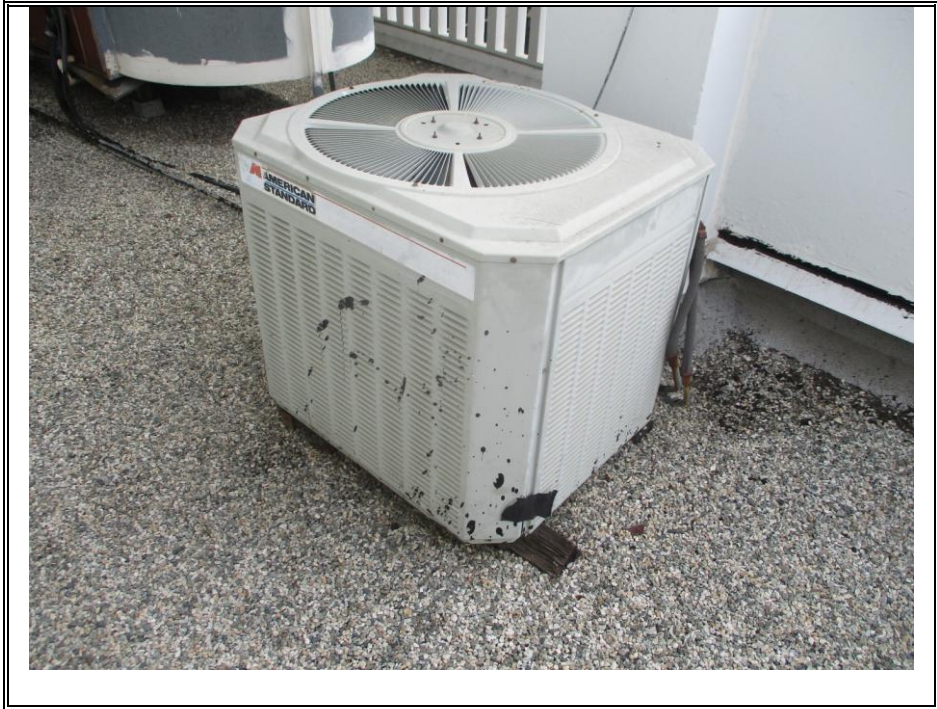
HEAT PUMPS-CONDENSERS (TYPICAL)

OBSERVATIONS: *This component addresses the condensers for the “American Standard” heat pumps (split systems). We were informed that they were installed in 2023, and they appeared to be in good condition.*

TO PROTECT YOUR INVESTMENT: *The condensers should be serviced twice a year. We recommend obtaining a maintenance contract with a reputable licensed heating/air conditioning company.*

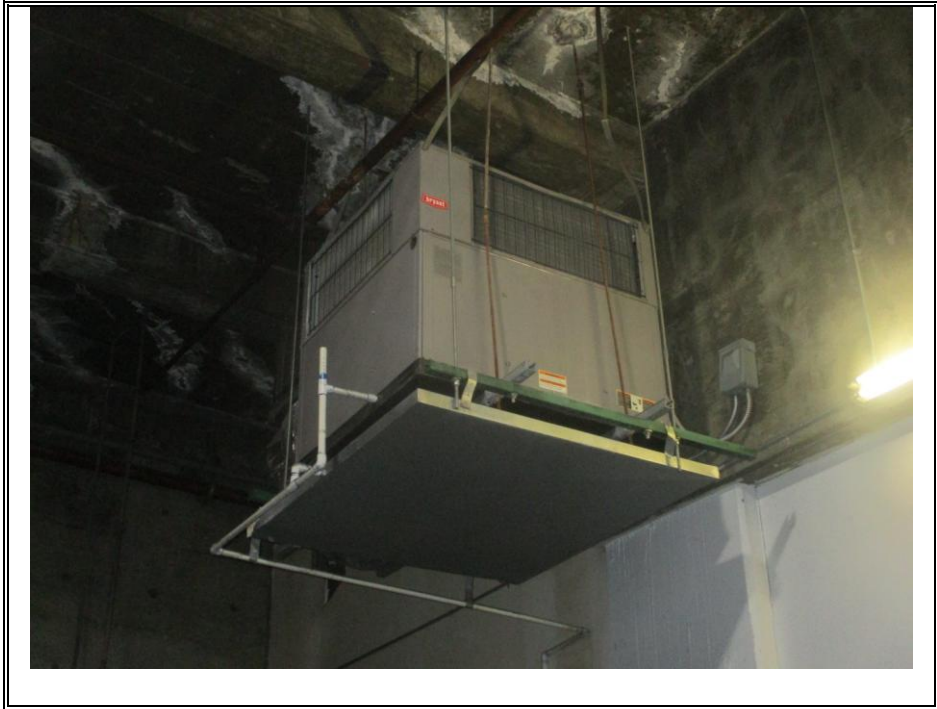
HEAT PUMPS-DUAL PACKS (TYPICAL)

OBSERVATIONS: *This component addresses the dual pack electric heat pumps in the garage. They were inaccessible for inspection (requiring a 16' ladder), however we were informed they were installed in 2023.*

TO PROTECT YOUR INVESTMENT: *The heat pumps should be serviced twice a year. We recommend obtaining a maintenance contract with a reputable licensed heating/air conditioning company.*

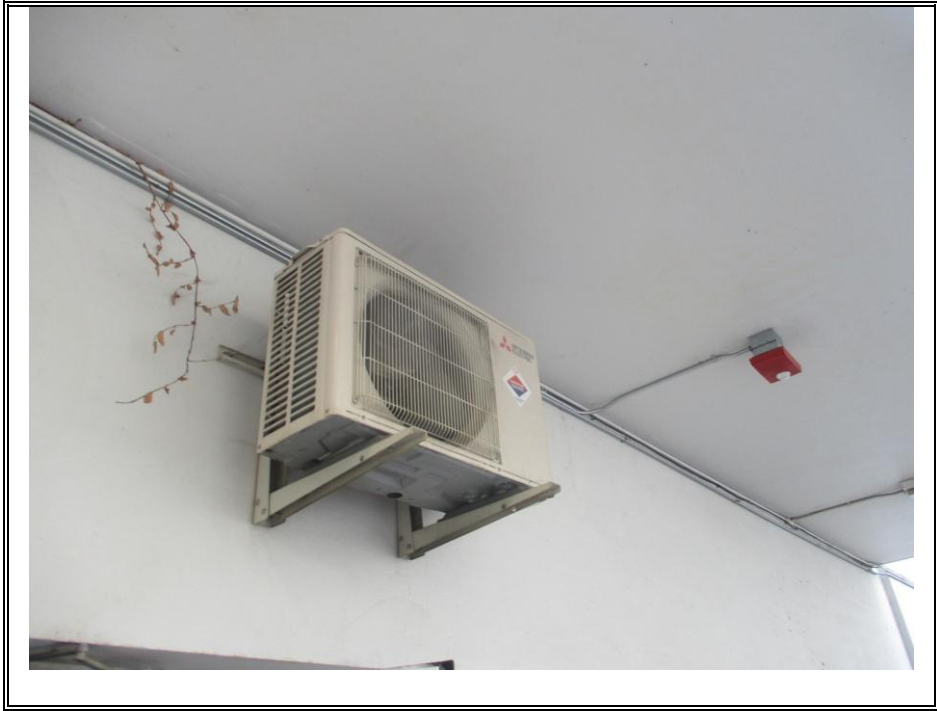
DUCTLESS AIR CONDITIONER (TYPICAL)

OBSERVATIONS: *This component addresses a “Mitsubishi” ductless air conditioning system serving the manager’s office. It appeared to be in good condition.*

TO PROTECT YOUR INVESTMENT: *The equipment should be serviced twice a year. We recommend obtaining a maintenance contract with a reputable licensed heating/air conditioning company.*

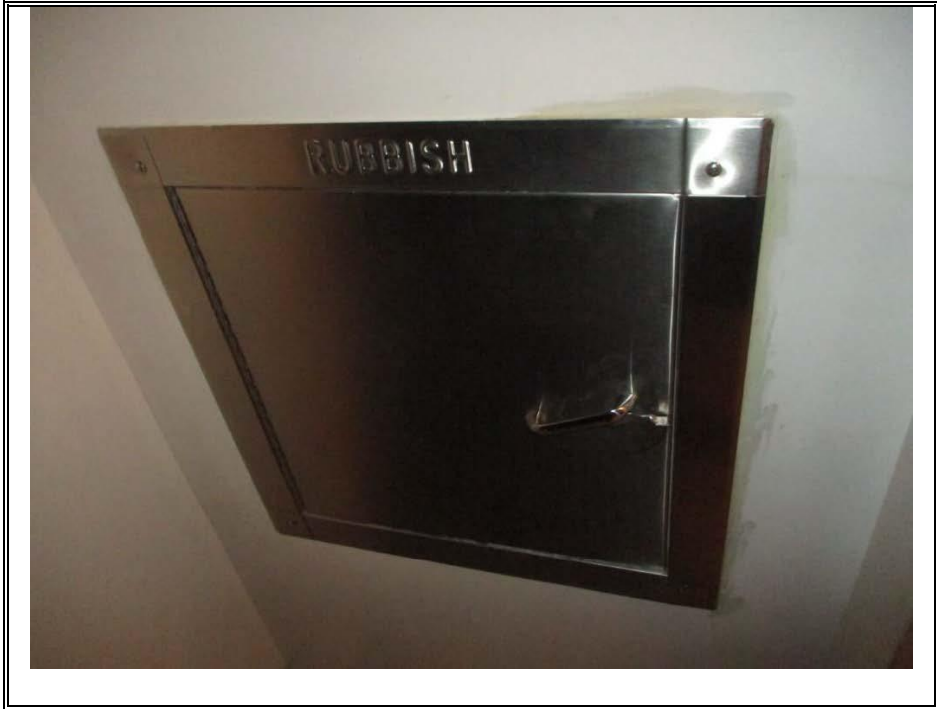
TRASH CHUTES (TYPICAL)

OBSERVATIONS: *This component addresses the replacement of the doors and other miscellaneous repairs to the trash chutes. We were informed that the chute was refurbished and the doors replaced in 2024, and they appeared to be in good condition.*

TO PROTECT YOUR INVESTMENT: *Testing should be done to ensure proper operation. A maintenance contract should be obtained with the appropriate specialist.*

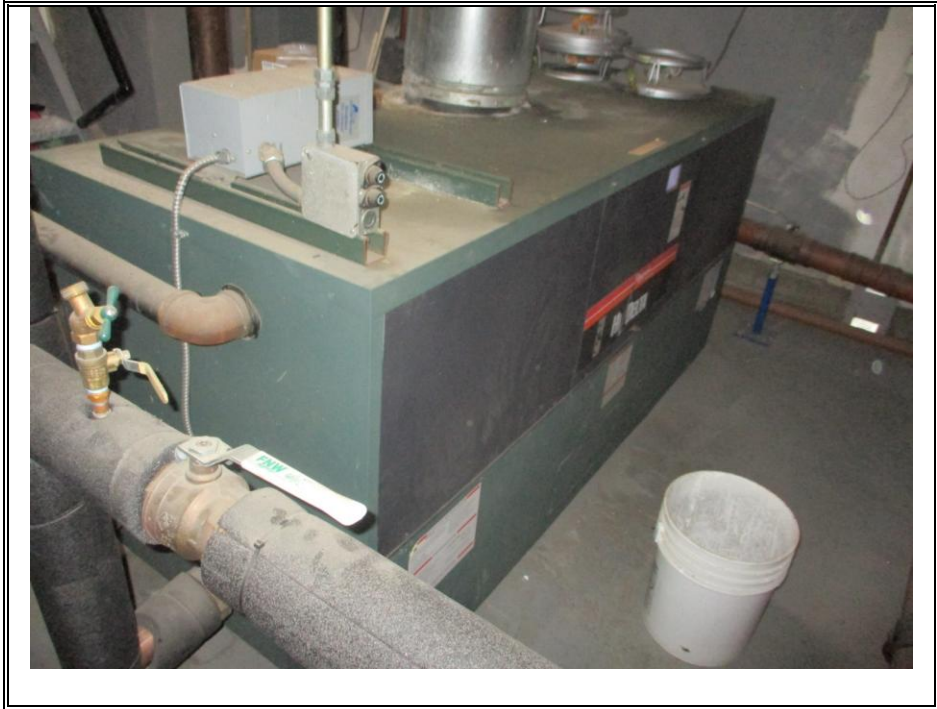
BOILER-REPLACE (TYPICAL)

OBSERVATIONS: *This component addresses a “Raypak Hi-Delta” 1,530,000 BTU boiler in the boiler equipment room. We were previously informed that it was installed in 2019 and it appeared to be in good condition. This type of equipment can fail without warning, often as a result of improper maintenance.*

TO PROTECT YOUR INVESTMENT: *It is recommended that a full-service maintenance contract be obtained with a reputable licensed plumbing contractor. Also, the addition of a water treatment system would serve to enhance the longevity of this component.*

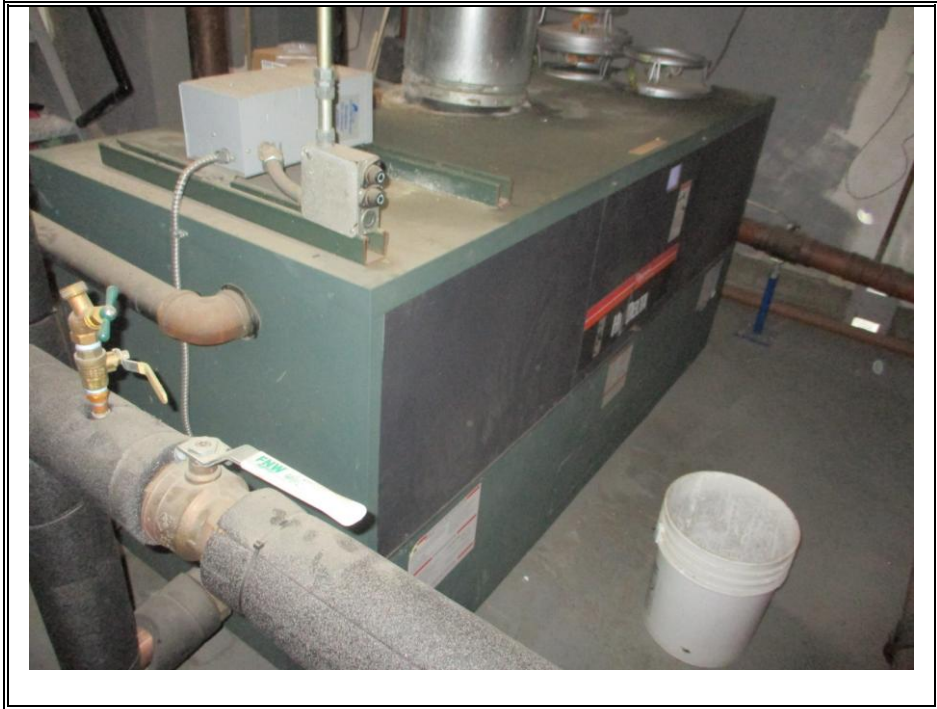
BOILER-OVERHAUL (TYPICAL)

OBSERVATIONS: *This component addresses the overhauling of the boiler. We were informed of pipe repair done in 2019 and a replacement pump installed in 2023. Such an overhaul should include reaming of the header/tube pack replacement to obtain maximum efficiency and service life from the boiler. This typically occurs at about mid-life of the boiler (i.e. 8 years). A life cycle of 16 years is therefore used for the purposes of reporting. It should be noted that a visual examination can make no predictions as to future performance (i.e. even with correct maintenance, this unit can fail without warning).*

TO PROTECT YOUR INVESTMENT: *It is recommended that a full-service maintenance contract be obtained with a reputable licensed plumbing contractor. Also, the addition of a water treatment system would serve to enhance the longevity of this component.*

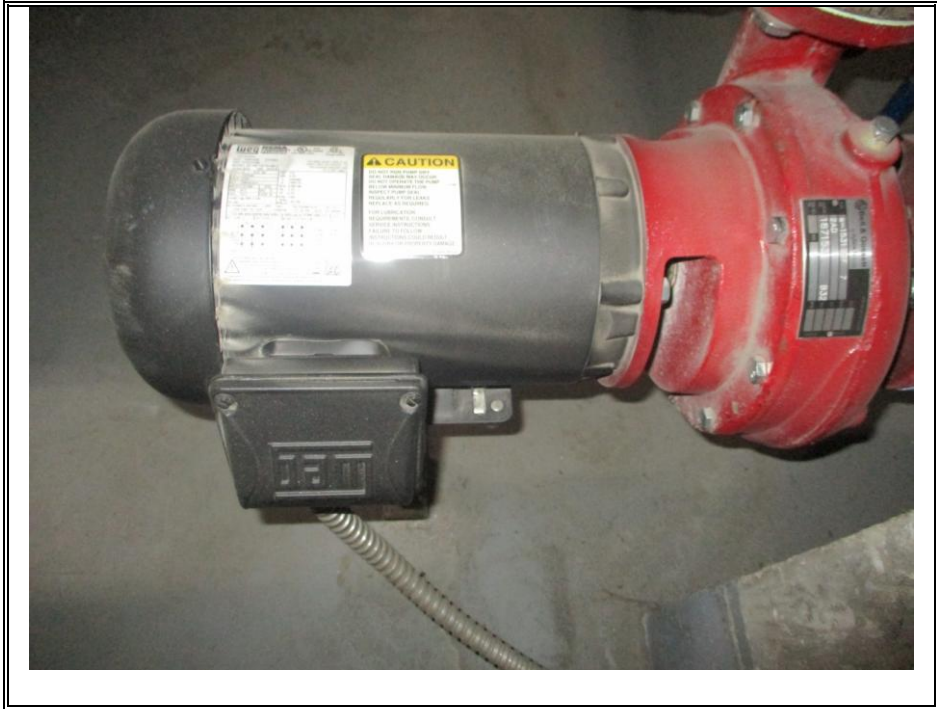
CIRCULATION PUMPS (TYPICAL)

OBSERVATIONS: *This component addresses the circulation pumps, comprised of 1 at 1 horsepower and 1 at ½ horsepower, which serve to expedite hot water provision to the individual units. We were previously informed that one was installed in 2018, and for the purposes of reporting the remaining life has been averaged.*

TO PROTECT YOUR INVESTMENT: *Maintenance should include periodic lubrication (which can considerably extend its life expectancy).*

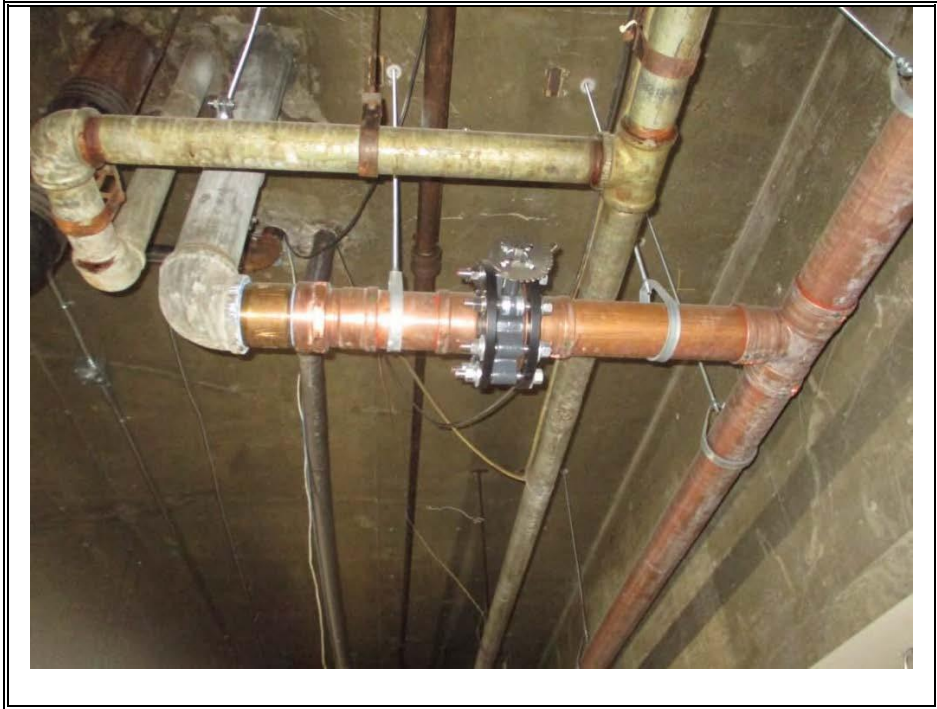
DISTRIBUTION PIPING (TYPICAL)

OBSERVATIONS: *This component addresses the copper distribution piping. We were informed that it was installed from 2019-2022, and the visible portions appeared to be in good condition. The typical useful life is approximately 40 years; however, it can fail as early as 15 years after installation. This is suspected to be primarily caused by changes in the chemical makeup of potable water. A rough cost estimate, based on the number of units, has been provided. It is recommended that further evaluation be obtained from a licensed plumbing consultant / contractor.*

TO PROTECT YOUR INVESTMENT: *Little by way of maintenance is needed other than examination for leaking, especially in the garage area. Leaks should be repaired upon discovery, as wood or soil kept constantly moist provides ideal conditions for termites.*

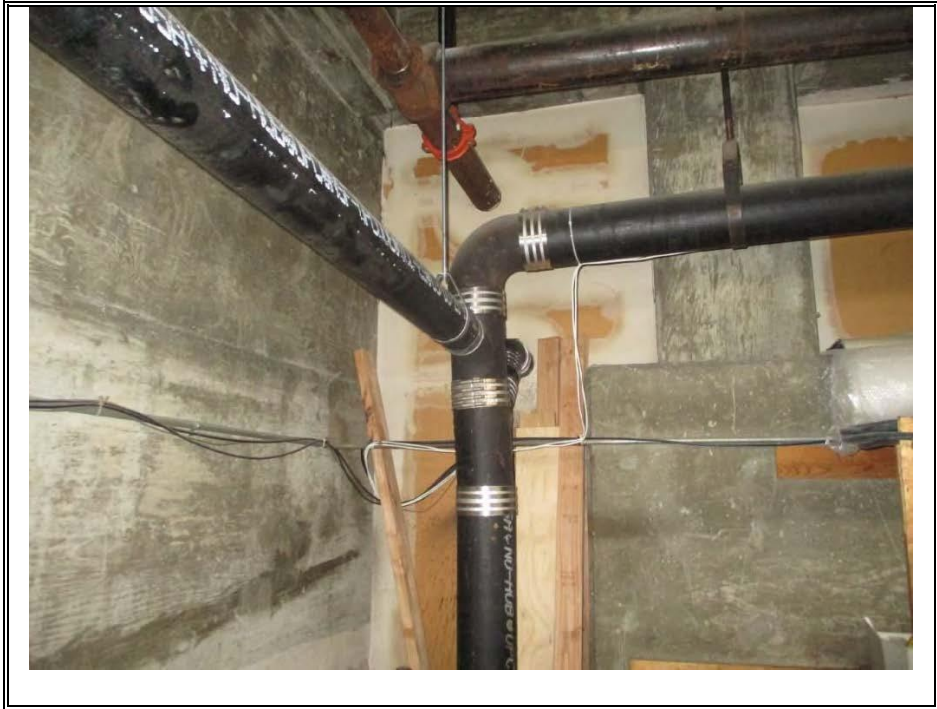
DRAINAGE/SEWER PIPING (TYPICAL)

OBSERVATIONS: *This component addresses the sewer and drainage piping. We were informed of repairs and replacements done 2019-2022, and the visible portions appeared to be in good condition. An allowance has been established for periodic cleaning and repairs. No amount has been provided for complete replacement as the piping would typically have a life in excess of the scope of this projection.*

TO PROTECT YOUR INVESTMENT: *Occasional routing should be performed to ensure that the drainage system is free-flowing.*

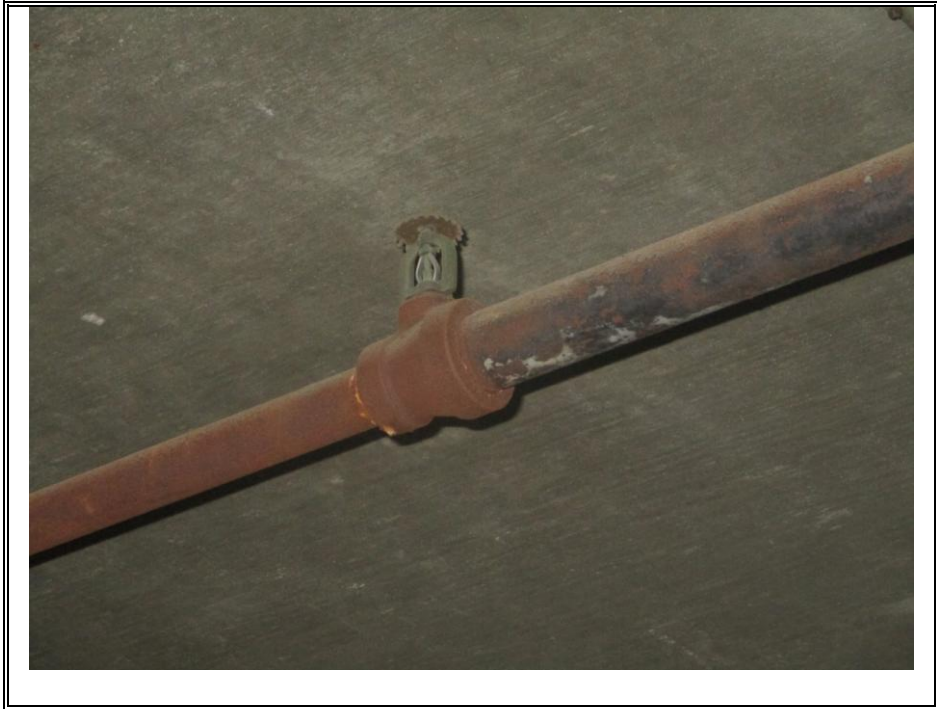
FIRE SPRINKLERS (TYPICAL)

OBSERVATIONS: *This component addresses the fire sprinklers in the garage. They appeared to be in an average condition. The fire sprinkler system would be considered to be a lifetime component. It is recommended that repairs be made on an as-needed basis and funded from the operating account.*

TO PROTECT YOUR INVESTMENT: *Periodic inspection and maintenance should be performed by a State Fire Marshall approved company.*

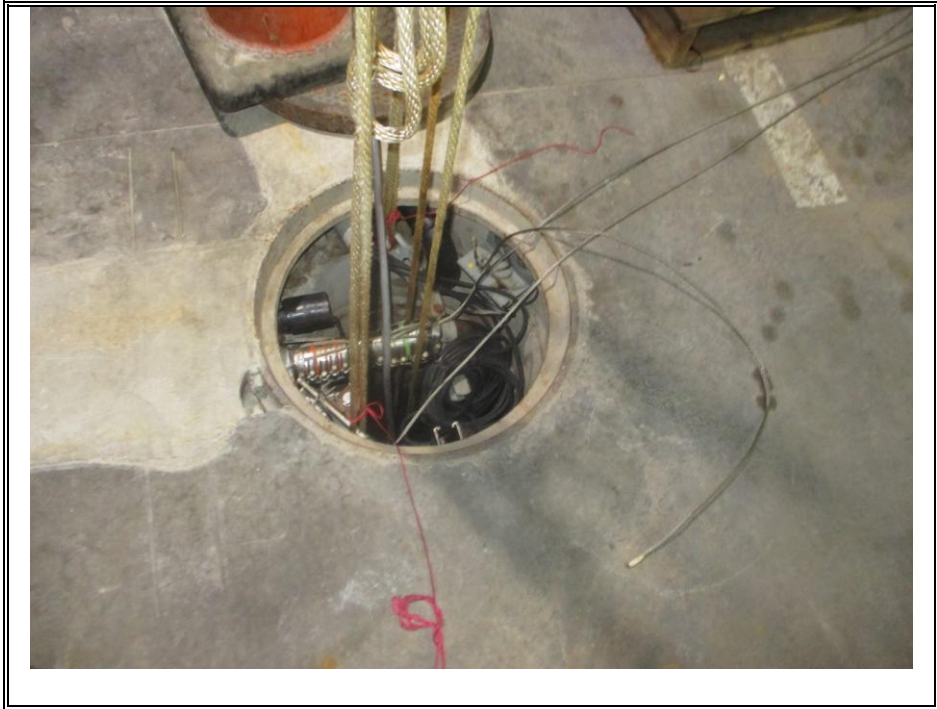
SUMP PUMPS (TYPICAL)

OBSERVATIONS: *This component addresses the sump pumps in the garage/stairwell. We were informed that they were replaced as part of a major renovation project. The pumps serve the purpose of preventing flooding by pumping water out to the street. These types of pumps are designed to operate automatically and are imperative for water removal during rainstorms. Failure of the pumps can also lead to over-saturation of the sub-surface soils and associated foundation and concrete slab settlement/cracking.*

TO PROTECT YOUR INVESTMENT: *Maintenance should include regular cleaning of the sumps along with verification that the pumps are operational. This should be specifically performed prior to the onset of the rainy season.*

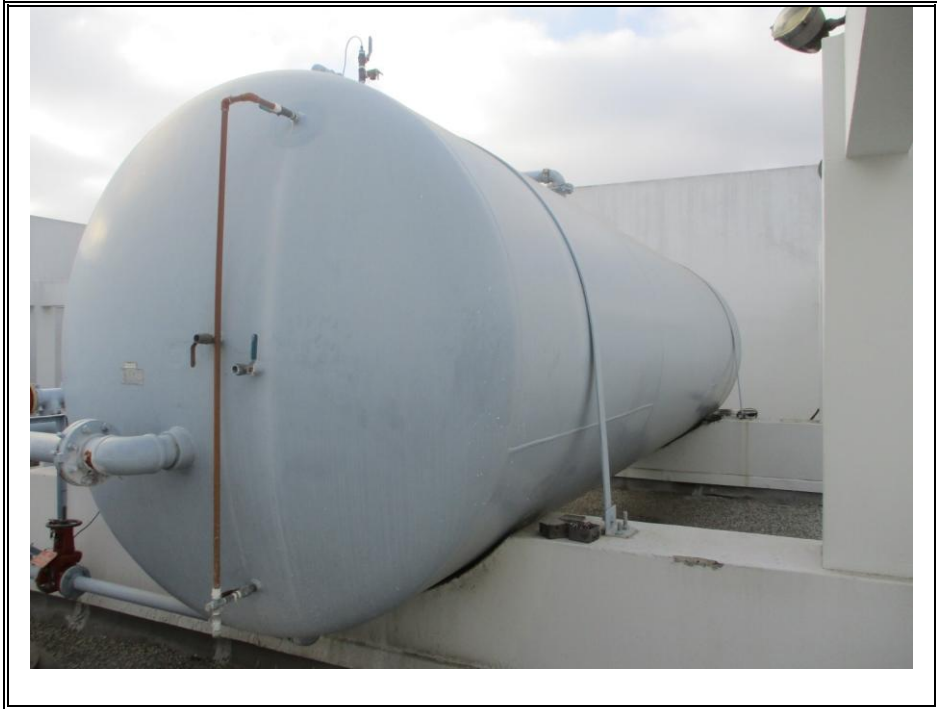
COLD WATER STORAGE TANK-RELINE (TYPICAL)

OBSERVATIONS: *This component provides for re-lining the ceramic lined cold water storage tank on the roof. We were previously informed that with periodic re-lining, the tank should have a life of 30+ years. We also previously informed that re-lining was last performed circa 2015.*

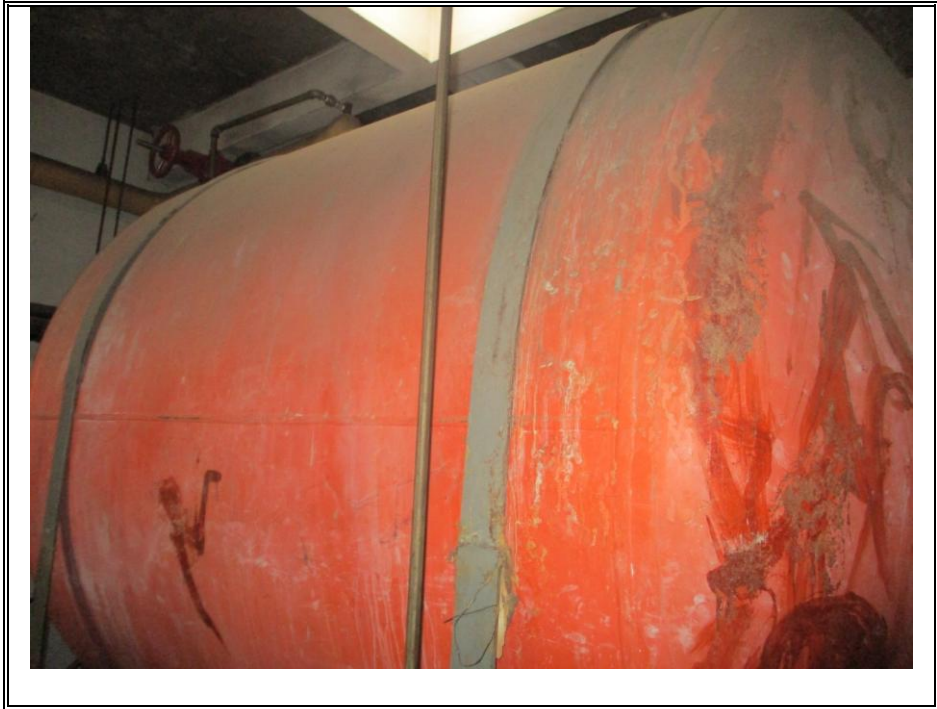
HOT WATER STORAGE TANK (TYPICAL)

OBSERVATIONS: *This component addresses a hot water storage tank in the boiler equipment room. The lining was inaccessible for inspection (encased); however, we were previously informed that it was re-lined in 2022, and for the purposes of reporting the remaining life has been estimated. This type of equipment can fail without warning, often as a result of improper maintenance.*

TO PROTECT YOUR INVESTMENT: *Maintenance should include periodic draining of a few gallons of water from the drain cock to relieve sediment build-up. It is also essential that the sacrificial anodes be checked at least every three months. A service contract with a reputable licensed plumbing contractor is again recommended for longevity of the system. The association may consider professionally installing a water treatment system, which would serve to enhance the longevity of the piping.*

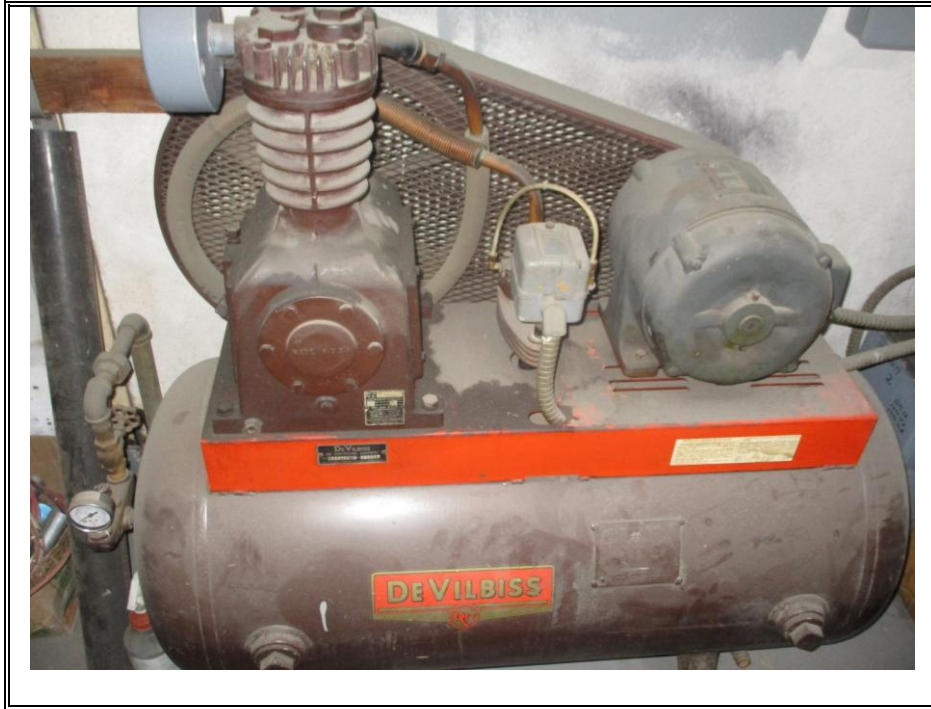
AIR COMPRESSOR (TYPICAL)

OBSERVATIONS: *This component addresses the air compressor in the boiler equipment room, manufactured in 1994, which services the boiler system. It appeared to be in average to aging condition.*

TO PROTECT YOUR INVESTMENT: *It is recommended that a full-service maintenance contract be obtained with a reputable licensed contractor.*

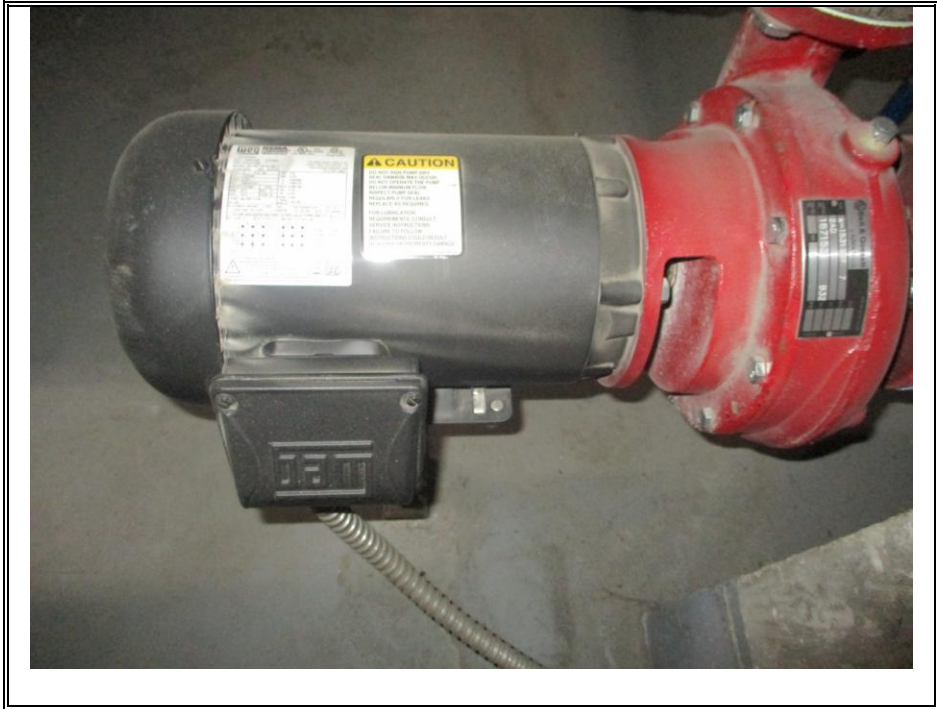
BOOSTER PUMP (TYPICAL)

OBSERVATIONS: *This component addresses the “Grundfos” booster pump and motor in a maintenance closet at garage level two, which serves to increase water pressure provision to the individual units. We were informed that it was installed in 2023, and it appeared to be in good condition.*

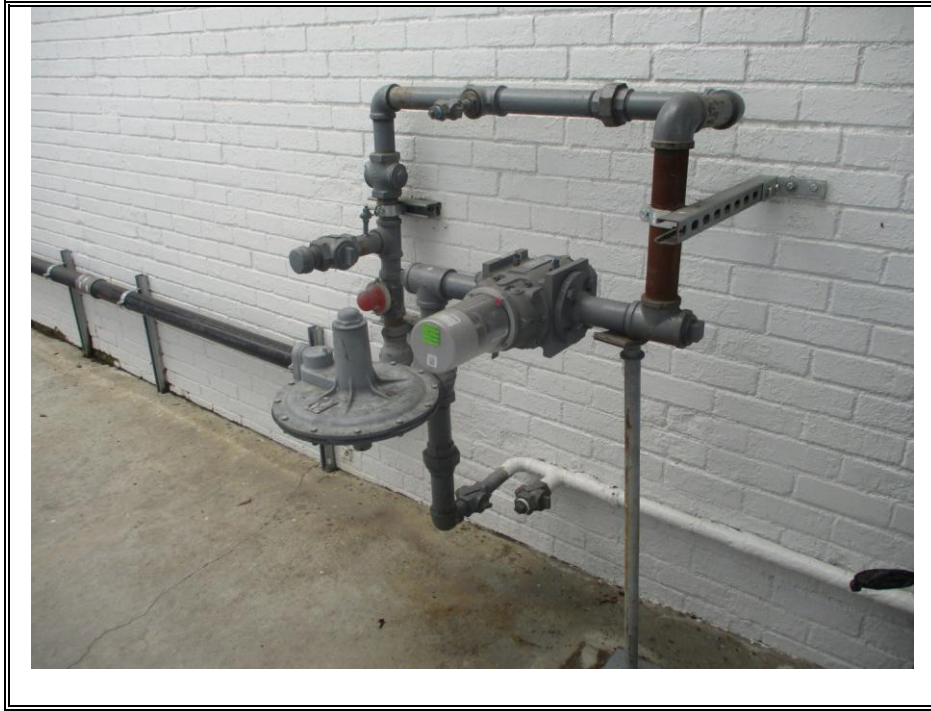
NATURAL GAS SYSTEM (TYPICAL)

OBSERVATIONS: *This component addresses natural gas iron distribution piping system. No amount has been provided for complete replacement as the system would typically have a life expectancy well in excess of the scope of this report.*

TO PROTECT YOUR INVESTMENT: *Little by way of maintenance can be performed for this component.*

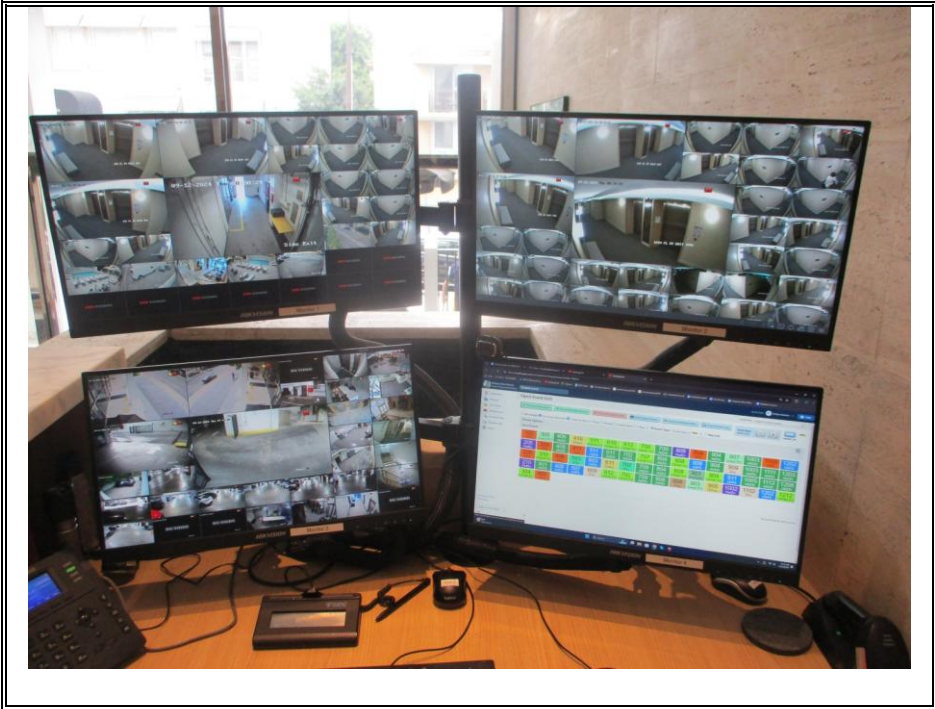
CCTV SYSTEM (TYPICAL)

OBSERVATIONS: *This component addresses the cameras and recorders for the closed-circuit television system. We were informed that the system was installed in 2024 and it appeared to be in good condition.*
