COMPLETE RSI RESERVE STUDY WITH SITE VISIT

HIGH RISE HOMEOWNERS' ASSOCIATION

1234 Main Street
Anywhere, California

2/10/2026

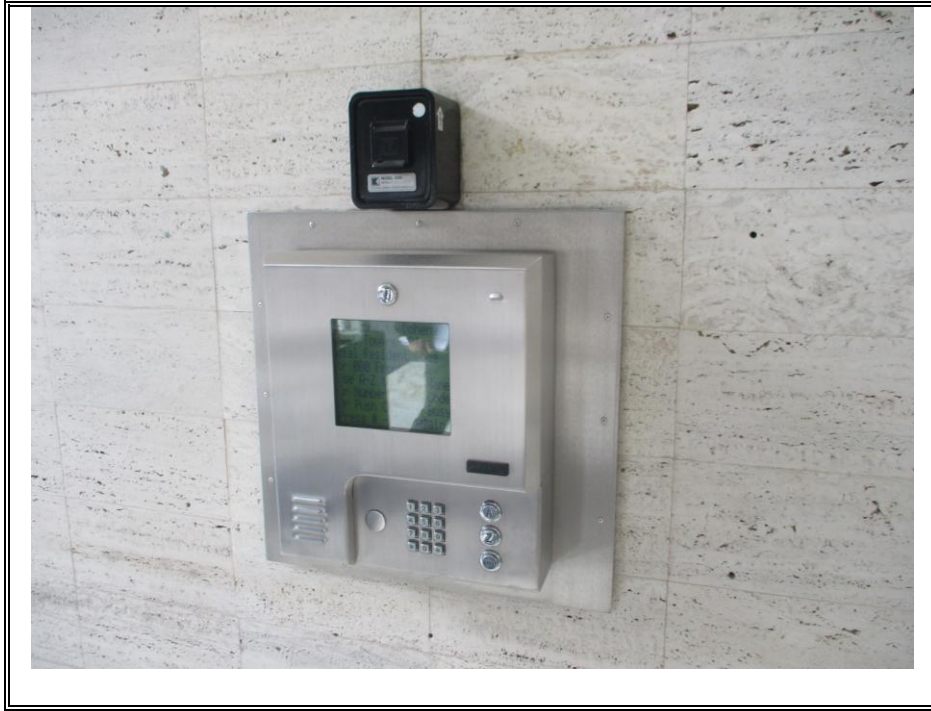
INTERCOM (TYPICAL)

OBSERVATIONS: *This component addresses a telephone-type entry intercom system with LCD scroll, at the pedestrian entry to the building. We were informed it was serviced in 2018, and it appeared to be in average condition for its age.*

TO PROTECT YOUR INVESTMENT: *Little by way of maintenance can be performed for this component, although minor operational problems are typically encountered (operating cost).*

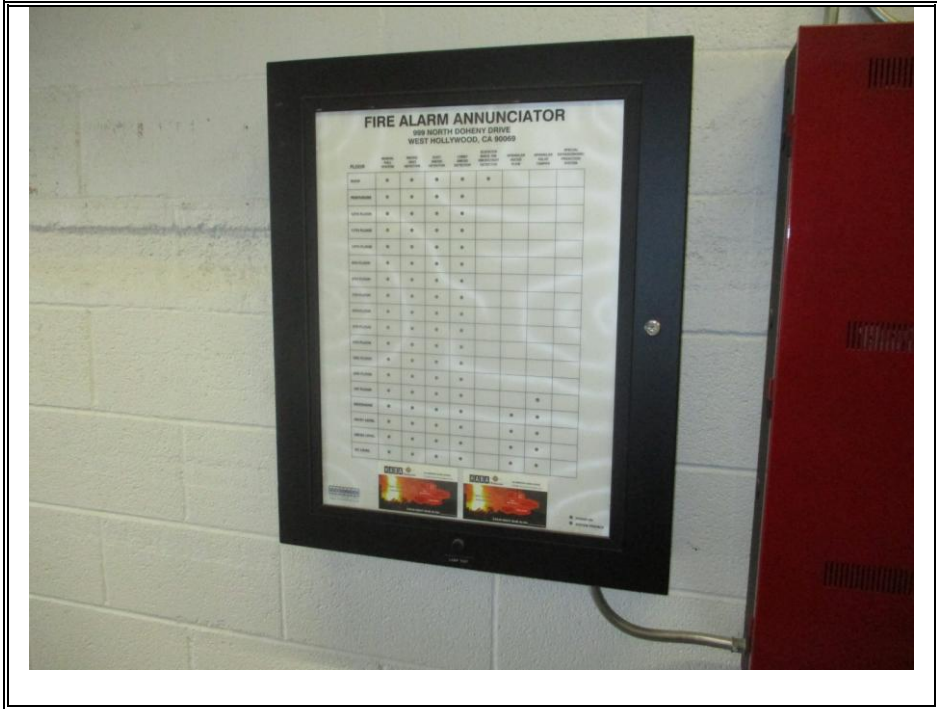
FIRE ANNUNCIATOR SYSTEM (TYPICAL)

OBSERVATIONS: *This component addresses a fire annunciator system (panel) adjacent to the manager’s office. We were informed that it was installed in 2024, and it appeared to be in good condition.*

TO PROTECT YOUR INVESTMENT: *Little by way of maintenance can be performed for this component. However, it should be professionally inspected on a regular (suggested annual) basis.*

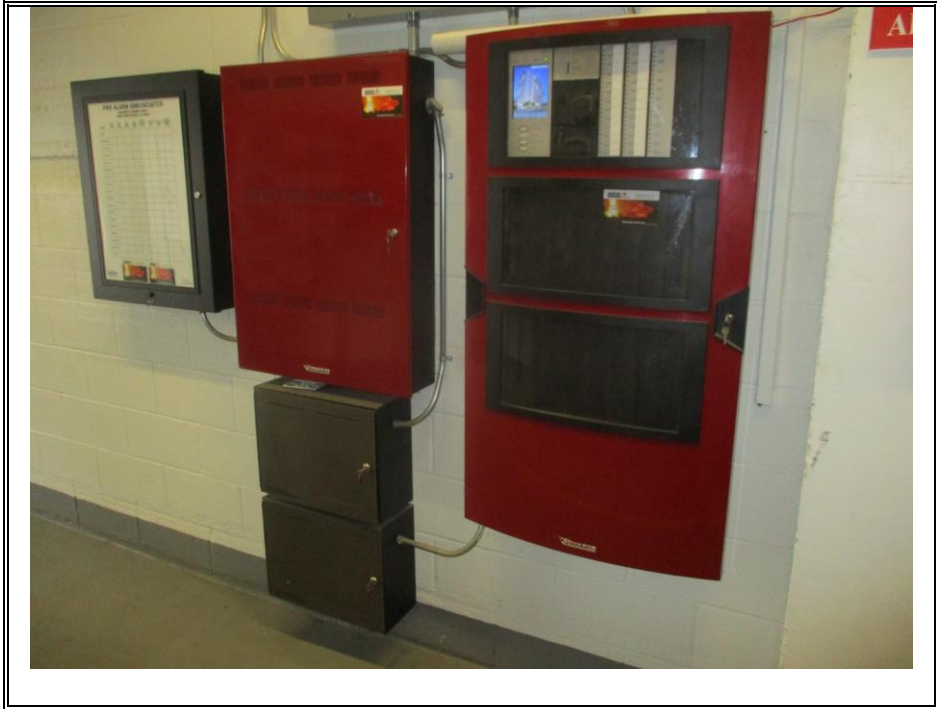
FIRE ALARM SYSTEM (TYPICAL)

OBSERVATIONS: *This component addresses a fire alarm system in the service hallway at the east end of the building. We were informed that it was installed in 2024, and it appeared to be in good condition. We were also previously informed by the service company that the current system is “grandfathered” from existing codes. To upgrade/replace the system would require re-wiring the entire building and substantial additional equipment such as audible speakers, smoke alarms, etc., and it would have to conform to the “2 door rule” mode. In addition, a potential asbestos removal problem may exist.*

TO PROTECT YOUR INVESTMENT: *Little by way of maintenance can be performed for this component. However, it should be professionally inspected on a regular (suggested annual) basis.*

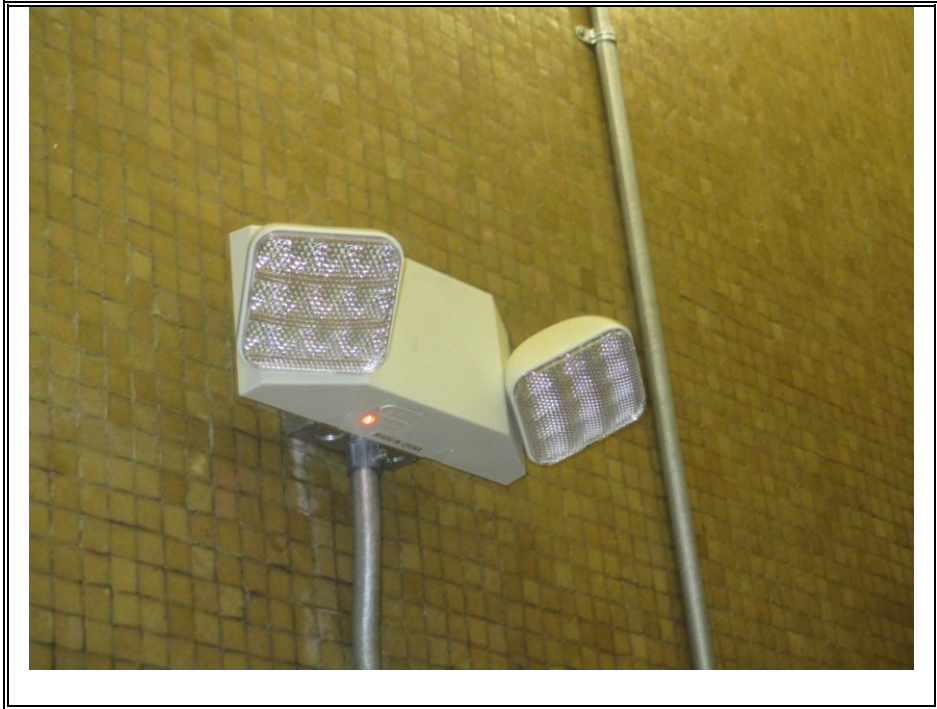
LIGHTING-EMERGENCY (TYPICAL)

OBSERVATIONS: *This component addresses the emergency light fixtures throughout the building. They appeared to be in an average condition. It is recommended that replacement be made on an as-needed basis and funded from the operating account.*

TO PROTECT YOUR INVESTMENT: *Maintenance would entail periodically checking the fixtures to make sure that they are secure and that the batteries are fully charged. Also, occasional examination for, and changing of burned out bulbs would be prudent. In addition, cleaning of the fixtures is recommended on an as-needed basis.*

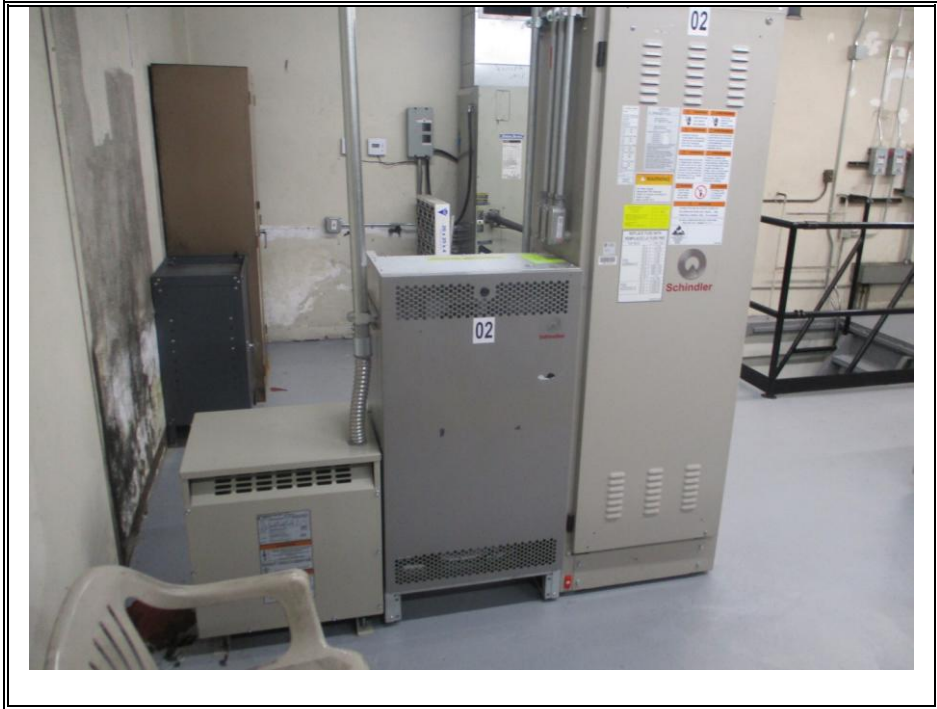
LIGHTING-EMERGENCY BACK-UP POWER (TYPICAL)

OBSERVATIONS: *This component addresses the battery pack back-up power systems for the emergency lights in the elevator equipment room. They were inaccessible for inspection (the cabinets were locked), and for the purposes of reporting the condition and remaining life has been estimated.*

TO PROTECT YOUR INVESTMENT: *Periodic testing should be performed for the system to ensure proper operation.*

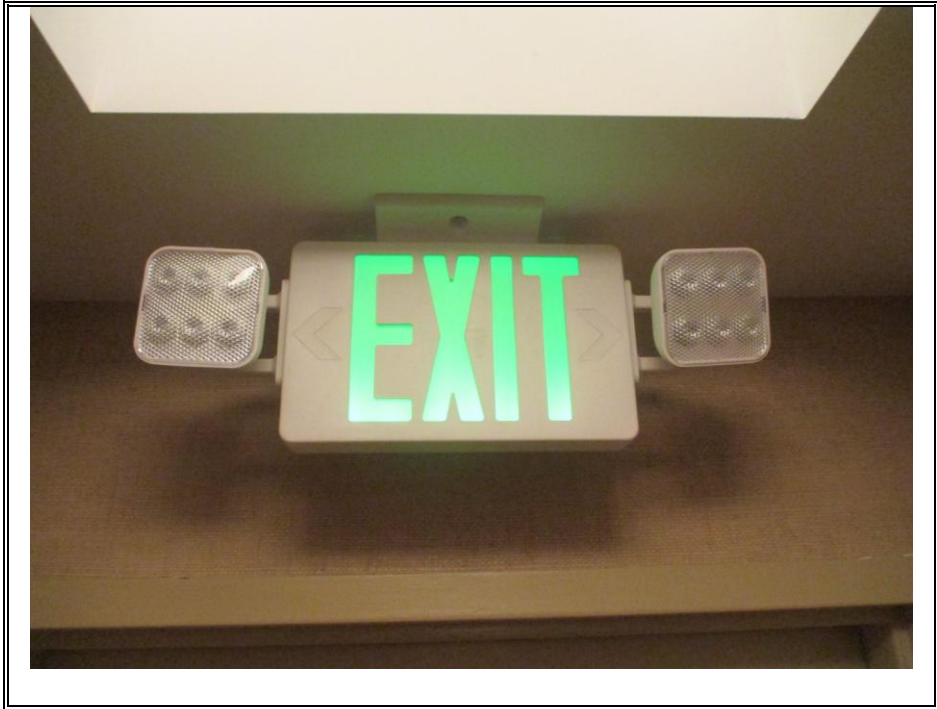
LIGHTING-EXIT SIGNS (TYPICAL)

OBSERVATIONS: *This component addresses the lighted exit signs throughout the complex. We were informed they were replaced or refurbished in 2024, and they appeared to be in good condition.*

TO PROTECT YOUR INVESTMENT: *Maintenance would entail periodically checking the fixtures to make sure that they are secure. Also, occasional examination for, and changing of burned-out bulbs would be prudent. In addition, cleaning of the fixtures is recommended on an as-needed basis.*

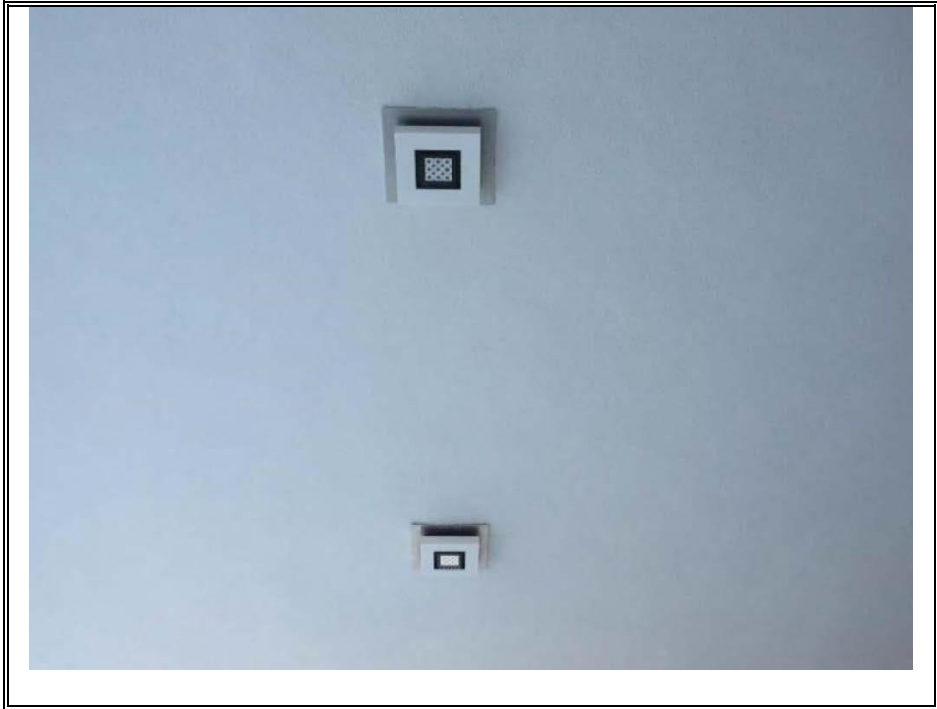
LIGHTING-EXTERIOR (DECORATIVE) (TYPICAL)

OBSERVATIONS: *This component addresses the LED wall and ceiling mounted decorative light fixtures at the balconies and exterior of the building. We were informed that they were installed in 2024, and they appeared to be in good condition.*

TO PROTECT YOUR INVESTMENT: *Maintenance would entail periodically checking the fixtures to make sure that they are secure. Also, occasional examination for, and changing of burned-out bulbs would be prudent. In addition, cleaning of the fixtures is recommended on an as-needed basis.*

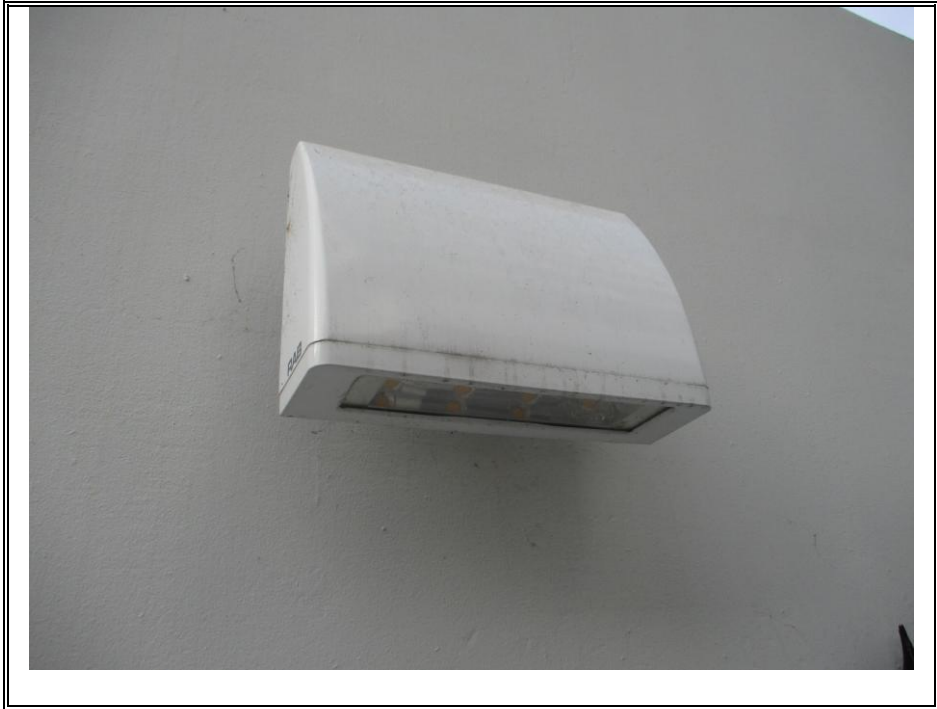
LIGHTING-EXTERIOR (UTILITARIAN) (TYPICAL)

OBSERVATIONS: *This component addresses the utilitarian light fixtures at the exterior of the building. They appeared to be in an average condition. It is recommended that repairs/replacement be done on an as-needed basis and funded from the operating account.*

TO PROTECT YOUR INVESTMENT: *Maintenance would entail periodically checking the fixtures to make sure that they are secure. Also, occasional examination for, and changing of burned-out bulbs would be prudent. In addition, cleaning of the fixtures is recommended on an as-needed basis.*

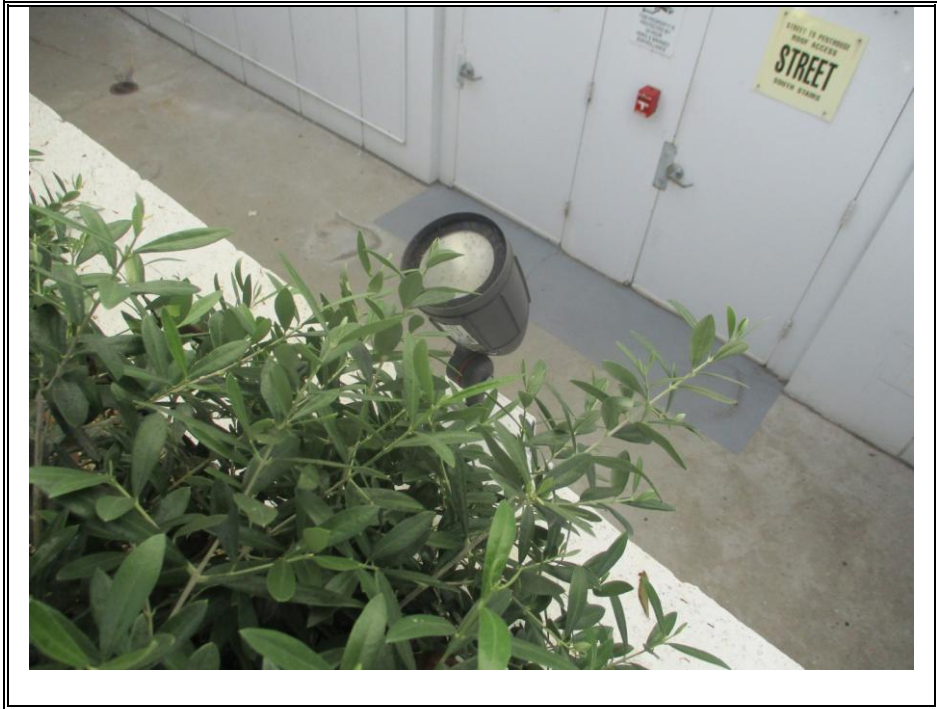
LIGHTING-EXTERIOR (SECURITY) (TYPICAL)

OBSERVATIONS: *This component addresses the high intensity discharge type floodlight fixtures at the exterior of the building. They appeared to be in an average condition. It is recommended that repairs/replacement be done on an as-needed basis and funded from the operating account.*

TO PROTECT YOUR INVESTMENT: *Maintenance would entail periodically checking the fixtures to make sure that they are secure. Also, occasional examination for, and changing of burned-out bulbs would be prudent. In addition, cleaning of the fixtures is recommended on an as-needed basis.*

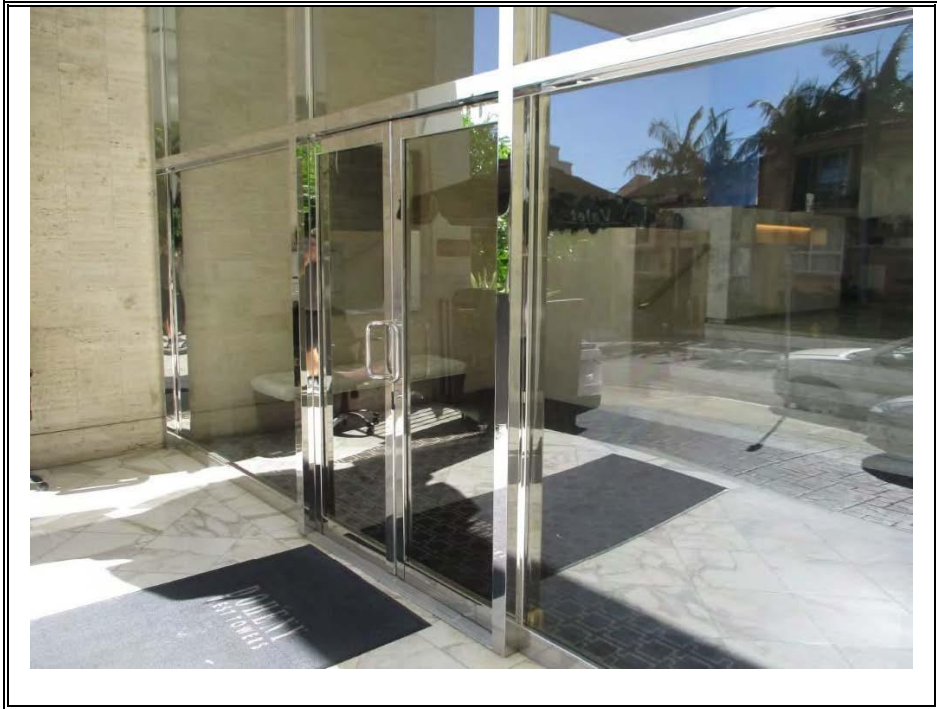
ACCESS CONTROL (TYPICAL)

OBSERVATIONS: *This component addresses an allowance to maintain the building's access control system, including key fobs. We were informed it was refurbished in 2024, and it appeared to be in good condition.*

TO PROTECT YOUR INVESTMENT: *Little by way of maintenance can be performed for this component, although minor operational issues are typically encountered.*

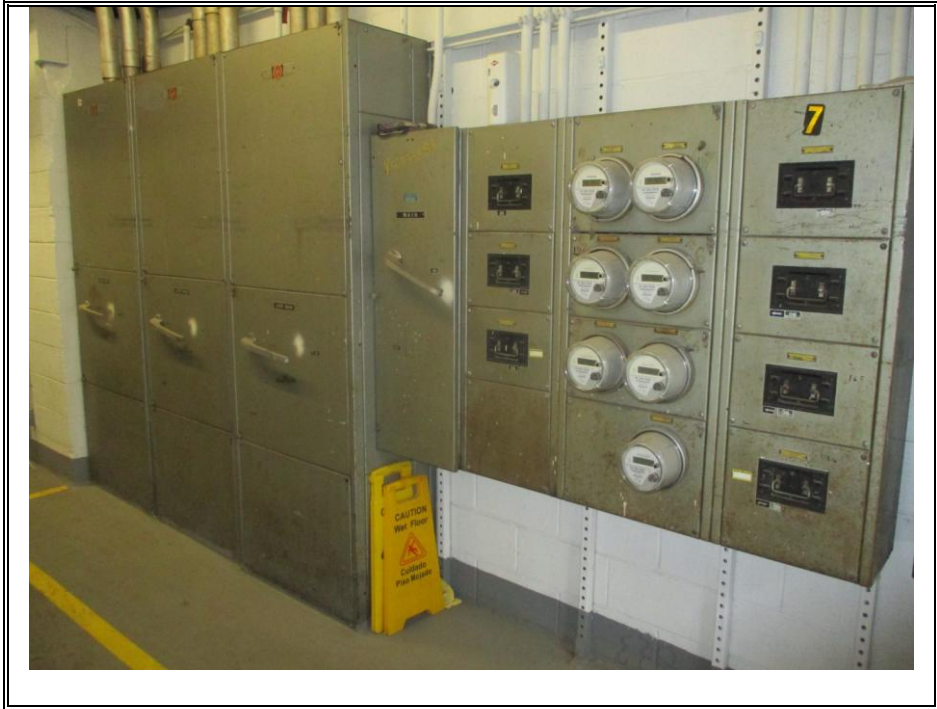
ELECTRICAL SYSTEM (TYPICAL)

OBSERVATIONS: *This component addresses the electrical system, including the main service panel, and any meter bays, sub-panels, transformers, and distribution lines. No amount has been provided for complete replacement as the systems would typically have a life expectancy in excess of the scope of this report.*

TO PROTECT YOUR INVESTMENT: *Little by way of maintenance can be performed for this component.*

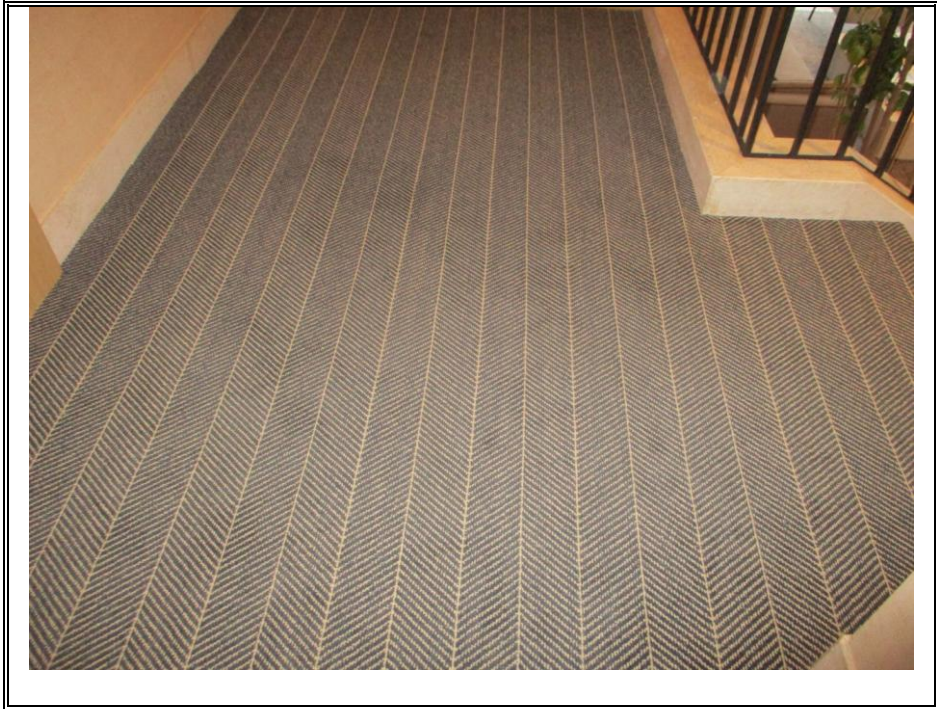
CARPETING (TYPICAL)

OBSERVATIONS: *This component addresses the carpeting in the internal hallways. We were informed that it was installed in 2024, and it appeared to be in good condition.*

TO PROTECT YOUR INVESTMENT: *Maintenance should entail regular vacuum cleaning (from once weekly to as often as daily for high traffic areas). Power pile lifting is recommended at least once a month for high traffic areas. Mats are suggested to remove dirt from shoes before it can be tracked onto carpeted areas (should be cleaned and rotated regularly to prevent soil build-up that may spread to the carpet). Spots and spills should be removed as soon as possible to prevent permanent staining. Deep cleaning should be performed on an as-needed basis (before soil is noticeable – usually not more than once every one or two years) and fluorochemical treatment applied immediately after. It is recommended that before applying any topical treatments, the carpet manufacturer be contacted to prevent voiding of the warranty. Damaged areas should be repaired as they can create a trip hazard resulting in association liability.*

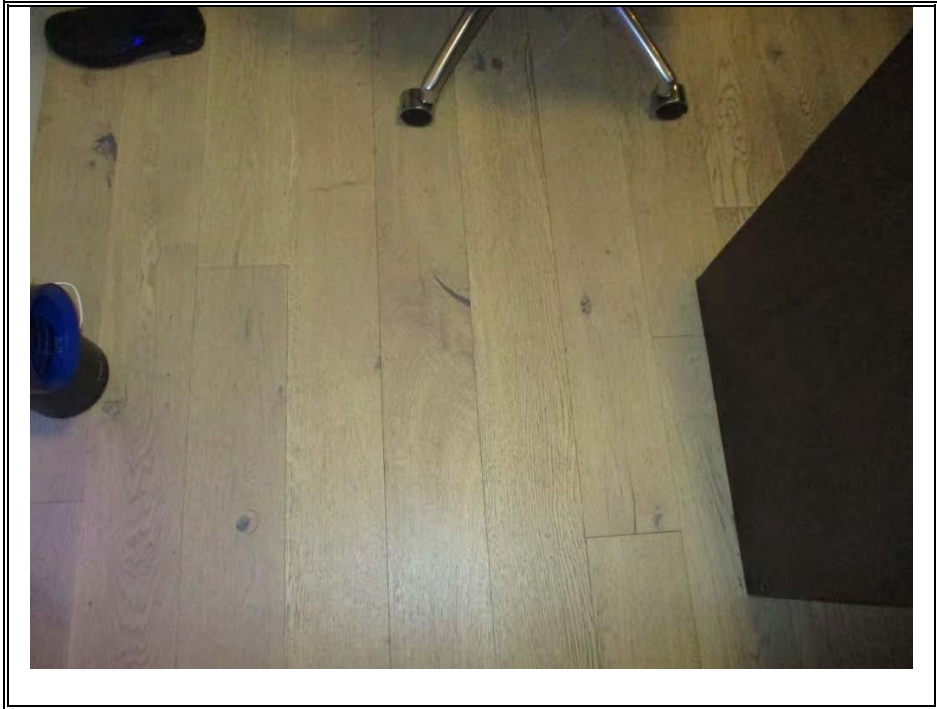
LAMINATE (TYPICAL)

OBSERVATIONS: *This component addresses the laminate flooring in the office, lobby, and other miscellaneous common areas. We were informed that it was installed in 2020, and it appeared to be in good condition.*

TO PROTECT YOUR INVESTMENT: *Lifting seams, corners, etc. should be re-glued and damaged areas repaired.*

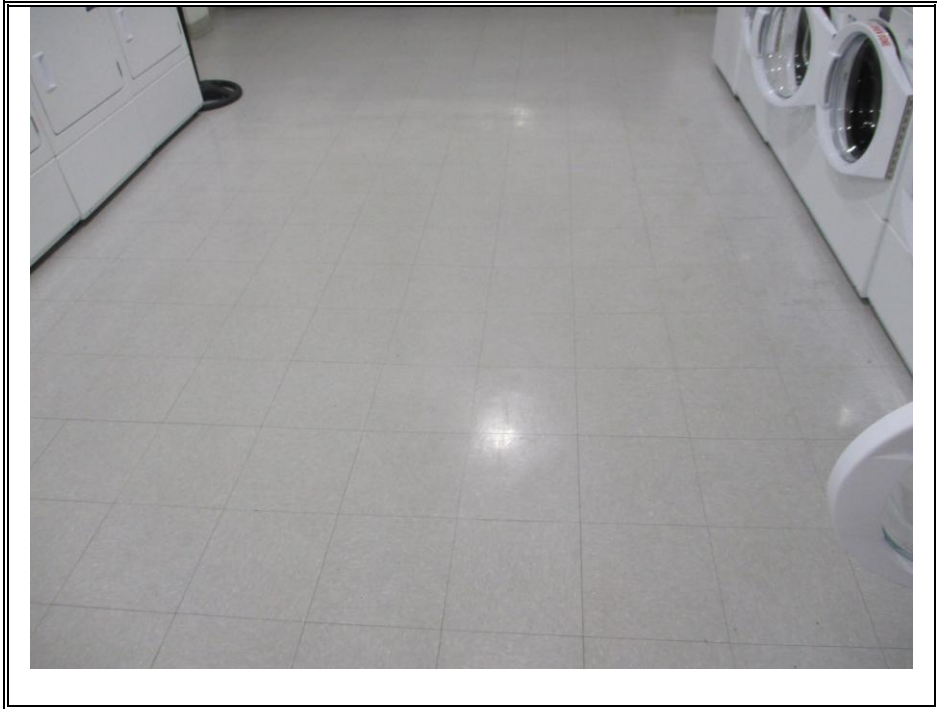
VINYL (TYPICAL)

OBSERVATIONS: *This component addresses the vinyl flooring in the laundry room, hallways, trash chutes, and miscellaneous common areas. We were informed that it was replaced or refurbished in 2024, and it appeared to be in good condition.*

TO PROTECT YOUR INVESTMENT: *Maintenance would entail regular cleaning with a mild detergent solution and warm water (care should be exercised to not flood the flooring). Do not use paste or solvent-based wax. Rubber backed rugs should be avoided as they can discolor the vinyl flooring. Soil collecting mats are recommended to remove dirt from shoe soles before it can be tracked onto the vinyl (they should be cleaned and rotated regularly to prevent soil build-up that will spread to the vinyl). Lifting seams, corners, etc. should be re-glued and damaged areas repaired as necessary.*

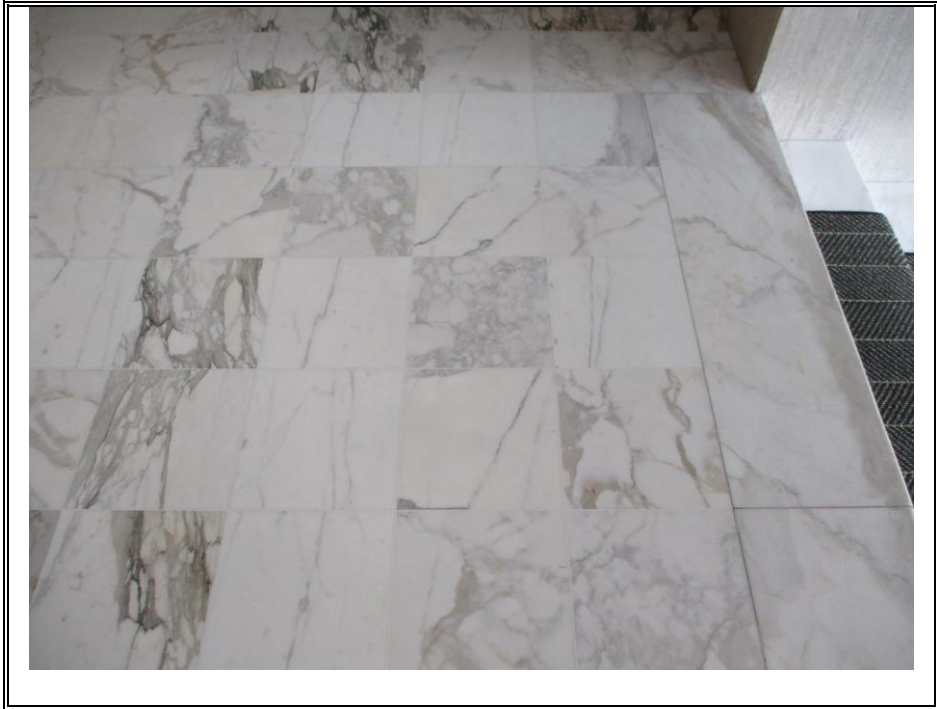
MARBLE-RESTORATION (TYPICAL)

OBSERVATIONS: *This component addresses the restoration of the marble flooring in the lobby and pedestrian entry to the building. It appeared to be in an average condition for its age. Included would be epoxy grout, heavy buff, polish, buff & seal. With regular maintenance the cycle for restoration should be at approximately 15-year intervals. If restored, the material itself would be considered to be a lifetime component. We were informed it was done in 2024, and it appeared to be in good condition.*

TO PROTECT YOUR INVESTMENT: *Only a mild soap and water solution should be used. Proprietary cleaners and sealers are discouraged. It is suggested that the marble be professionally cleaned on an annual basis.*

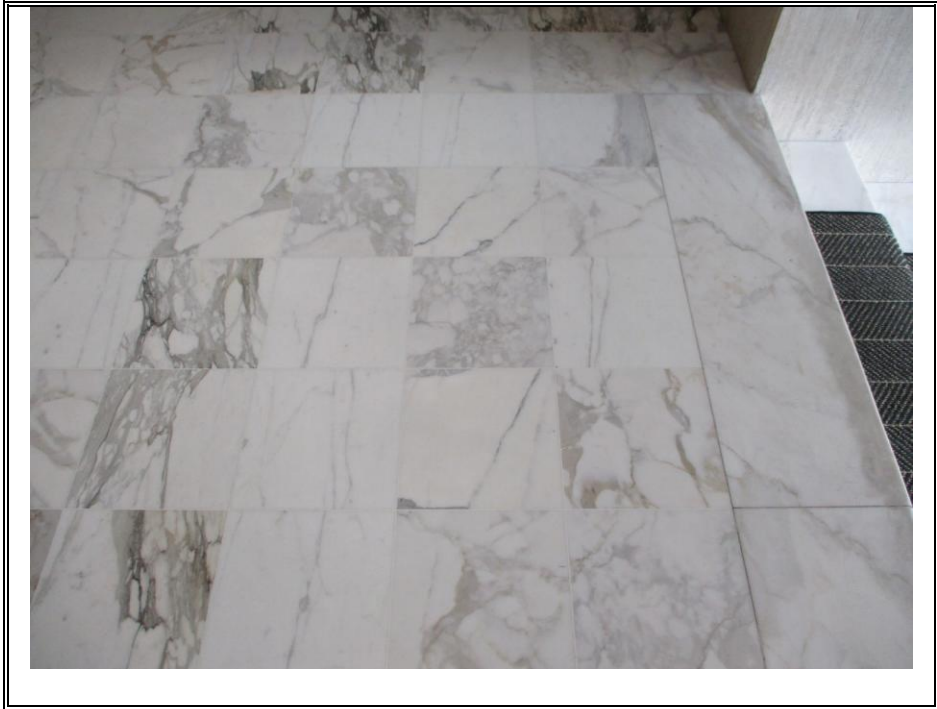
MARBLE-POLISHING (TYPICAL)

OBSERVATIONS: *This component provides for more frequent buffing and polishing of the marble flooring. We were informed that it was done in 2024, and it appeared to be in average condition.*

TO PROTECT YOUR INVESTMENT: *Only a mild soap and water solution should be used. Proprietary cleaners and sealers are discouraged. It is suggested that the marble be professionally cleaned on an annual basis.*

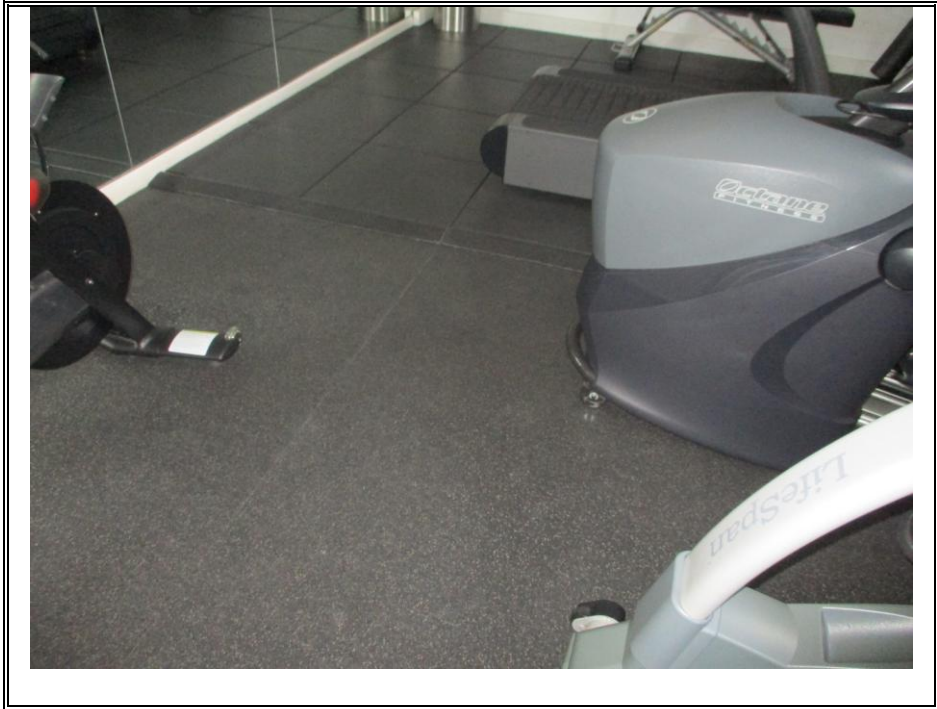
RUBBER (TYPICAL)

OBSERVATIONS: *This component addresses the rubber flooring in the gym. It appeared to be in average condition for its age.*

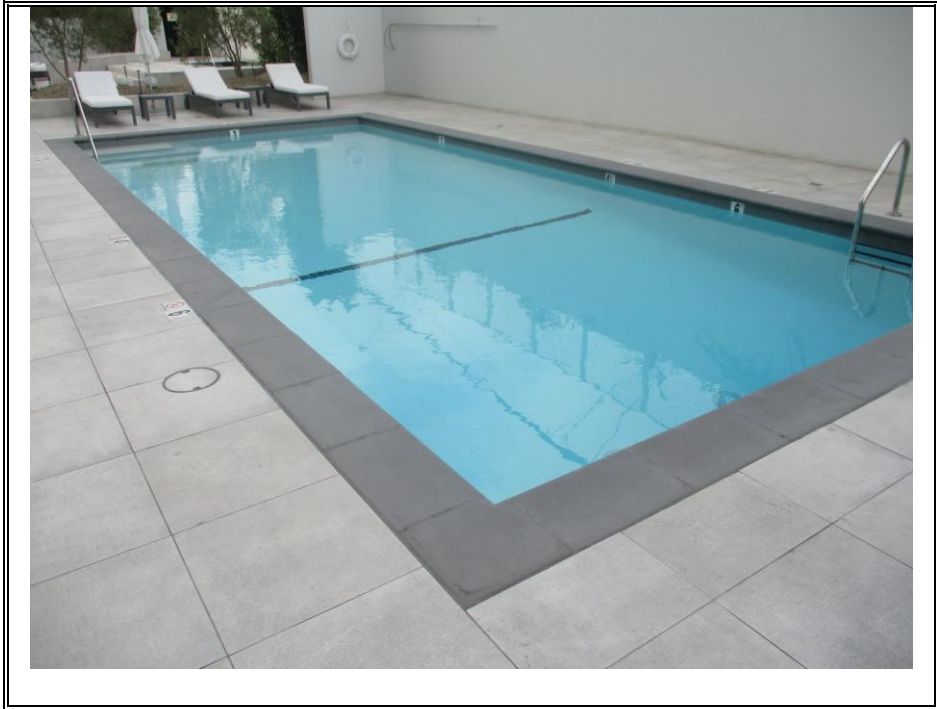
PLASTER-POOL (TYPICAL)

OBSERVATIONS: *This component addresses the plaster lining of the pool. We were informed that it was installed in 2024, and it appeared to be in good condition. Coarseness of the plaster, which occurs over time, is conducive to algae growth and can be injurious to users of the pool (potential association liability).*

TO PROTECT YOUR INVESTMENT: *Maintenance of a clean surface and proper chemical balance is essential for the longevity of the plaster lining.*

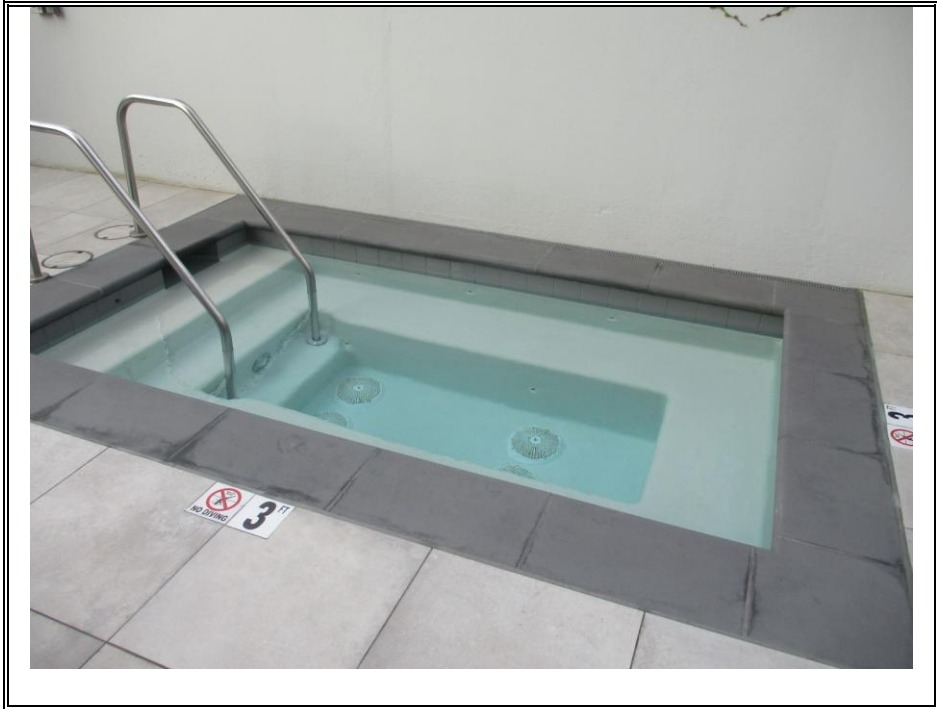
PLASTER- SPA (TYPICAL)

OBSERVATIONS: *This component addresses the plaster lining of the spa. We were informed that it was installed in 2024, and it appeared to be in good condition. Coarseness of the plaster, which occurs over time, is conducive to algae growth and can be injurious to users of the pool (potential association liability).*

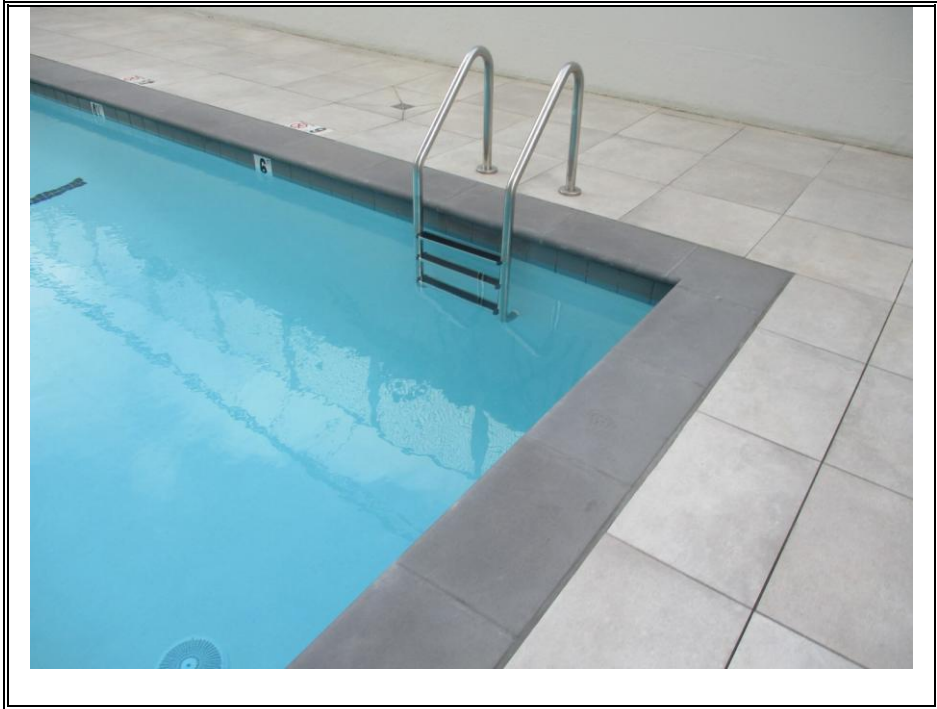
COPING JOINT (TYPICAL)

OBSERVATIONS: *This component addresses the caulking for the control joint (gap) between the pool and spa decking and the coping. It appeared to be in good condition.*

TO PROTECT YOUR INVESTMENT: *Maintenance of a well-sealed joint will reduce the potential for cracking and settlement of the pool decks. Prior to subsequent re-caulking of the coping joint, the existing caulk should be removed first. Otherwise, little by way of maintenance can be performed for this component.*

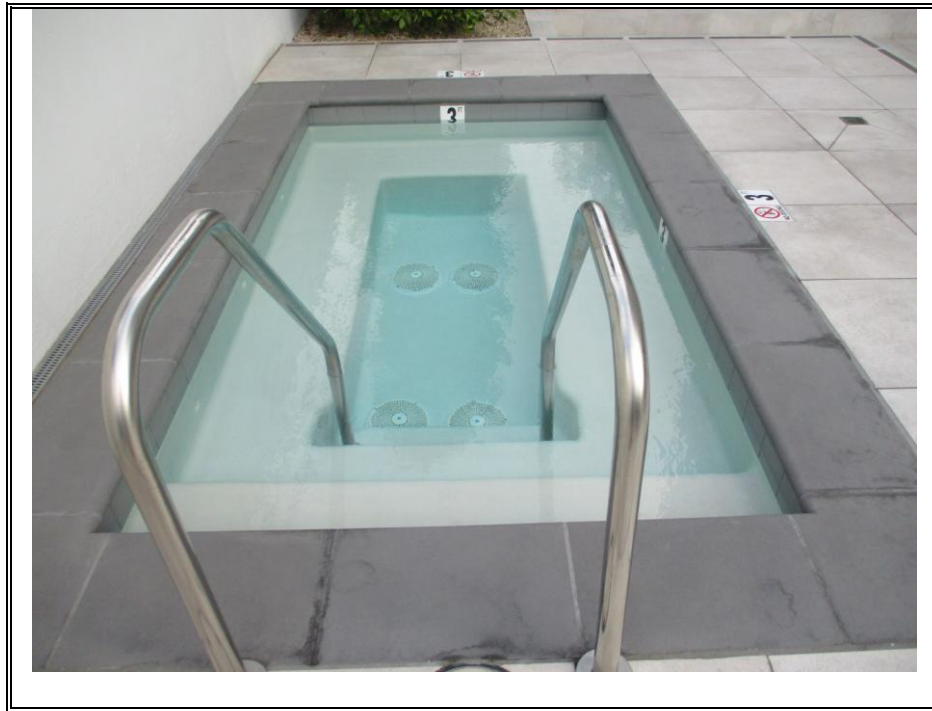
COPING/TILE (TYPICAL)

OBSERVATIONS: *This component addresses the coping and tile around the perimeter of the pool and spa. It appeared to be in good condition.*

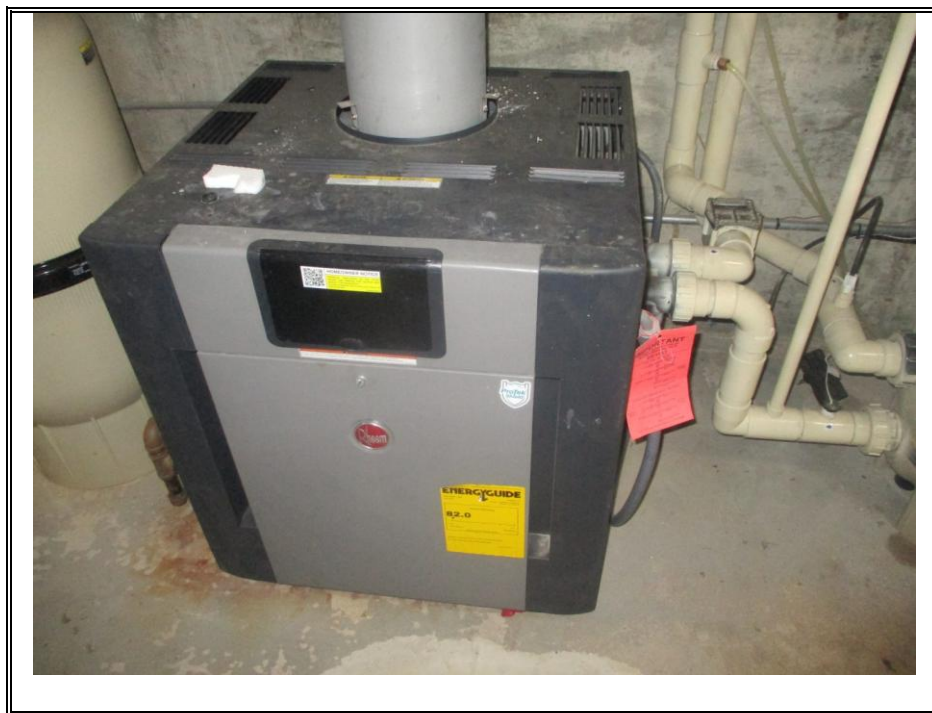
HEATERS (TYPICAL)

OBSERVATIONS: *This component addresses the heaters for the pool and spa, comprised of 1 at 332,500 BTU and 1 at 399,000 BTU. They appeared to be in good condition.*

TO PROTECT YOUR INVESTMENT: *The heaters should be professionally cleaned and serviced on an annual basis.*

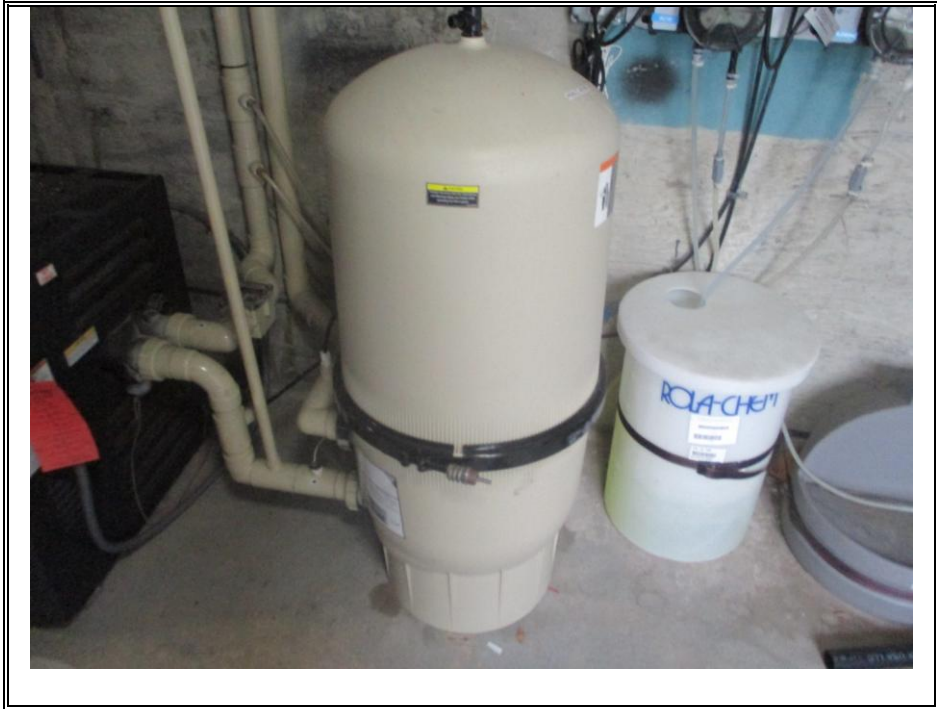
FILTERS (TYPICAL)

OBSERVATIONS: *This component addresses the “Pentair” diatomaceous earth filters for the pool and spa. They appeared to be in good condition.*

TO PROTECT YOUR INVESTMENT: *The filters should be regularly cleaned and the media re-charged or replaced (backwashed).*

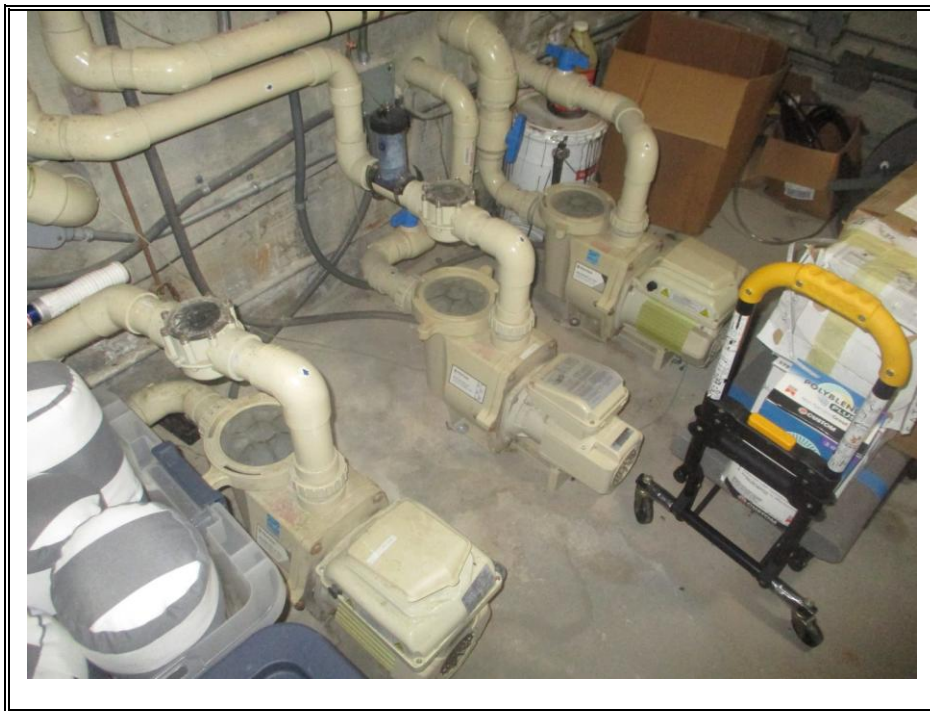
MOTORS/IGNITORS/TRANSFORMERS (TYPICAL)

OBSERVATIONS: *This component addresses the "A. O. Smith" motors, ignitors, and transformers for the pool and spa, comprised of 1 at 1 horsepower and 2 at 2 horsepower. They appeared to be in good condition.*

TO PROTECT YOUR INVESTMENT: *The motors should be regularly examined, lubricated and serviced as necessary.*

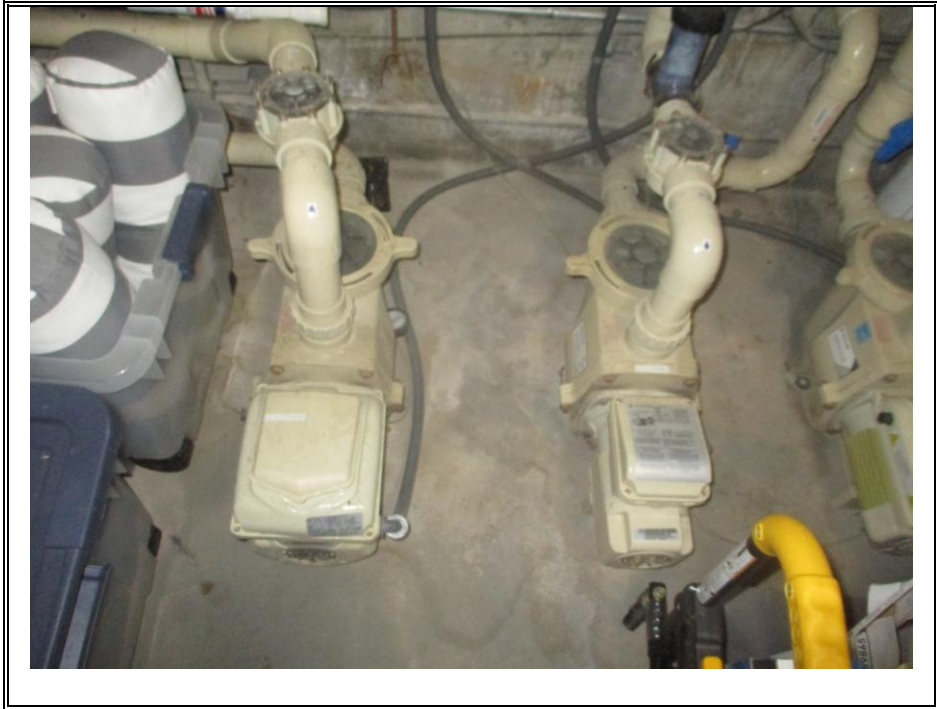
PUMPS (TYPICAL)

OBSERVATIONS: *This component addresses the “Whisper Flo” and “Stealth” pumps for the pool and spa, comprised of 1 at 1 horsepower and 2 at 2 horsepower. They appeared to be in good condition.*

TO PROTECT YOUR INVESTMENT: *The pumps should be regularly examined, lubricated and serviced as necessary.*

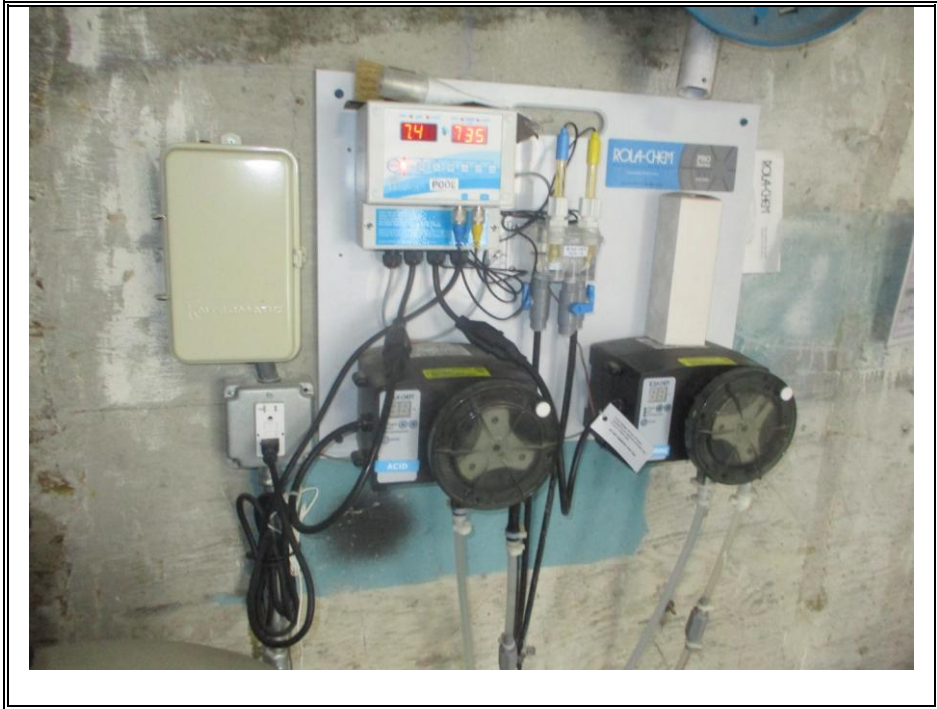
CHLORINATORS (TYPICAL)

OBSERVATIONS: *This component addresses liquid chlorinators systems serving the pool and spa. They appeared to be in good condition.*

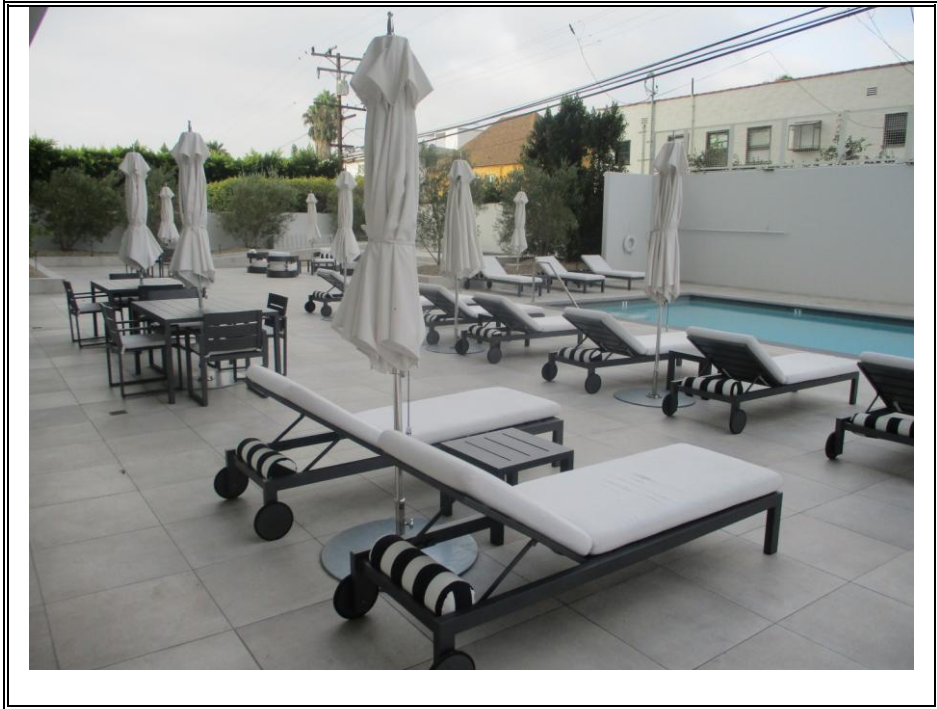
FURNITURE (TYPICAL)

OBSERVATIONS: *This component provides for the replacement of the furniture around the pool and spa, comprised of tables, vinyl strapped chairs, vinyl strapped chaises, and umbrellas. We were informed that it was placed into service in 2024, and it appeared to be in good condition. Exposure to dirt, dust, suntan oils, tree sap, pool chemicals, insecticide sprays, and environmental factors (especially ultraviolet light); contribute significantly to the deterioration of this type of furniture. Proper maintenance can significantly enhance its longevity.*

TO PROTECT YOUR INVESTMENT: *Vinyl strapped furniture should be hosed down on a weekly basis and a vinyl protection product applied regularly (cleansers, undiluted bleach, scouring agents, solvents, and gasoline should never be used). The painted metal frames should occasionally be cleaned with a mild soap and water solution, and an automotive wax applied seasonally. Acrylic/plastic tabletops can be protected / restored with automotive wax as well. Umbrella fabrics can be cleaned with a solution of 1 cup of bleach mixed with 1cup of dish detergent in 3 gallons of water. Corrosion on aluminum umbrella poles can be removed with an aluminum brightener. If possible, the furniture should be covered/put in storage when not in use (especially during off-season).*

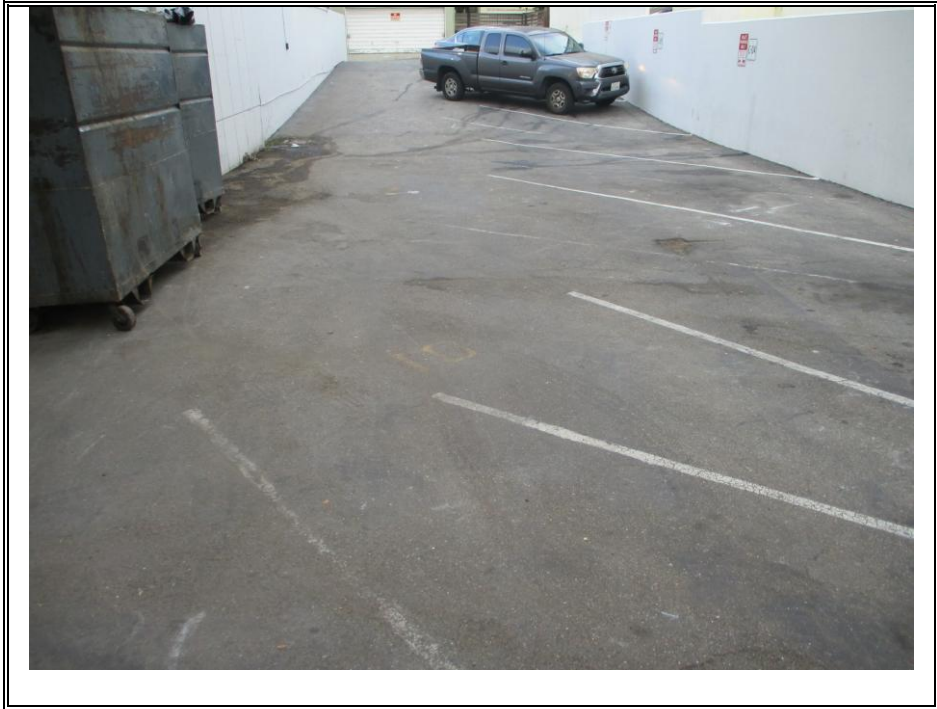
ASPHALT SEAL COAT (TYPICAL)

OBSERVATIONS: *This component addresses the seal coat for the asphalt employee/vendor parking area at the east end of the property. It appeared to be in an aged condition. While a relatively inexpensive procedure, the seal coat serves to enhance the longevity of the underlying asphalt as well as its appearance by replenishing the oil and fine aggregates of the underlying asphalt. It is important that this procedure always be undertaken within 6 months of any overlay or resurfacing and performed thereafter on a 3 – 5 year cycle (typically a warranty requirement).*

TO PROTECT YOUR INVESTMENT: *All asphalt areas should be examined at least annually and any cracks exceeding ¼ inch should be repaired with a rubberized sealant compound. Irrigation run-off can accelerate degradation and should be prevented / diverted.*
