COMPLETE RSI RESERVE STUDY WITH SITE VISIT

HIGH RISE HOMEOWNERS' ASSOCIATION

1234 Main Street
Anywhere, California

2/10/2026

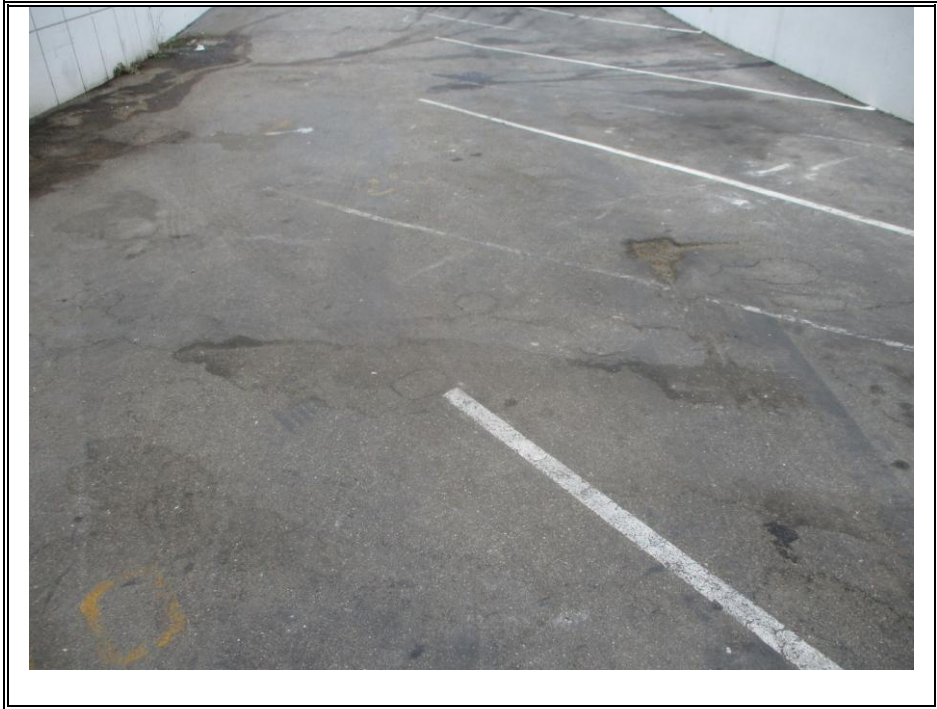
ASPHALT REPLACEMENT (TYPICAL)

OBSERVATIONS: *This component provides for replacement of the asphalt surfaces. We were previously informed that they were installed in 2013, and they appeared to be in an average condition. Aging, oxidation, and vehicle traffic eventually cause cracking, ponding, and uneven pavement. Such surface irregularities may result in improper drainage and compromised driving surfaces. Asphalt replacement entails removal of the existing pavement, grading and compaction of the existing aggregate base material, and the installation of hot asphalt pavement. It is recommended that pavement engineering be obtained prior to replacement in order to guarantee that new pavement specifications will meet or exceed the needs of the common area pavement. In conjunction with replacement, seal coat should be performed within 6 months and then at 3 – 5 year intervals thereafter. It is recommended that prior to replacement, further evaluation be obtained from a soils/geotechnical engineer.*

TO PROTECT YOUR INVESTMENT: *All asphalt areas should be examined at least annually and any cracks exceeding ¼ inch should be repaired with a rubberized sealant compound. Irrigation run-off can accelerate degradation and should be prevented / diverted.*

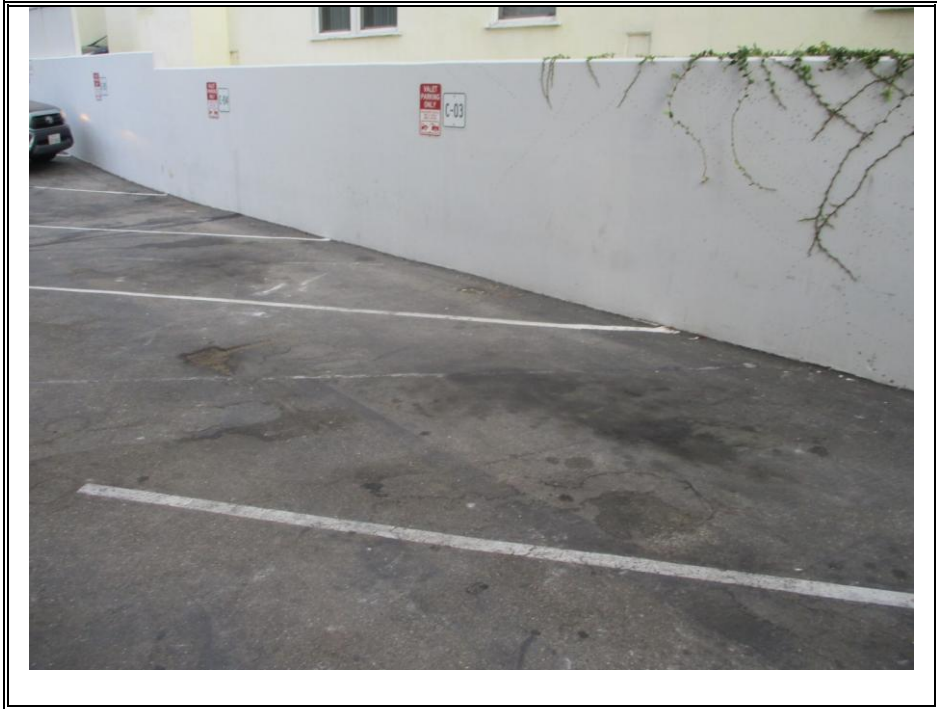
CONCRETE FLATWORK/BLOCK WALLS (TYPICAL)

OBSERVATIONS: *This component addresses the concrete flatwork and block walls throughout the property. Although they appeared to be in an average condition, they should be regularly monitored for cracking and vertical displacement, which can create potential trip hazards (and liability for the association). Otherwise, concrete areas are generally considered a lifetime component. Occasional repairs would typically be funded from the operating account.*

TO PROTECT YOUR INVESTMENT: *Any sections observed to be vertically displaced should be repaired immediately upon discovery. Emphasis should be placed on areas adjacent to trees, as their roots are often the culprits of such damage. As the need for such repairs is difficult to predict, the associated costs should be disbursed either from the association's operating account or the contingency reserve.*

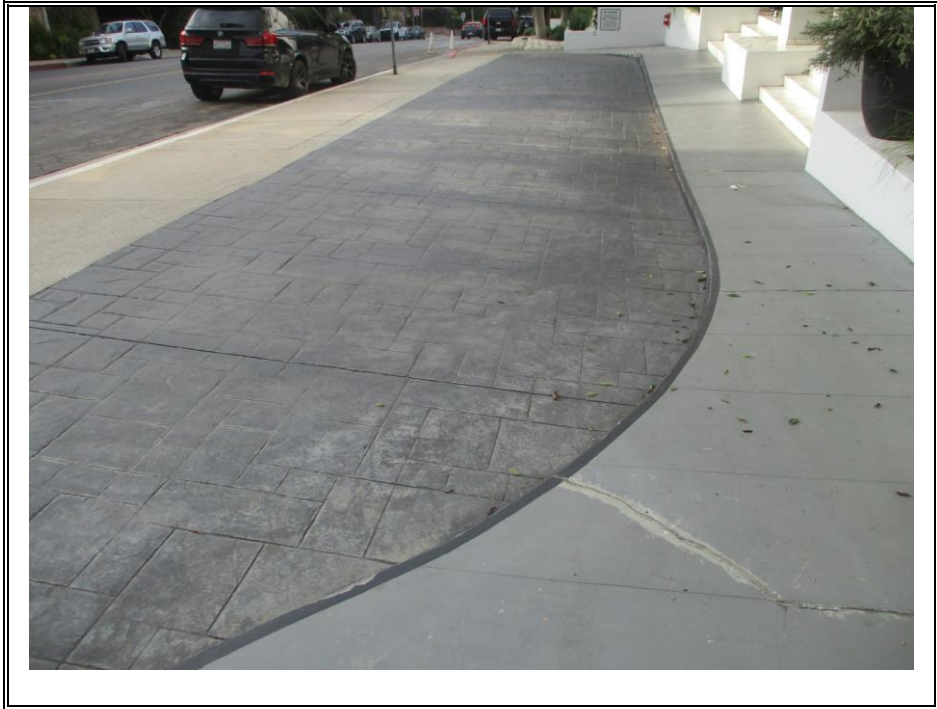
CONCRETE PAVERS (TYPICAL)

OBSERVATIONS: *This component addresses the concrete pavers of the valet parking area at the front of the building. We were previously informed that they were installed in 2012, and they appeared to be in an average condition.*

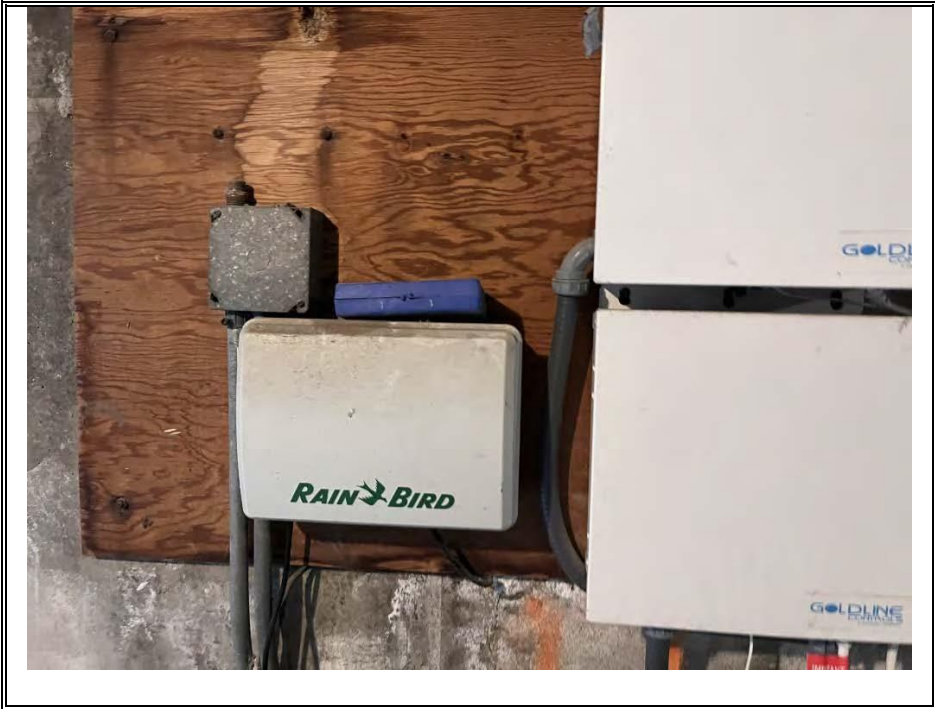
IRRIGATION CONTROLLERS (TYPICAL)

OBSERVATIONS: *This component addresses the irrigation controllers at the pool equipment area and in the maintenance closet. We were previously informed that they were installed in 2020, and they appeared to be in an average condition. They tend to have a more predictable life expectancy, and the average component cost provides for their replacement. However, average life expectancies cannot be predicted for the other sprinkler components or automatic valve actuation systems. Repairs or replacements of such systems usually occur on an ongoing basis and should be covered under the operating account.*

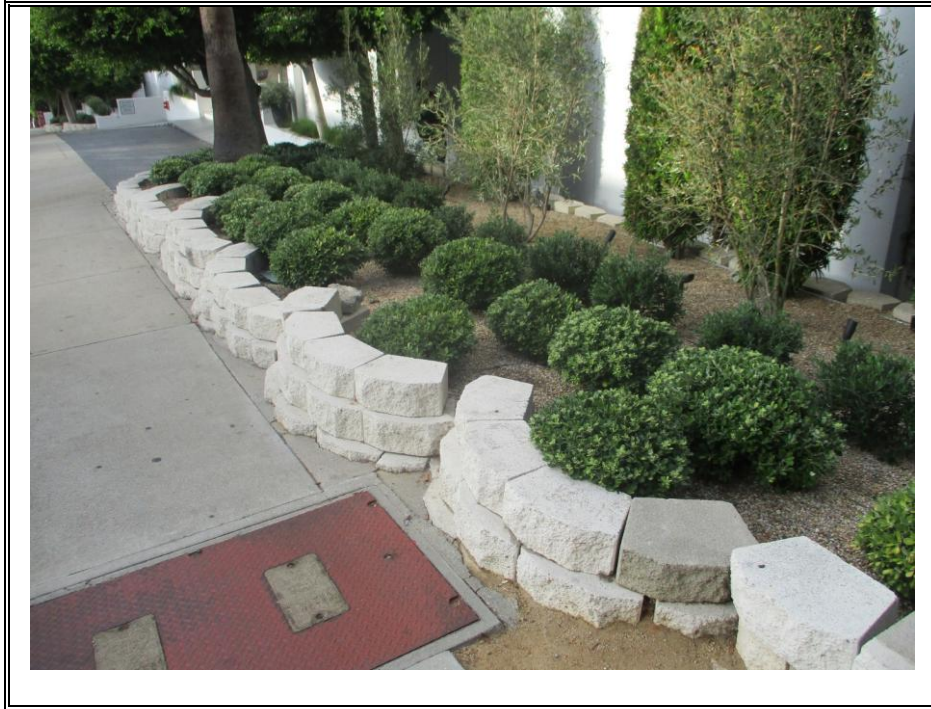
LANDSCAPE REMODEL (TYPICAL)

OBSERVATIONS: *This component provides an allowance for landscape remodeling. We were informed it was remodeled in 2025, and it appeared to be in good condition.*

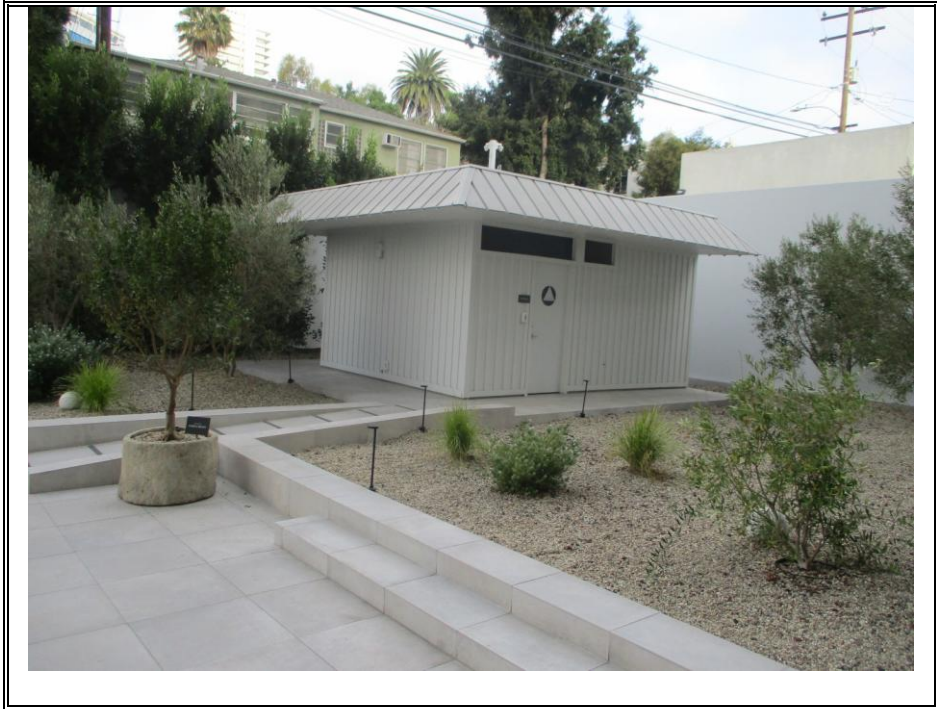
MAJOR TREE TRIMMING/REMOVAL (TYPICAL)

OBSERVATIONS: *This component addresses major tree trimming or removal. There were no major problems observed (or reported to us) with respect to structural damage from any trees.*

TO PROTECT YOUR INVESTMENT: *Annual tree trimming (operating budget item) will minimize the need for major tree topping, which may be detrimental to both the growth and stability of the trees.*

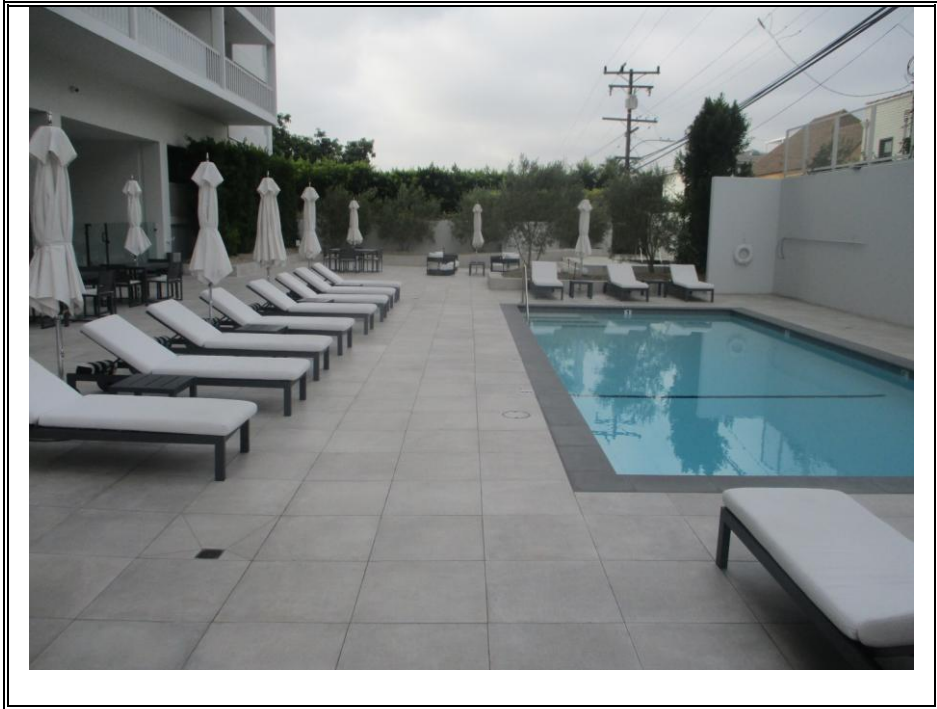
FENCING (TYPICAL)

OBSERVATIONS: *This component addresses the concrete fencing at the pool perimeter. We were previously informed that it was installed in 2019. Although it appeared to be in an average condition, it should be regularly monitored for cracking and separating. Otherwise, concrete areas are generally considered a lifetime component. Occasional repairs would typically be funded from the operating account.*

TO PROTECT YOUR INVESTMENT: *Any sections observed to be vertically displaced should be repaired immediately upon discovery. Emphasis should be placed on areas adjacent to trees, as their roots are often the culprits of such damage. As the need for such repairs is difficult to predict, the associated costs should be disbursed either from the association's operating account or the contingency reserve.*

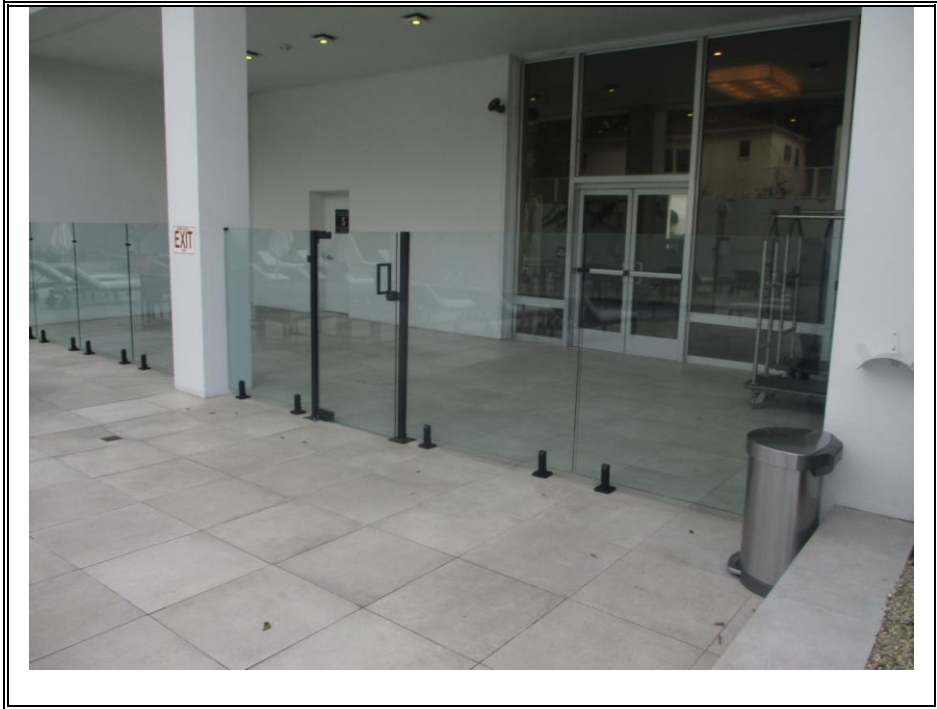
GLASS SCREEN WALLS (TYPICAL)

OBSERVATIONS: *This component addresses the glass screen walls and gates at the rear courtyard. They appeared to be in good condition.*

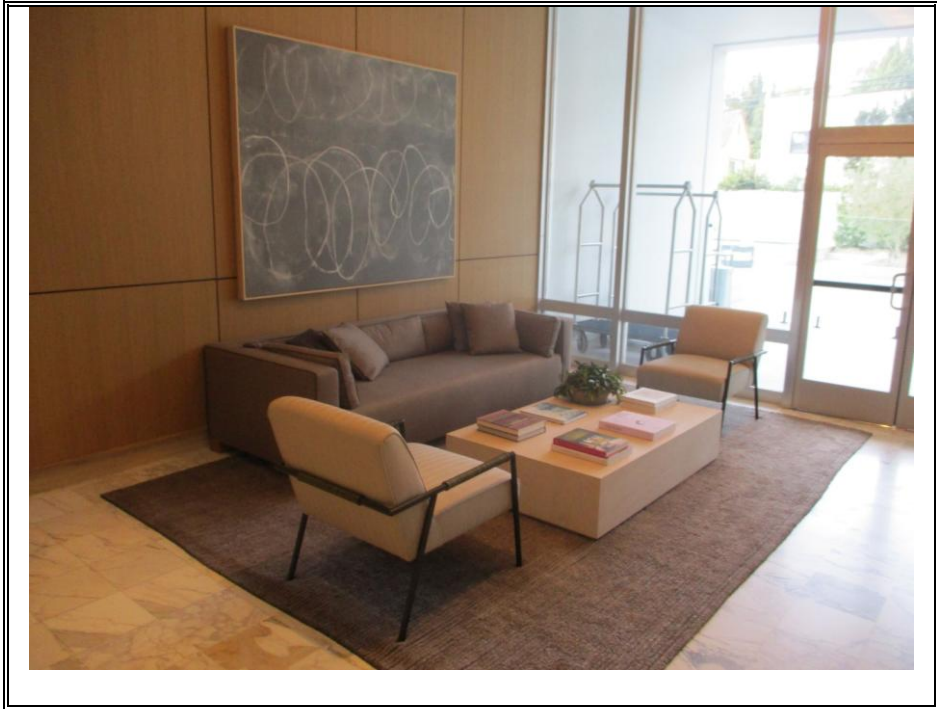
FURNISHINGS-LOBBY (TYPICAL)

OBSERVATIONS: *This component addresses the furnishings in the lobby, comprised of sofas, chairs, benches, tables, wall hangings, planters, credenzas, ceiling lights, hanging lights, ash trays, and mirrors. The average component cost is general for the type of furnishings in use. We were informed that the lobby was refurbished in 2024, and it appeared to be in good condition.*

TO PROTECT YOUR INVESTMENT: *General cleaning should be performed on a regular basis. Wood surfaces should be cleaned with a standard furniture polish. Upholstered areas should be vacuumed periodically and cleaned as necessary with a mild soap solution or professionally steam cleaned simultaneously with carpeted areas.*

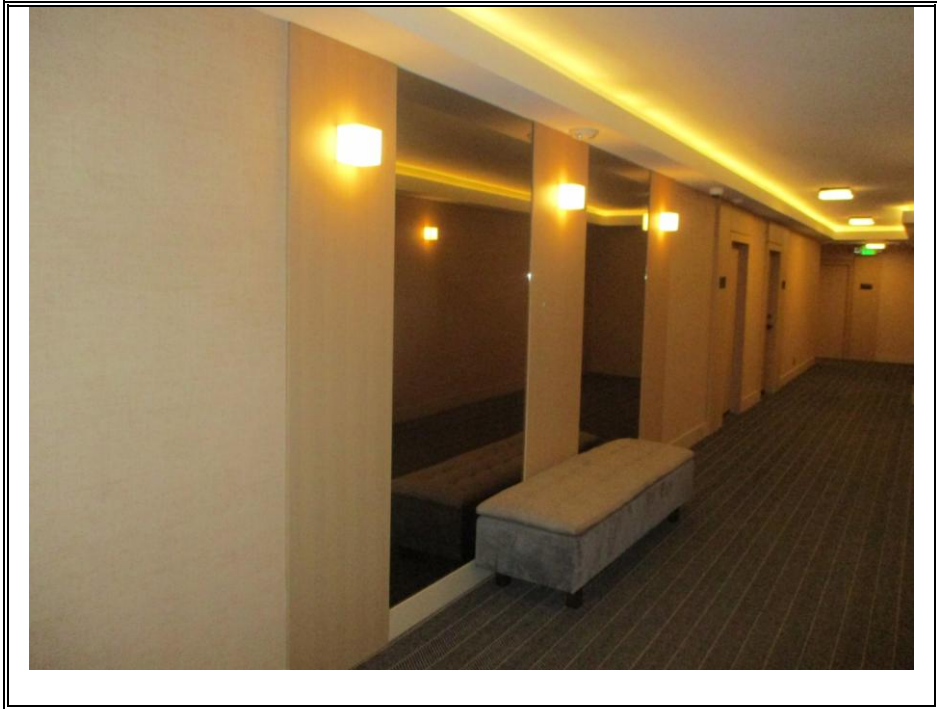
FURNISHINGS-HALLWAYS (TYPICAL)

OBSERVATIONS: *This component addresses the furnishings in the hallways, comprised of wall mirrors and benches. We were informed that they were placed into service in 2024, and they appeared to be in good condition. The average component cost is general for the type of furnishings in use.*

TO PROTECT YOUR INVESTMENT: *General cleaning should be performed on a regular basis. Wood surfaces should be cleaned with a standard furniture polish. Upholstered areas should be vacuumed periodically and cleaned as necessary with a mild soap solution or professionally steam cleaned simultaneously with carpeted areas.*

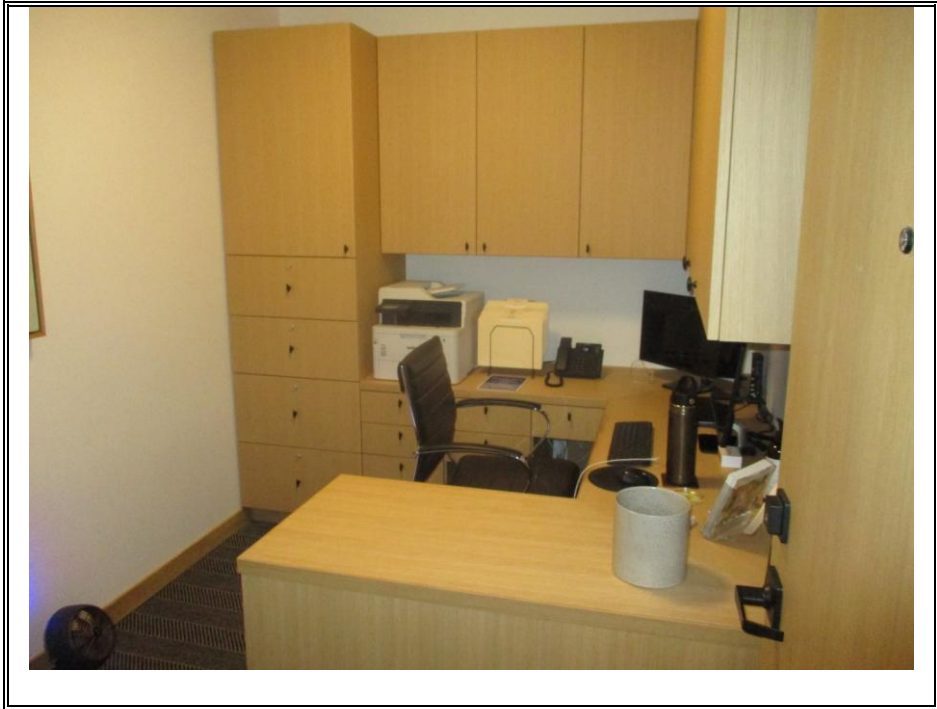
FURNISHINGS-OFFICE (TYPICAL)

OBSERVATIONS: *This component addresses the office equipment in the manager's office; comprised of built-in cabinets, a wood filing cabinet, a wood book cabinet, a computer, a monitor, a copier/scanner/fax/printer, a small desk, and a desk chair. It appeared to be in various conditions, and for the purposes of reporting, the remaining life has been averaged. The average component cost is general for the type of equipment in use.*

TO PROTECT YOUR INVESTMENT: *Maintenance should be performed according to the various manufacturers' specifications (refer to the respective operating manuals for same).*

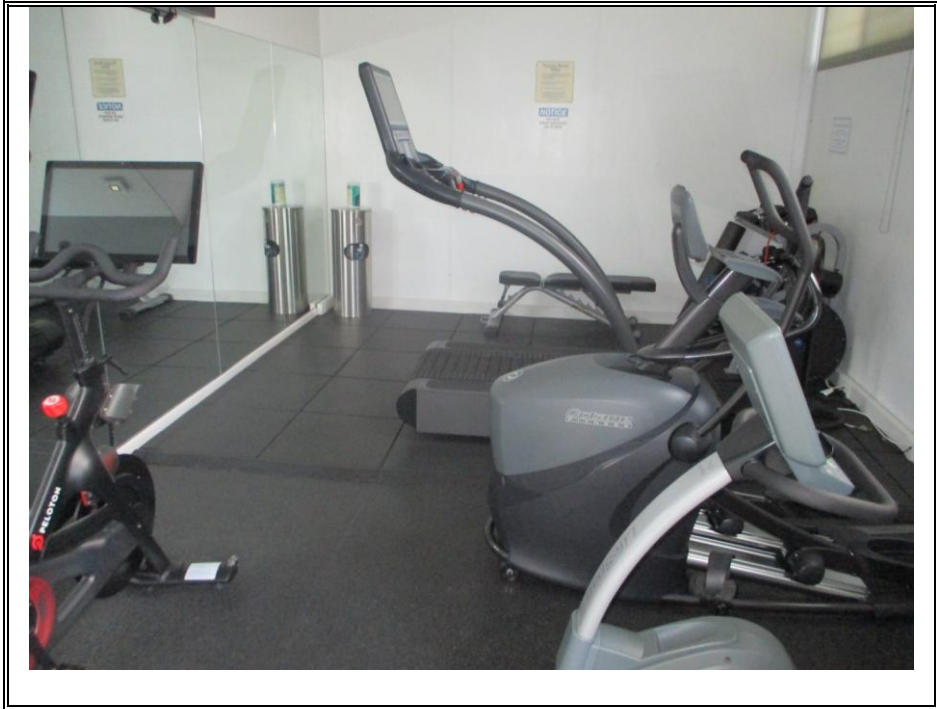
FITNESS EQUIPMENT (TYPICAL)

OBSERVATIONS: *This component addresses the fitness equipment in the gym, comprised of a treadmill, an elliptical machine, a lifecycle, weight machines/benches, a newer rack with dumbbells, a resistance tower, a mirror, window treatments, a television, and a fan. It appeared to be in various conditions, and for the purposes of reporting the remaining life has been averaged. Some of the equipment would most likely be replaced while other items may lend themselves to being refurbished. The average component cost is general for this type of equipment.*

TO PROTECT YOUR INVESTMENT: *The equipment should be maintained in a sanitary condition. Applicable instructions as well as warnings should be posted with respect to proper use of the equipment.*

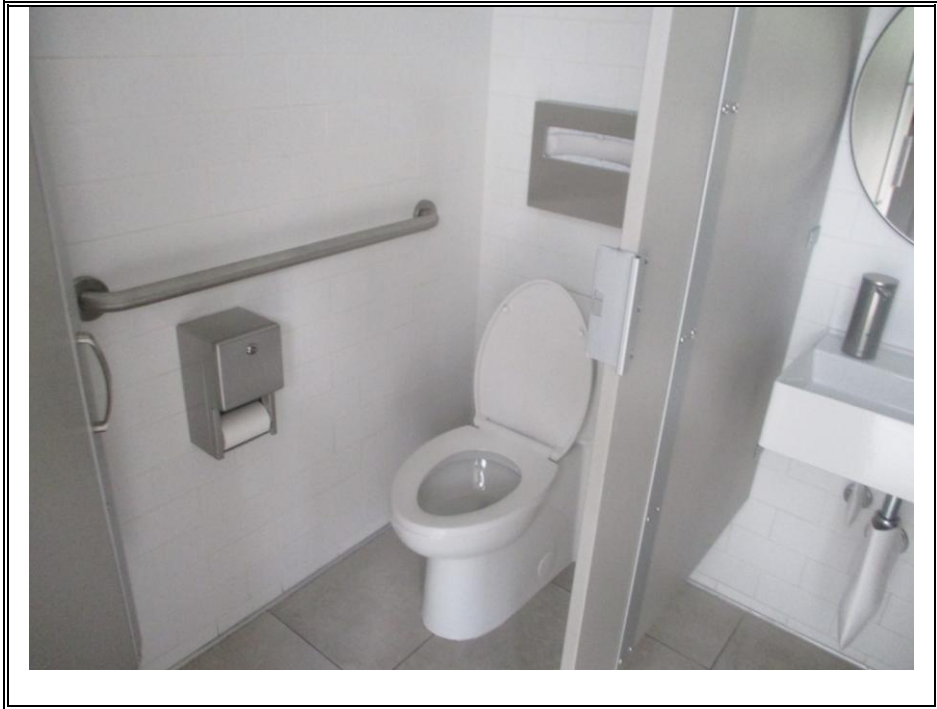
RESTROOMS (TYPICAL)

OBSERVATIONS: *This component addresses the remodeling of the common area restrooms, comprised of sinks, toilets, partitions, mirrors, showers, towel dispensers, soap dispensers, and wall and floor tiles. We were informed that the pool area restrooms were remodeled in 2024, and they appeared to be in good condition.*

TO PROTECT YOUR INVESTMENT: *The restroom should be maintained in a sanitized condition.*

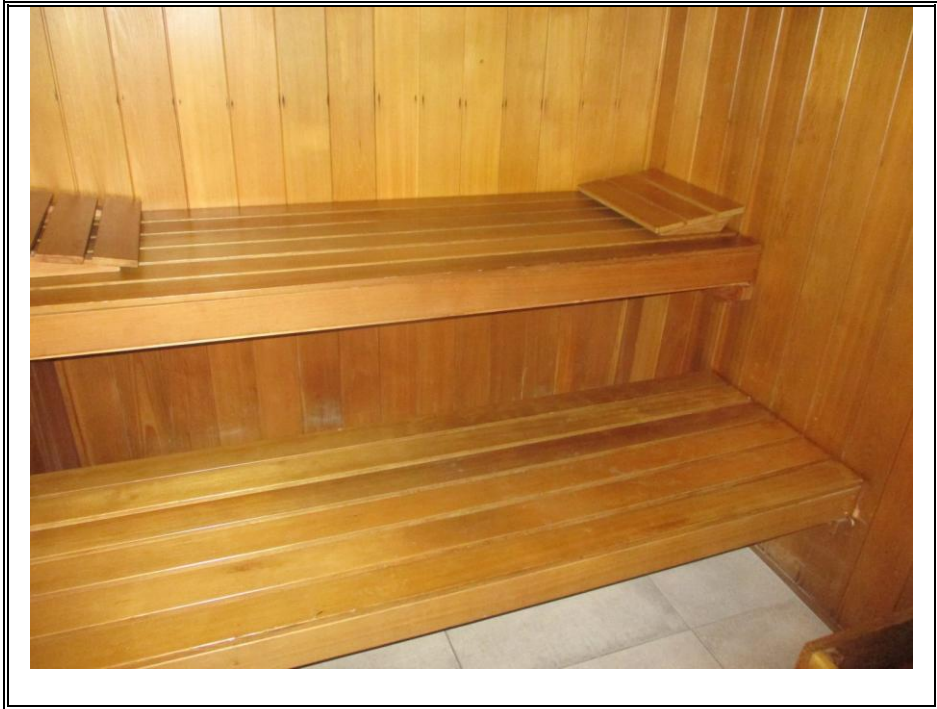
SAUNAS-REFINISH (TYPICAL)

OBSERVATIONS: *This component addresses the refinishing of the wooden sauna enclosures at the pool area restrooms. We were informed that they were remodeled in 2023, and they appeared to be in good condition. Longevity of this component is a function of level of usage and refinishing is recommended for aesthetic as well as hygienic reasons.*

TO PROTECT YOUR INVESTMENT: *Maintenance of the sauna enclosure entails periodically sealing with a preservative, dependent upon level of use.*

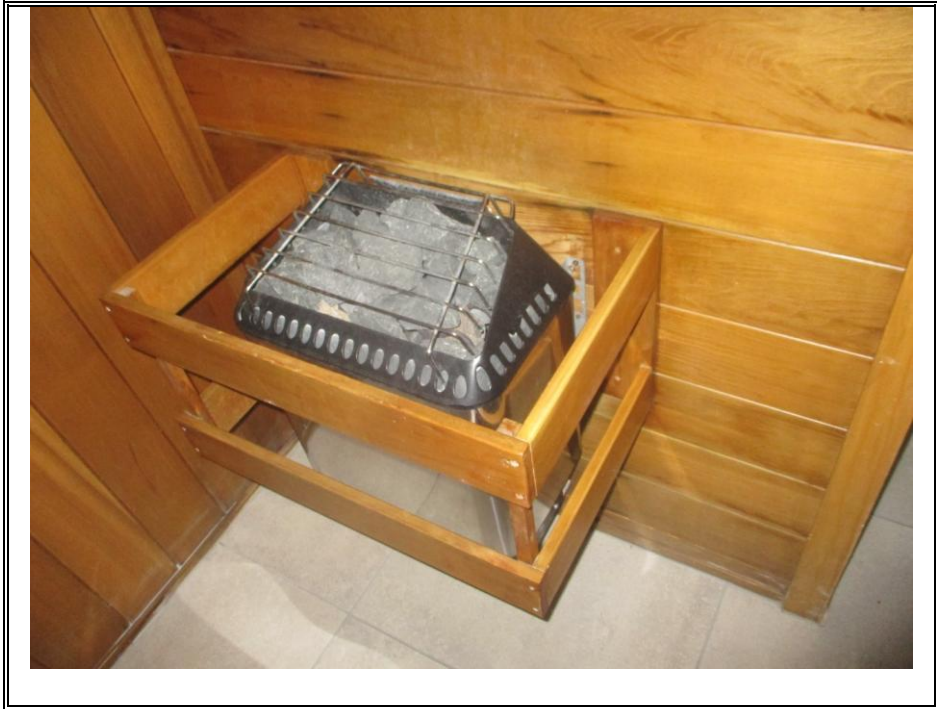
SAUNAS-HEATERS (TYPICAL)

OBSERVATIONS: *This component addresses the electric sauna heaters, at 8 kilowatts each. We were informed that they were refurbished in 2024, and they appeared to be in good condition. Frequency and sporadic usage are factors affecting the longevity of this component.*

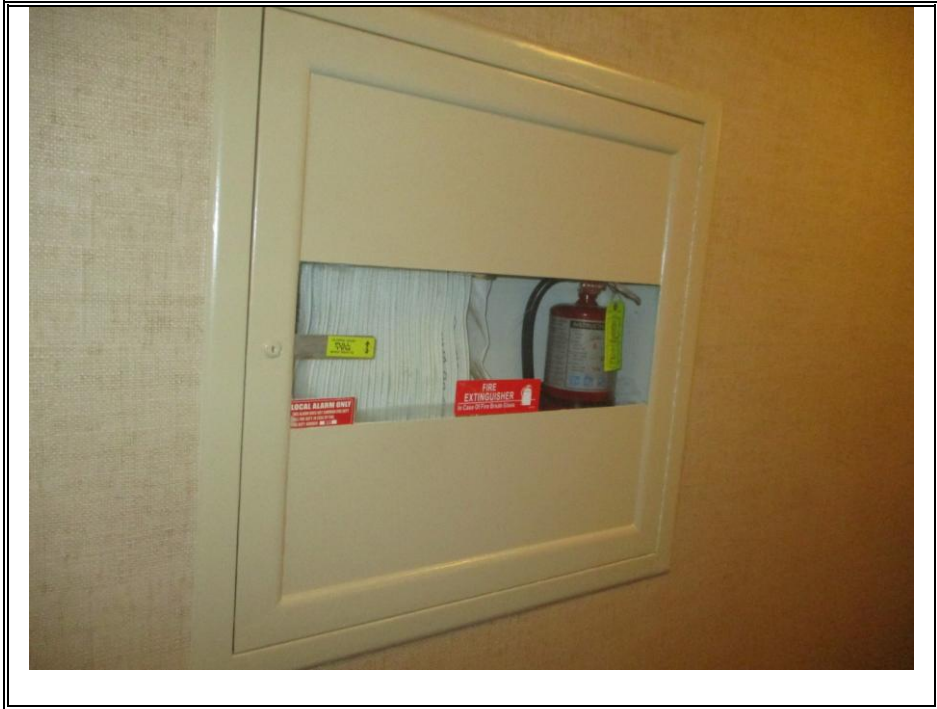
FIRE EXTINGUISHERS (TYPICAL)

OBSERVATIONS: *This component addresses the fire extinguishers throughout the property. We were informed that they were placed into service in 2023, serviced in 2024, and they appeared to be in good condition.*

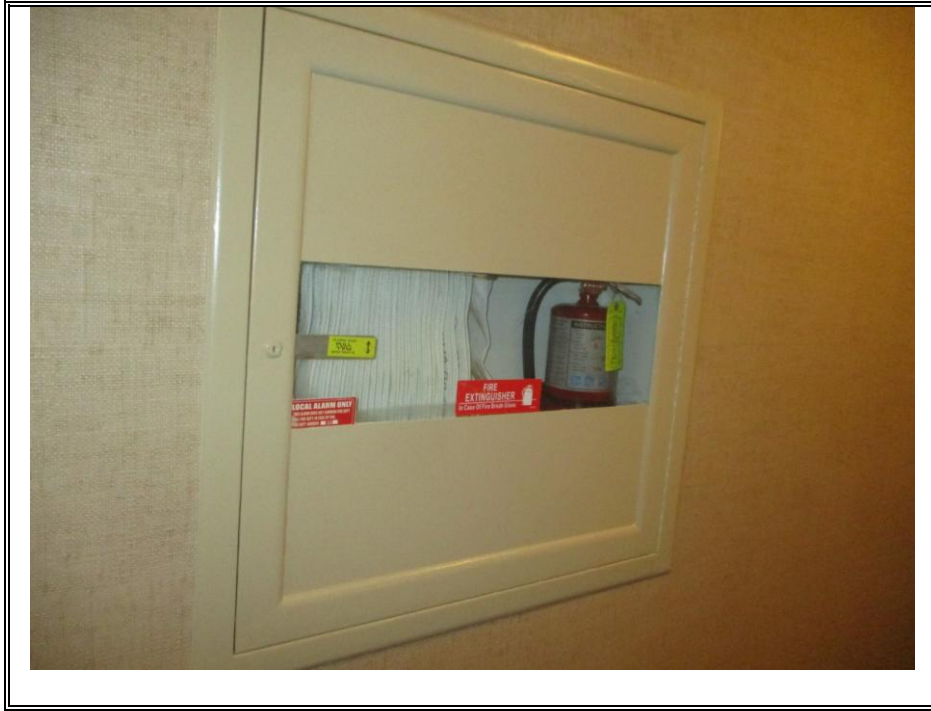
FIREHOSES (TYPICAL)

OBSERVATIONS: *This component addresses the fire hoses throughout the property. They appeared to be in various conditions, and for the purposes of reporting the remaining life has been averaged. The average component cost provides for replacement of only the hoses and nozzles.*

TO PROTECT YOUR INVESTMENT: *The fire hoses should be inspected by a State Fire Marshall approved company at a maximum of 1-year intervals (or as required by law).*

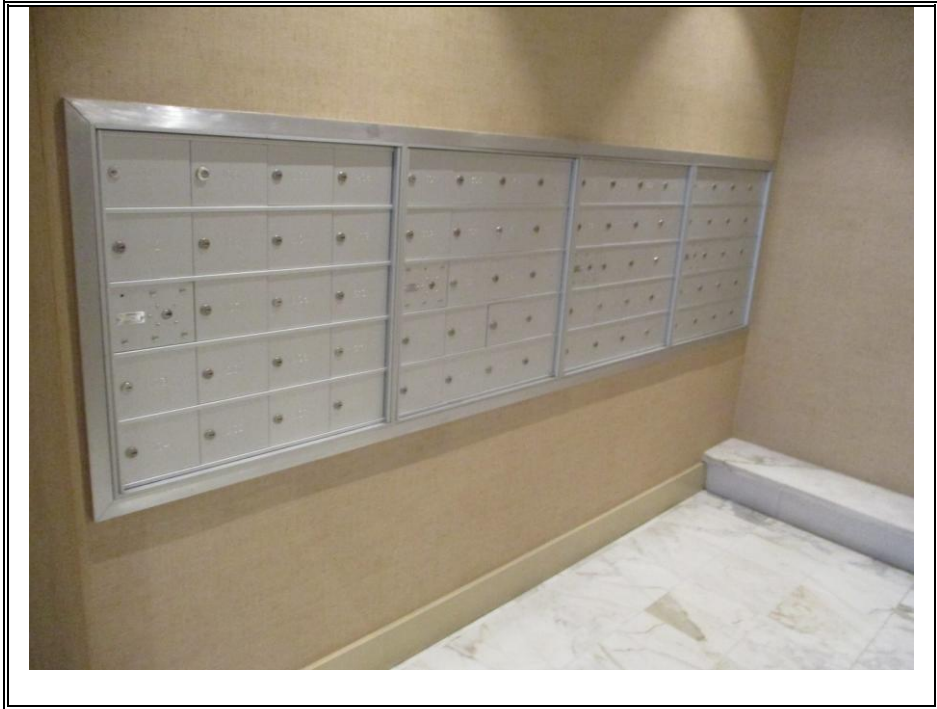
MAILBOXES (TYPICAL)

OBSERVATIONS: *This component addresses the clusters of individual mailboxes at the mailbox center in the main lobby. We were informed that they were installed in 2020, and they appeared to be in good condition.*

TO PROTECT YOUR INVESTMENT: *Other than occasional lubrication of the locks, little can be performed by way of maintenance for this type of equipment.*

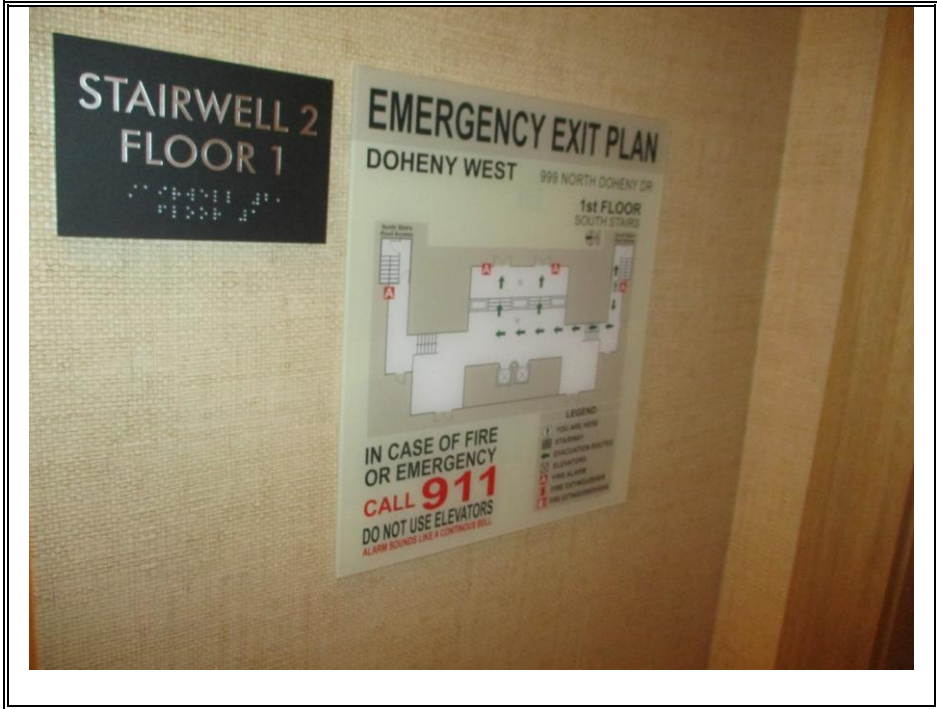
SIGNS (TYPICAL)

OBSERVATIONS: *This component addresses the plastic signs throughout the property. They appeared to be in good condition. It is recommended that replacement be done on an as-needed basis and funded from the operating account.*

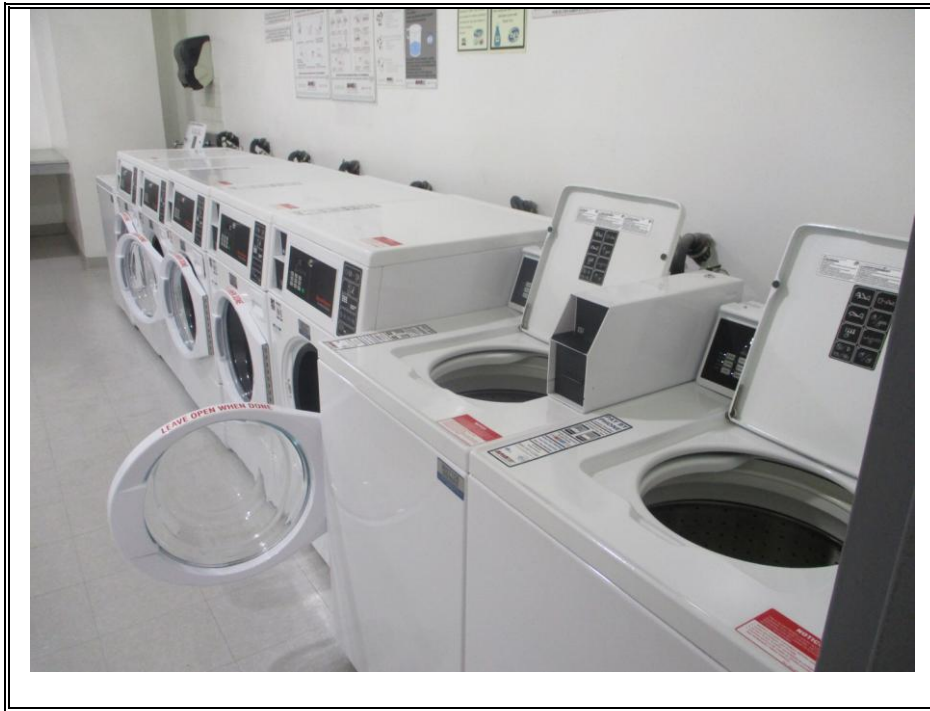
LAUNDRY EQUIPMENT (TYPICAL)

OBSERVATIONS: *This component addresses the coin operated washers and dryers in the laundry rooms of the apartment buildings. We were informed they are leased.*
